Asphalt Concrete Pavement Arterial Roadway Salt and Brine Impact Study Edmonton, AB

PRESENTED TO
City of Edmonton

DECEMBER 3, 2020
ISSUED FOR USE
FILE: ENG.EMAT03787-01

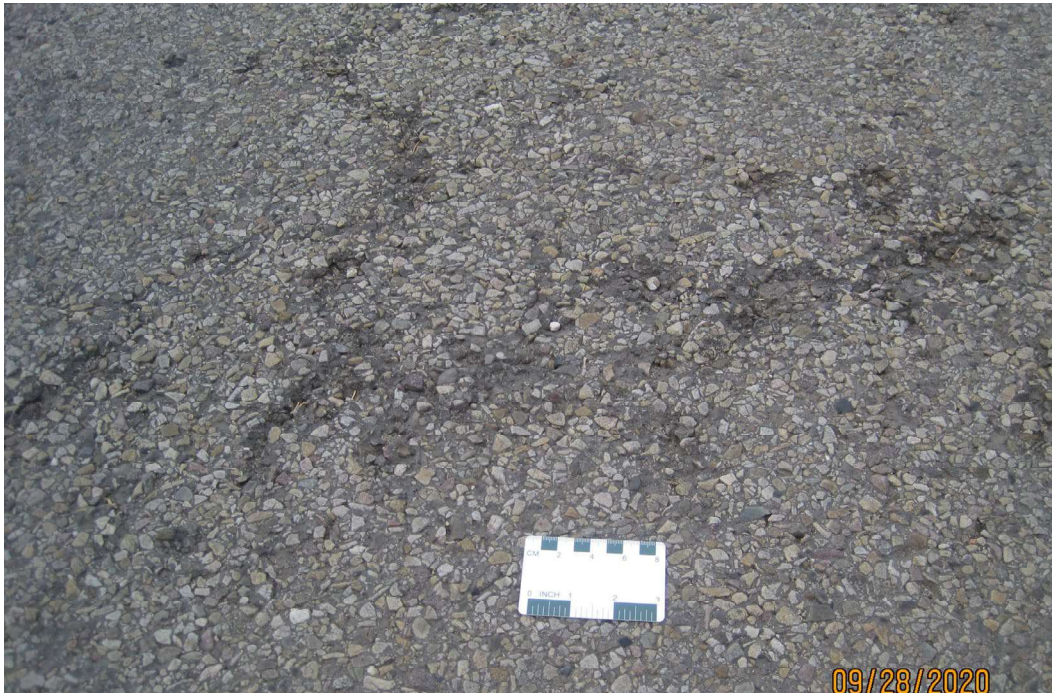
Observations from the 2020 field review and pavement condition assessment indicated an overall good to fair roadway condition. In general, the pavement condition was observed to be worse (i.e., more ravelling) from the field review compared to the 2020 photologs. The primary distress types included coarse aggregate loss, and localized ravelling.

Photo 1: 122 St NW at 62 Ave–Pavement condition at segregated area, close-up

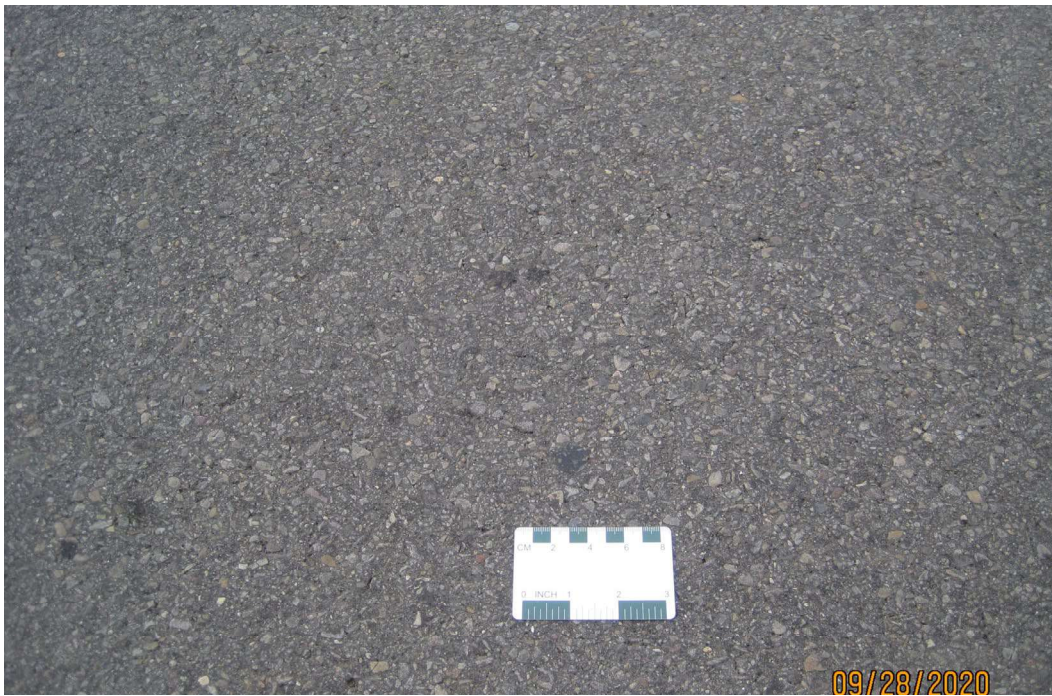
Photo 2: 122 St NW at 51 Ave–General pavement condition, close-up

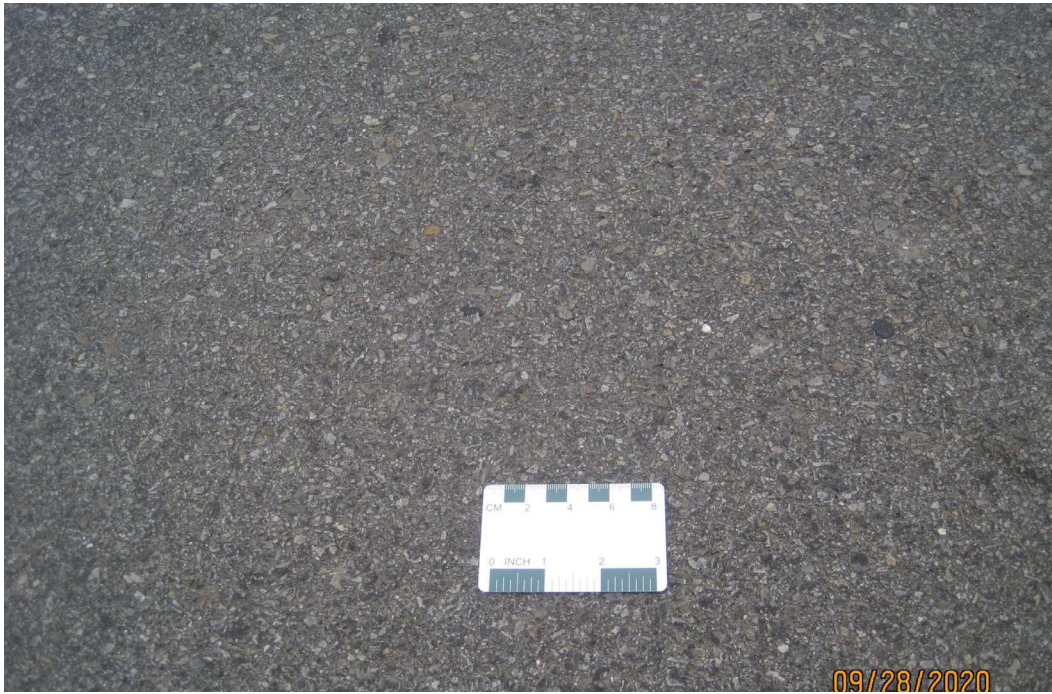
Observations from the 2020 field review and pavement condition assessment indicated an overall good roadway condition. The primary distress type included medium to high density (~5 m) transverse cracking – assumed to be reflective cracking. No significant areas of ravelling, segregation, or hairline cracking were observed.

Photo 3: Groat Road at 89 Ave, General pavement condition, close-up

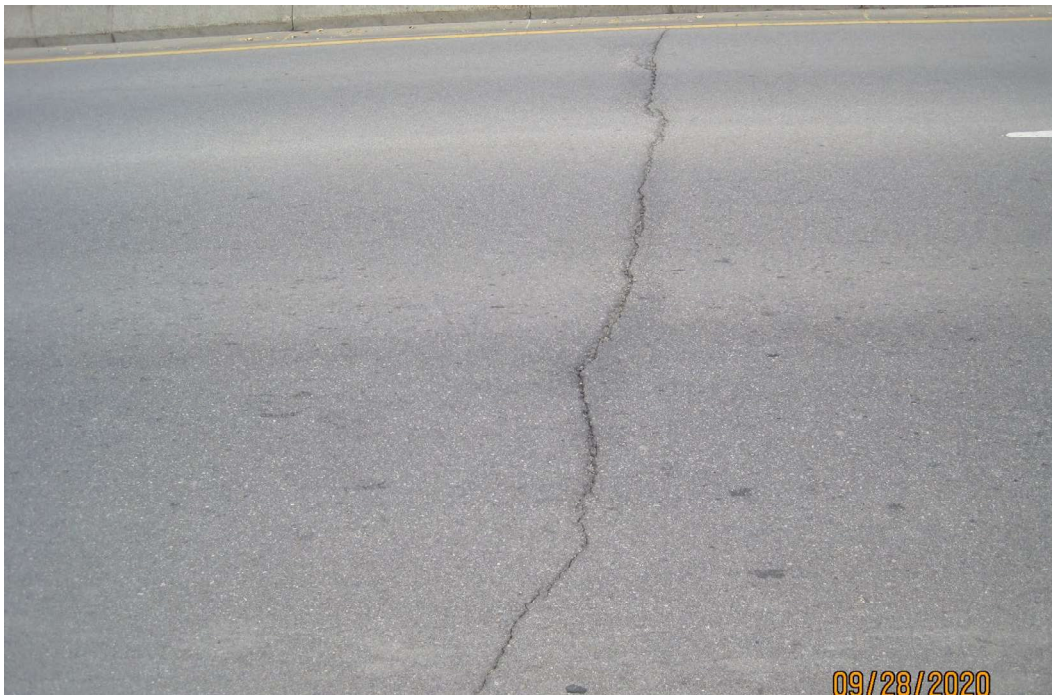
Photo 4: Groat Road at 89 Ave, Transverse crack, looking south

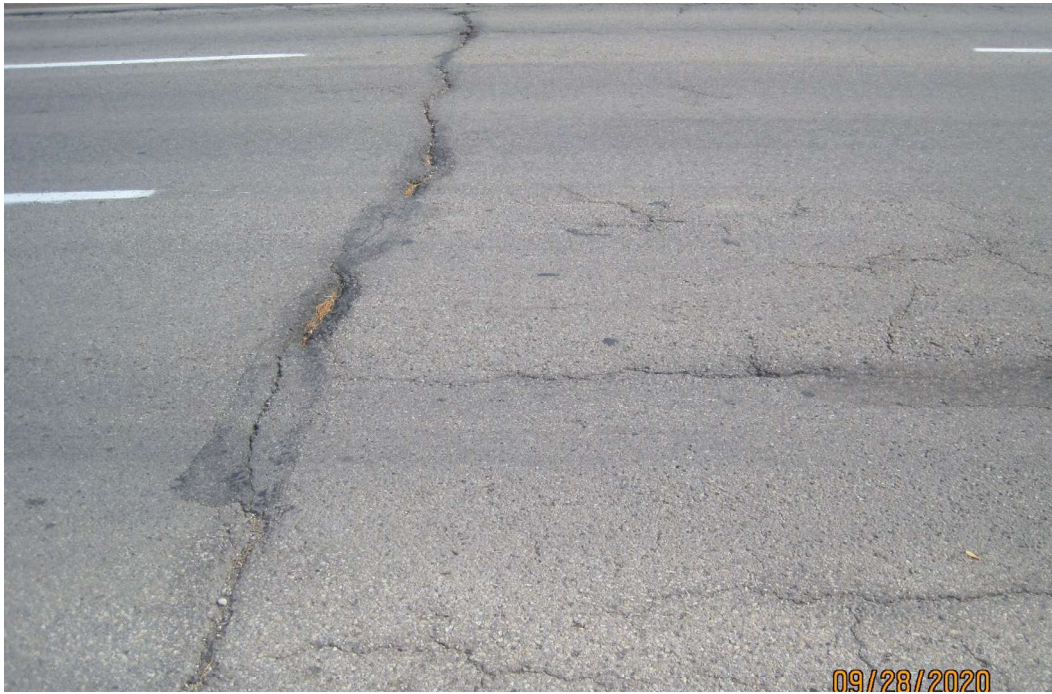
Observations from the 2020 field review and pavement condition assessment indicated an overall poor or very poor roadway condition. The primary distress type included medium to high density (~5 m) longitudinal and transverse cracking. Frequent instances of potholes were also observed. This section of roadway presented the highest rate of general ravelling of all the five roadway sections. The presence of ongoing spray patching was evident in both the photo logs and field review.

Photo 5: 178 St NW at 93 Ave—Transverse crack, looking east

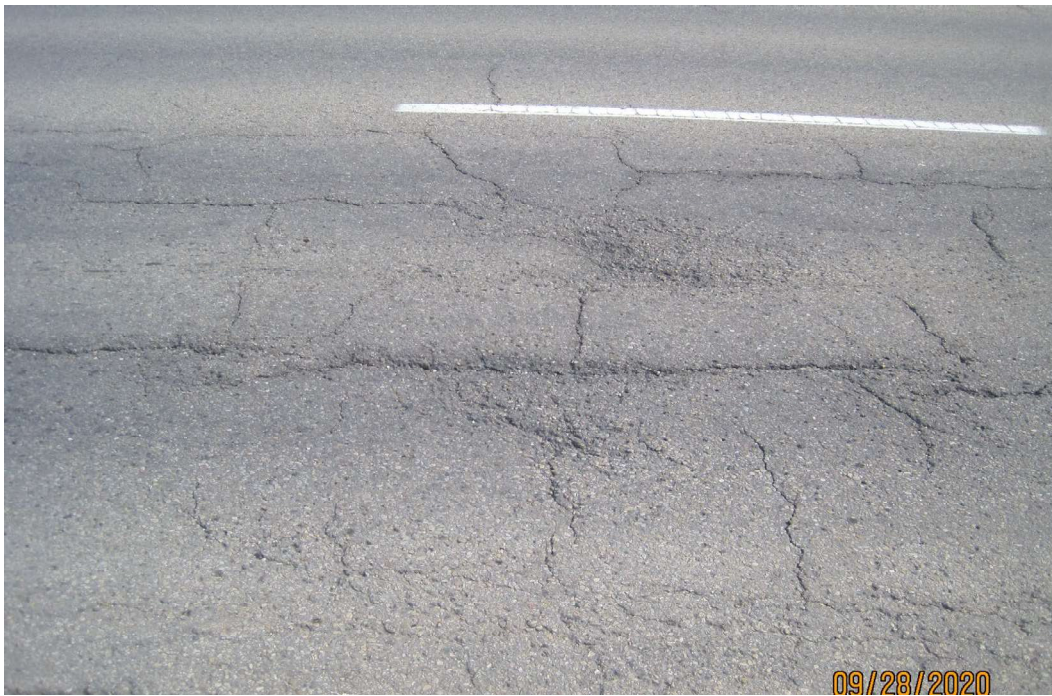
Photo 6: 178 St NW at 93 Ave—General pavement condition, looking east

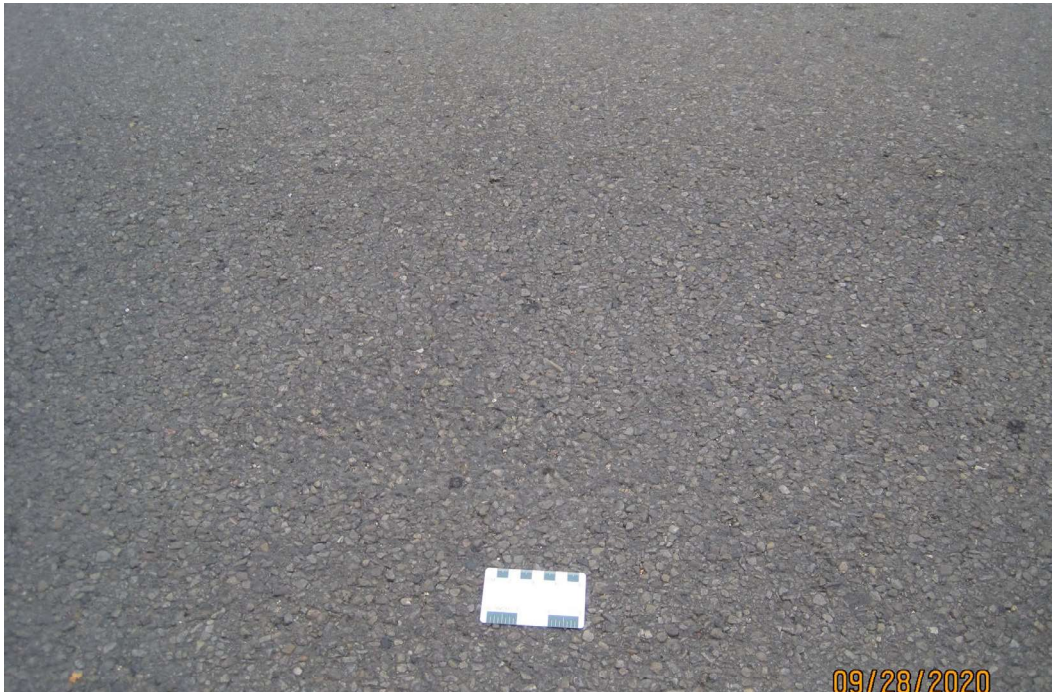
Observations from the 2020 field review and pavement condition assessment indicated an overall good pavement condition. The primary distress type included low density (~15 m) transverse cracking – assumed to be reflective cracking. Only localized areas of ravelling, segregation or hairline cracking were observed. In most cases, these distresses were observed to be of low severity.

Photo 7: 111 Ave NW at 130 St, General pavement condition, close-up

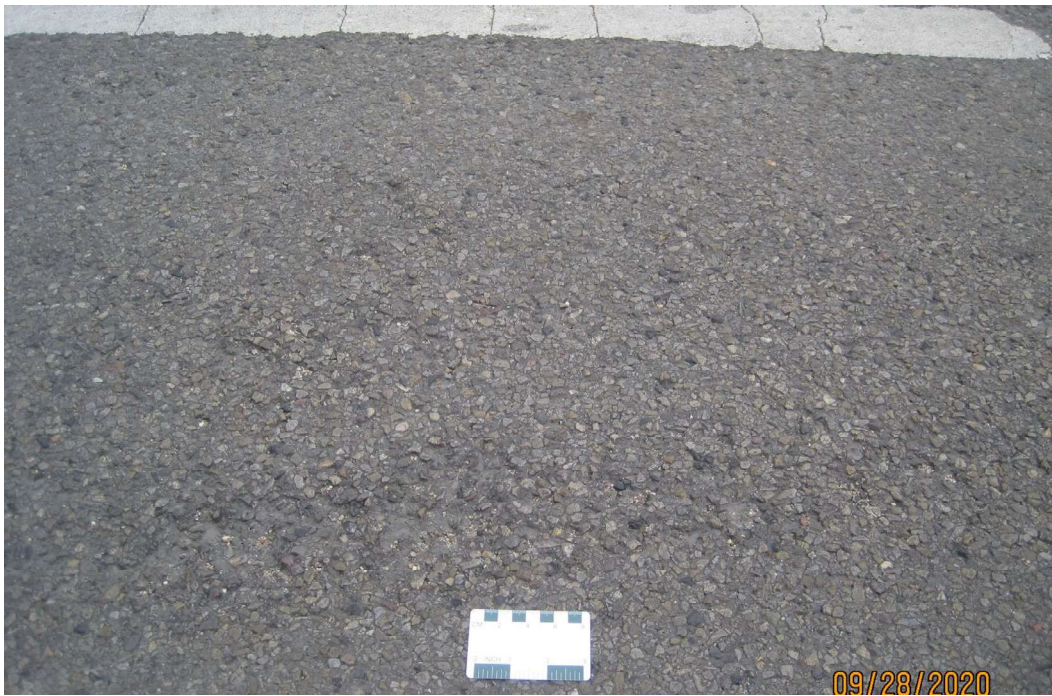
Photo 8: 111 Ave NW at 129 St, Pavement condition at segregated area, close-up

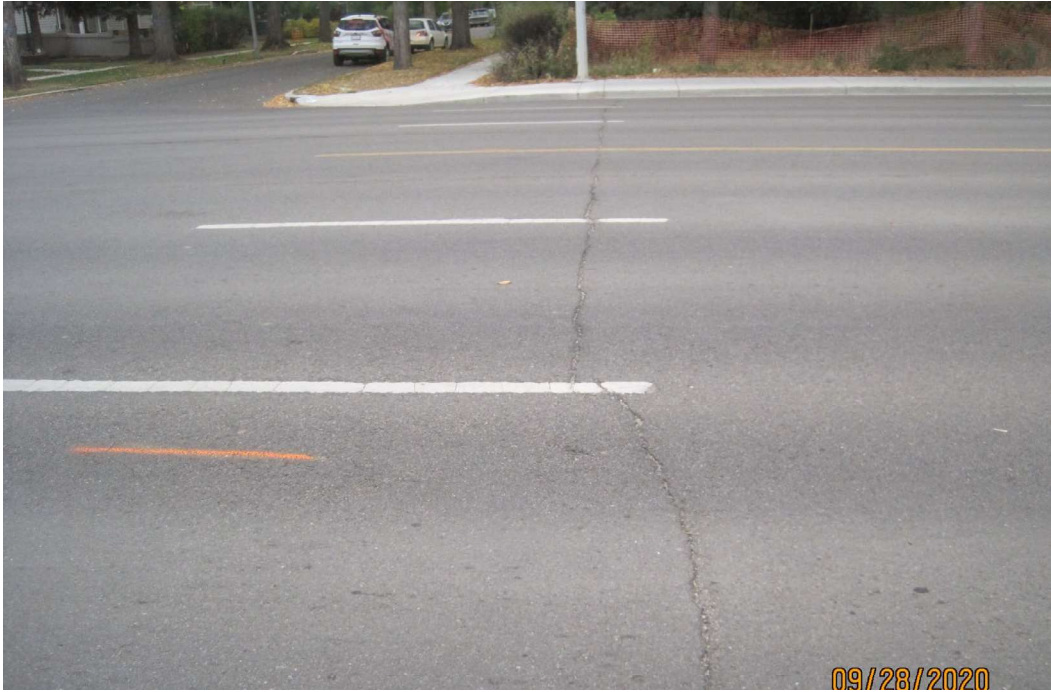
Photo 9: 111 Ave NW at 126 St, Transverse crack, looking north

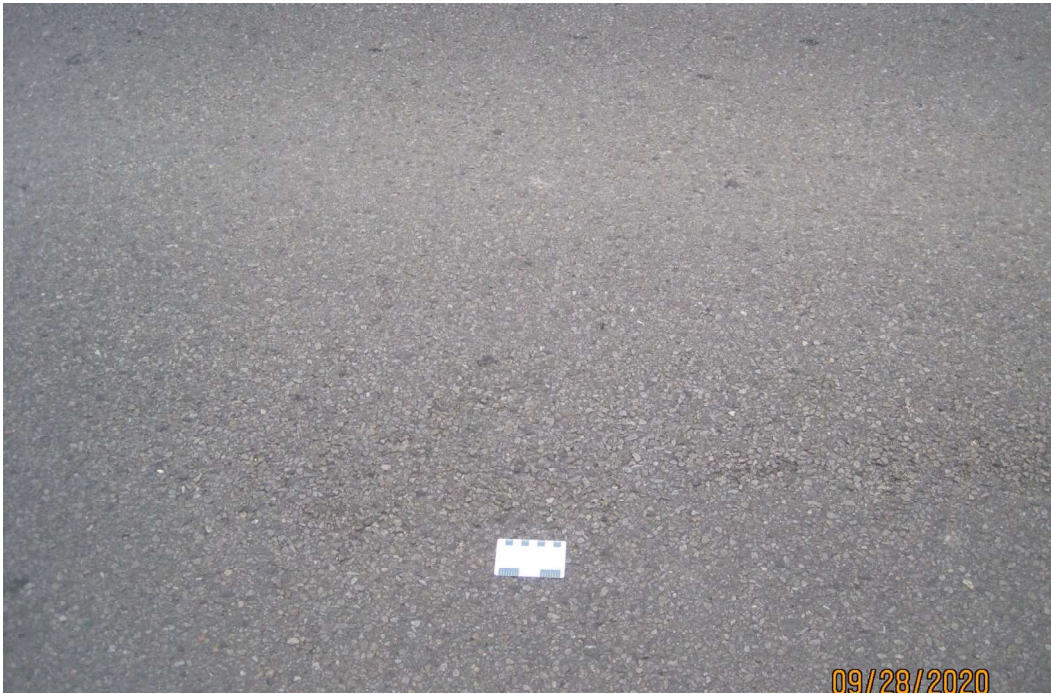
Photo 10: 111 Ave NW at 125 St, Pavement condition at segregated area, close-up

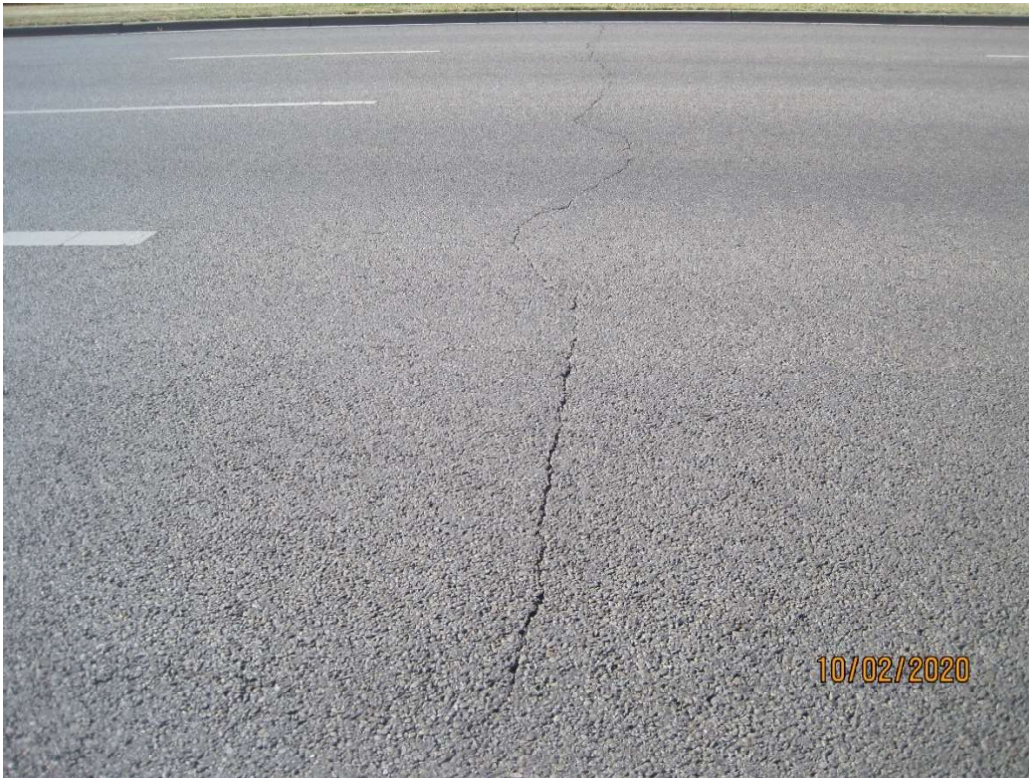
Observations from the 2020 field review and pavement condition assessment indicated an overall good roadway condition. The primary distress type included infrequent (~30 m) transverse cracking – assumed to be reflective cracking. No significant areas of ravelling, segregation or hairline cracking were observed.

Photo 11: 97 St NW (NB) at 153 Ave, Transverse crack, looking west

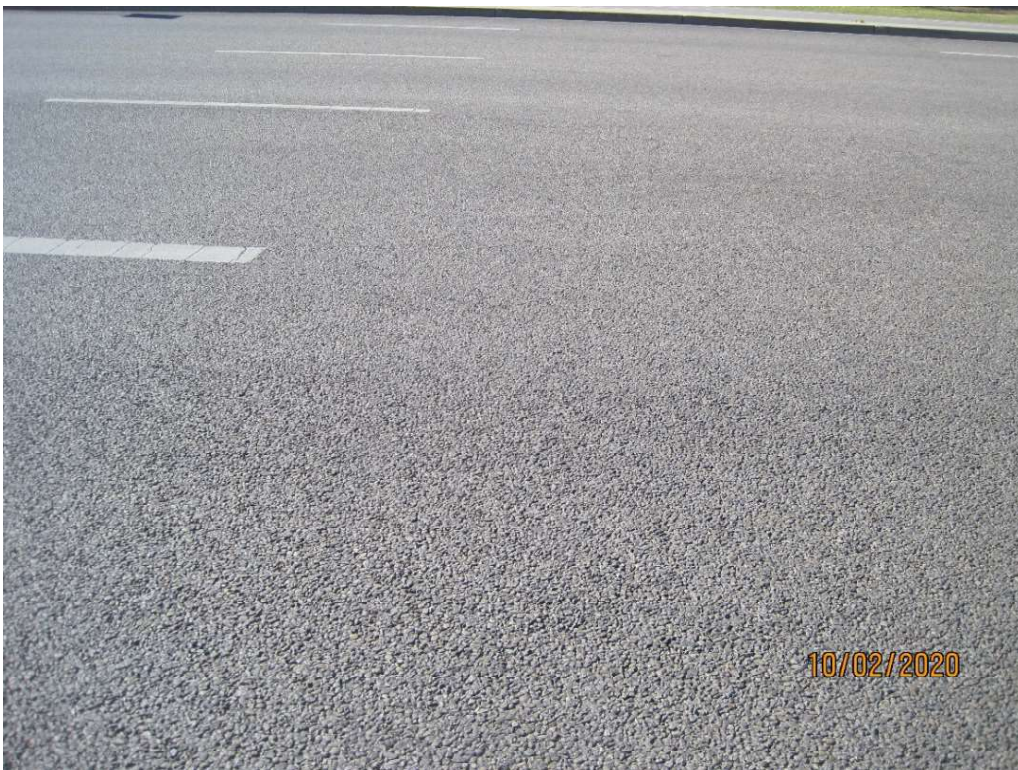
Photo 12: 97 St NW (NB) at 165 Ave, General pavement condition, close-up

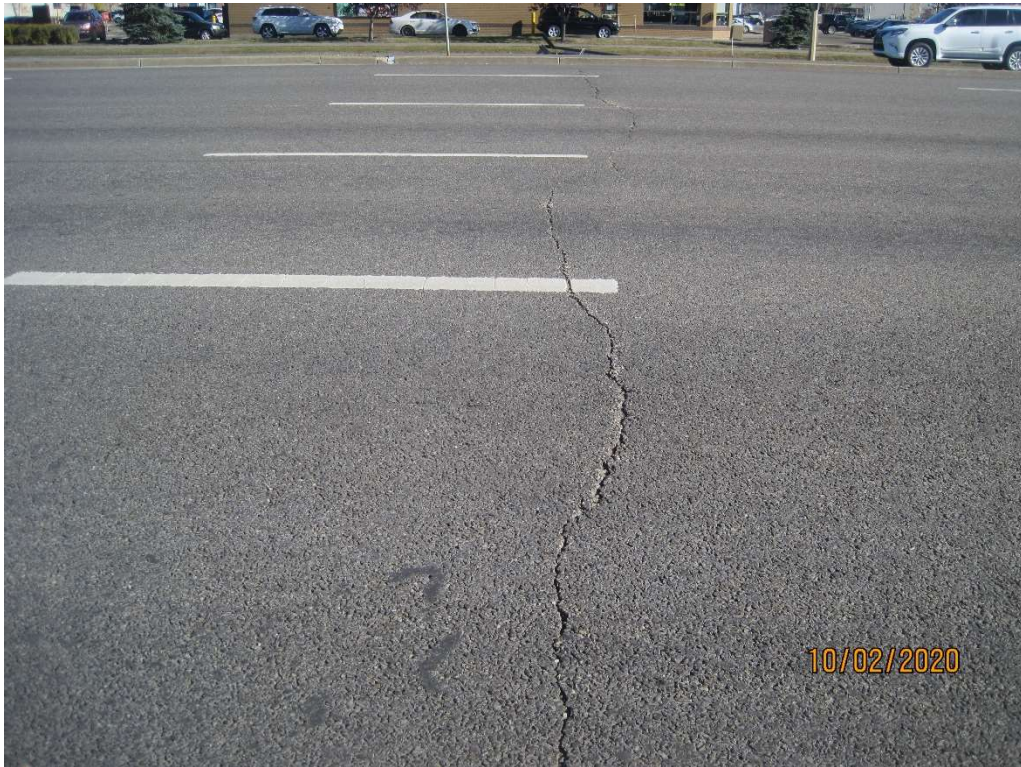
Photo 13: 97 St NW (NB) at 160 Ave, Transverse crack, looking east

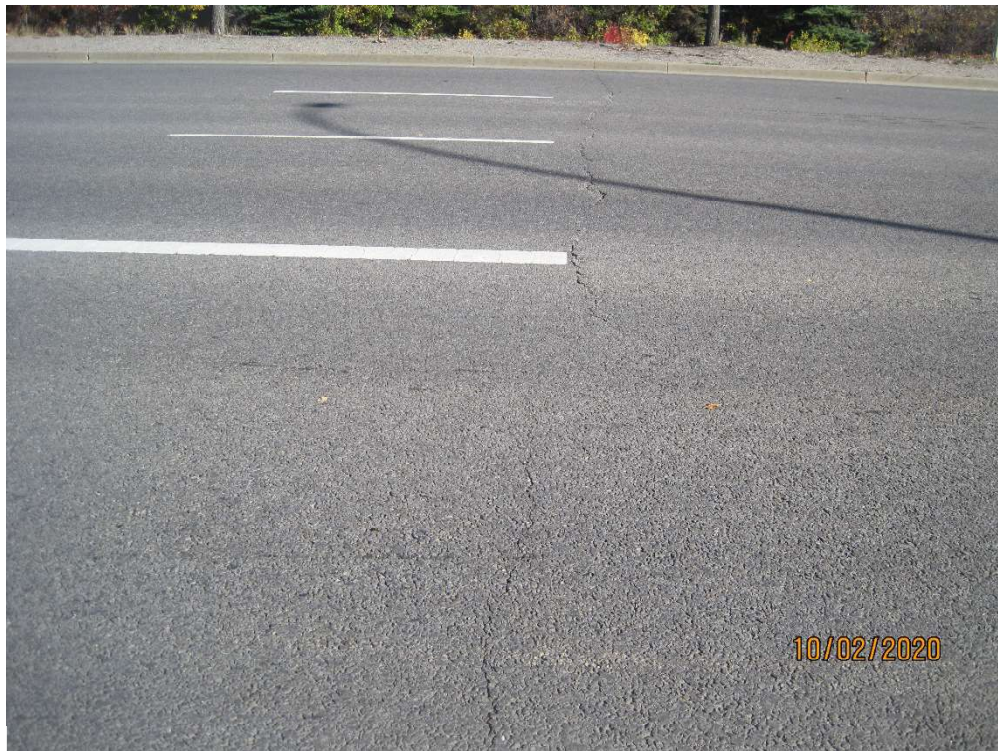
Photo 14: 97 St NW (NB) at Griesbach Rd, Transverse crack, looking east

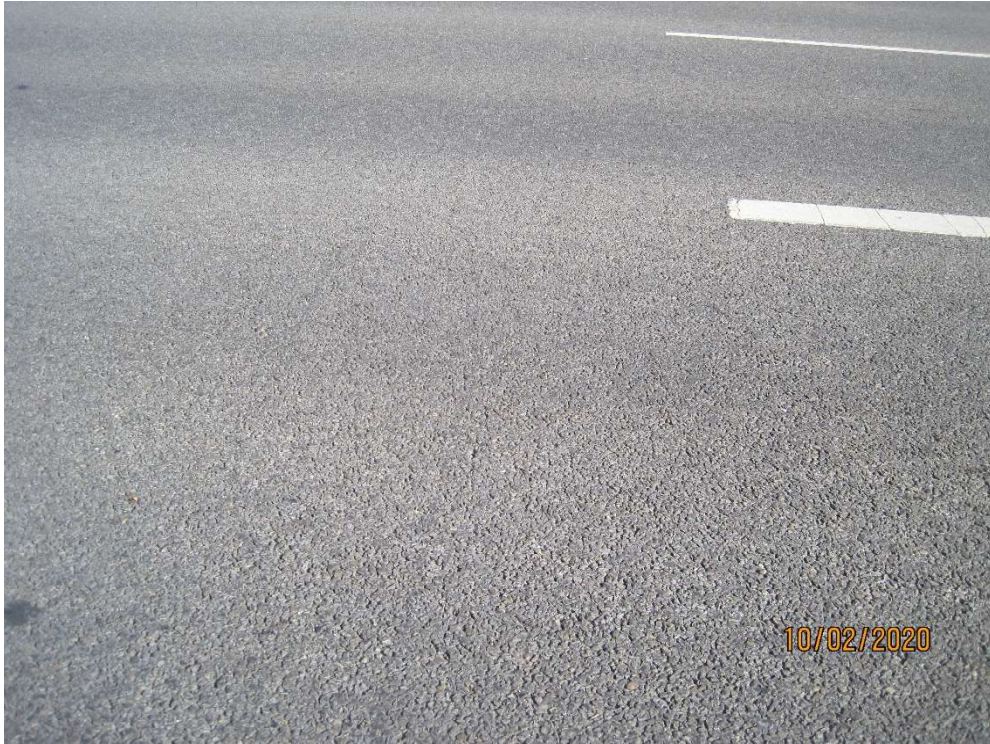
Photo 15: 97 St NW (NB) at Griesbach Rd, General pavement condition, close-up
