SUMMARY REPORT FOR 2020 CORROSION RESEARCH STUDY

City of Edmonton

**Prepared By:
Corrpro Canada, Inc.
Edmonton, AB**

CORRPRO DOCUMENT No.: 0120-4632-CED-CRR-002-0

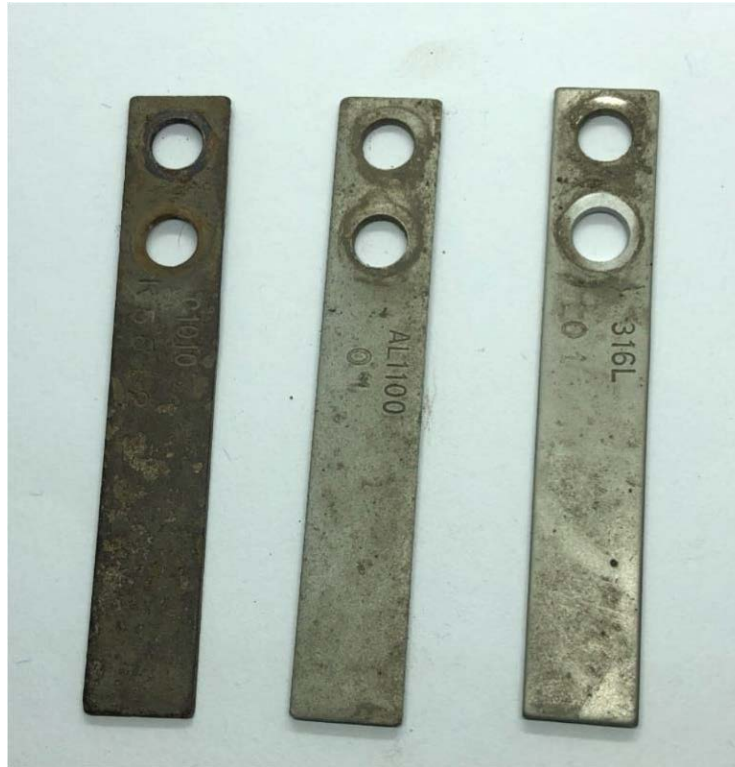
Figure 8 - Corroded Bus Coupons Installed on Spruce Grove Bus (Left to Right: Carbon Steel, Aluminum And Stainless Steel)

An example photo of the retrieved field coupons installed on buses are shown in 'Figure 8'. The coupons are slightly covered in dirt; however, it is still visible that the carbon steel coupons corroded the most, aluminum coupons had minimal corrosion, and the stainless steel coupons did not visibly corrode.

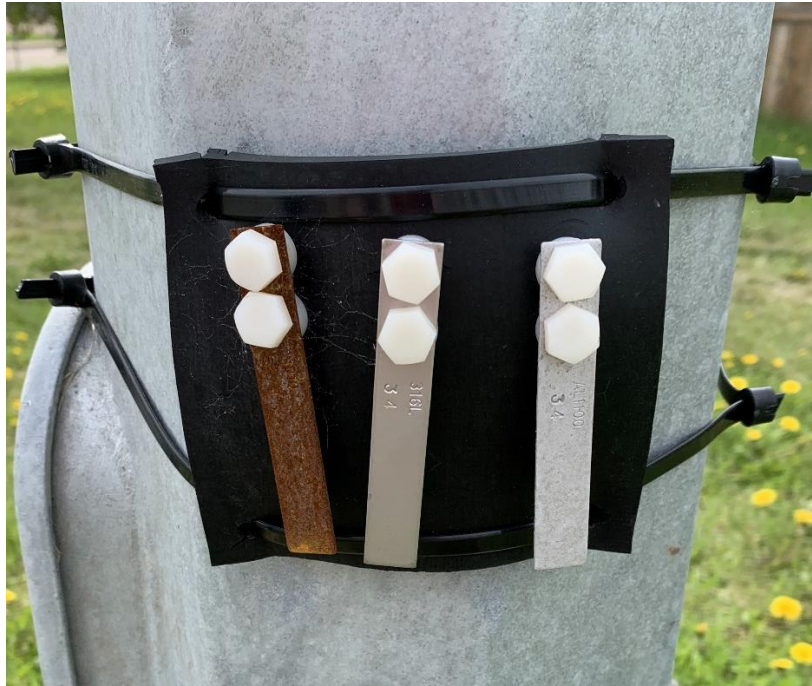
Figure 9 - Corroded Field Coupons Installed On 178 Street (Left to Right: Carbon Steel, Stainless Steel and Aluminum)

An example photo of retrieved field coupons installed on infrastructure near roadways are shown in 'Figure 9'. The coupons shown in this figure was installed in an area exposed to the de-icing chemicals used in Edmonton's winter road maintenance program.

The corrosion observed on the environmental control coupons shown in ‘Figure 11’ is visibly less than the corrosion observed on the infrastructure related coupons in ‘Figure 9’, which is most evident on the carbon steel coupons.

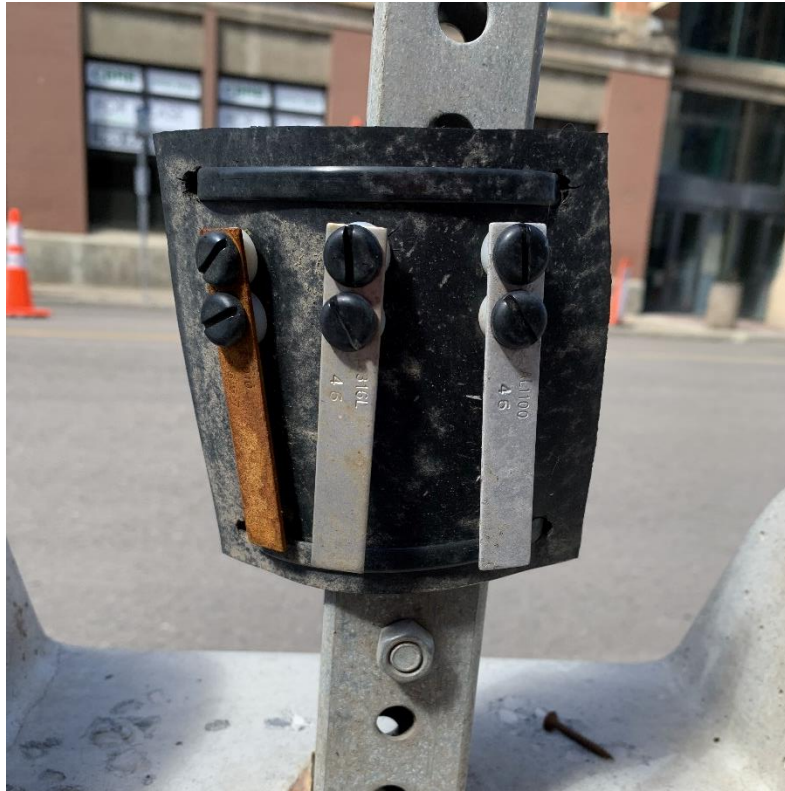
Figure 10 - Corroded Coupons Installed on Bicycle Lanes (Left to Right: Carbon Steel, Stainless Steel and Aluminum)

'Figure 10' shows a set of coupons installed on infrastructure near bicycle lanes after exposure to conditions in Edmonton during winter 2019/2020.

The mass change for the carbon steel coupons attached to the bicycle lanes was lower as compared to the coupon attached to metal infrastructure. The stainless steel and aluminum coupons attached to bicycle lanes experienced similar mass loss to those attached to metal infrastructure.

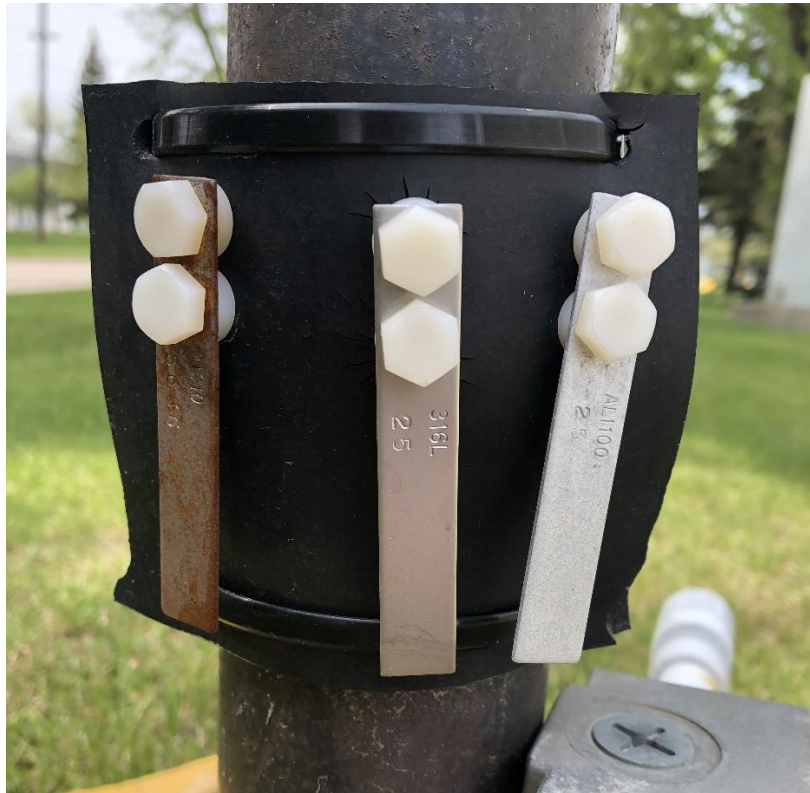
Figure 11 – Corroded Environmental Control Field Coupons Installed Near Corrpro Office (Left to Right: Carbon Steel, Stainless Steel and Aluminum)

A photo of the environmental control field coupons is shown in 'Figure 11'. The coupons shown in this figure were installed in an area not exposed to the City's winter road maintenance program.

Compared with the coupons installed on city infrastructure near roadways and on buses, less corrosion was observed and measured on the environmental control coupons. Based on the installation location, these coupons would not have experienced any splashing from roadways and would have received minimal exposure to anti-icing/de-icing chemicals. Consequently, the corrosion would have been due to regular environmental conditions in Edmonton (snow, rain, wind, fluctuating temperatures, etc.). This highlights the corrosive nature of the local environments found around roadways in Edmonton.

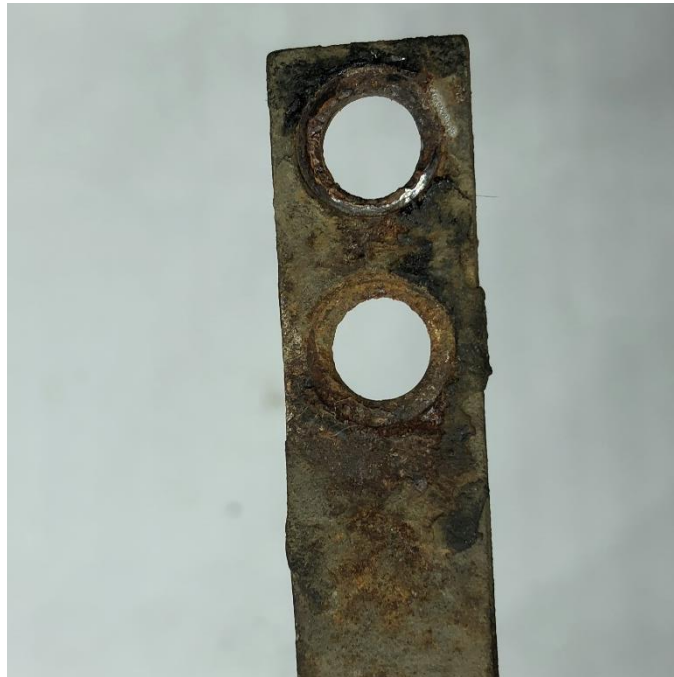
Figure 12 - Crevice corrosion on carbon steel coupon

Significant corrosion typically occurred near the holes where the coupons were secured with the bolts. This localized corrosion is likely caused by the crevice between the nylon insulators and the coupon (crevice corrosion). 'Figure 12' shows a closer view of the corrosion near the mounting holes in the coupons.

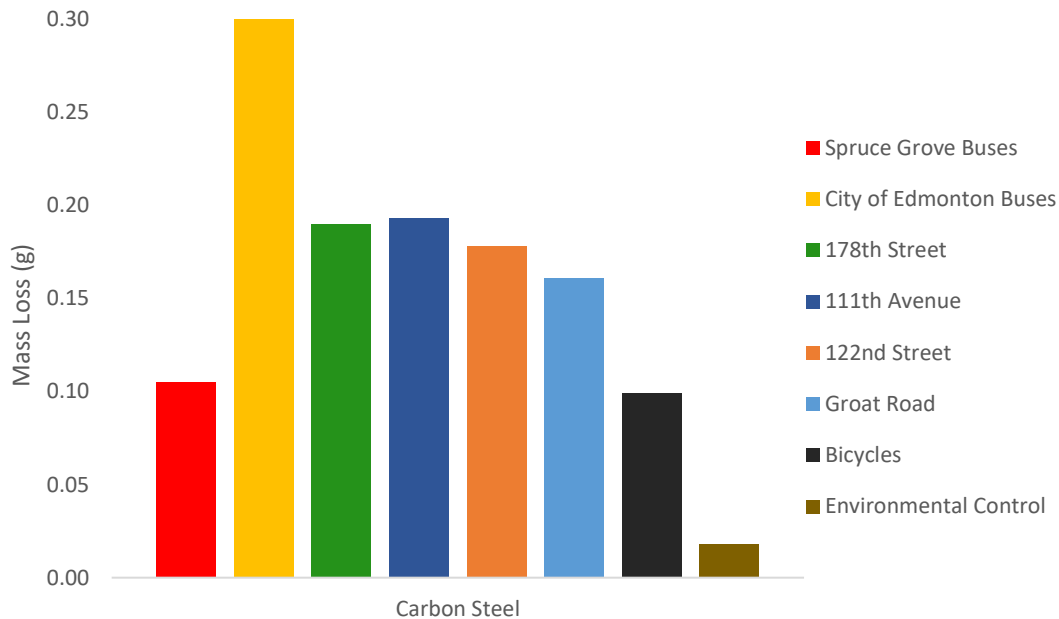
Figure 13 - Average Mass Loss of Carbon Steel Coupons

‘Figure 13’ and ‘Figure 14’ show the graphical representation of the average mass loss measured on the carbon steel coupons and aluminum coupons, respectively, exposed to the various infrastructure/equipment analyzed during this field program. There is no graph for the stainless steel coupons because the mass loss experienced by the stainless steel coupons was too low to be able to accurately distinguish the values from actual mass loss or measurement error.

For the carbon steel coupons, the amount of corrosion observed varied based on coupon location. More corrosion was observed on coupons installed on bus mud flaps versus coupons installed further away from the road and wheel (on cabling behind the wheel well). More

corrosion was observed on coupons installed on City of Edmonton buses versus coupons installed on municipal infrastructure. Additionally, more corrosion was observed on coupons installed on municipal infrastructure near to major roadways (car traffic) versus coupons installed near bicycle lanes. The least corrosion was observed on the carbon steel coupons installed on municipal infrastructure located further away from roadways (environmental control) because there is less probability of splash exposure from vehicles.

As seen in both graphs, the coupons attached to the City of Edmonton buses had significantly higher mass losses as compared to the coupons attached to the Spruce Grove buses. This is likely due to the Spruce Grove buses being out of service for a period of the testing time (reduced exposure to corrosive environment).

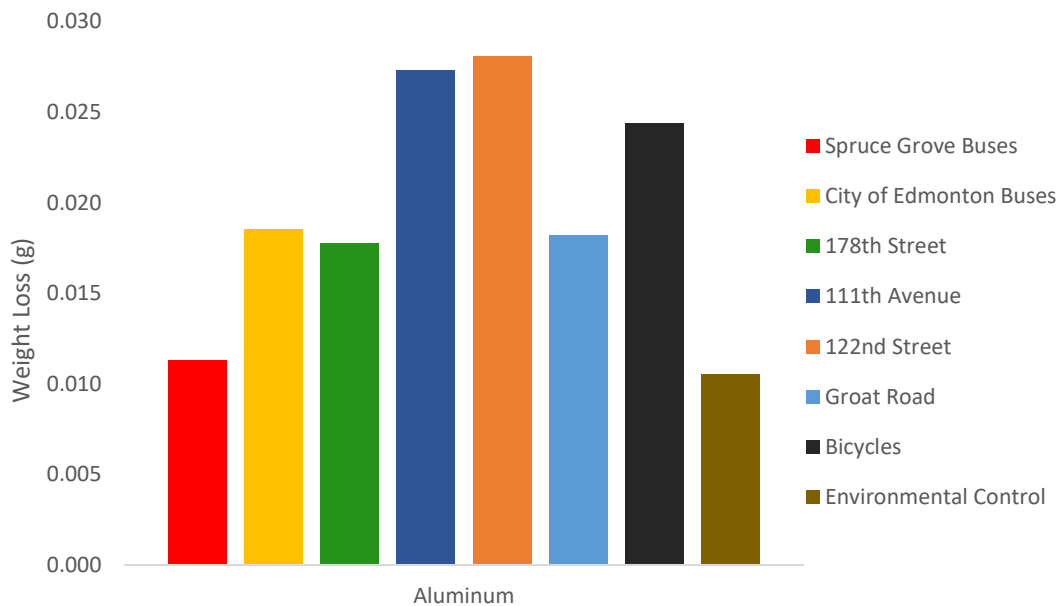
Figure 14 - Average Mass Loss of Aluminum Coupons

The aluminum coupons showed significantly less mass loss as compared to the carbon steel coupons. However, the aluminum coupons did not corrode similar to carbon steel coupons in the sense that areas with the highest amount of exposure to splash did not always show the highest amount of mass loss. An influencing factor could be the amount of anti-icing/de-icing products that were applied in each corresponding area. Literature shows that aluminum is very susceptible to corrosion in environments that contain high amounts of chlorides [7] [8] [9]. The areas where the coupons are showing higher mass losses (111th Avenue, 122nd Street, and bicycle lanes downtown), could have had a higher amount of anti-icing/de-icing applications or build-up on the roads compared to the other areas tested. In the winters of 2018/2019 and 2019/2020, the studied bicycle lanes were subject to multiple applications of both anti-icing and de-icing materials [3] [10].

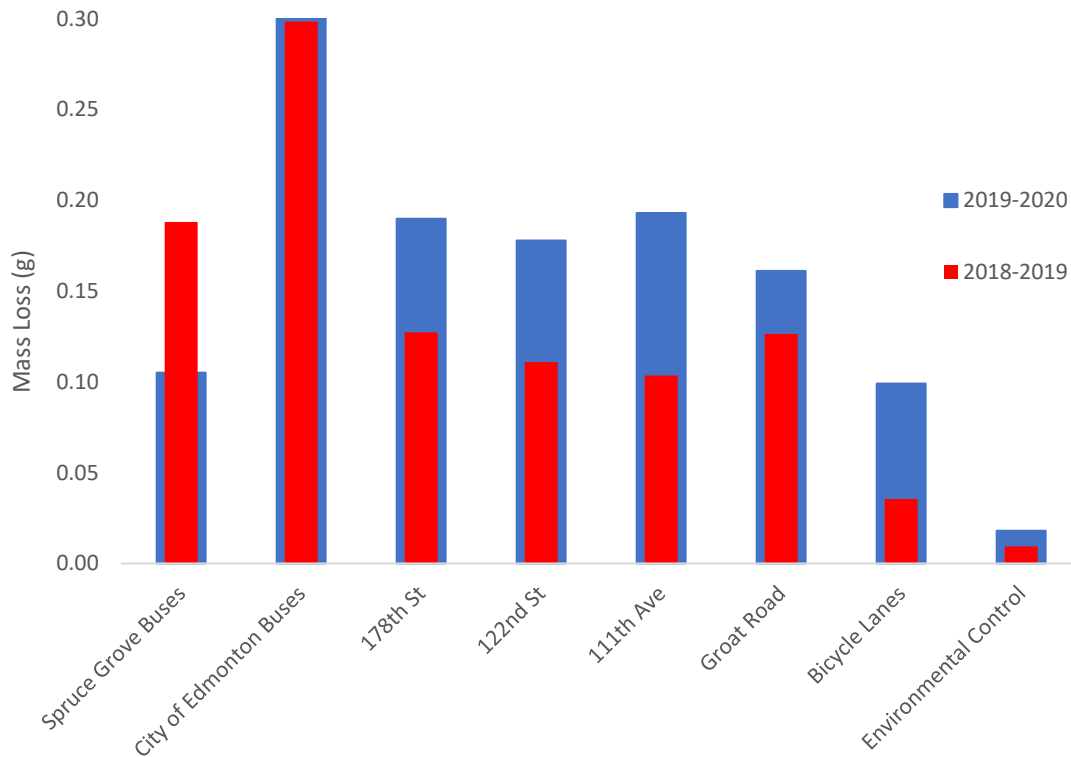
Figure 15 - Comparison of Average Mass Loss of Carbon Steel Coupons Between 2018/2019 And 2019/2020

The results of the 2019/2020 program were compared to the 2018/2019 program to attempt to identify significant differences in corrosion. ‘Figure 15’ and ‘Figure 16’ show graphical representations comparing the corrosive effect of the winter road maintenance programs used the last two winter seasons in Edmonton. The graphs show the average mass loss of carbon steel coupons and aluminum coupons, respectively. The mass loss of the stainless steel coupons was not graphed as they showed minimal to no mass loss.

As seen from the graphs, the majority of coupons experienced higher amounts of mass loss in 2019/2020 as compared to 2018/2019 for all metal types. The only exception being the carbon steel coupons on the Spruce Grove buses, which experienced higher weight loss averages in 2018/2019 as compared to 2019/2020. This could be primarily due to reduced environmental exposure for the coupons on the Spruce Grove buses due to the buses being out of service due to COVID-19 safety concerns for the last few months of the testing period.
