## **Residential Concrete Sidewalk & Curb Brine Impact Study 2020 Edmonton, AB**

PRESENTED TO  
**City of Edmonton**

DECEMBER 3, 2020  
ISSUED FOR USE  
FILE: ENG.EMAT03787-01

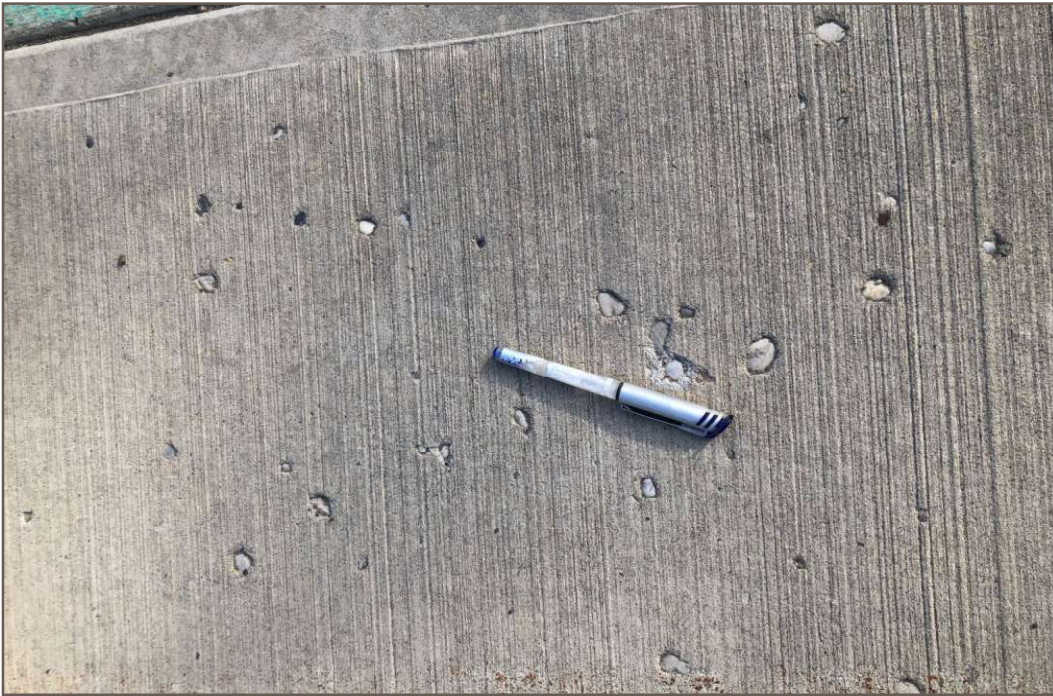
Some mortar flaking of the surface was observed in isolated areas. Mortar flaking occurs when a near surface coarse aggregate particle blocks bleedwater migrating to the concrete surface. The overlying mortar layer then prematurely dries out. This weaker mortar layer eventually flakes off, exposing the underlying coarse aggregate particle. This is primarily a construction defect that is observed after one to two years of winter exposure. An example of mortar flaking is shown in Photo 1.

**Photo 1:** 122 Street near Fox Drive, September 2020: Mortar flaking on sidewalk surface caused by drying of surface above coarse aggregate.

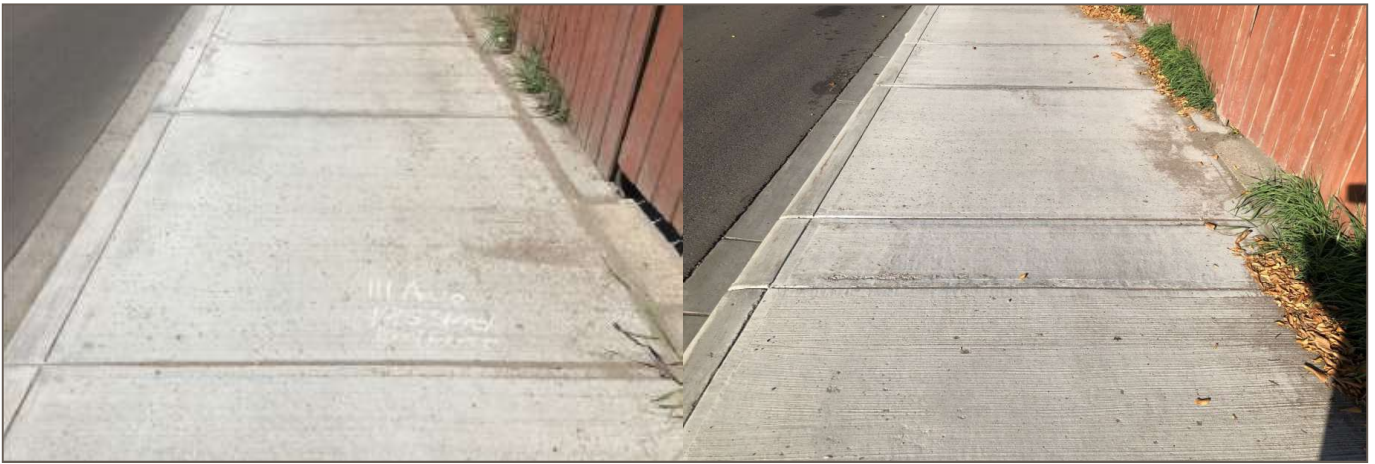
**Photo 2:** 111 Avenue: July 2019 photo on left, September 2020 photo on right. No noticeable change in mortar flaking volume.

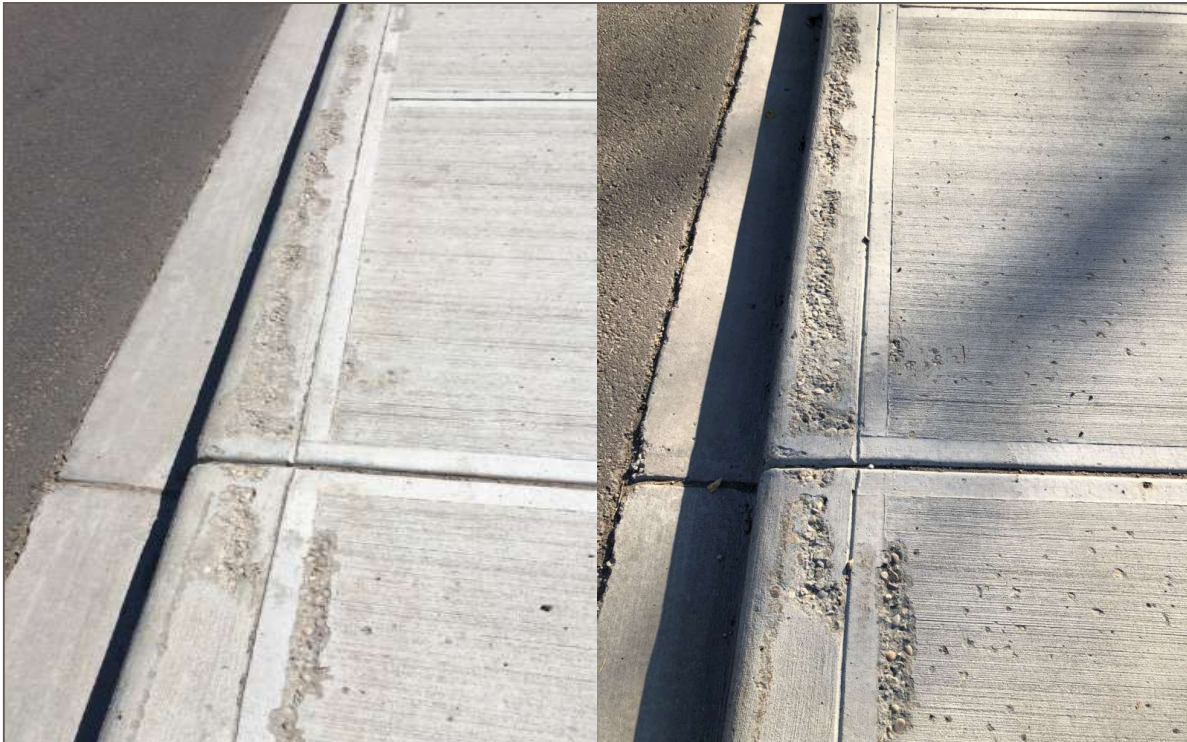
Tetra Tech previously reported severe concrete damage observed on the curbs and sidewalks caused by snow clearing equipment. It appears that snowplows would place the edge of the blade to the edge/face of curb. It also appears that skid steers loaders (or equivalent equipment) may have been used to clear snow from the sidewalks. As this is completed, some of the concrete surface may have been removed. Once the concrete surface mortar is removed, the exposed interior is more prone to be saturated when frozen, leading to a decrease in service life. The amount of concrete surface removal caused by snow clearing damage did not appear to increase in size from 2019 to 2020 (Photo 3).

**Photo 3:** 111 Avenue: July 2019 photo on left, September 2020 photo on right. No noticeable difference in damage to volume of concrete removal by snow clearing equipment.

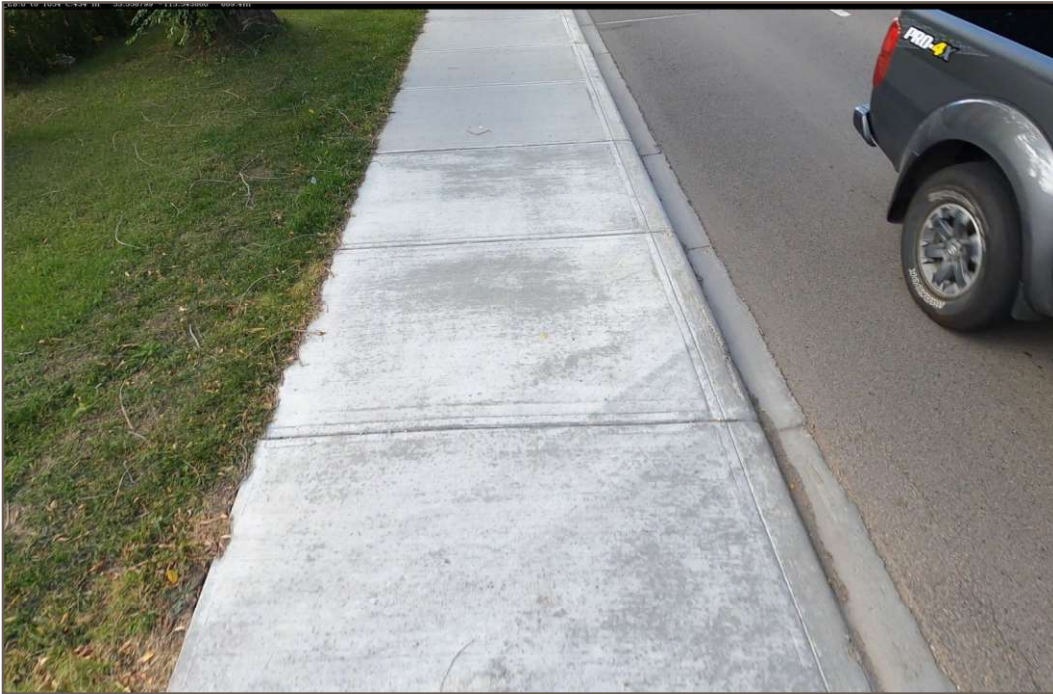
A slight difference in the surface colour of the concrete was observed (Photo 4). This is attributed to continuing ultraviolet breakdown of the white concrete curing compound and/or scraping of the surface by snow clearing.

**Photo 4:** 111 Avenue, August 2020: Difference in concrete surface colour due to removal of curing compound.

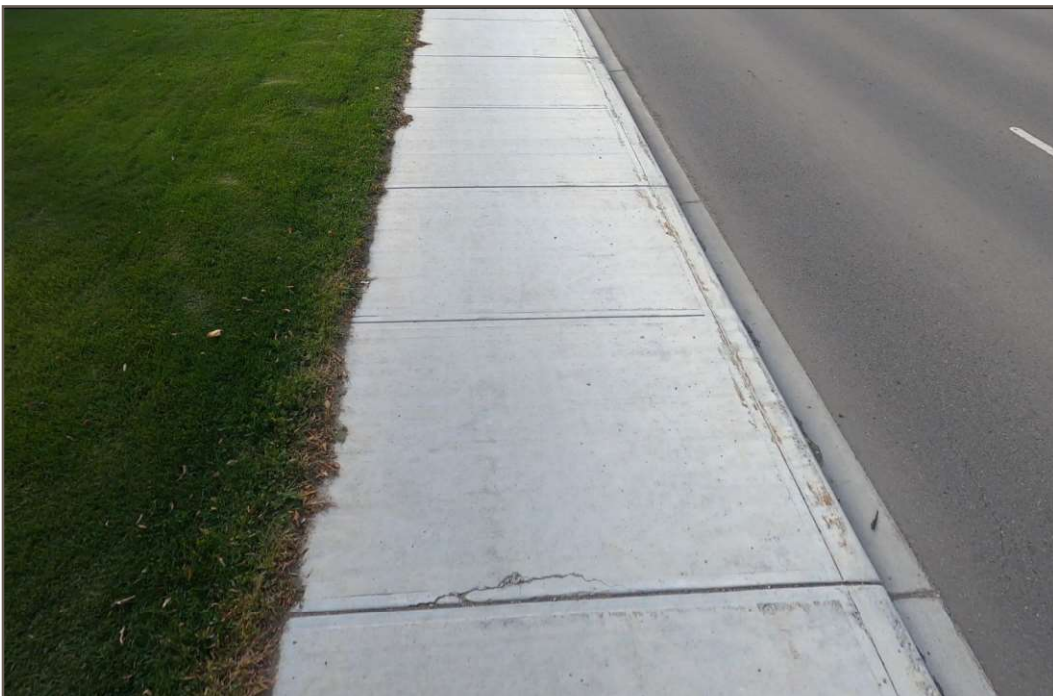
A couple sidewalk panels developed cracks (Photo 5). These cracks are likely due to contraction joints not being tooled deeply enough to be effective.

**Photo 5:** 111 Avenue, August 2020: Concrete cracking on sidewalk panel.

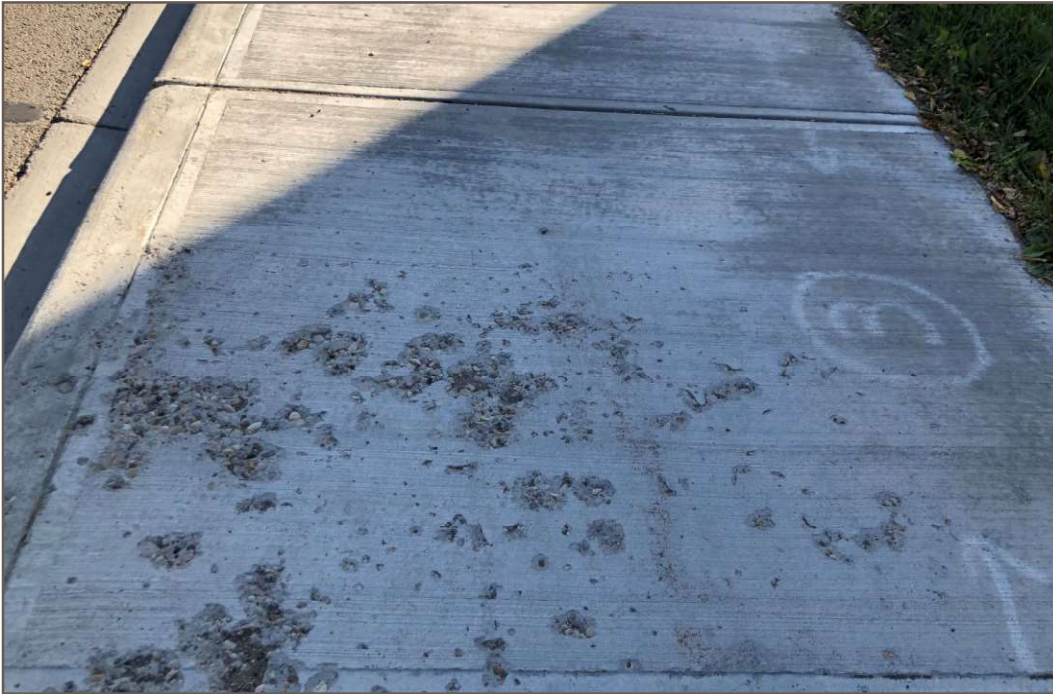
**Photo 6:** 111 Avenue, September 2020: One panel with severe scaling, likely to be removed.

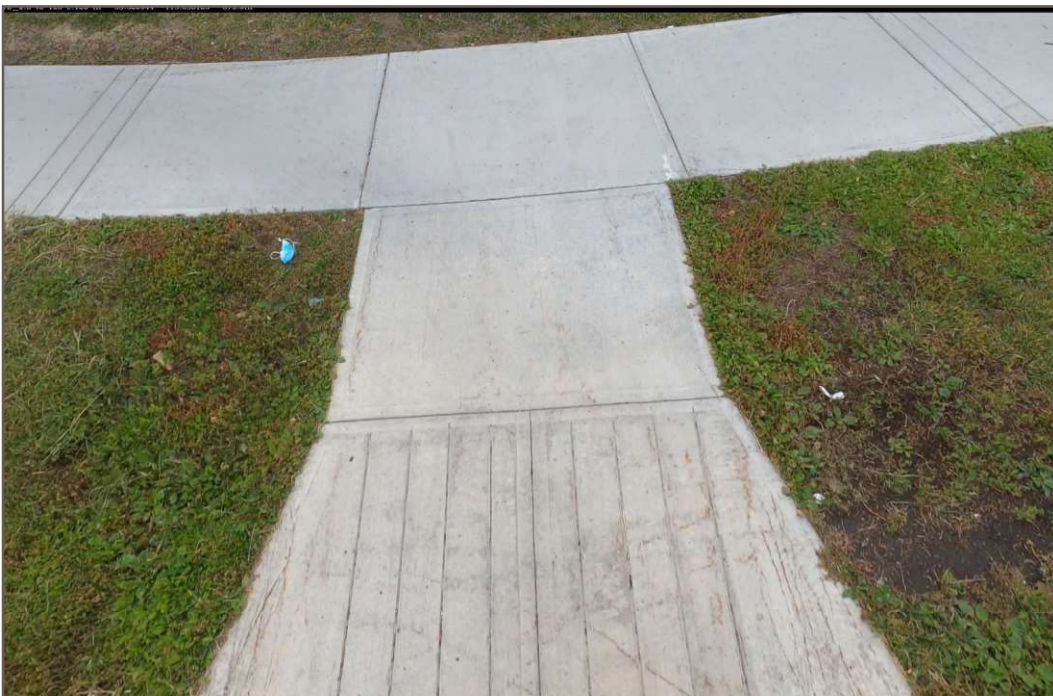
Some maintenance caused discoloration on pararamps, which may not be aesthetically pleasing (Photo 7).

**Photo 7:** 178 Street, August 2020: Discolouration and scraping of pararamp caused by snow removal.

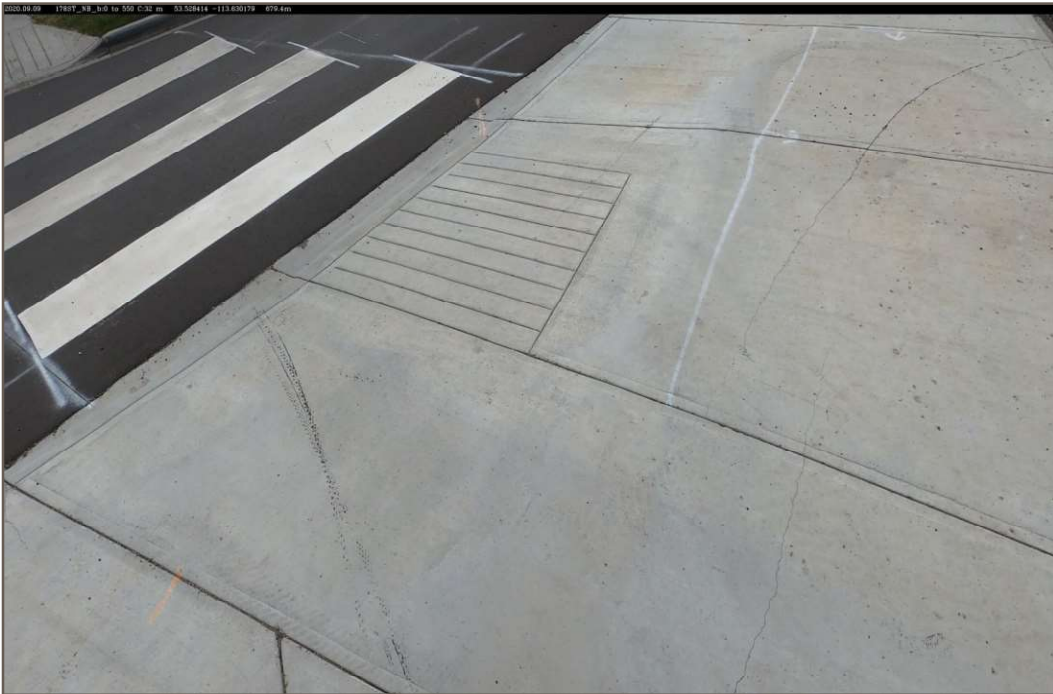
A couple sidewalk panels developed cracks (Photo 8). Some of the cracks occurred in recently placed concrete and is construction related.

**Photo 8:** 178 Street, August 2020: Recently placed concrete with cracks related to construction.

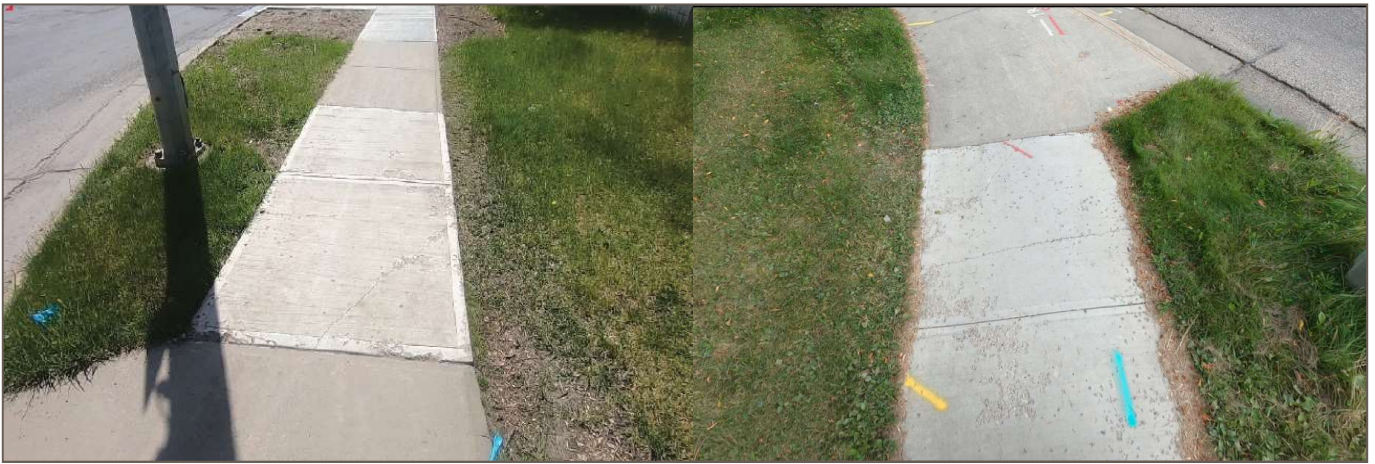
Severe scaling was observed on southbound 178 Street but is isolated to a few panels (Photo 9). This defect is likely the cause of construction as opposed to chemical damage due to the small number of affected panels.

**Photo 9:** 178 Street: May 2019 photo on left, August 2020 photo on right. Severe scaling on panel likely construction related. Likely to be removed.

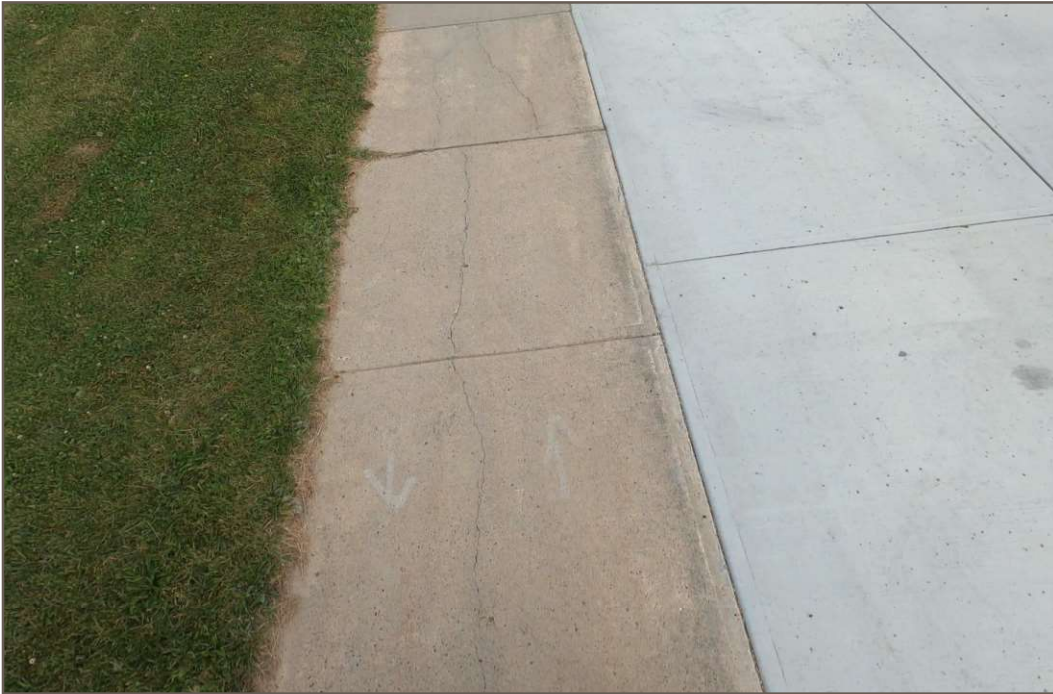
Some other areas contained minor mortar flaking but is likely a construction defect (Photo 10).

**Photo 10:** 178 Street, August 2020: Minor mortar flaking on concrete apron on right side of photo.

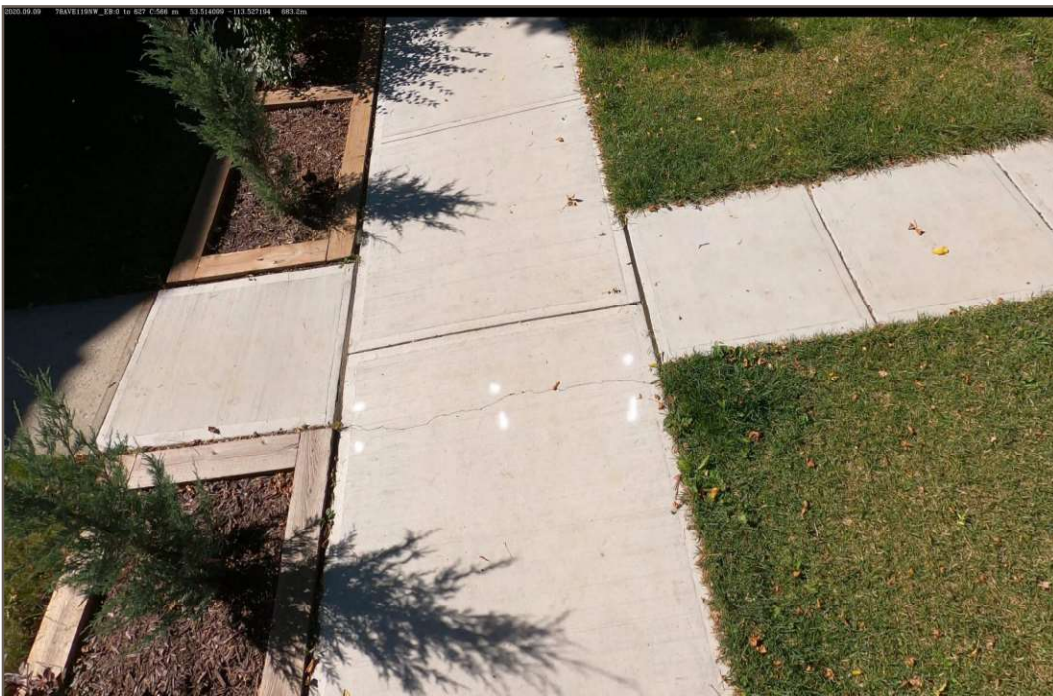
The concrete from time of construction to 2020 generally appeared of good quality. Some panels developed transverse cracks (Photo 11) but are likely the result of settlement and/or shrinkage. These panels were marked with paint by others and may be replaced as part of warranty work.

**Photo 11:** Belgravia, August 2020: Transverse concrete crack observed on isolated concrete panel.

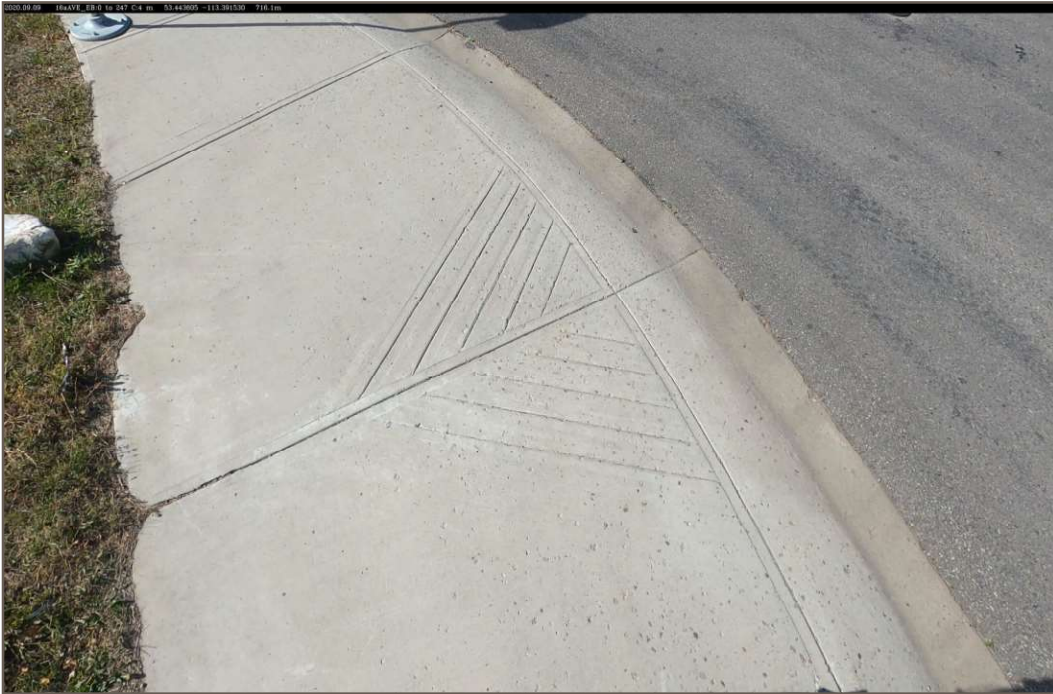
**Photo 12:** Laurel, August 2020: Moderate amount of mortar flaking observed on pararamp.

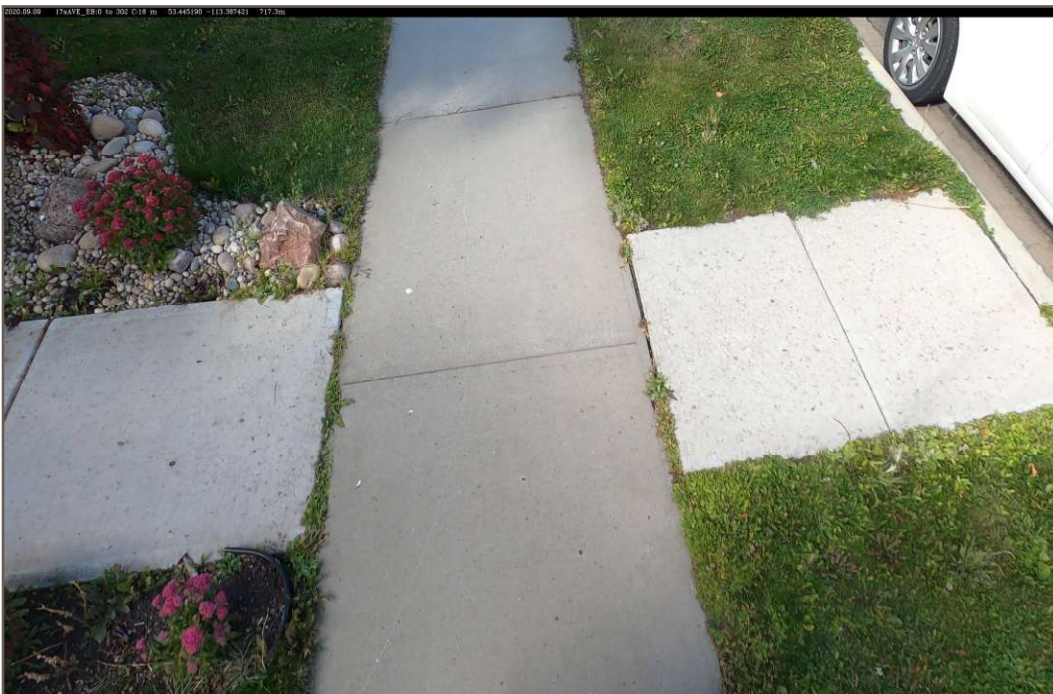
The concrete observed generally appeared to have remained in good condition when the fall 2018 survey is compared to the summer 2020 observations. It appears that the concrete sidewalks include several vintages of construction. Some of the finished surface comprised of rough texturing/aggressive booming. No noticeable change in size or severity of defects were observed from 2019 to 2020 (Photo 12). This includes sidewalk panels with differing amounts of mortar flaking. This also includes a few panels that appeared to have surface damage caused by ice chipping by home occupants (Photo 13).

**Photo 13:** Laurel, August 2020: Private panel on right with damage likely caused by chipping ice.

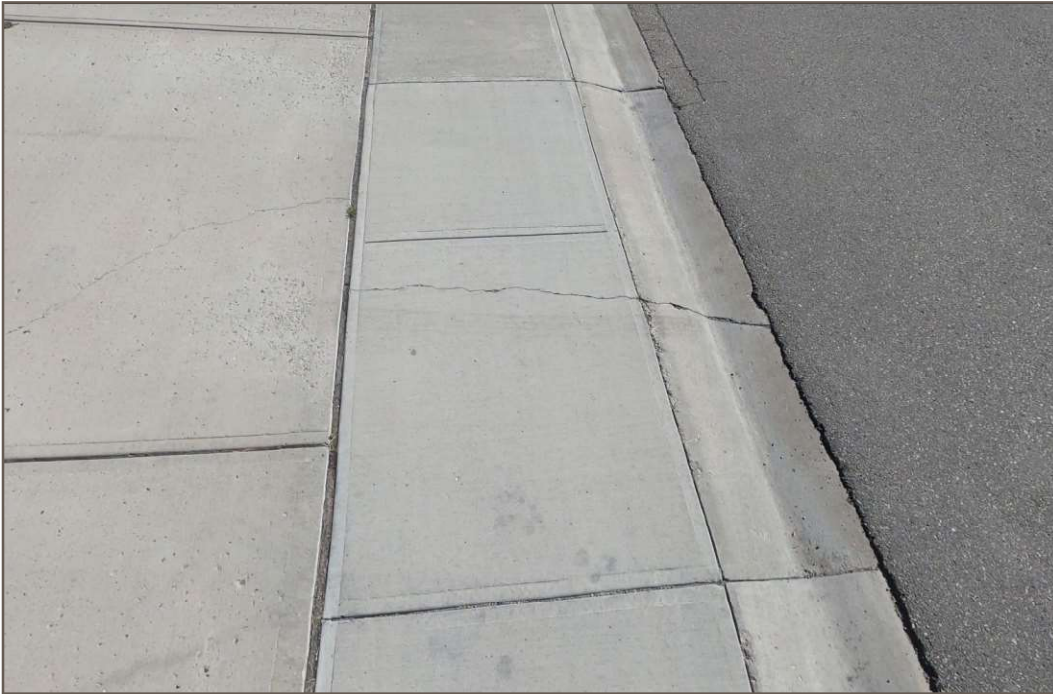
A couple sidewalk panels contained cracks (Photo 14). These cracks are likely settlement or freeze thaw related.

**Photo 14:** Laurel, August 2020: Random cracking in sidewalk panel.

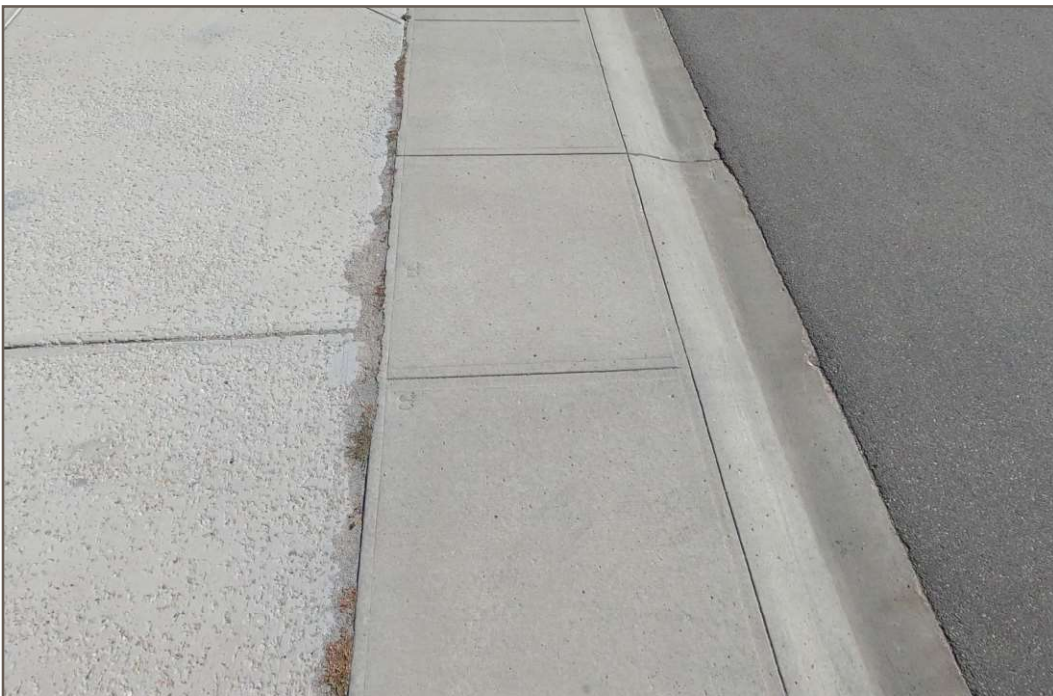
As previously reported in 2019, some of the private driveways exhibited moderate to severe surface deterioration, while the adjacent CoE sidewalks were in good condition (Photo 15).

**Photo 15:** Laurel, August 2020: Severe scaling on private driveway compared to typical concrete sidewalk with no damage.

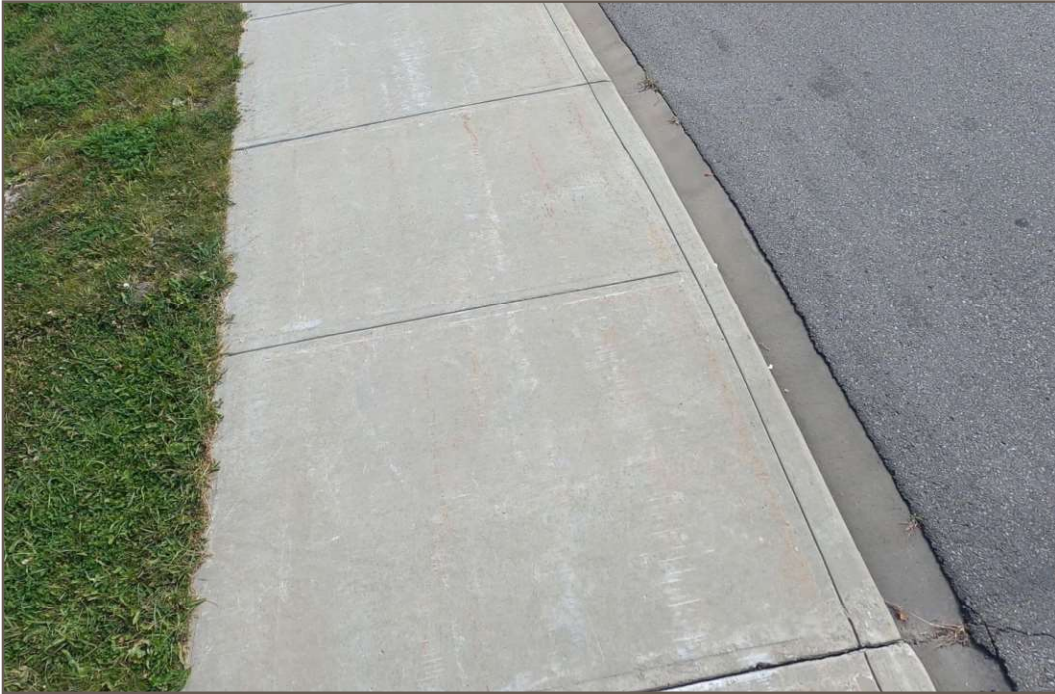
Some maintenance scraping and rust discolouration were caused by snow removal (Photo 16). This should not have a negative long-term impact as long as no further surface damage occurs.

**Photo 16:** Laurel, August 2020: Scraping on sidewalk caused by snow removal.
