Roadway Concrete Sidewalk & Curb Brine Impact Study 2020 Edmonton, AB

PRESENTED TO
City of Edmonton

DECEMBER 3, 2020
ISSUED FOR USE
FILE: ENG.EMAT03787-01

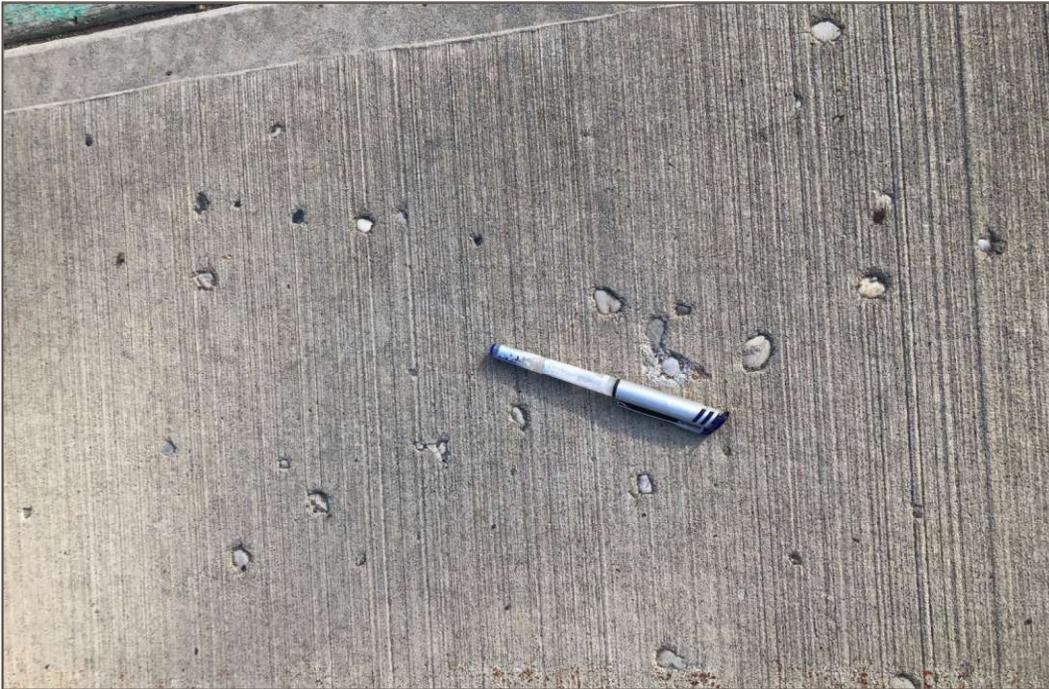
Some mortar flaking of the surface was observed in isolated areas. Mortar flaking occurs when a near surface coarse aggregate particle blocks bleedwater migrating to the concrete surface. The overlying mortar layer then prematurely dries out. This weaker mortar layer eventually flakes off, exposing the underlying coarse aggregate particle. This is primarily a construction defect that is observed after one to two years of winter exposure. An example of mortar flaking is shown in Photo 1.

Photo 1: 122 Street near Fox Drive, September 2020: Mortar flaking on sidewalk surface caused by drying of surface above coarse aggregate.

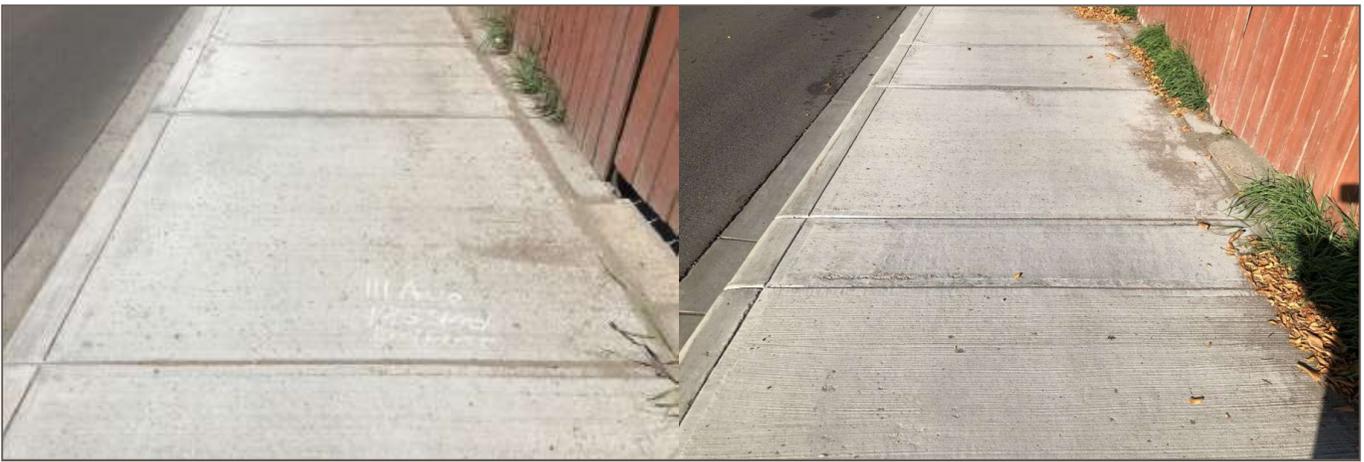
Photo 2: 111 Avenue: July 2019 photo on left, September 2020 photo on right. No noticeable change in mortar flaking volume.

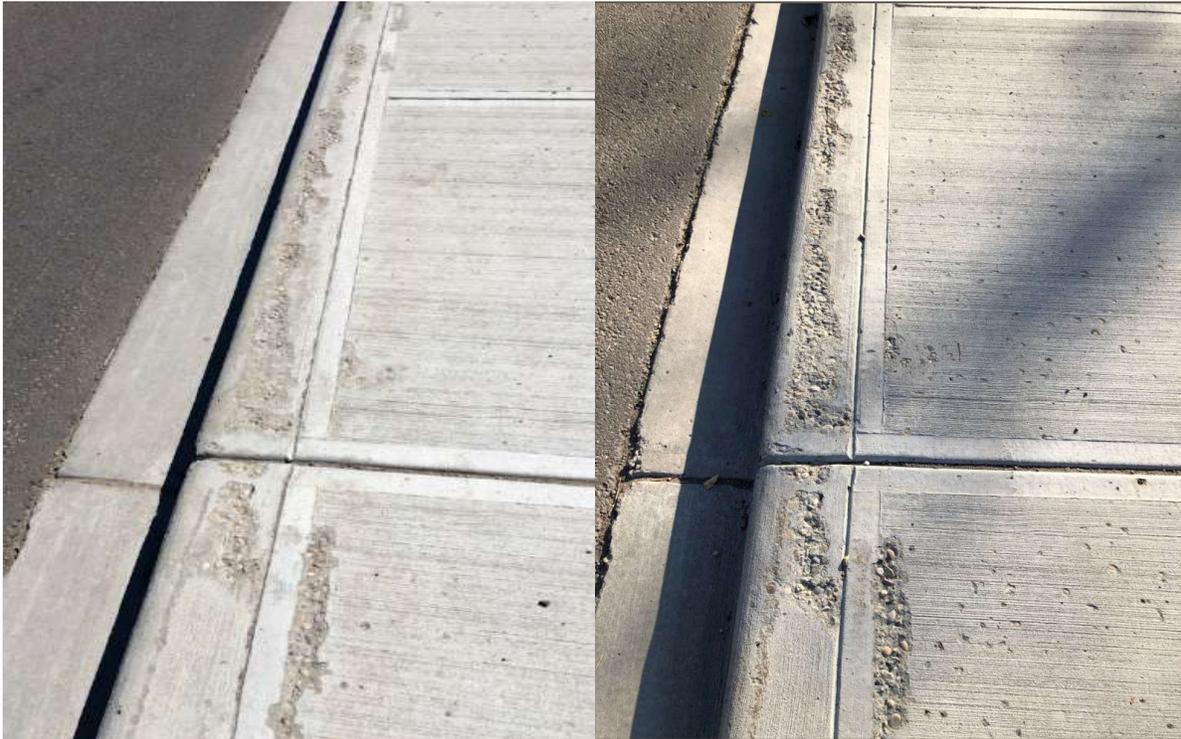
Tetra Tech previously reported severe concrete damage observed on the curbs and sidewalks caused by snow clearing equipment. It appears that snowplows would place the edge of the blade to the edge/face of curb. It also appears that skid steers loaders (or equivalent equipment) may have been used to clear snow from the sidewalks. As this is completed, some of the concrete surface may have been removed. Once the concrete surface mortar is removed, the exposed interior is more prone to be saturated when frozen, potentially leading to a decrease in service life. The amount of concrete surface removal caused by snow clearing damage did not appear to increase in size from 2019 to 2020 (Photo 3) at this location. Between 2019 and 2020, no increase in the amount of concrete damage caused by snow clearing activities was noted.

Photo 3: 111 Avenue: July 2019 photo on left, September 2020 photo on right. No noticeable difference in damage to volume of concrete removal by snow clearing equipment.

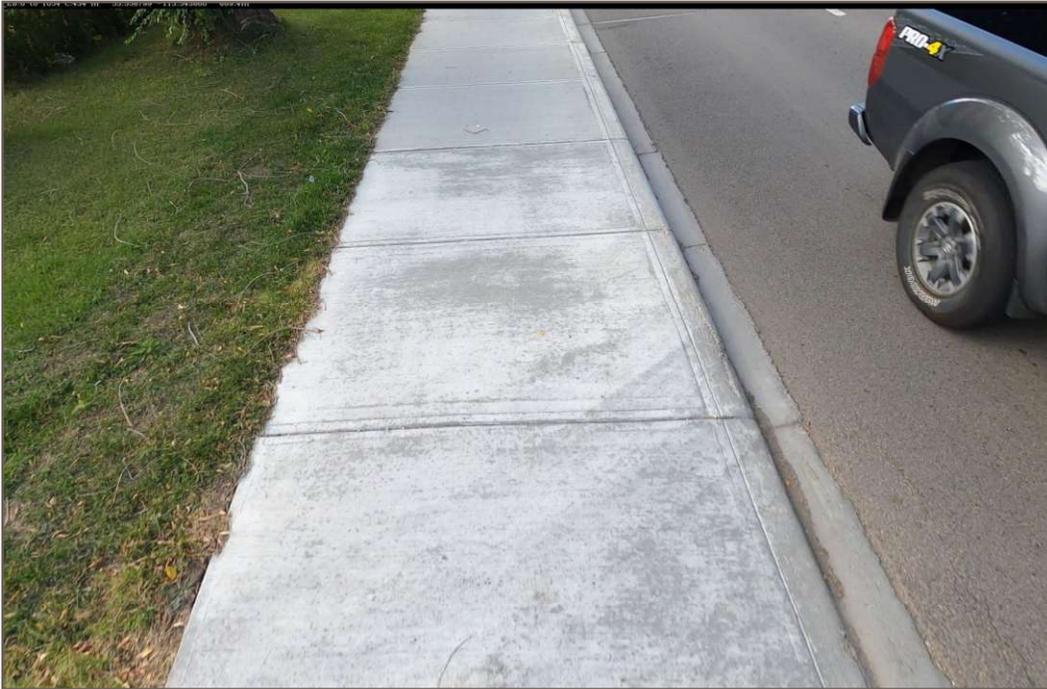
A slight change in the surface colour of the concrete was observed (Photo 4). This is attributed to continuing ultraviolet breakdown of the white concrete curing compound and/or scraping of the surface by snow clearing.

Photo 4: 111 Avenue, August 2020: Difference in concrete surface colour due to removal of curing compound.

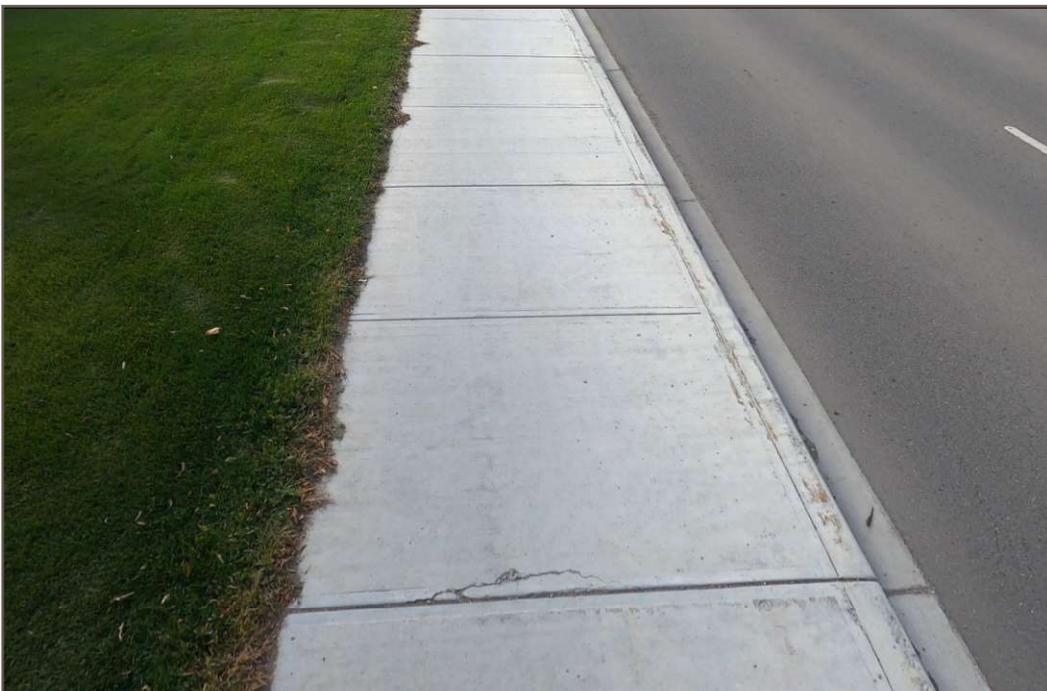
A couple sidewalk panels developed cracks (Photo 5). These cracks are likely due to contraction joints not being tooled deeply enough to be effective.

Photo 5: 111 Avenue, August 2020: Concrete cracking on sidewalk panel.

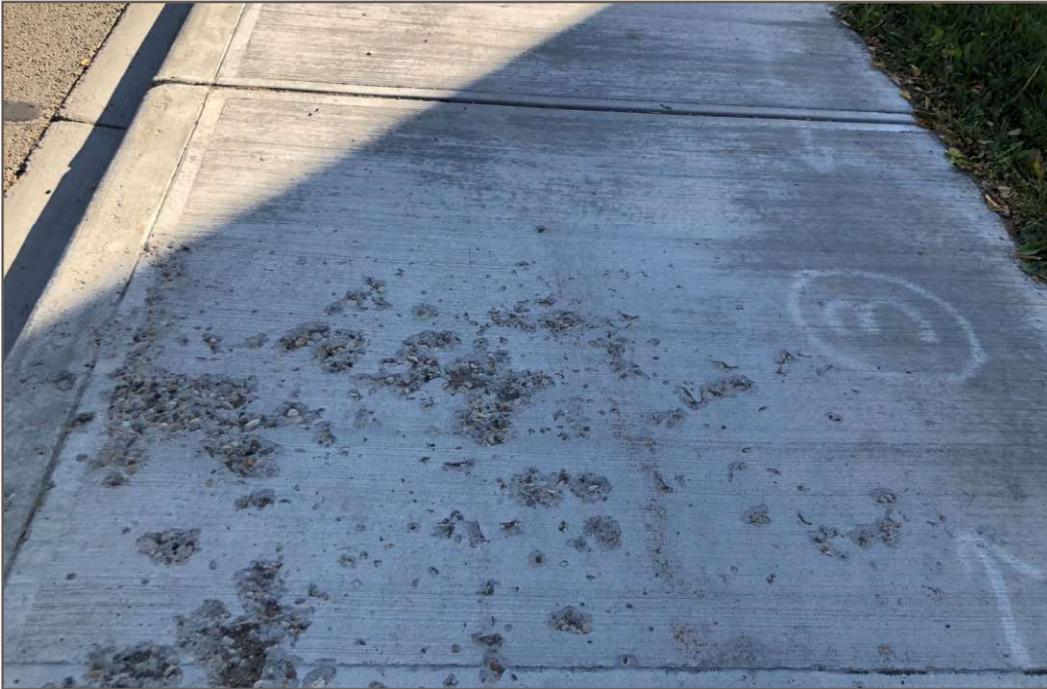
Photo 6: 111 Avenue, September 2020: One panel with severe scaling, likely to be removed.

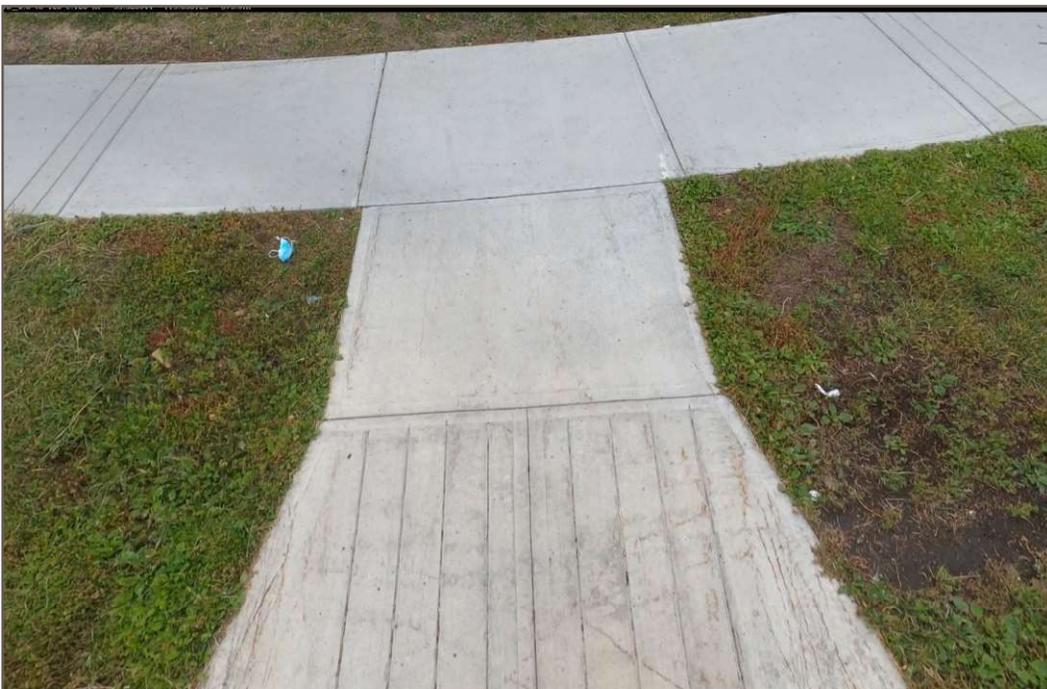
Some maintenance caused discoloration on pararamps which may not be aesthetically pleasing (Photo 7).

Photo 7: 178 Street, August 2020: Discolouration and scraping of parapramp caused by snow removal.

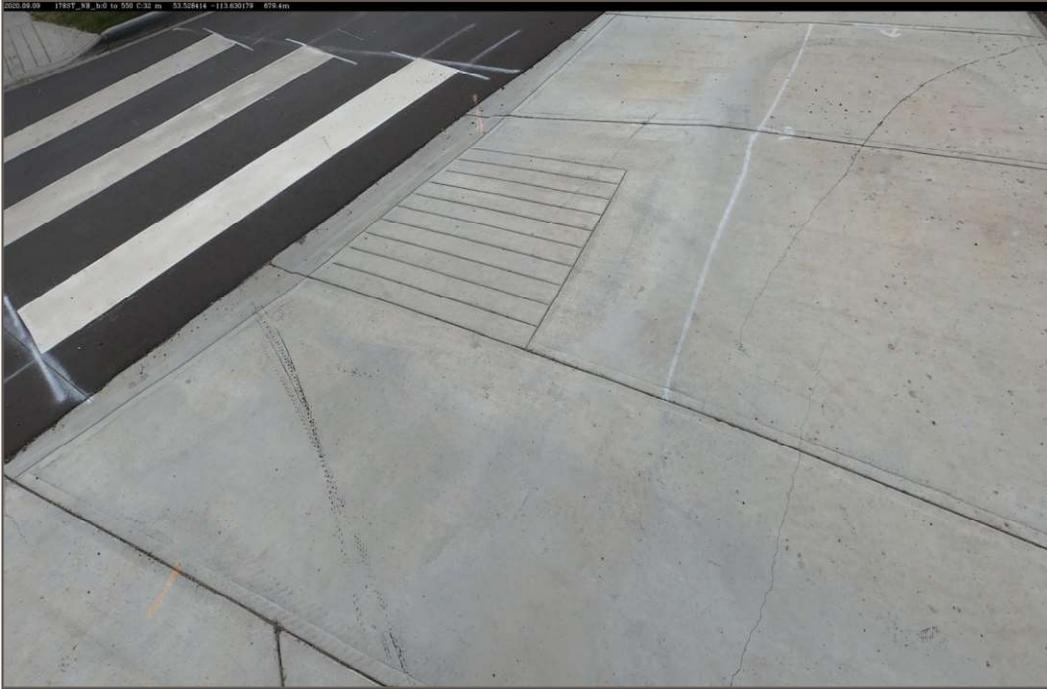
A couple sidewalk panels developed cracks (Photo 8). Some of the cracks occurred in recently placed concrete and are identified as construction related.

Photo 8: 178 Street, August 2020: Recently placed concrete with cracks related to construction.

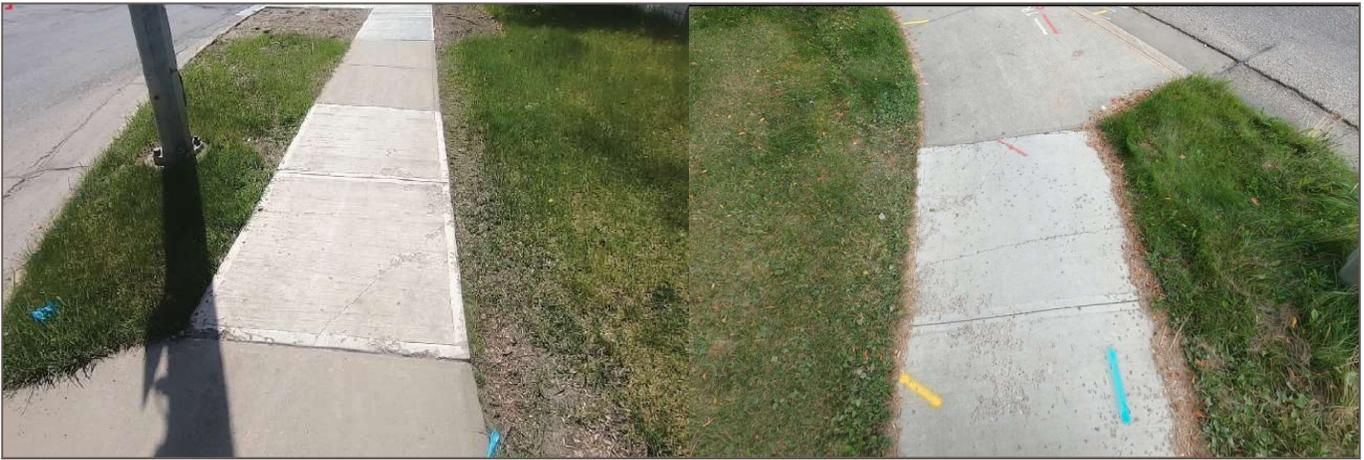
Severe scaling was observed on Southbound 178 Street, but this is isolated to a few panels (Photo 9). This defect appears to be construction related as opposed to the impact of deicing salts

Photo 9: 178 Street: May 2019 photo on left, August 2020 photo on right. Severe scaling on panel likely construction related. Likely to be removed.

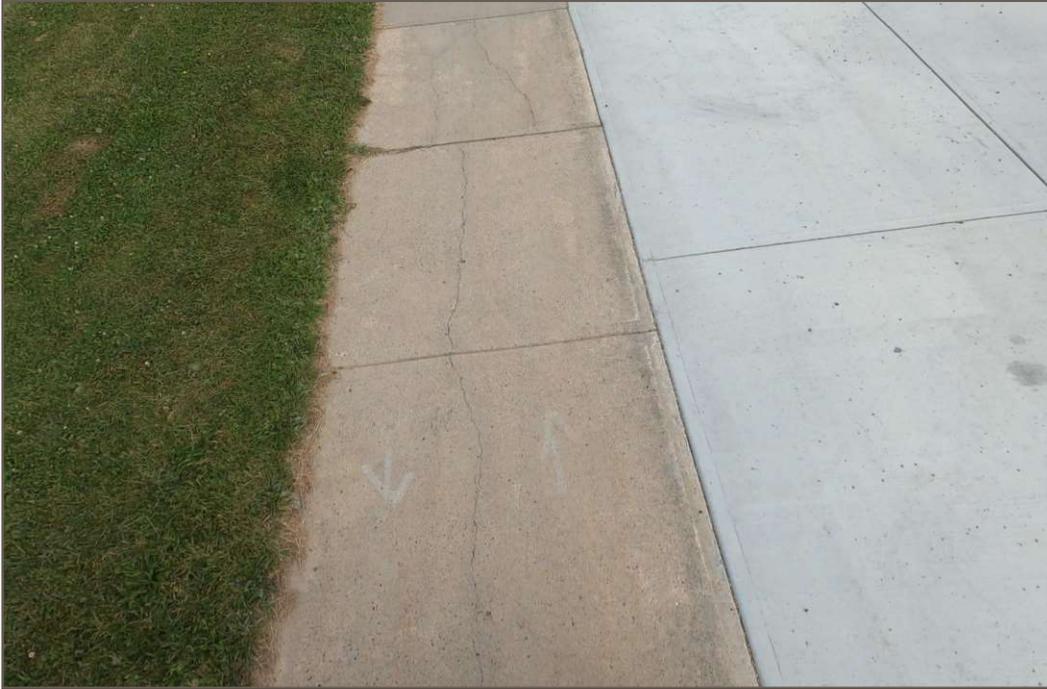
Some other areas contained minor mortar flaking, but these are considered to be construction defects (Photo 10).

Photo 10: 178 Street, August 2020: Minor mortar flaking on concrete apron on right side of photo.

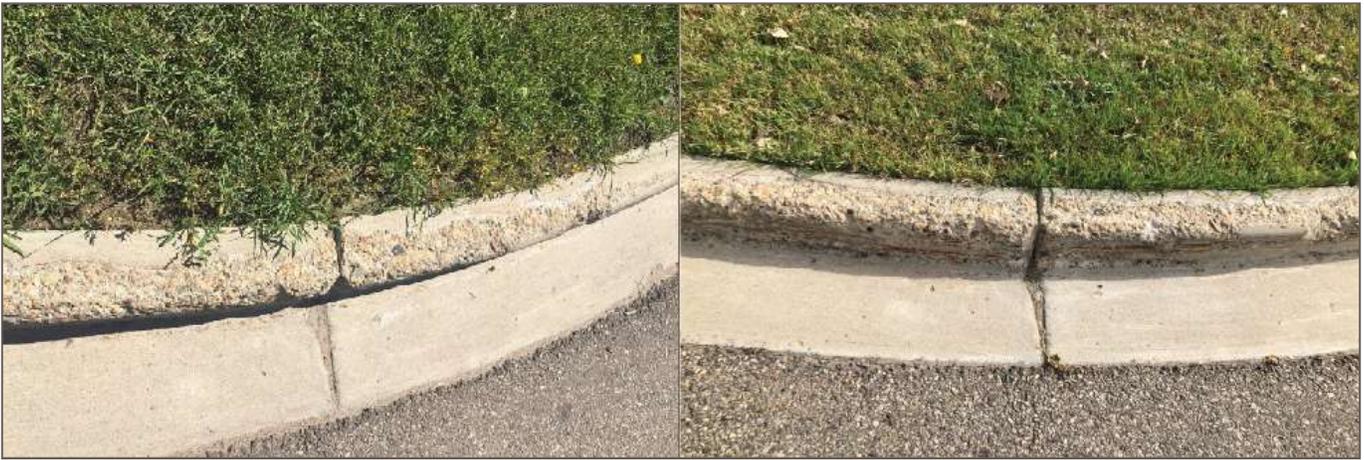
The curbs and bus pad bench aprons appeared to be in good condition from the fall of 2018 to the summer of 2020, with the exception of a few curb panels damaged by snow clearing maintenance operations. It is expected that these areas will deteriorate further due to freeze thaw cycles. The severity of damage did not seem to increase in size from 2019 to 2020 (Photo 11).

Photo 11: 50 Street and 106A Avenue: July 2019 photo on the left, September 2020 photo on the right. No visible increase in snowplow damage at rounded curb transition.

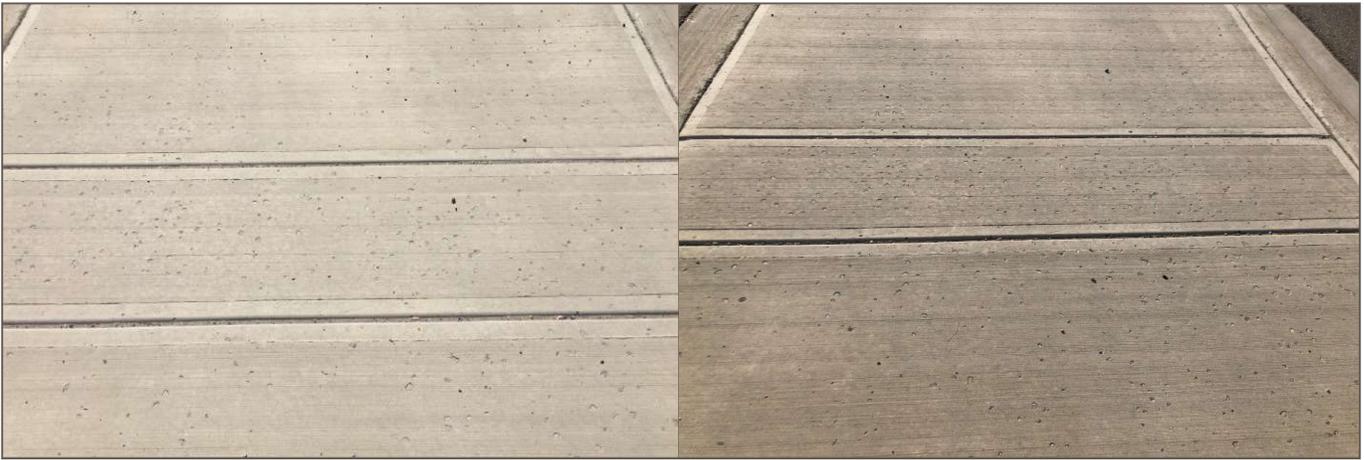
Some of the median at 101 Avenue contained a moderate amount of mortar flaking. This is attributed to a construction defect. The severity of mortar flaking did not seem to increase from 2019 to 2020 (Photo 12). Some of the photos contain dark specs on the median but these were confirmed to be dark aggregate on the concrete surface that can be swept off of the surface.

Photo 12: 50 Street and 101 Avenue: July 2019 photo on the left, September 2020 photo on the right. No visible increase in volume of mortar flaking.

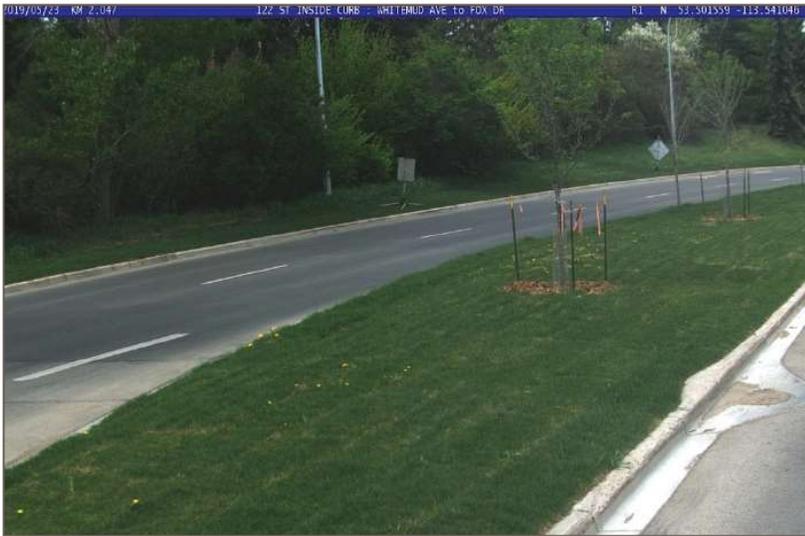
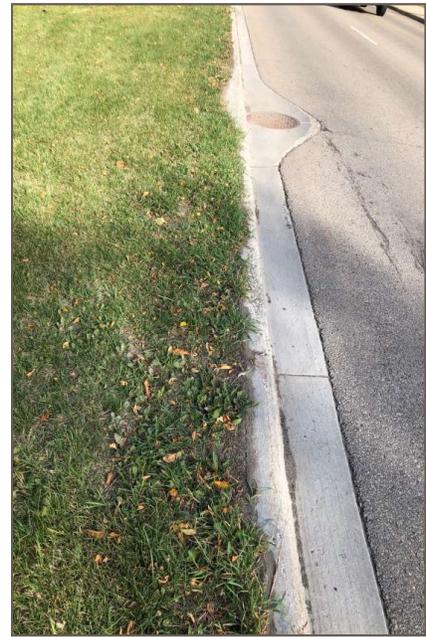
The concrete observed from the fall of 2018 to the summer of 2020 was generally in good condition. Rust streaks were originally observed on long stretches of the curb face indicating the snowplows/graders scraped the curb during snow removal. Areas of damaged concrete was observed due to snow removal. No significant increase in damage was noted from 2019 to 2020 (Photo 13). These areas were usually located at rounded curb transitions.

Photo 13: 122 Street: May 2019 photo on left, September 2020 photo on right. No visible increase in curb damage caused by snow removal.
