Rossdale Low Pressure Plant

Structural Evaluation

10155 - 96 Avenue NW, Edmonton, AB

RJC Engineers

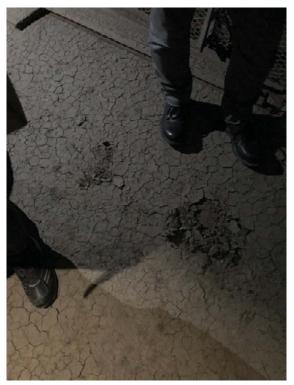
Photo 8: Main Floor – Typical Hole in Floor. Requires Removal of Corroded Steel to Infill

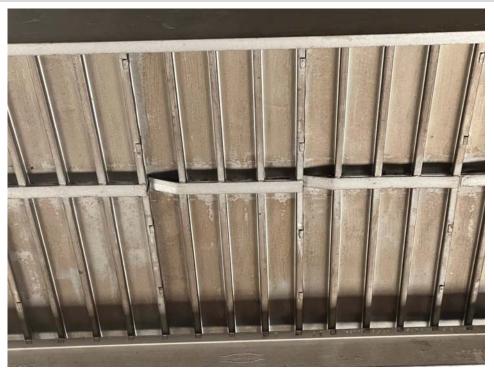
Photo 12: Roof –Damaged Central deck plate at peak. Insufficient support provided.

Could lead to localized failure

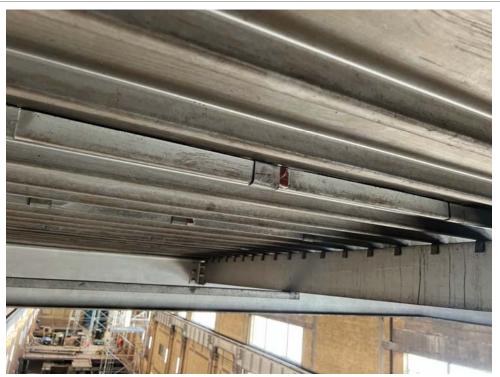
Photo 13: Roof – Deck connector potentially loose. Affects roof diaphragm to carry lateral loads.

Possible additional connection required when roof removed.

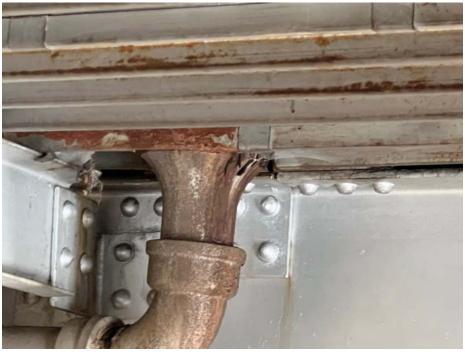
Photo 14: Roof – Rusted deck at drain. Could lead to localized failure.

Removal or Repair could be required.

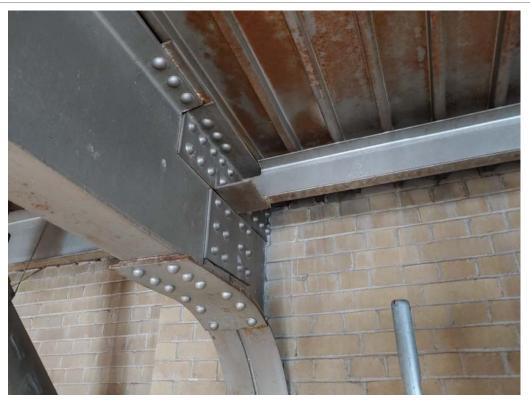
Photo 15: Roof – Girder and deck rust. Appears generally to be surface rust.

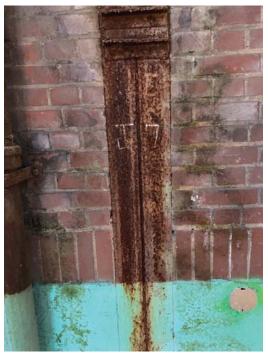
Photo 16: Main Floor – Column with rust on Boiler Hall side. Loss of section likely results in decreased column capacity. Removal of rust and reinforcement could replace damage.

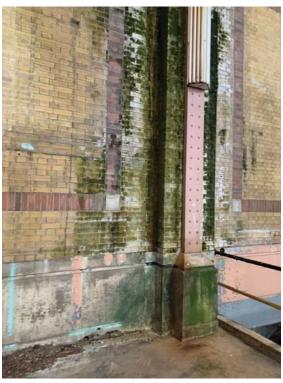
Photo 17: Main Floor – Column with organic growth. Likely deterioration of brick and potentially most rust of column inside of wall. Rust would lead to lower capacity column.

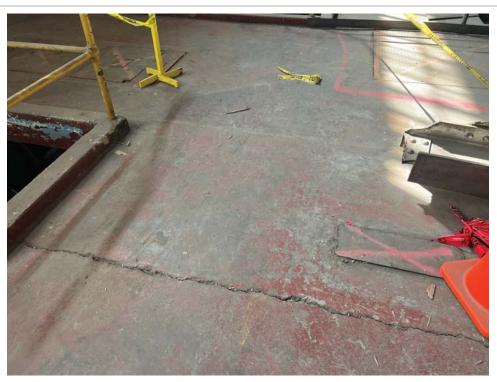
Photo 18: Main Floor – Damaged / cracked floor area. Floor is currently not supported due to removed beam. Safety concern needing to be addressed.

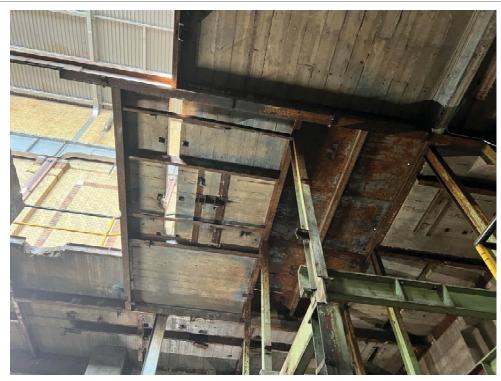
Photo 19: Main Floor – North framing incomplete. Needs reinforcement. No discerable load path for some of the elements.

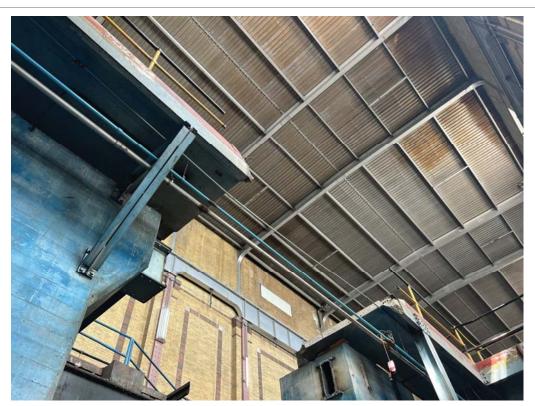
Photo 20: Main Floor – Walkway framing incomplete. Area currently taped off as not safe. Fall risk.

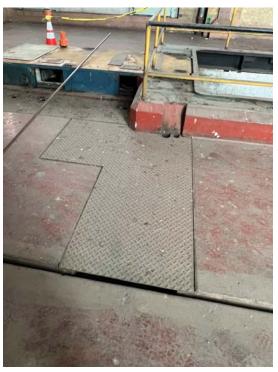
Photo 21: Main Floor – Typical plated areas. In general some of these are not sufficiently supported and could lead to failure

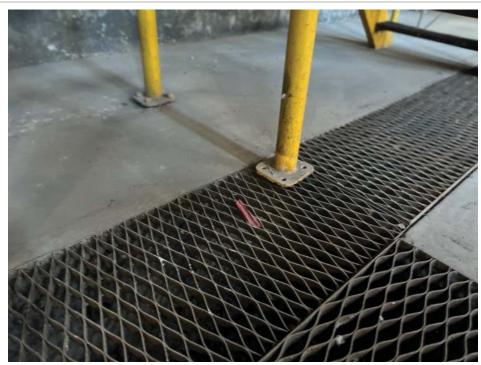
Photo 24: Basement – Typical stair bearing condition. Grating likely not capable of point load support. Could lead to partial failure of stairs.

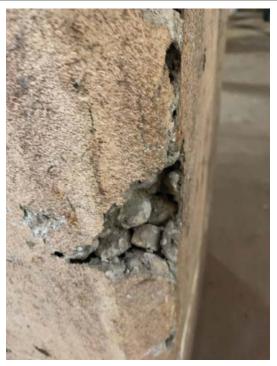
Photo 25: Basement – Column consolidation. Can lead to localized lower compressive capacity of the element and potentially additional damage if stressed differently than previous.

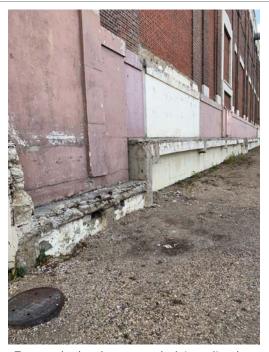
Photo 27: Exterior – West side. Exposed rebar has corroded. Localized repairs to cover rebar and protect damaged areas could be used to extend life-span.

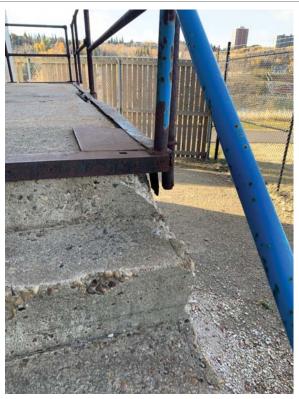
Photo 28: Exterior – Stair. Poor condition generally for use.

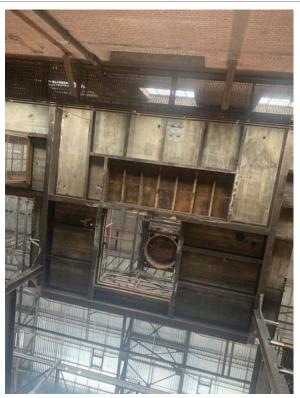
Photo 33: Mezzanine – Underside spalling. Could lead to localized deterioration and failure.

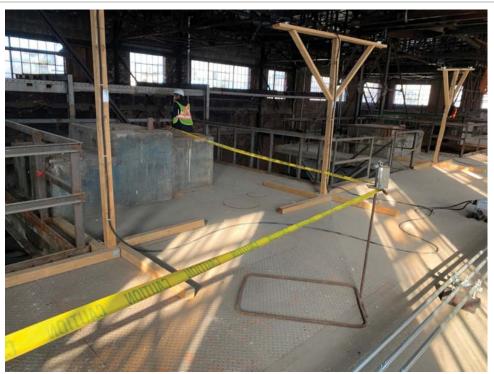
Photo 34: Mezzanine – Plated areas blocked off. Blocked off as determined not suitable for traffic. Repairs of these areas could be needed to open again.

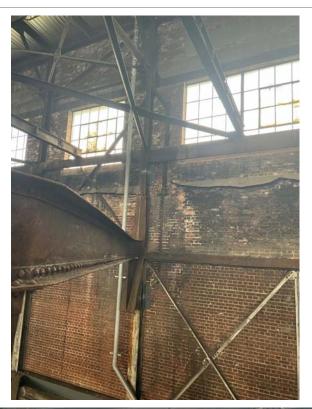
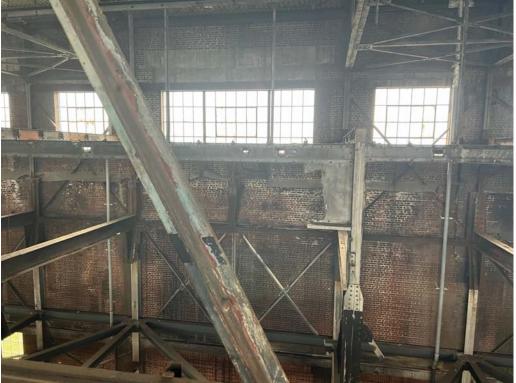
Photos 35 and 36: 2nd Floor – Typical condition of boiler frames. Cut, bent and corroded steel in some areas results in lower capacity of members. Depending on future use some repairs might be necessary.

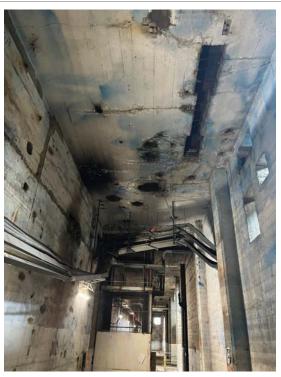
Photo 41: Main Floor – Condition down hallway. Corroded and spalled concrete. Local damage could cause capacity issues on floor above. Repair may be necessary by removing corroded bar and infill concrete.

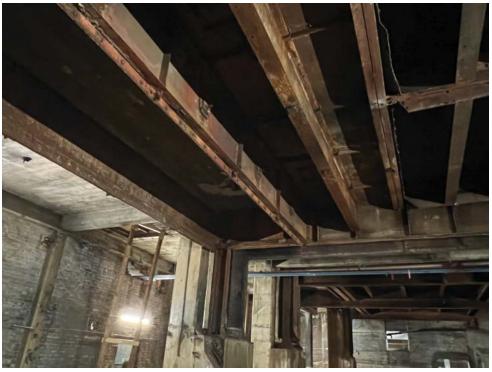
Photo 42: Main Floor – Steel infill. Some significant corrosion on surface. Where section is lost, could affect local capacity.

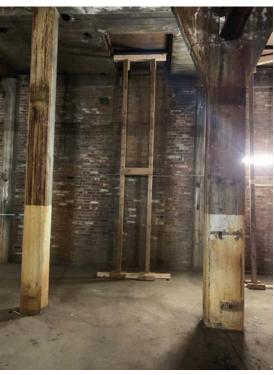
Photo 43: Main Floor – Temporary shoring. Does not adequately support plate above. Could lead to failure of floor plate.

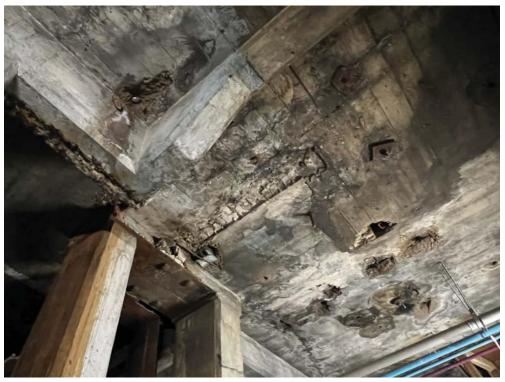
Photo 44: Main Floor – Underside condition. Deteriorated concrete could lead to local failure. Repair may be necessary by removing corroded bar and infill concrete.

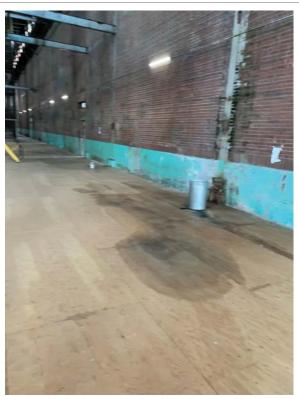
Photo 45: Main Floor – Signs of water infiltration. Water can damage structure and lead to loss of lifespan.

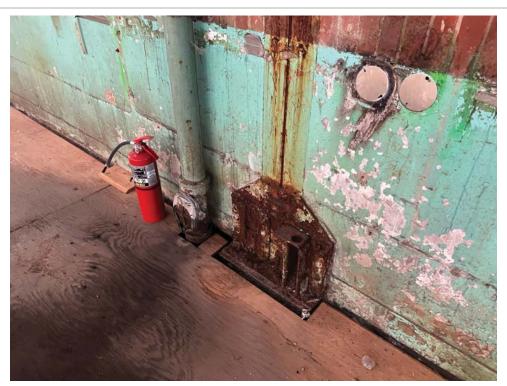
Photo 46: Main Floor – Anchor bolt missing. Column is no longer connected at base.

This could lead to instability of column base.

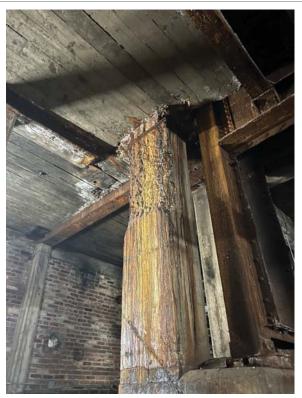
Photo 47: Basement – Deteriorated concrete column. Reinforcement is necessary to repair column.

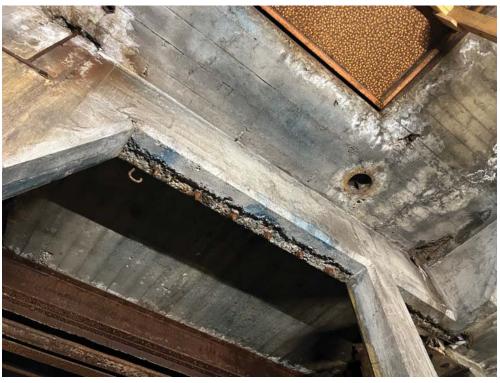
Photo 48: Basement – Beam with bolts through. Unusual detail which may have been a temporary repair. Exposed rebar and bolts should be covered with concrete.
