Rossdale Power Plant Advanced Assessment and Priority Rehabilitation

Pump House #1 Condition Assessment

Submitted to: City of Edmonton

Date Submitted: 2021-03-15

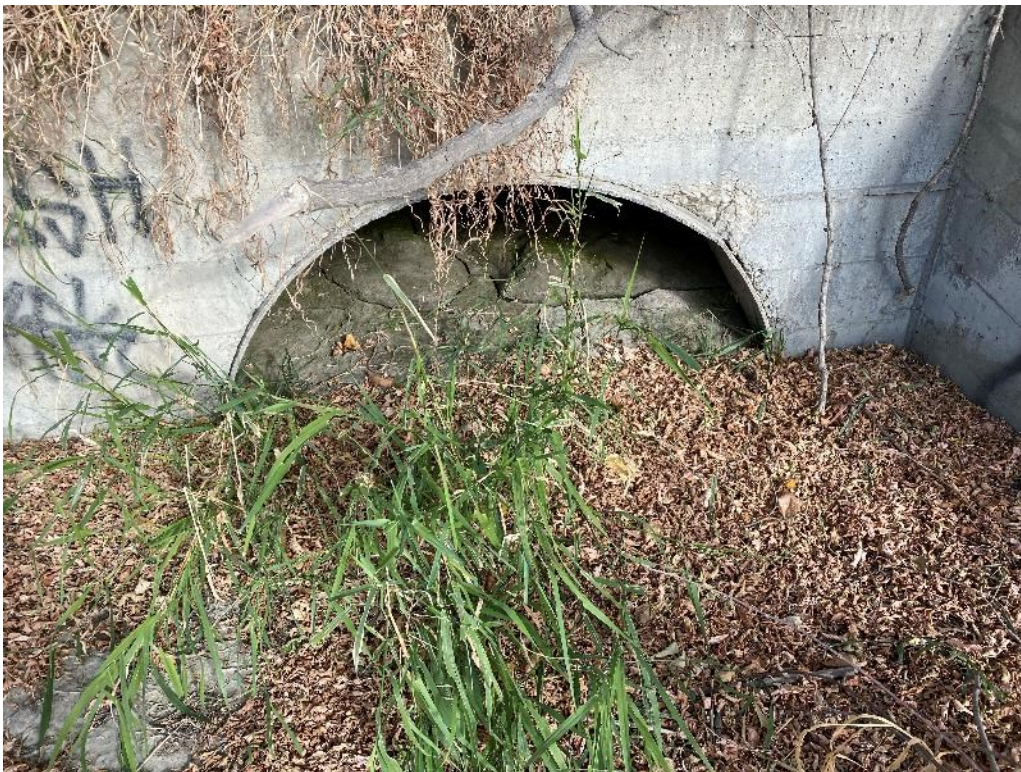
Above: Abandoned outfall piping from building

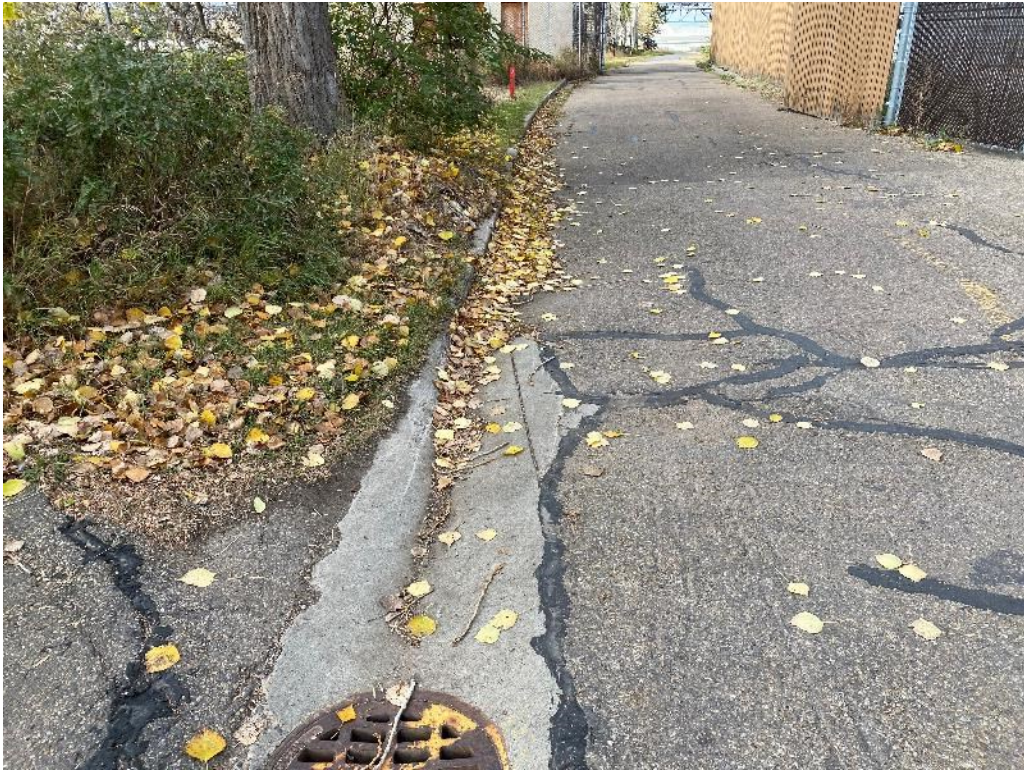
Above: Public trail between Pump House 1 and the Low Pressure Plant

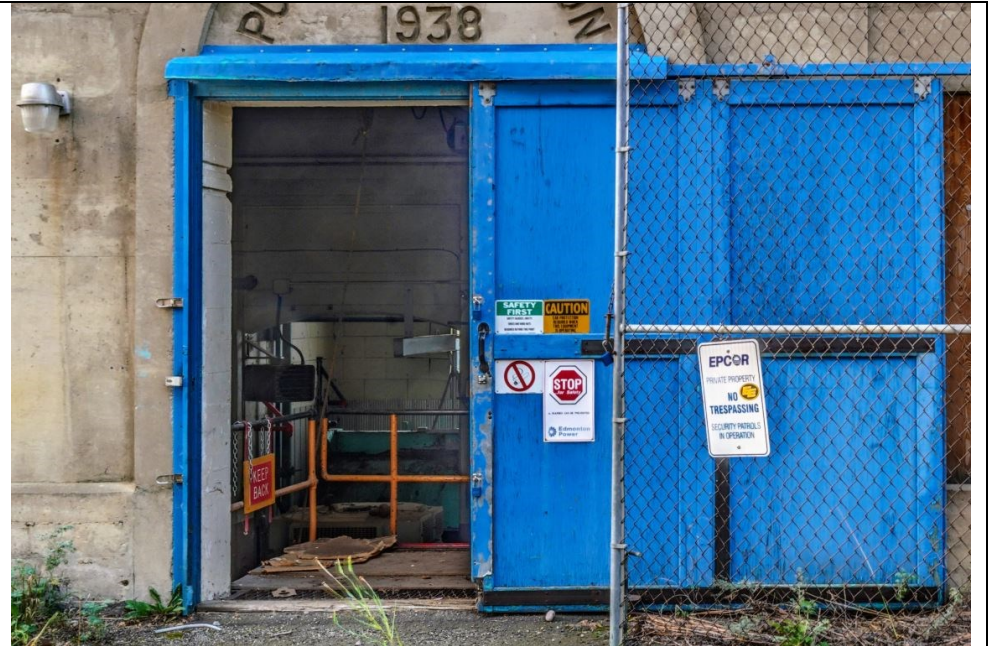
2.2.1 Building Entrance

Door: Modifications have led to the original double swinging doors to become one sliding door. Modifications include steel strengthening, likely for security purposes, lock modifications, and rail installation. Vibrant Prussian-blue door paint colour is associated with Edmonton Power Company colours circa 1980-1990 era, and has had multiple campaigns. The most recent coating layer is likely failing in areas because of an improperly prepared substrate. Older seafoam green colour is visible in areas of higher wear.

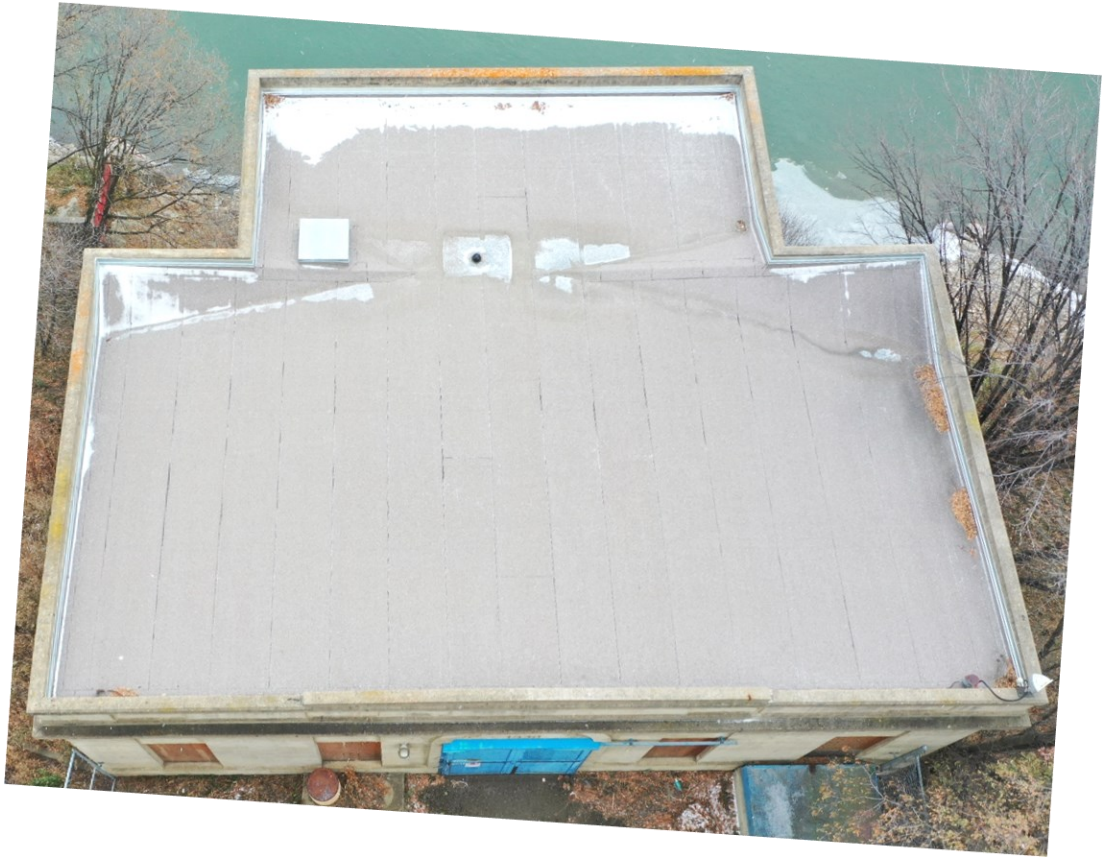
2.2.2 Pump House Roof

Roof: Good serviceable condition, will require monitoring and periodic cleaning of leaf litter to avoid bio-growth. Roof access hatch and drain are noticeable on the upper part of the photo, the south end of the roof.

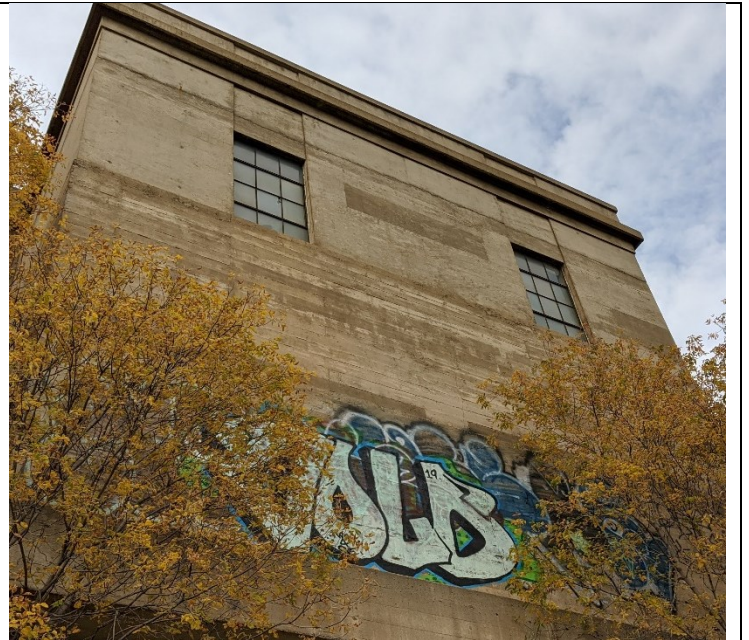
Exterior Surfaces: Graffiti and EPCOR overpaint are scattered across elevations. Photo illustrates the south elevation.

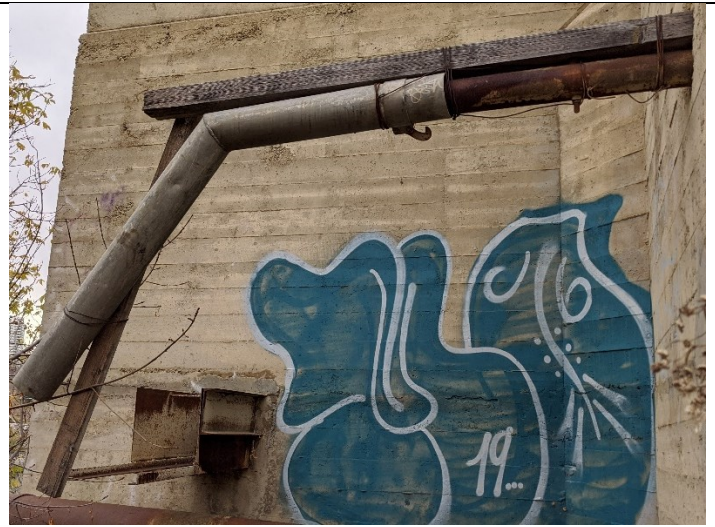
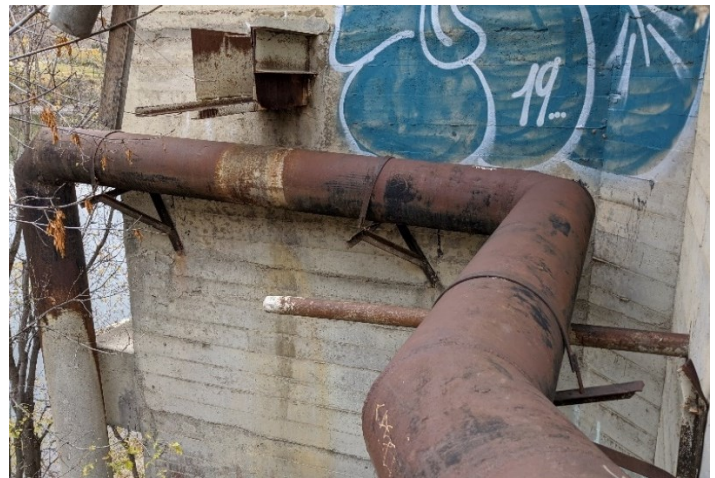
Relict Mechanical Services: Various pipes/ pipe-ends remain from historic mechanical services, some of these have been patched with cementitious materials. Southwest elevation pipes in particular require stabilisation — as seen in photo. Upper photo illustrates pipes reinforced with wood members and metal wire. Lower photo illustrates failed support brackets of larger diameter pipe.

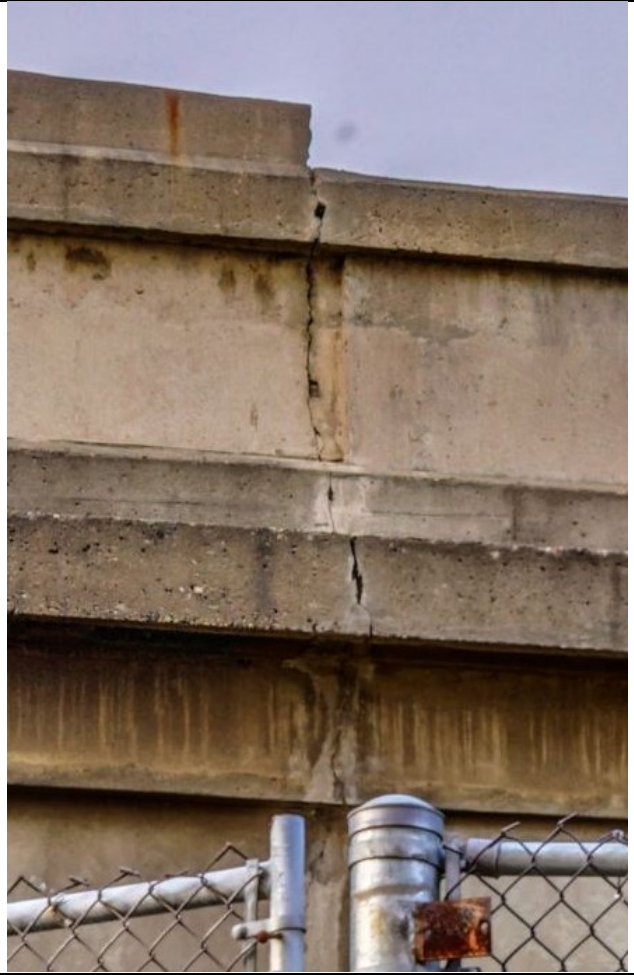
North Elevation Parapet & Cornice: A vertical crack propagates from the westerly pediment termination of the north elevation. Crack radiates across unadorned frieze and cornice banding.

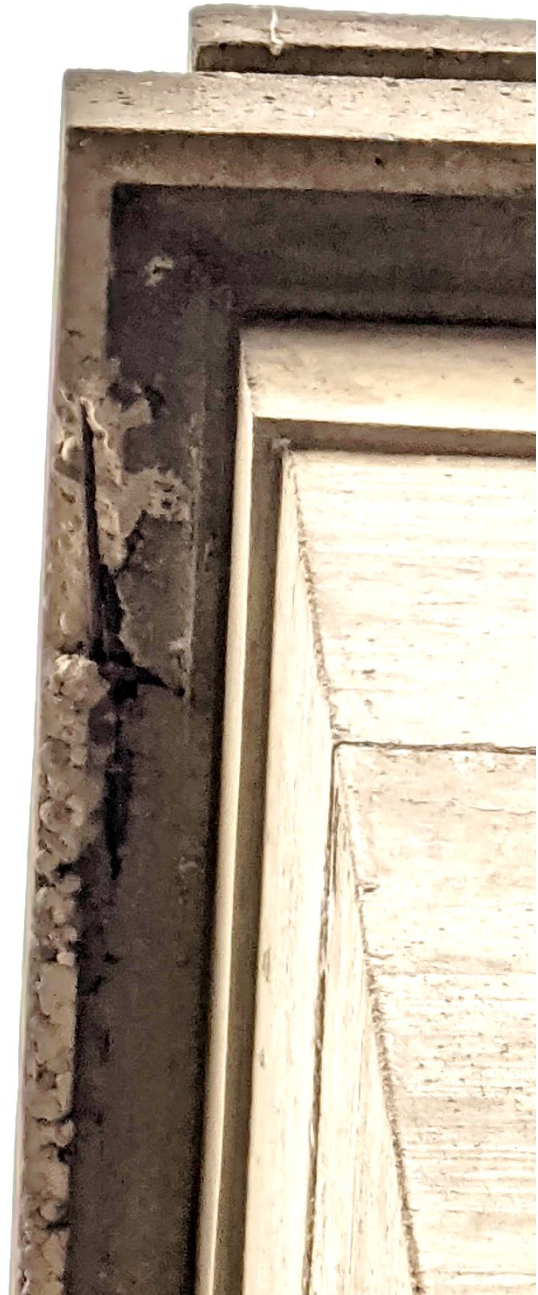
Cornice: Cornice and drip edge has numerous shallowly bedded reinforcement and honeycomb deterioration patterns - likely due to lack of adequate vibration during pouring processes, and shallow placements of reinforcement.

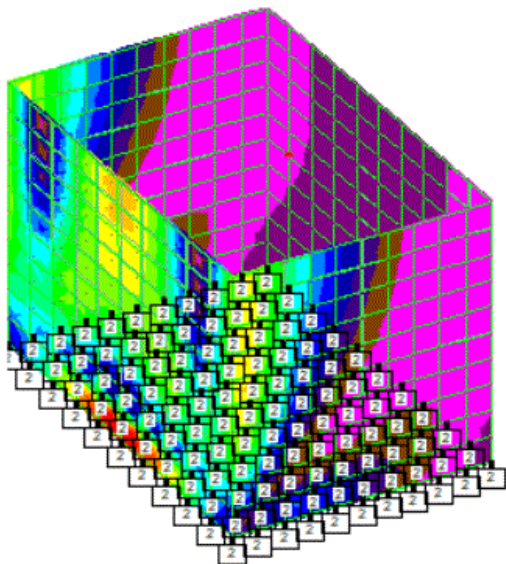
The idealised stress contour modelling of a rectangular water tank with max absolute stress of 18.70 N/mm² is illustrated as below, suggesting if the Screen Washing Room was used as a tank, that the crack could be a natural expansion crack correlating to one of the areas of highest loading¹:

Note that the locations of highest loading do correlate to crack propagation. Not an active concern as the wet well is no longer being used.

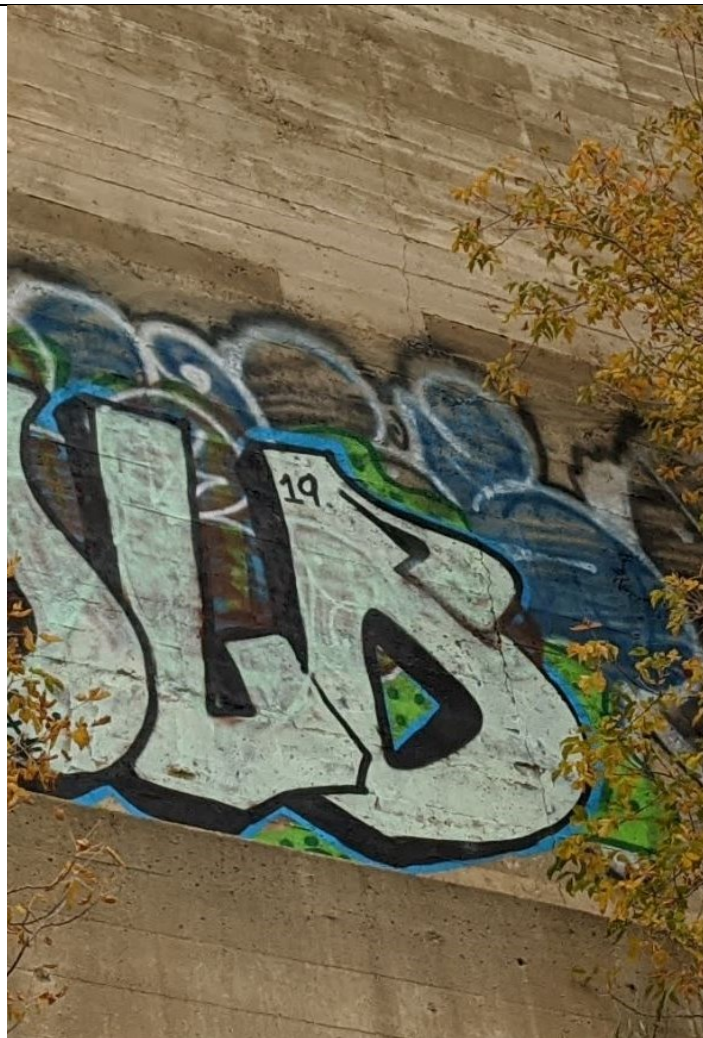
South Elevation Crack: Vertical propagating crack emanating of what might be two reinforcing ferroconcrete beams. This wall section is thinner than below, based on original design with the travelling water screen room being at Lower Level 1. It is possible that after the design decision sealed up this room (unknown date or specific sequence) and positioned the water screen on the main operating floor the plant gained more usable water storage for their wet well. However, if this originally intended water screen room became used to hold water it is possible that the designed loads could have been exceeded by increased water capacity — leading to later reinforcement with two reinforced concrete beams as below this crack.

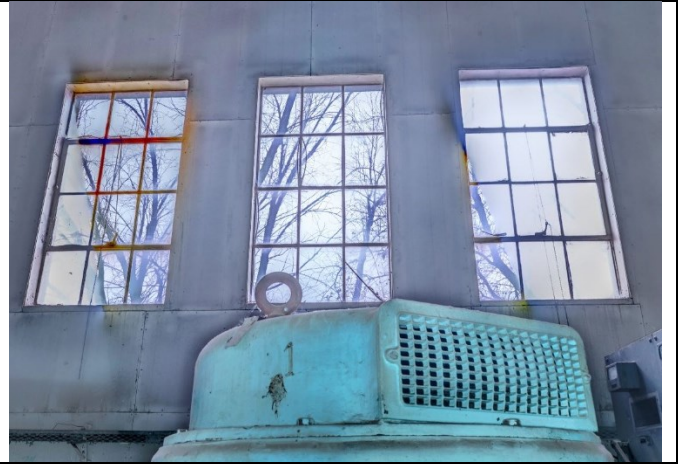
2.2.4 Windows

Windows: All multi-light leaded glass windows have failing glazing putty, numerous broken or missing window lights, and failing sash-caulking. Detailed condition of steel frame, mullions, rails, and operable louvers (including lubrication of movable parts) is unknown, but is assumed to be deficient and requiring service. Full replacement of windows is not required, as they are designed for long serviceable lives, and can be restored in parts.

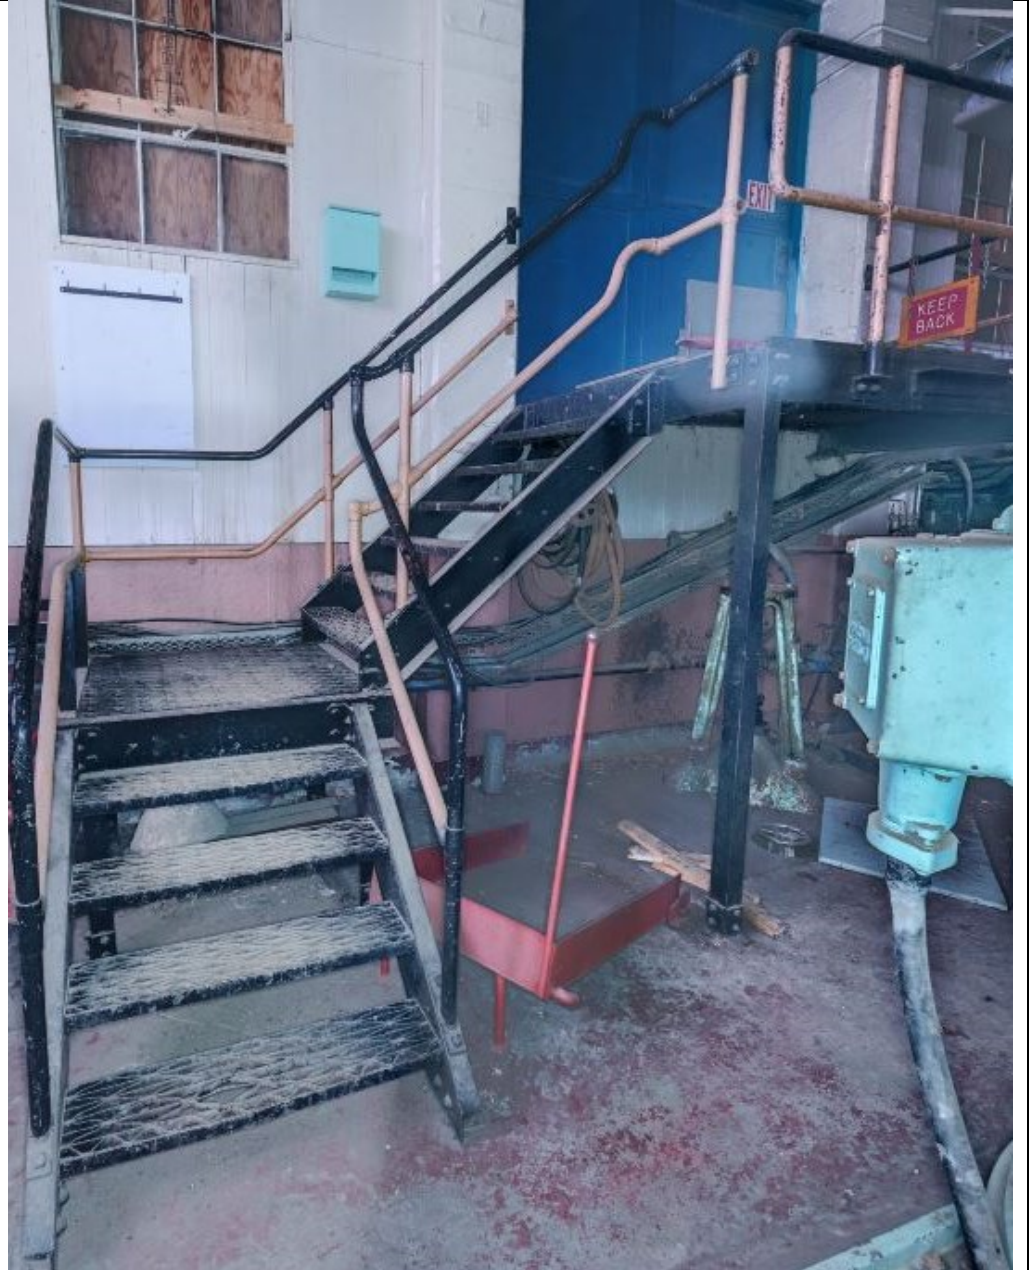
Entrance Landing: Good condition, some minor surficial corrosion and paint failure on floor grates, rails, stairs, and posts.

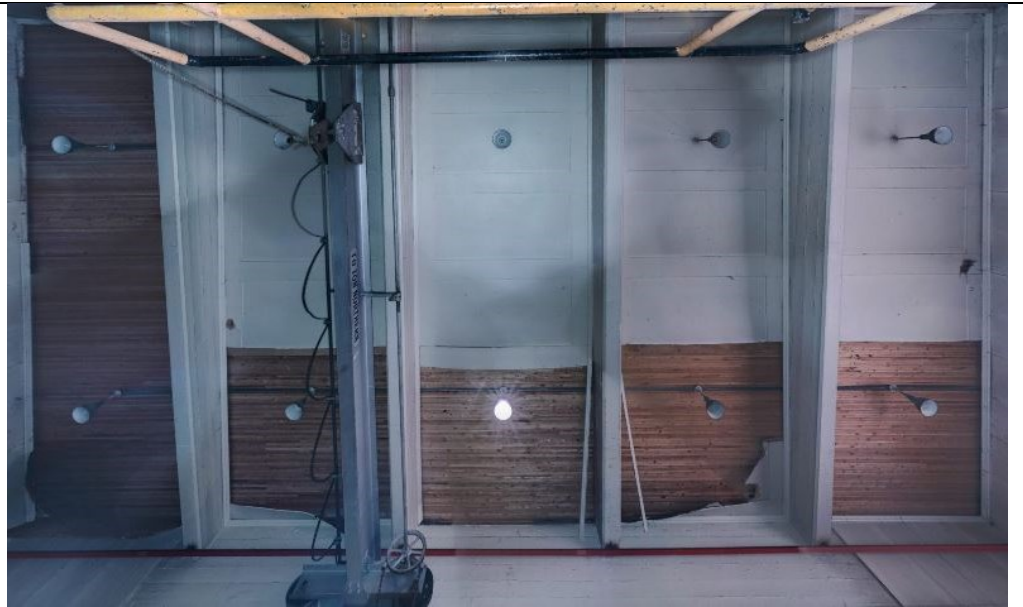
Walls & Ceiling: Various insulating fibre board units have been detached, have failing fixtures, and are dimensionally distorted. Others have been disposed of due to water damage. Paint is dirty, but serviceable.

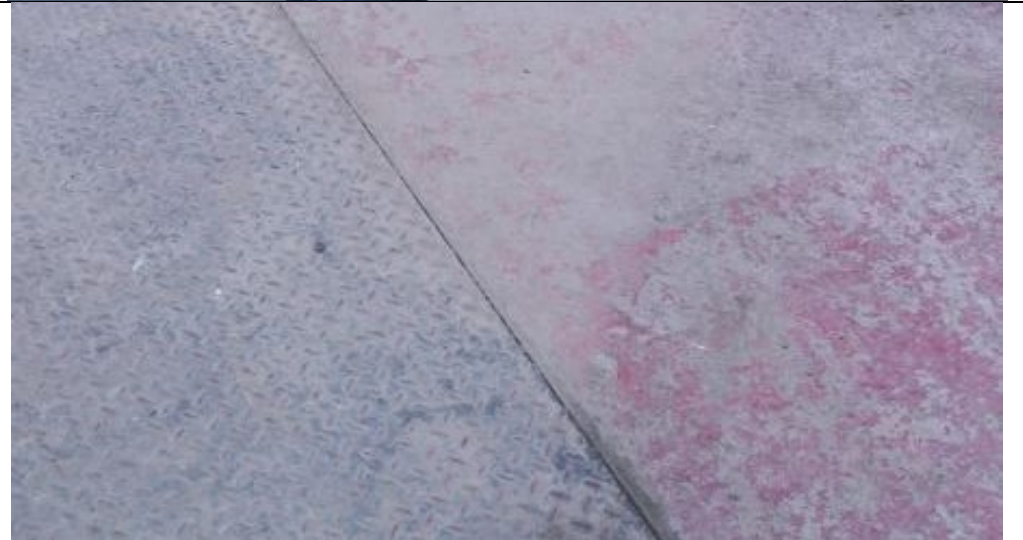
Concrete floors & Access Hatch: Red paint coating is failing, but concrete is in good condition. Minor surficial corrosion on lower levels access hatches.

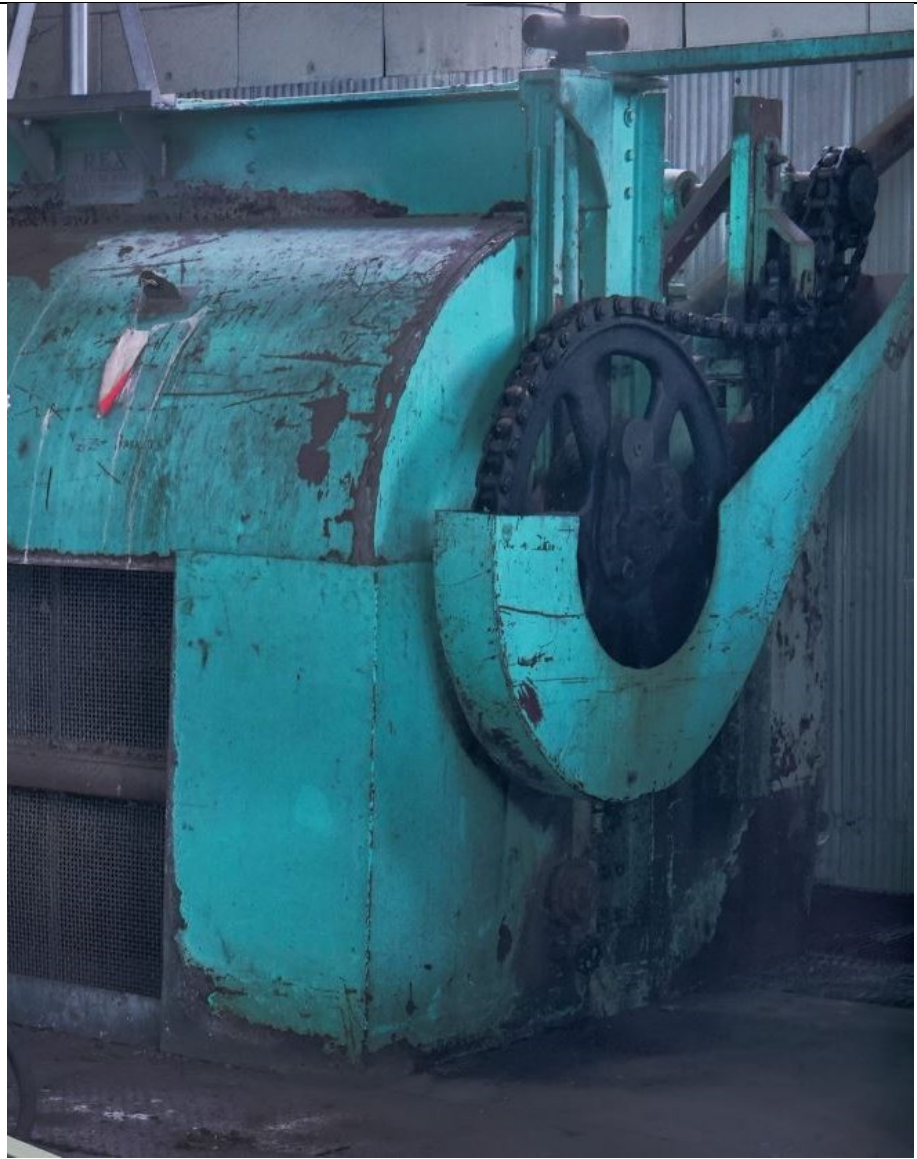
Relict Machinery and Equipment: Coatings are dirty, chipped, and abraded but generally exhibit good structural adhesion where no mechanical damage has occurred. Relict lubricants are soiled and oil-based. Basement and wet well machinery and equipment have more advanced levels of corrosion due to free water ingress.

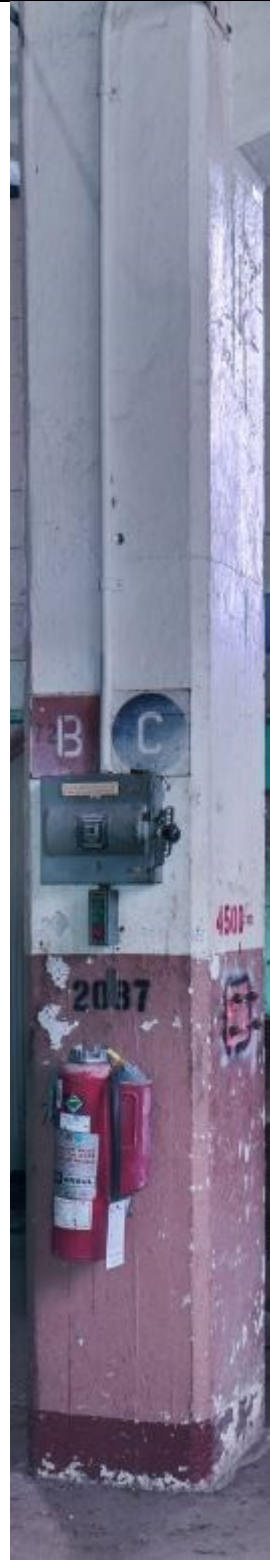
Exposed Concrete Structural Elements: Red and pink paint coatings at human level are failing due to activity related abrasion and impacts.

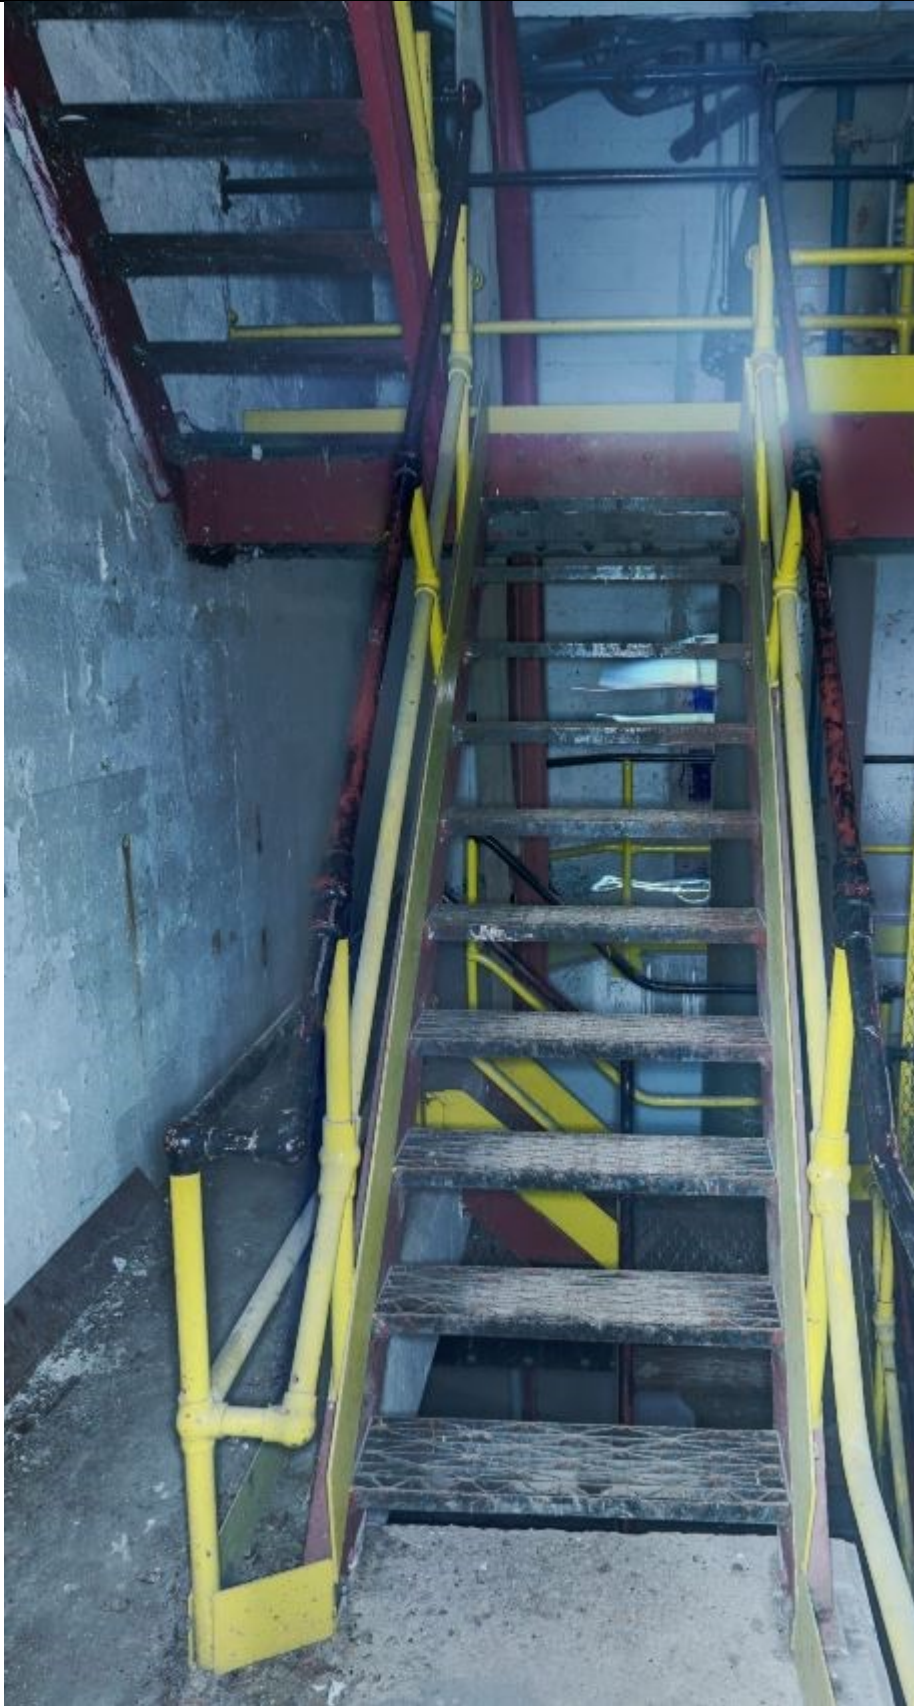
Stairs & Catwalks:

Generally all stairs and catwalks are in good condition other than coating failures. Structurally, they are in good condition though are not to current building code

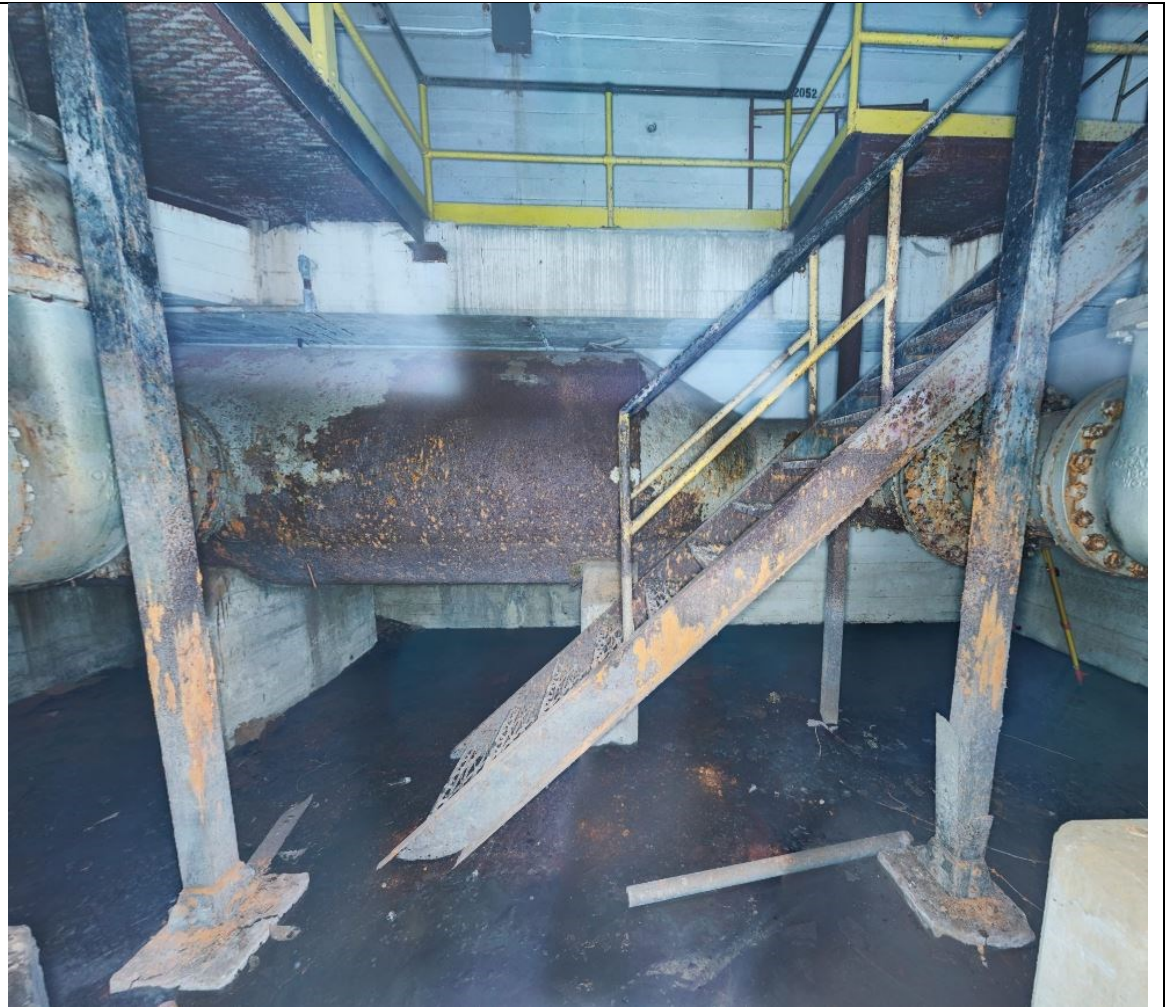
Basement stairs:

One exception to good stair, as noted above, is the lowest stair support posts, L4-101, on the basement floor. These are exhibiting advanced corrosion, loss of section, and coating failures due to standing water and free ions, or river salts, exacerbating deterioration.

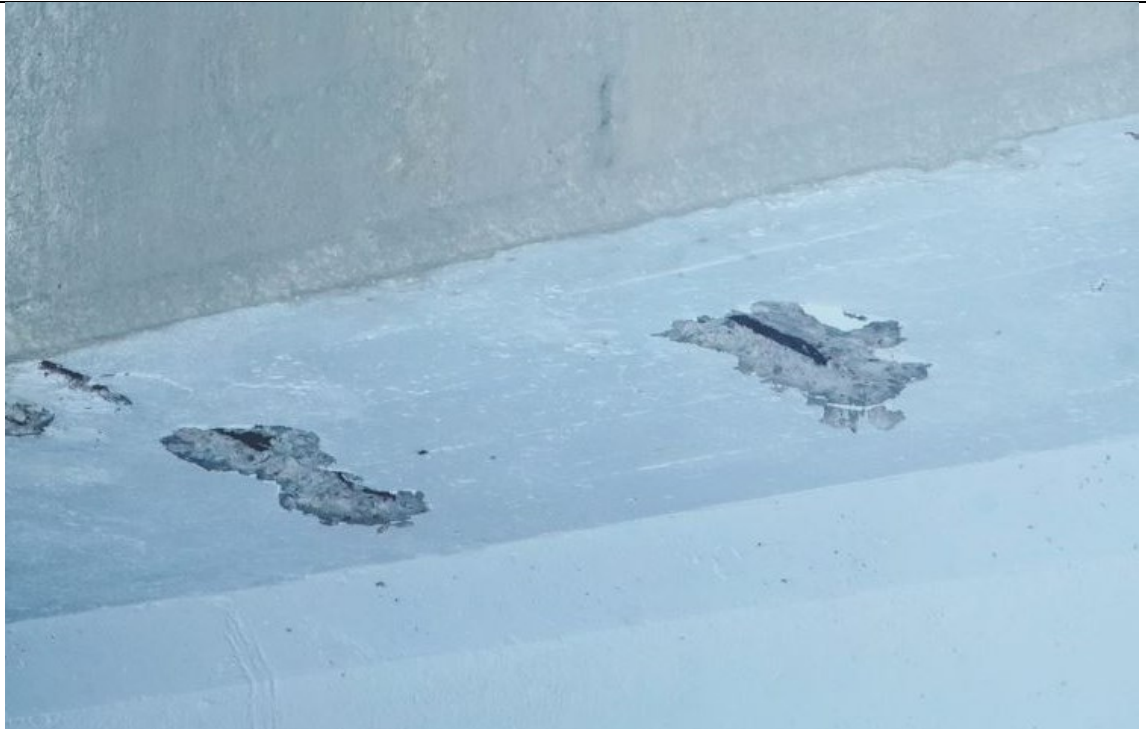
Concrete: Paint coating of all concrete surfaces is soiled and failing in areas. There are isolated areas of exposed reinforcement bar of no more than 1 metre square. This is likely due to positioning of reinforcement too close to the surface (carbonation), corrosion present, and active free flowing water and soluble salts.

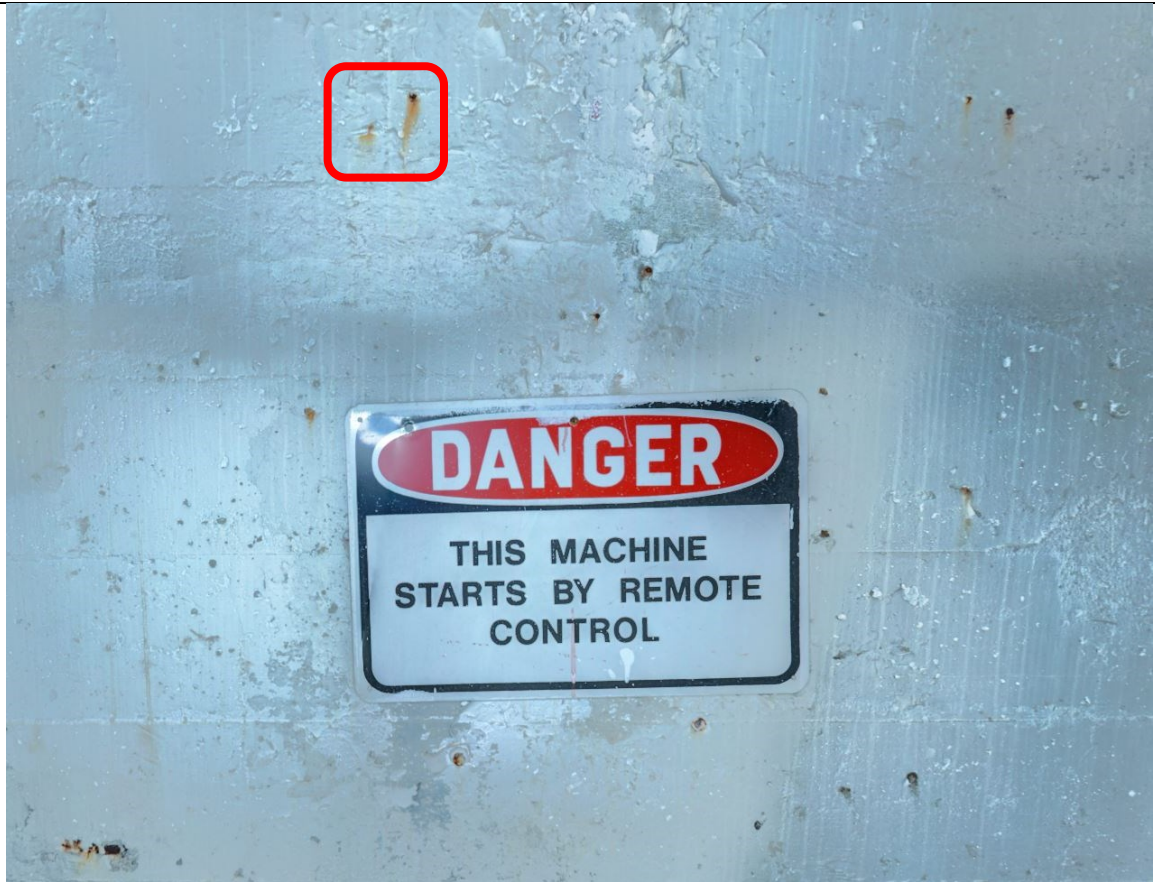
**Reinforcement
Metal Ends:**

Reinforcement bar ends are visible throughout all interior wall surface, and include some minor ferrous staining. This staining can be confused with various minor past mechanical fixings and utilities which have been cut off and left in the walls or patched with cementitious fills.

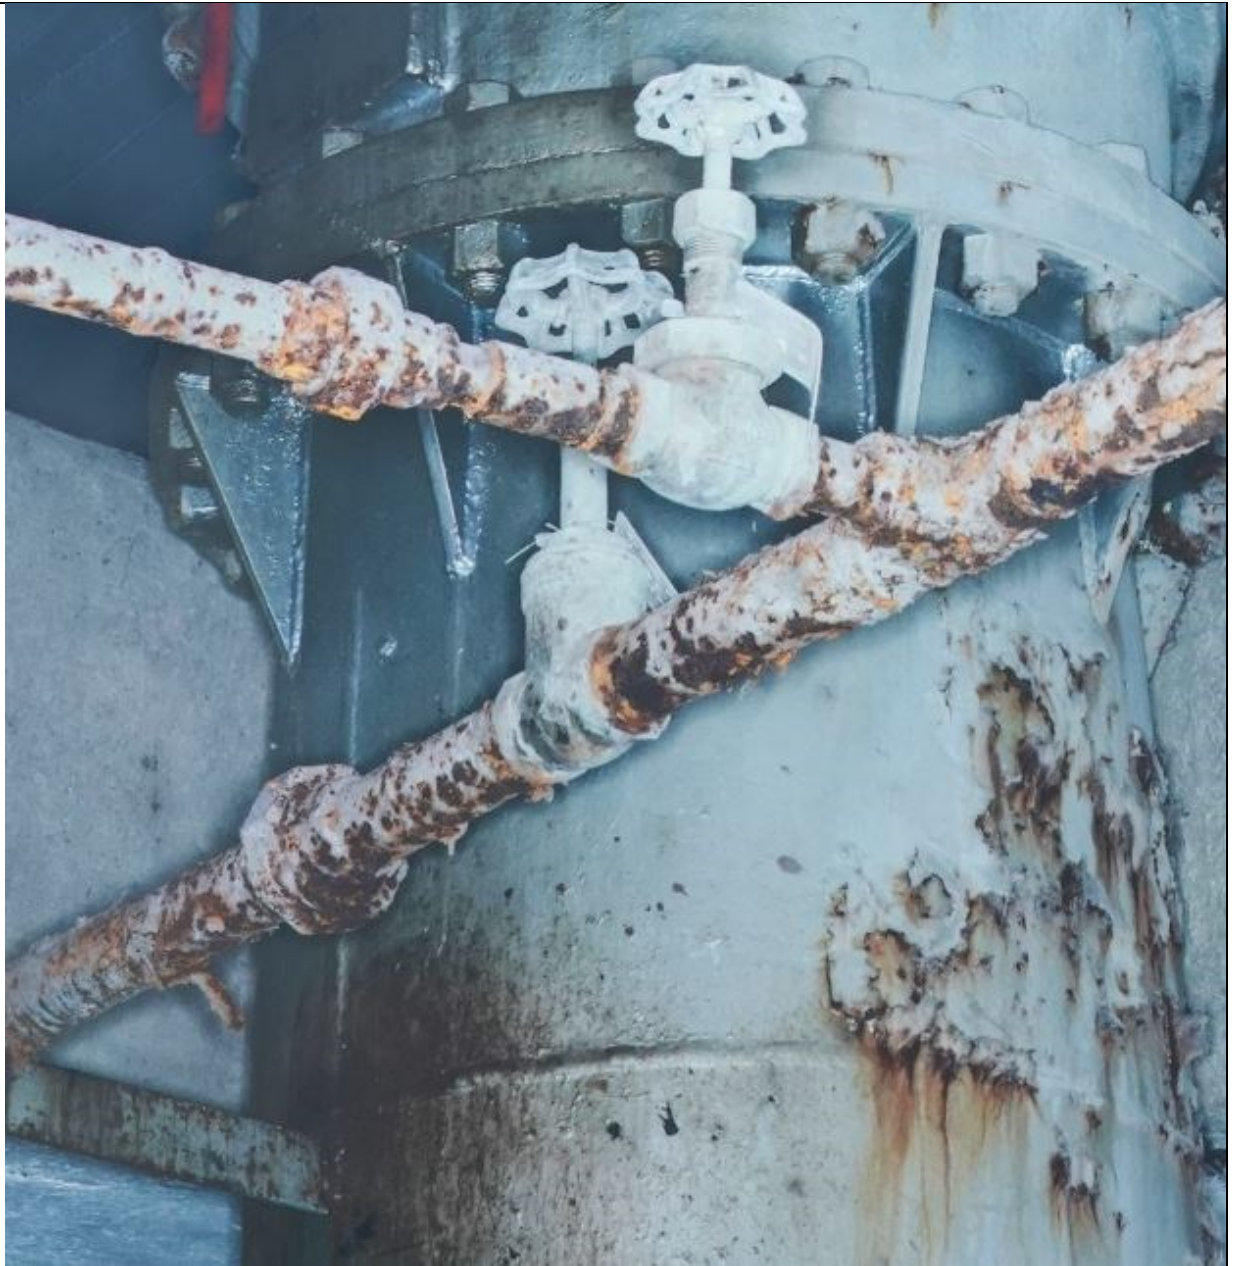
Relict Mechanical Systems: All metal pipes, machinery, and fixtures are in generally good condition throughout. Coating failure and minor surficial/passivated corrosion is present on many. The photograph at right illustrates a slightly more advanced level of decay than is the norm because of its position on L4 - Lower Level 4 floor. Lower Level 4 is subject to water ingress as outlined in more detail under **Travelling Water Screens / Wet-Well Water / Poor Seal**

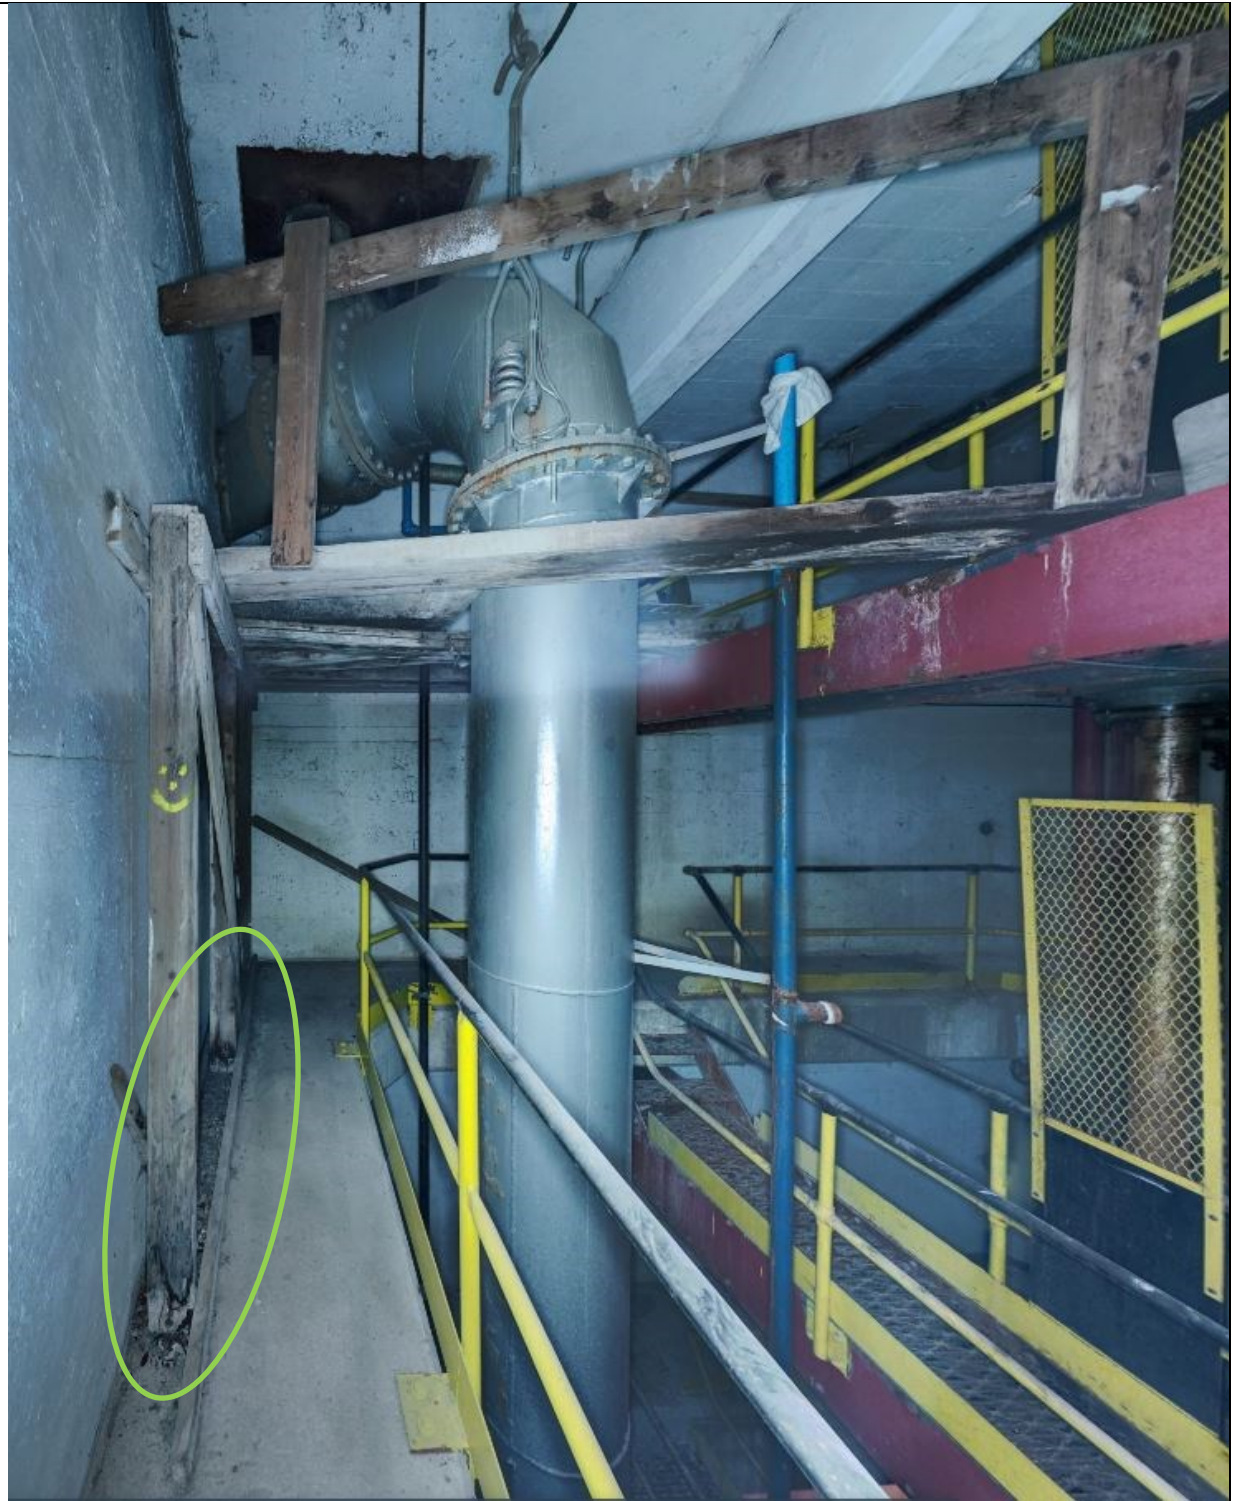
Wood Decay:

Ad-hoc wood scaffold evidences fungal decay on basal section of vertical posts (encircled in green in the photograph) resting on concrete floor at L1-102. These support a wooden platform at the catwalk height at L1-102 used to gain service access to the pipe it surrounds.

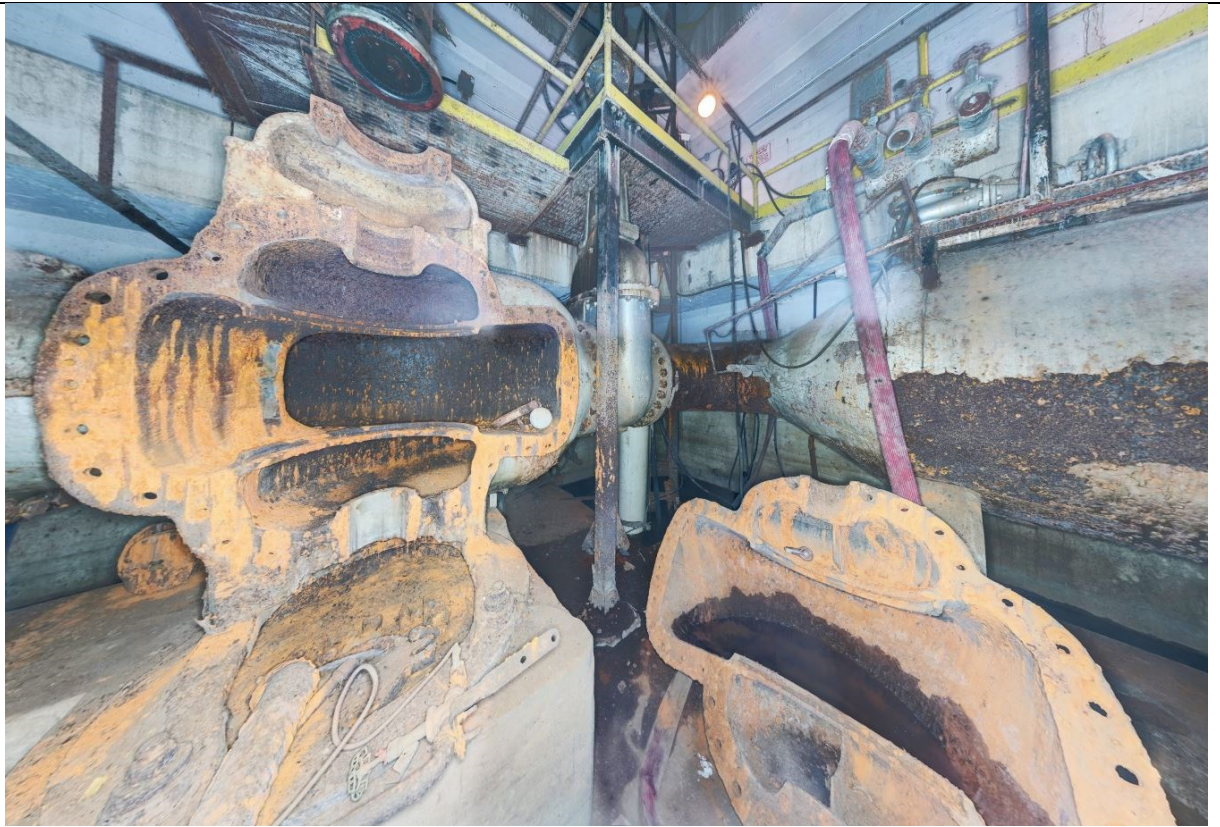
Metal: There is one exception to mechanical system conditions on L4-102, the basement operating floor. There is a continual leak that ultimately comes from the wet well, travels through the suction headers, and leaks alternatively at the centrifugal pumps or valves. This has caused extensive corrosion to all pipes/valves/pots and coatings leading to loss of section and corrosion packing. As previously mentioned, this is also causing deterioration of vertical posts, supporting stairs, ladders, and landings.
