Rossdale Power Plant Advanced Assessment and Priority Rehabilitation

Pump House #1 Condition Assessment

Submitted to: City of Edmonton

Date Submitted: 2021-03-15

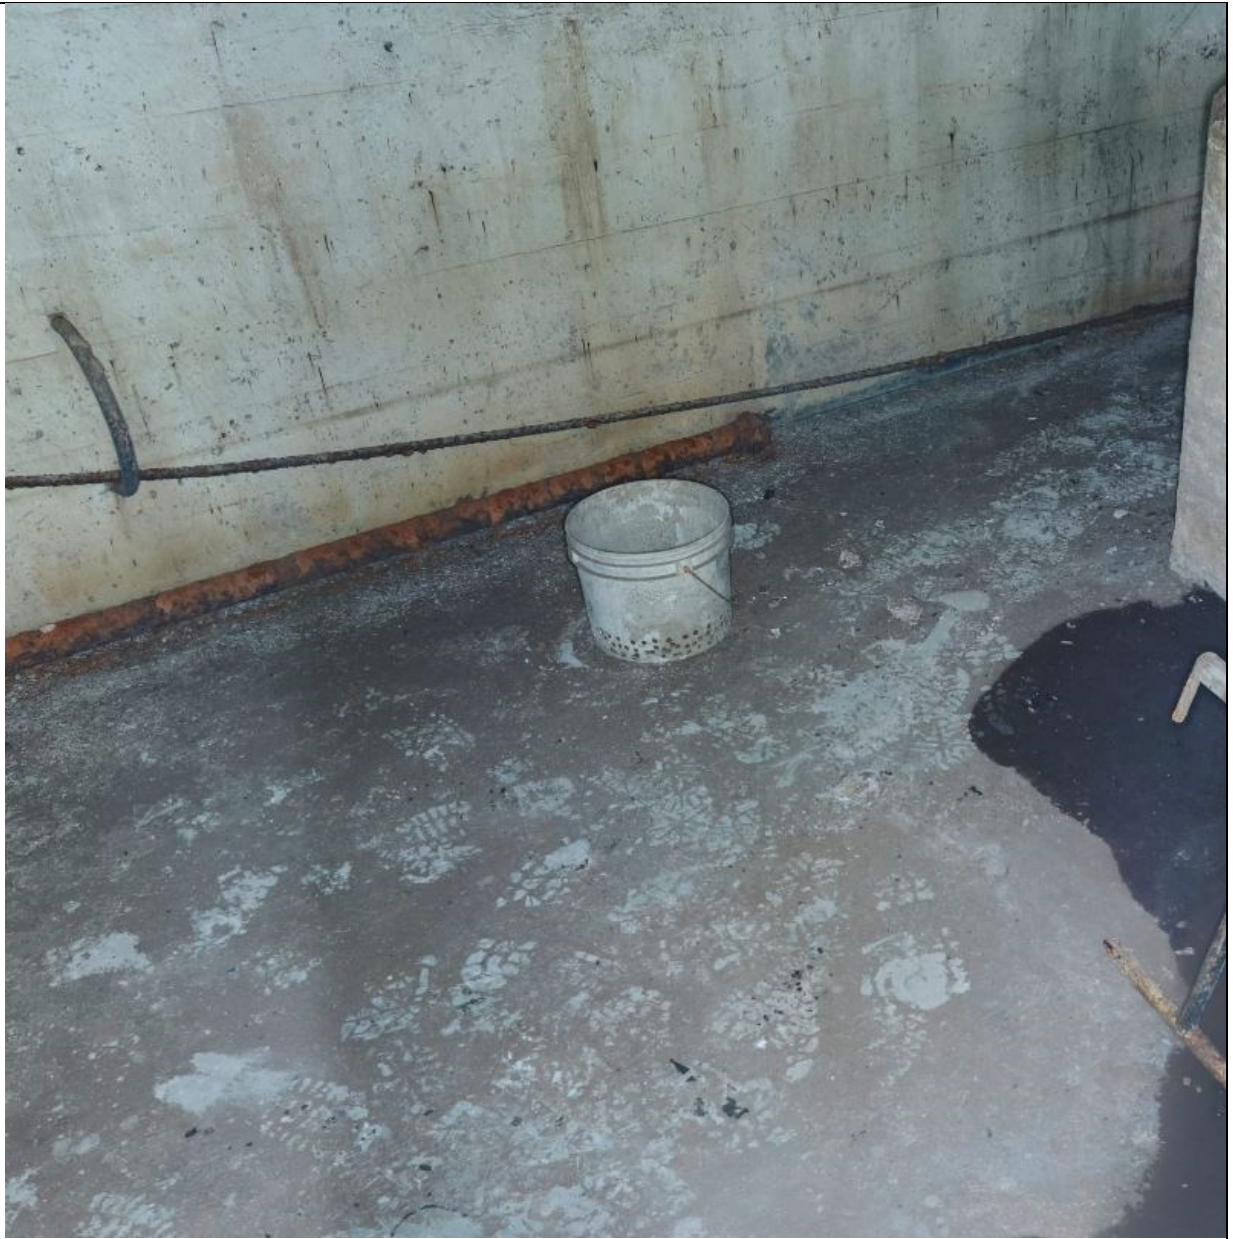
Basement floor is covered in clay/silt due to the leak mentioned above. It is unknown if this sump pump is still operable considering the quantity or depth of river deposits. Perforated plastic bucket is positioned around the sump pump location in hopes to filter out debris.

The basement level sumps should be cleaned. Verify that pumps are functioning properly, and ensure that duplex pumps are available and operational to prevent flooding should a single pump fail.

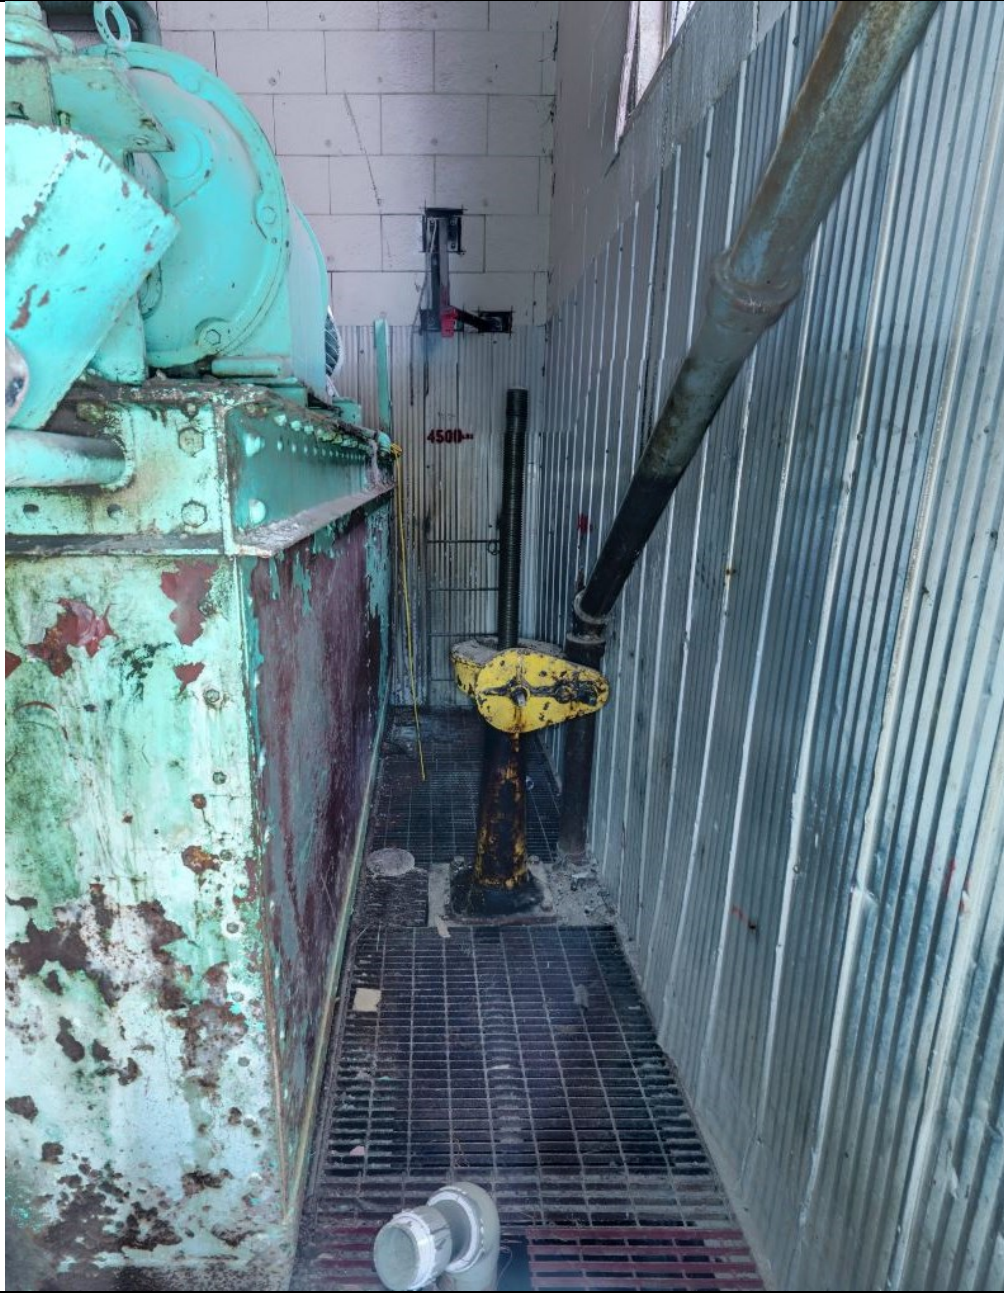
Access:
There is poor access to the wet well from a ladder through the Main Floor, MN-102, floor grates. Because this is a dark confined space of poor access, with deep standing water below, it could not be fully inspected. Further investigation is required. The wet well lies below the metal floor grates in the photograph to the right.

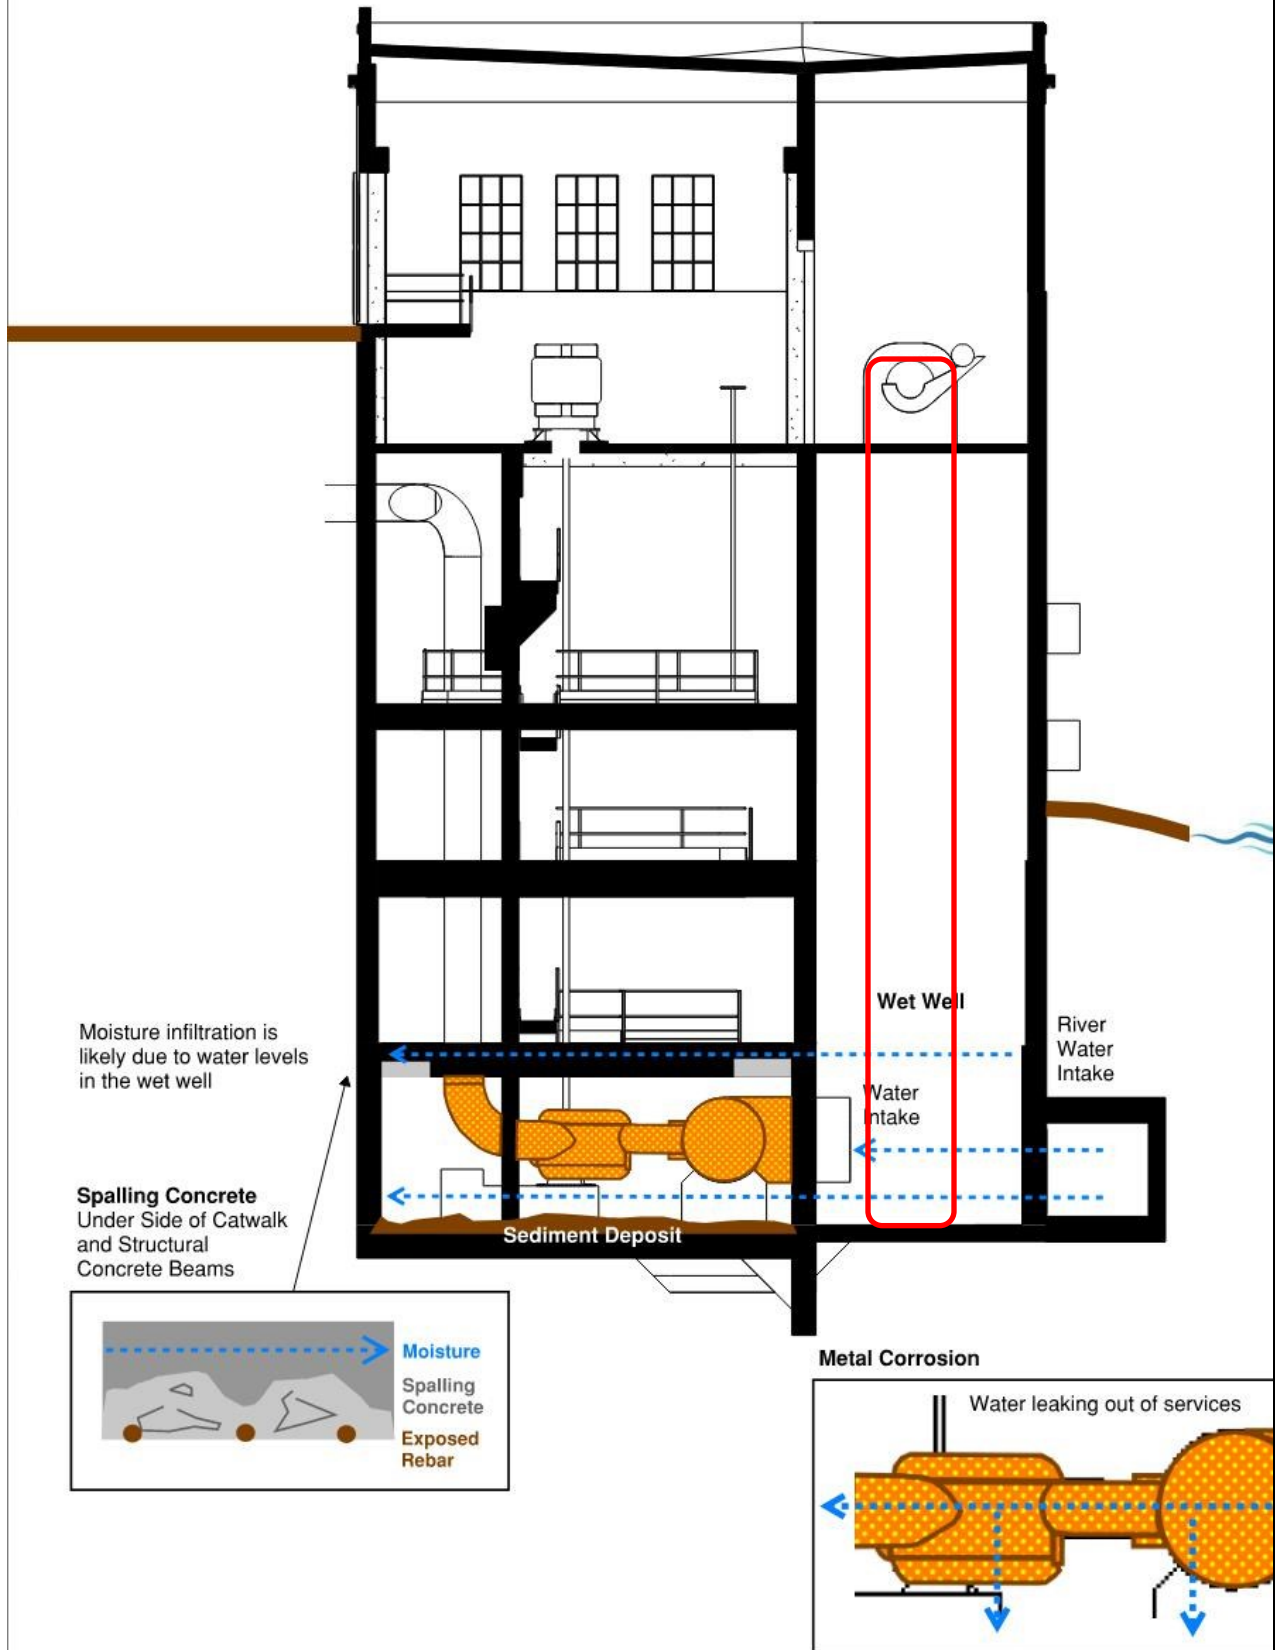
Pump House #1 Principal Deterioration Schematic

Travelling Water Screens / Wet-Well Water / Poor Seal:
 The traveling water screens and structural guides that descend into the wet well are likely heavily corroded within, and are just above the standing water line. In the diagram to the right, the pathway of current water flow in blue. Water is not sealed and is leaking into the wet well and then into the dry well via pumps/pipes. The pathway of travelling waterscreens indicating great likelihood of advanced corrosion is highlighted in red. Further investigation is required.

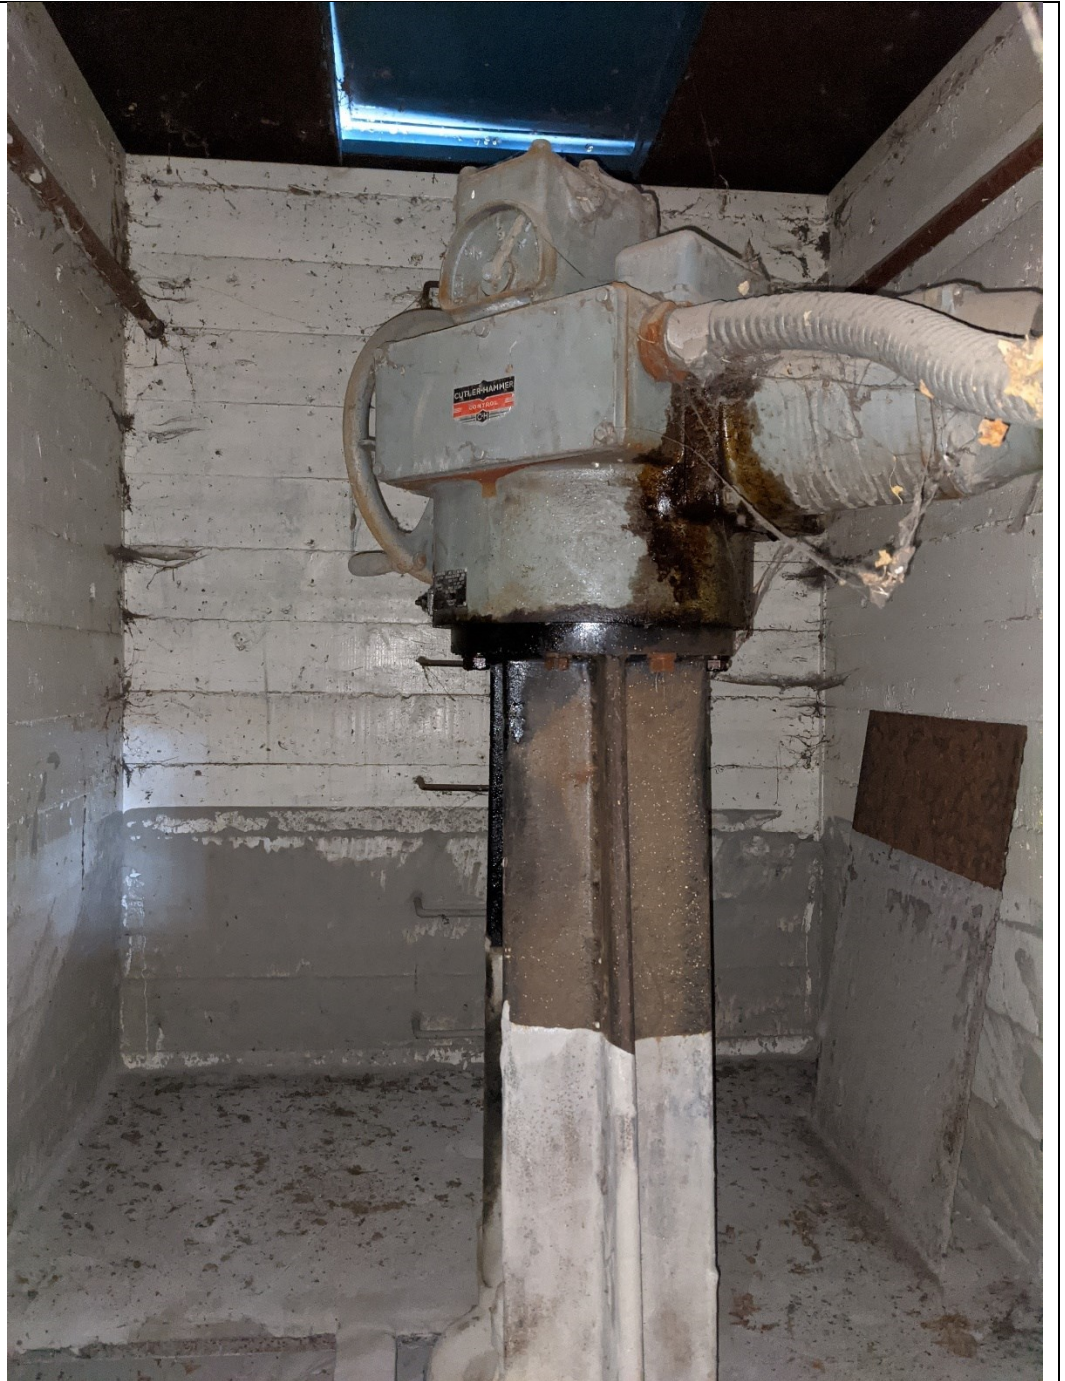
Pump Hatch Appendage:

Good condition, some soiling and surficial/passivated corrosion. Pump hatch door is in fine condition, but will likely require some maintenance such as attention to finishes and operable parts.
