# Rossdale Power Plant Advanced Assessment and Priority Rehabilitation

## Pump House #2 Condition Assessment

**Submitted to: City of Edmonton**

**Date Submitted: 2021-03-15**

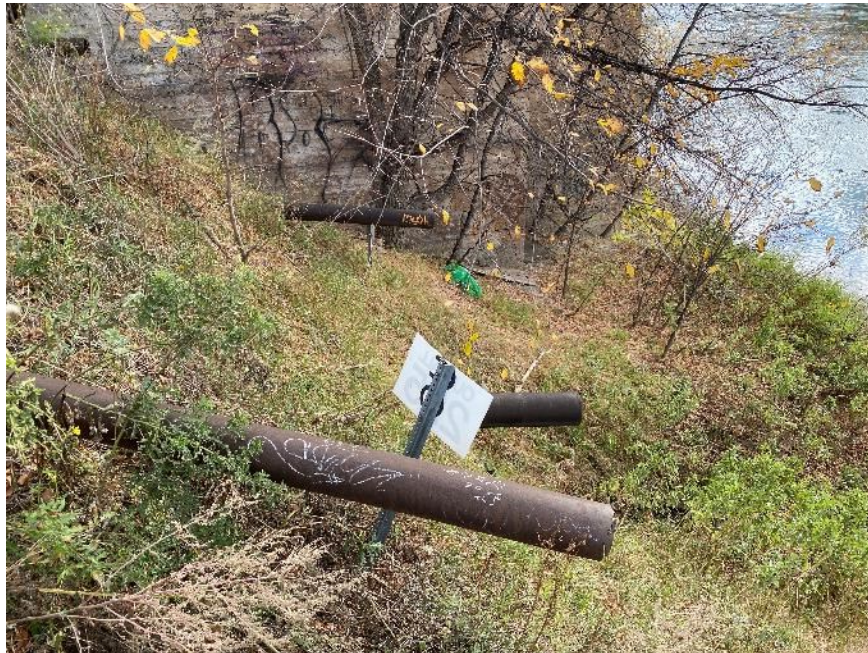
Above: Outfalls possibly from building storm leaders west of Pump House 2

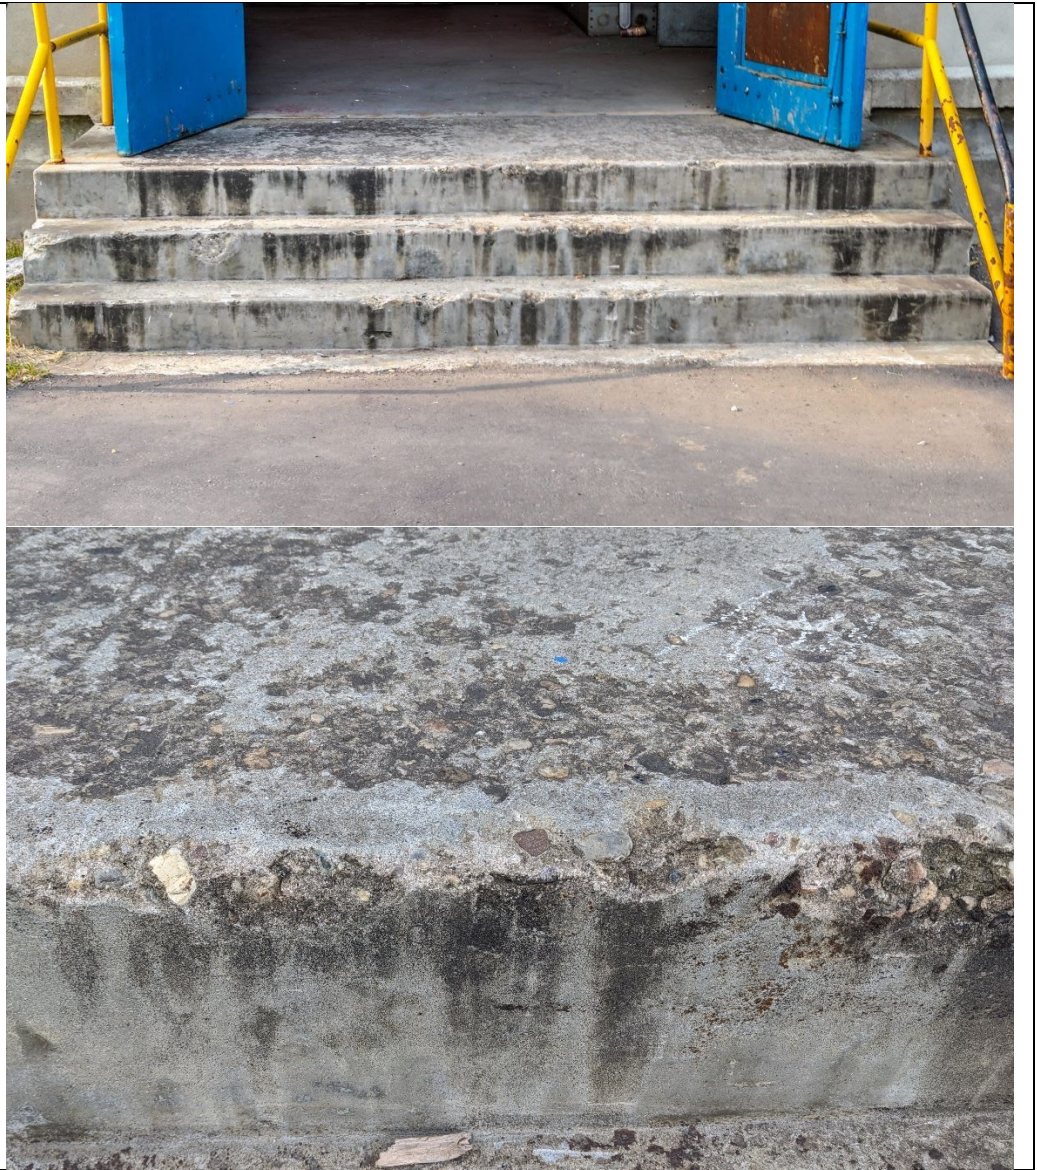
**MN 104, Entrance Stairs and Threshold:** Concrete threshold and entrance staircase scaling, likely due to de-icing salts. Various soiling is also present.

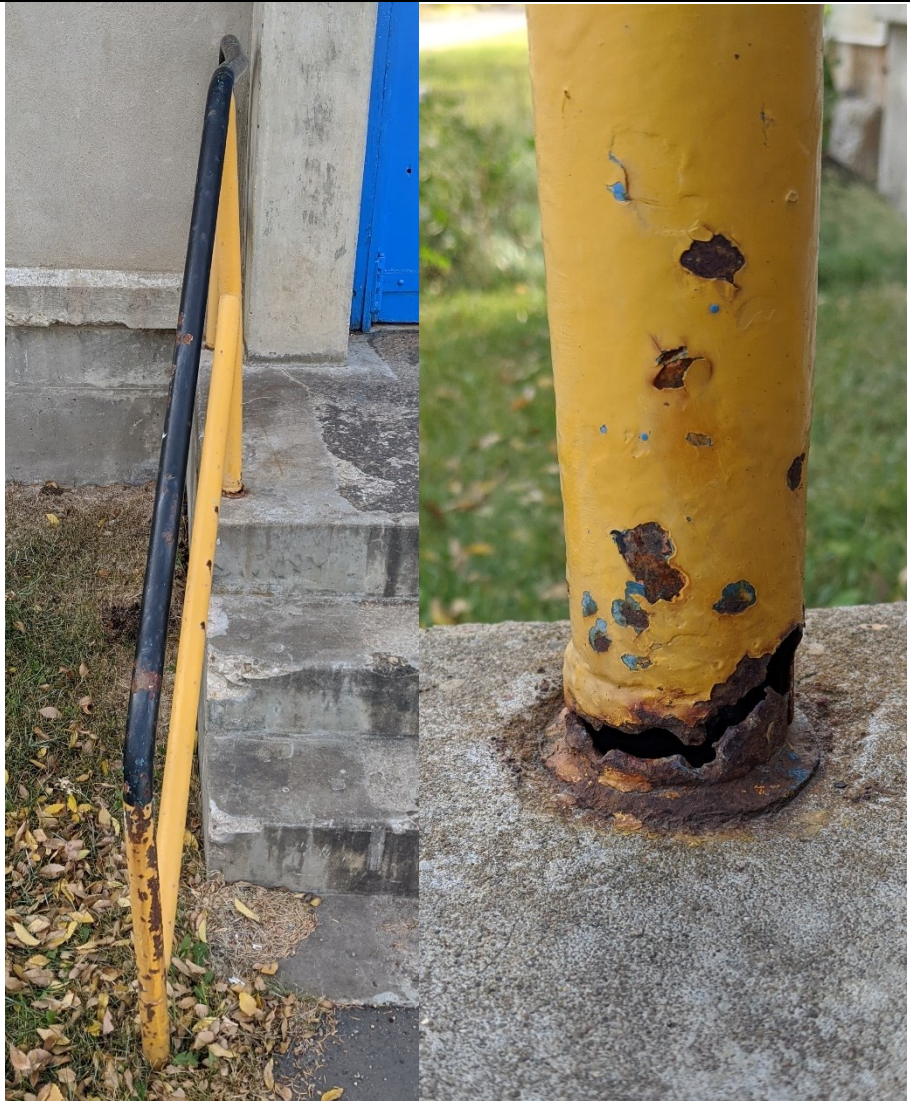
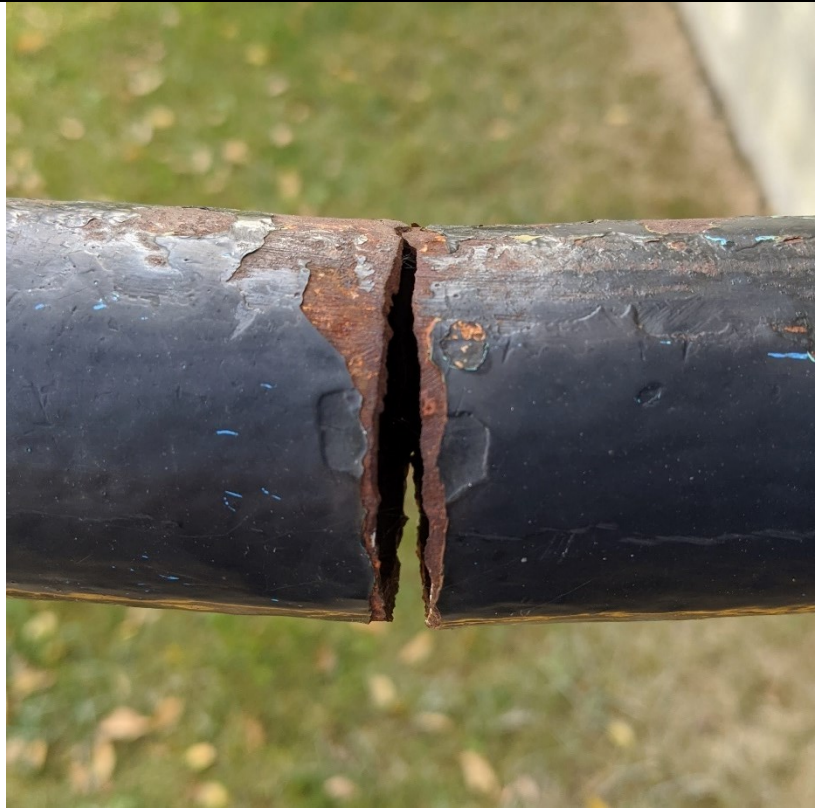
**Hand Rails:** Railings have deformed and fractured, likely due to mechanical impact damage.

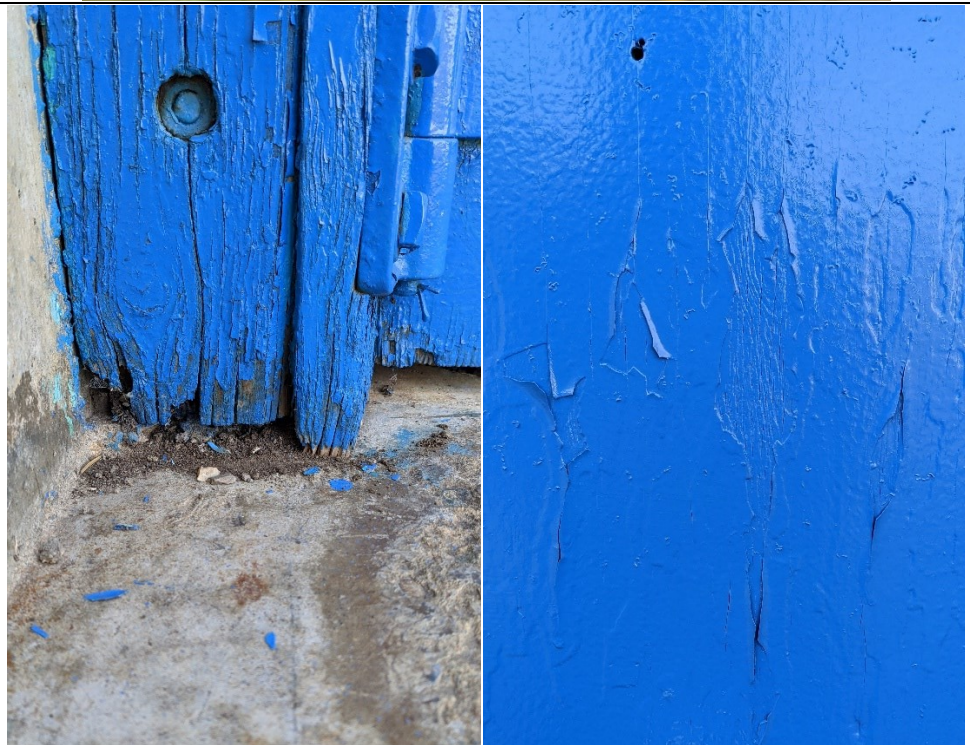
**Door:** Modifications have led to the original double swinging doors to become a sliding door. Modifications include steel strengthening, likely for security purposes, lock modifications, and rail installation. Vibrant Prussian-blue door paint colour is associated with Edmonton Power Company colours - circa 1980-1990 era, and has had multiple campaigns. The most recent coating layer is likely failing in areas because of an improperly prepared substrate. Basal fungal deterioration is evident at door jambs. Older seafoam green colour is visible in areas of higher wear.

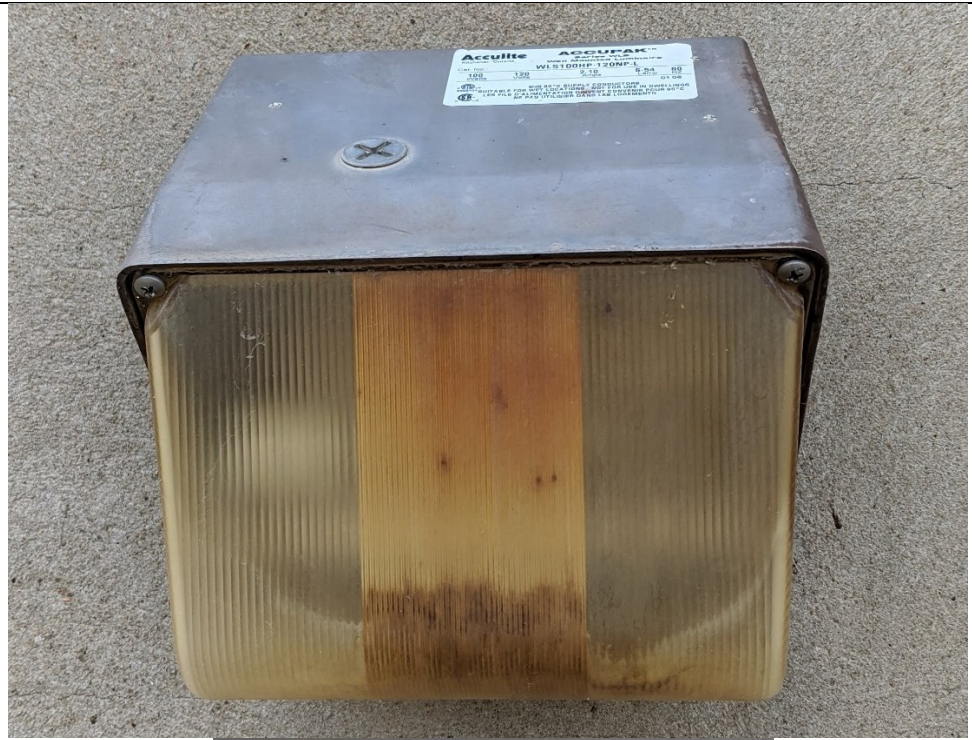
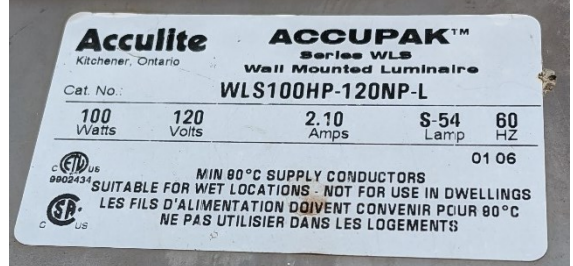
**Light Fixtures:** Not original, polymer shade appears to be yellowing, likely due to UV deterioration. Paint failure and minor corrosion on the fixture hood.

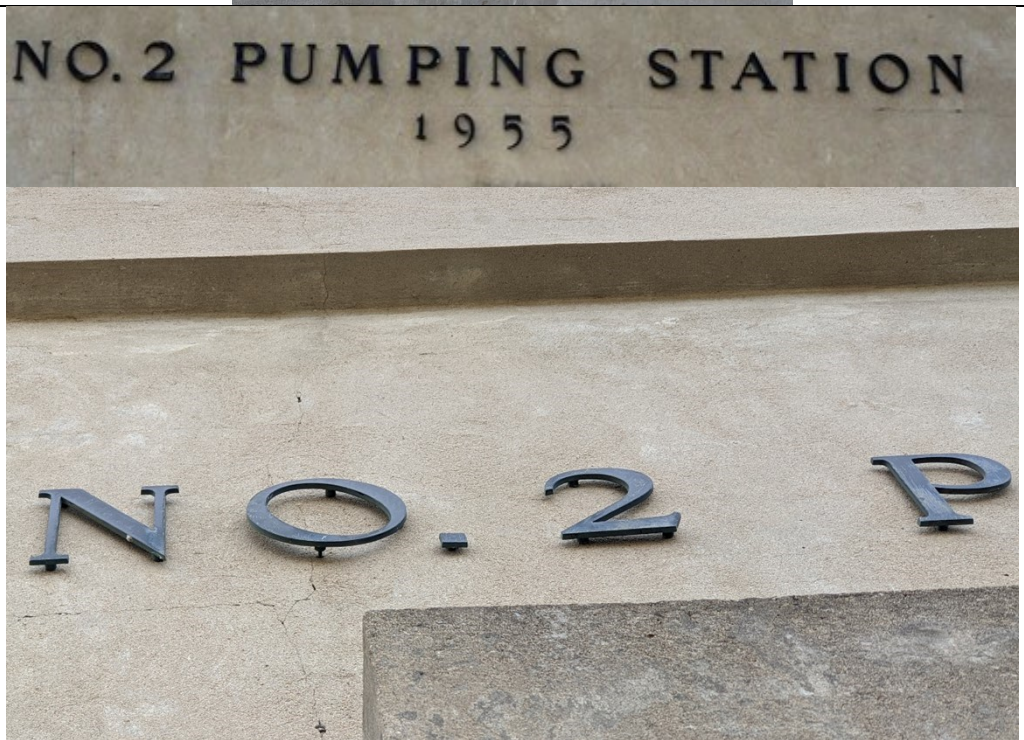
**Lettering:** Identified as painted aluminum in the original specifications, lettering appears to have passivated corrosion, of what appears to be cupric corrosion products. This suggesting that the letters are copper or some sort of copper/aluminum alloy.

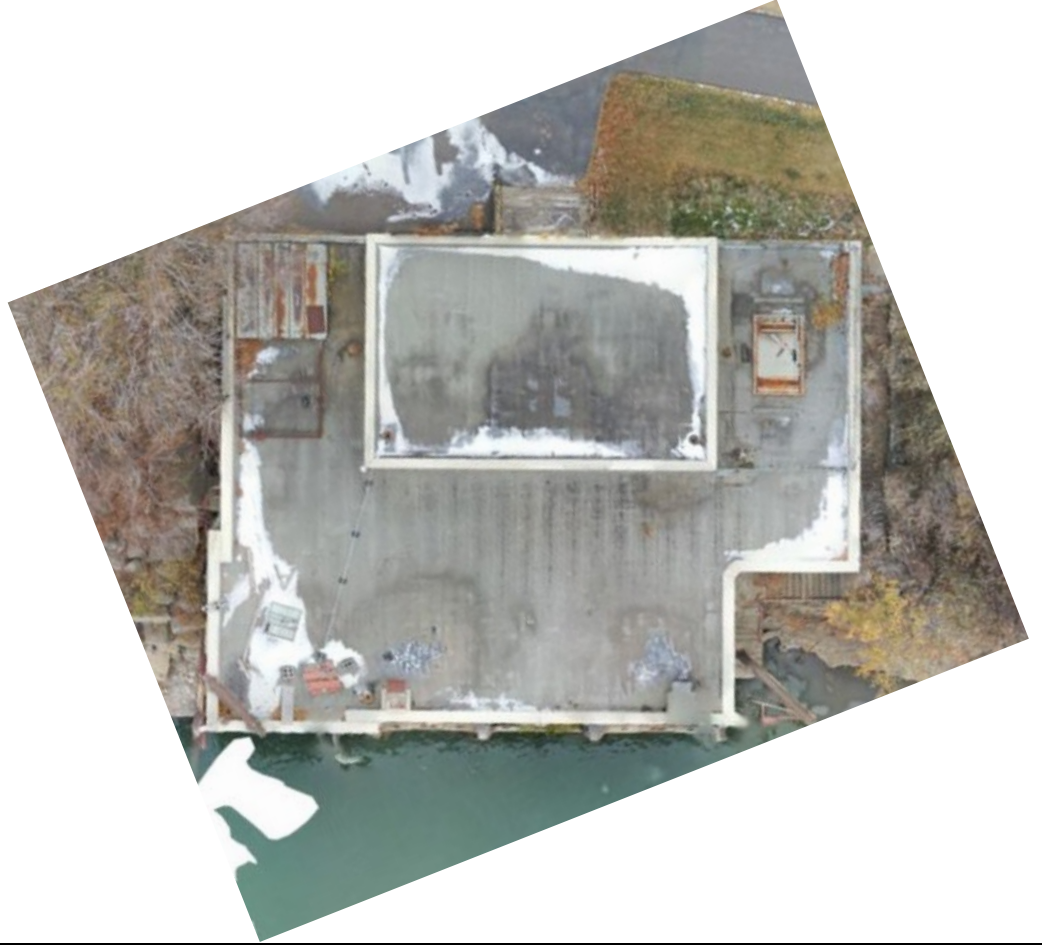
**Roofing Membrane:** Membrane has exceeded its serviceable life and requires replacement. RF-101 in particular has various holes and tree growth through the membrane.

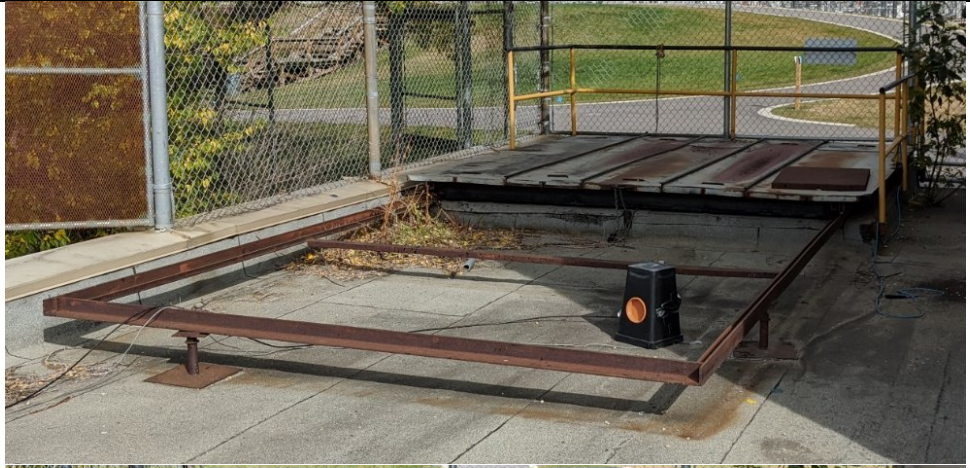
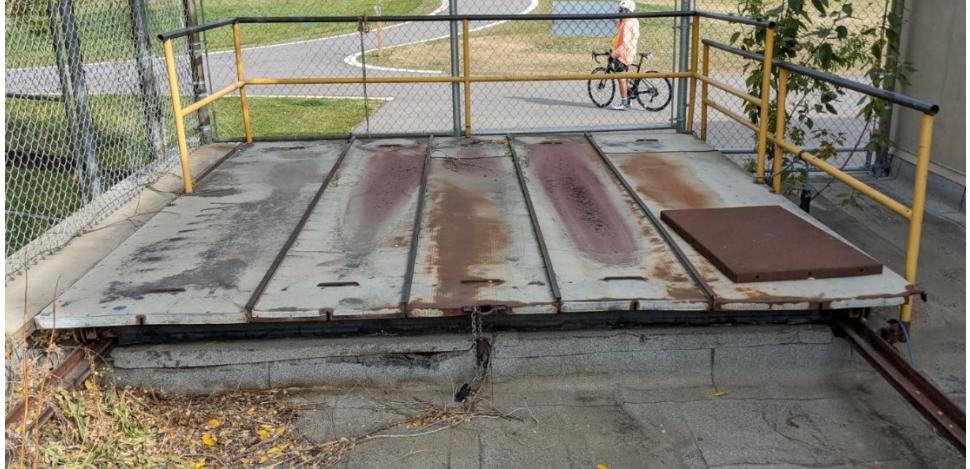
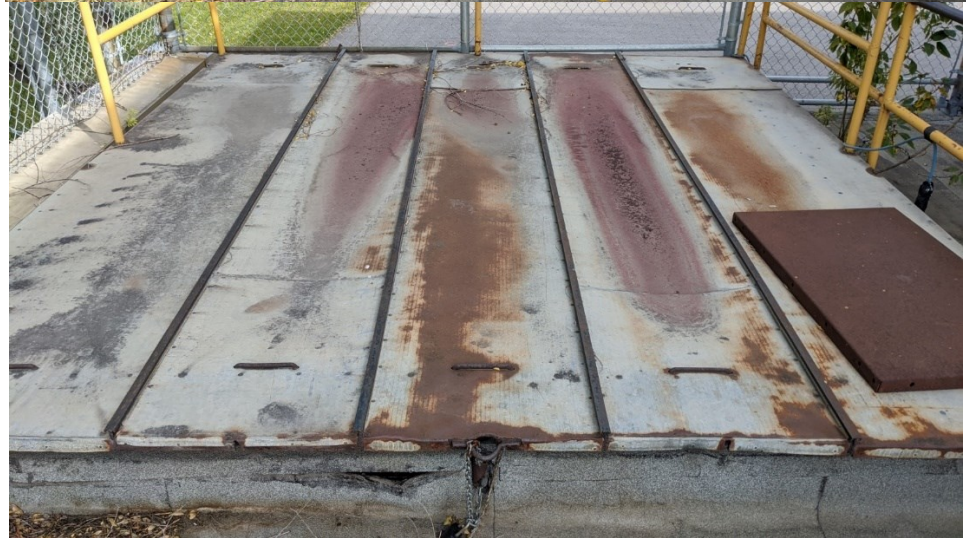
**Roof-Access Hatch:** Sliding metal access roof-hatch leaks, evidences advanced corrosion, and generally does not meet performance requirements of an exterior hatch in terms of weather proofing, safety, and ease of use.

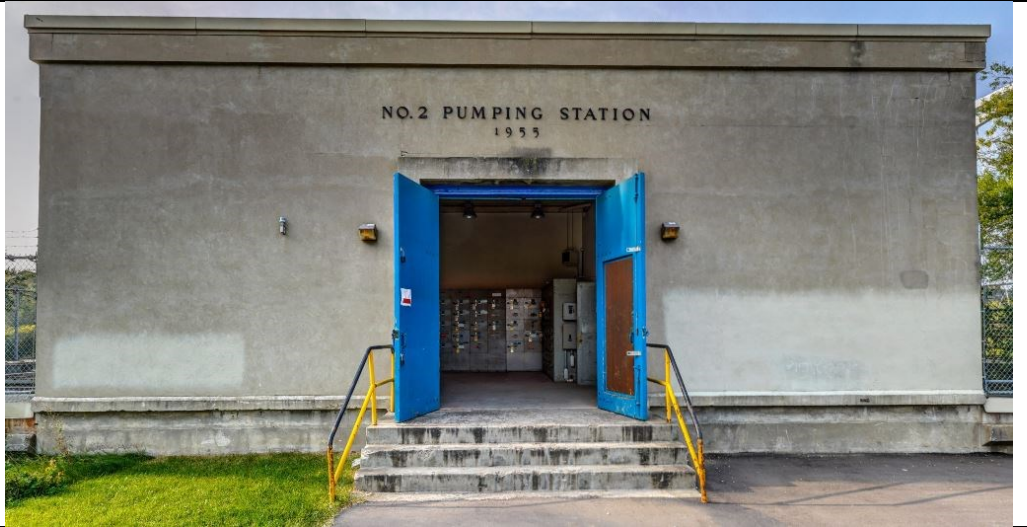
**Exterior Surfaces:** Graffiti and EPCOR overpaint are scattered across elevations. The photo illustrates the north elevation.

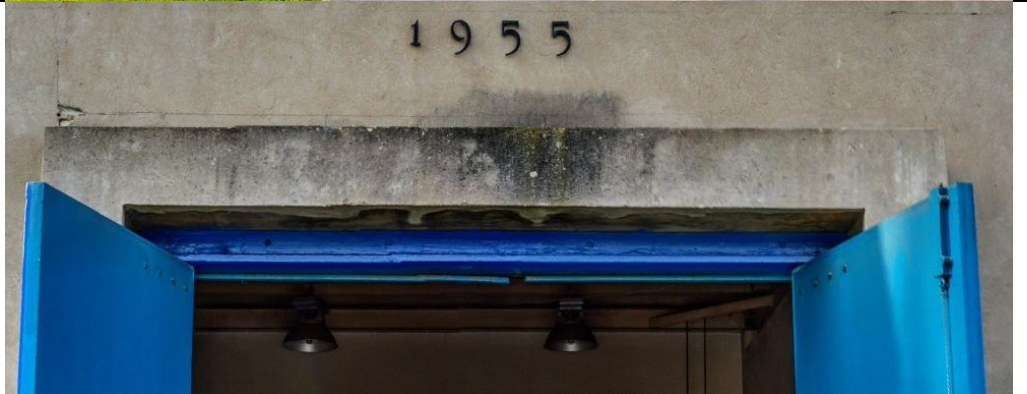
**Bio-growth/Soiling:** Concrete door surround exhibits darkening likely due to accumulation of rain-water and snow causing biogrowth and aiding associated atmospheric soiling.

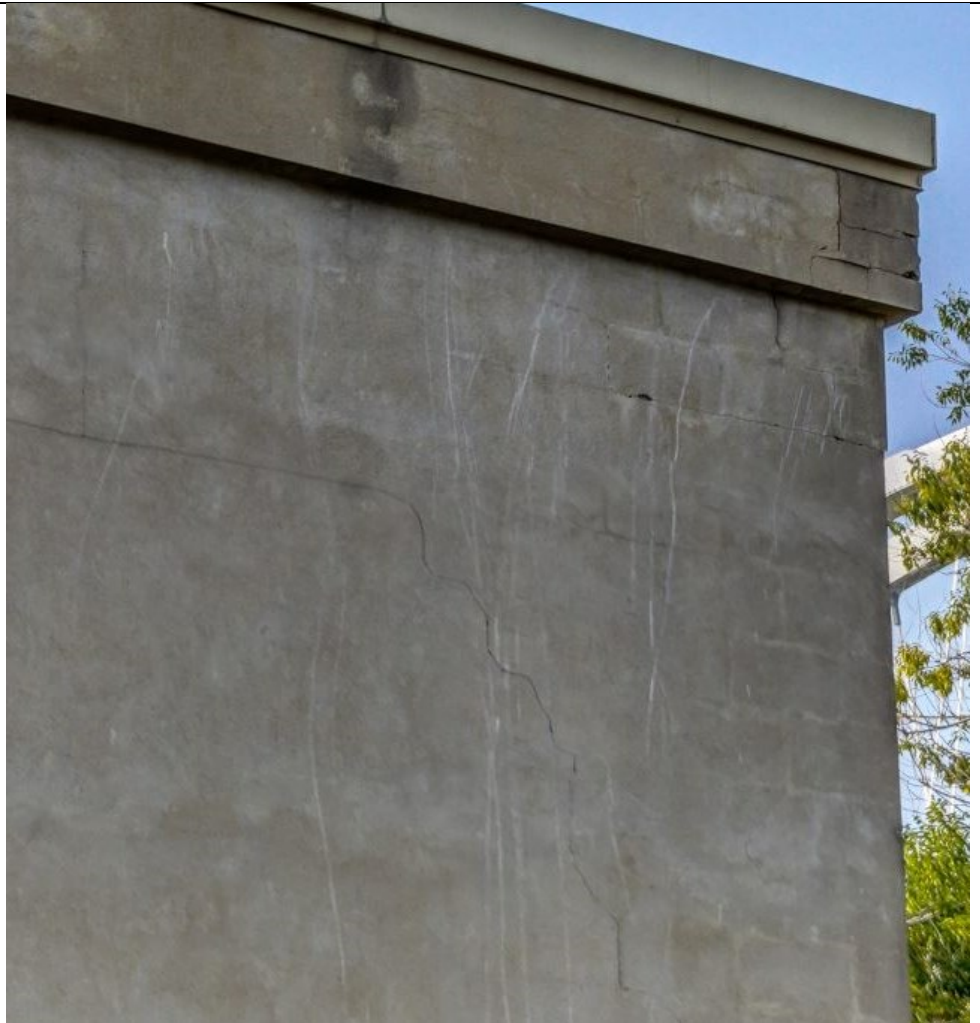
A small number of cracks on the north-west corner and on the west and east elevations are the result of displaced units, likely ferrous reinforcement that is moving. Further investigation would be required to determine cause and effect.

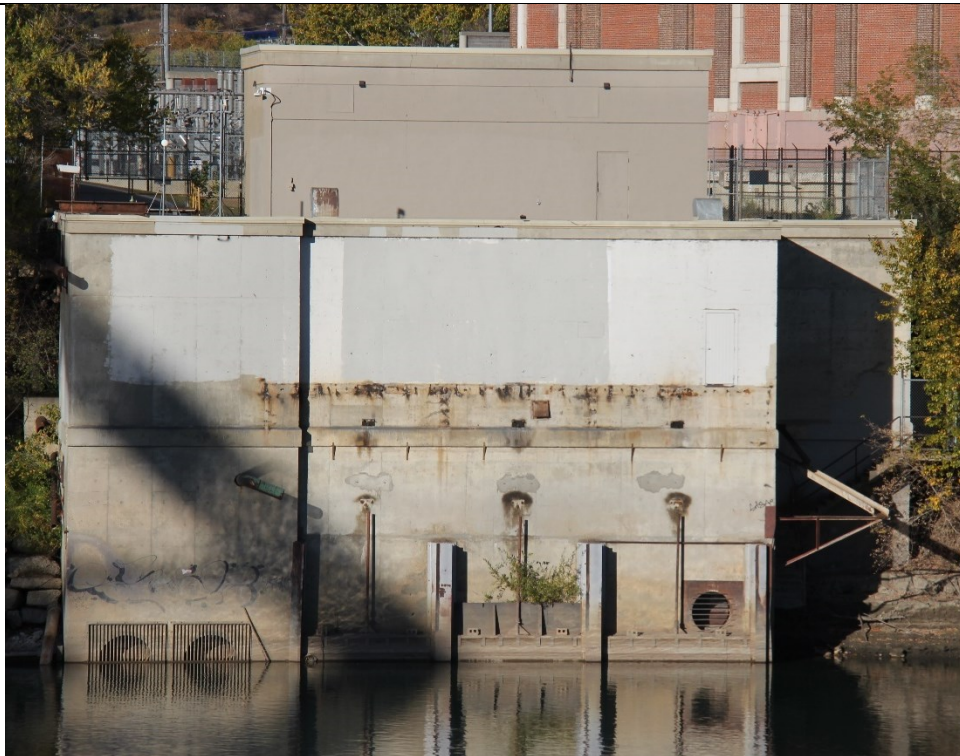
Graffiti and EPCOR overpaint are evident across elevations. Photograph to the right illustrates the south elevation.

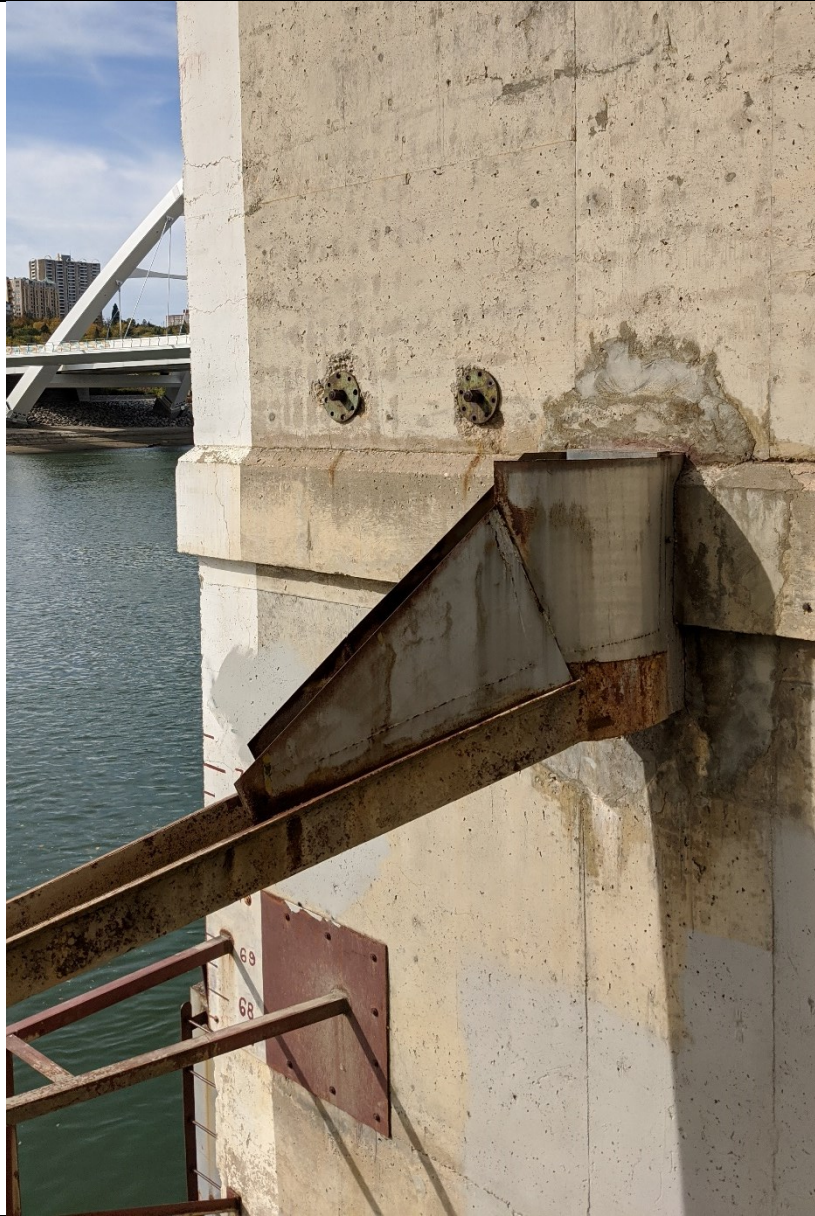
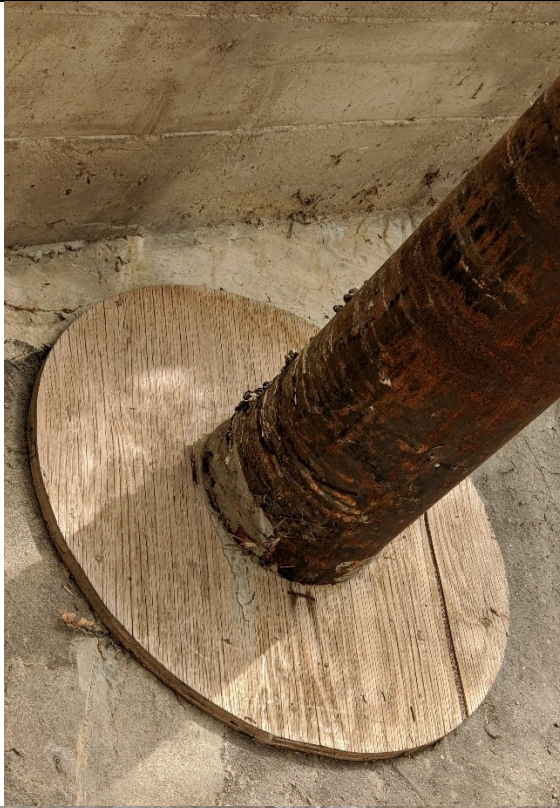
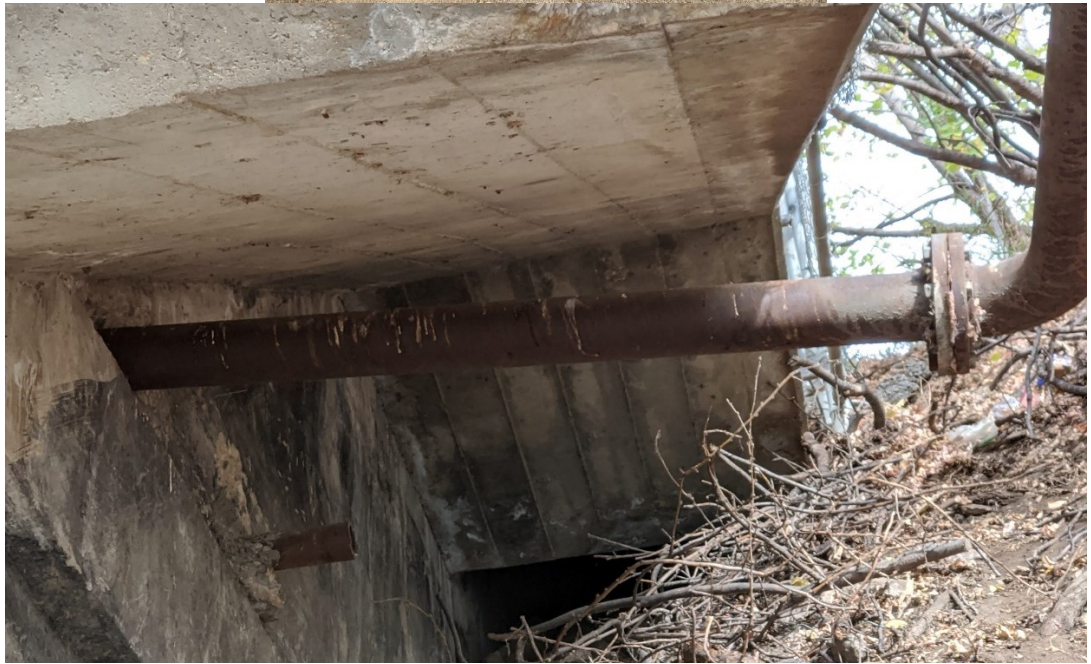
Various pipes, pipe-ends, and water drainage chutes remain from historic mechanical services, some of these have been patched with cementitious materials. The smallest pipe in the lower photo is currently open to the main operating floor space, and should be filled to seal out animal intrusion and slow some deleterious effects of the elements. This pipe is located on the east elevation.

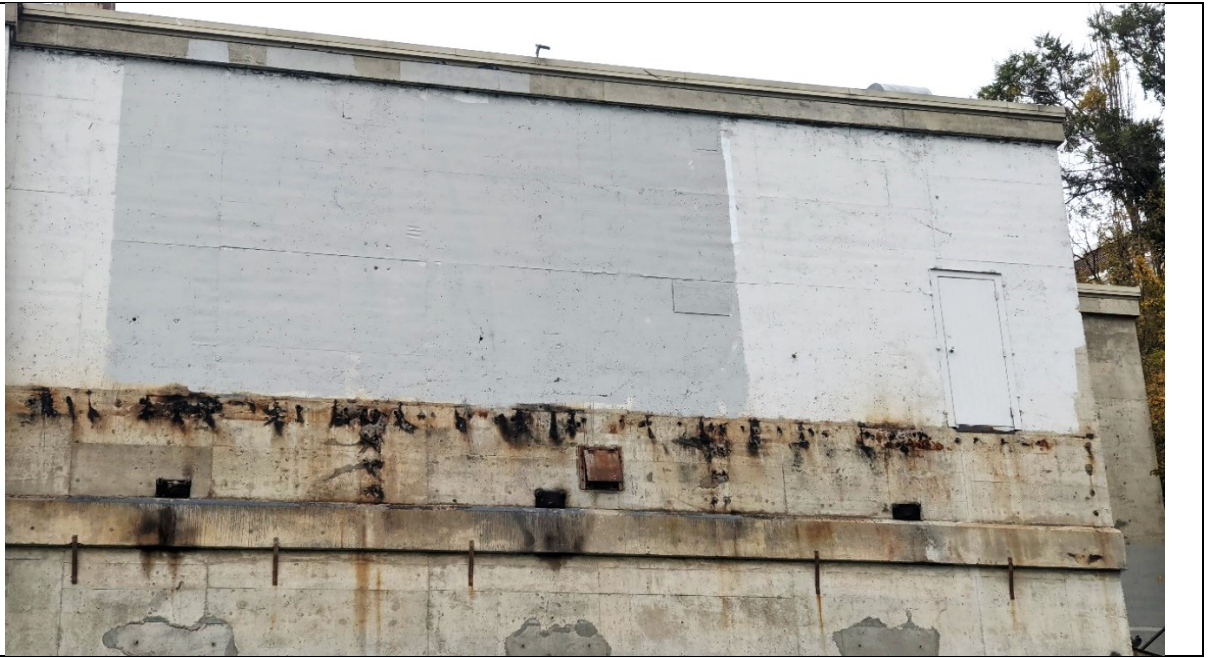
**Relict Catwalk:**  
Corroding remnant metal catwalk supports is causing weeping ferrous stains.

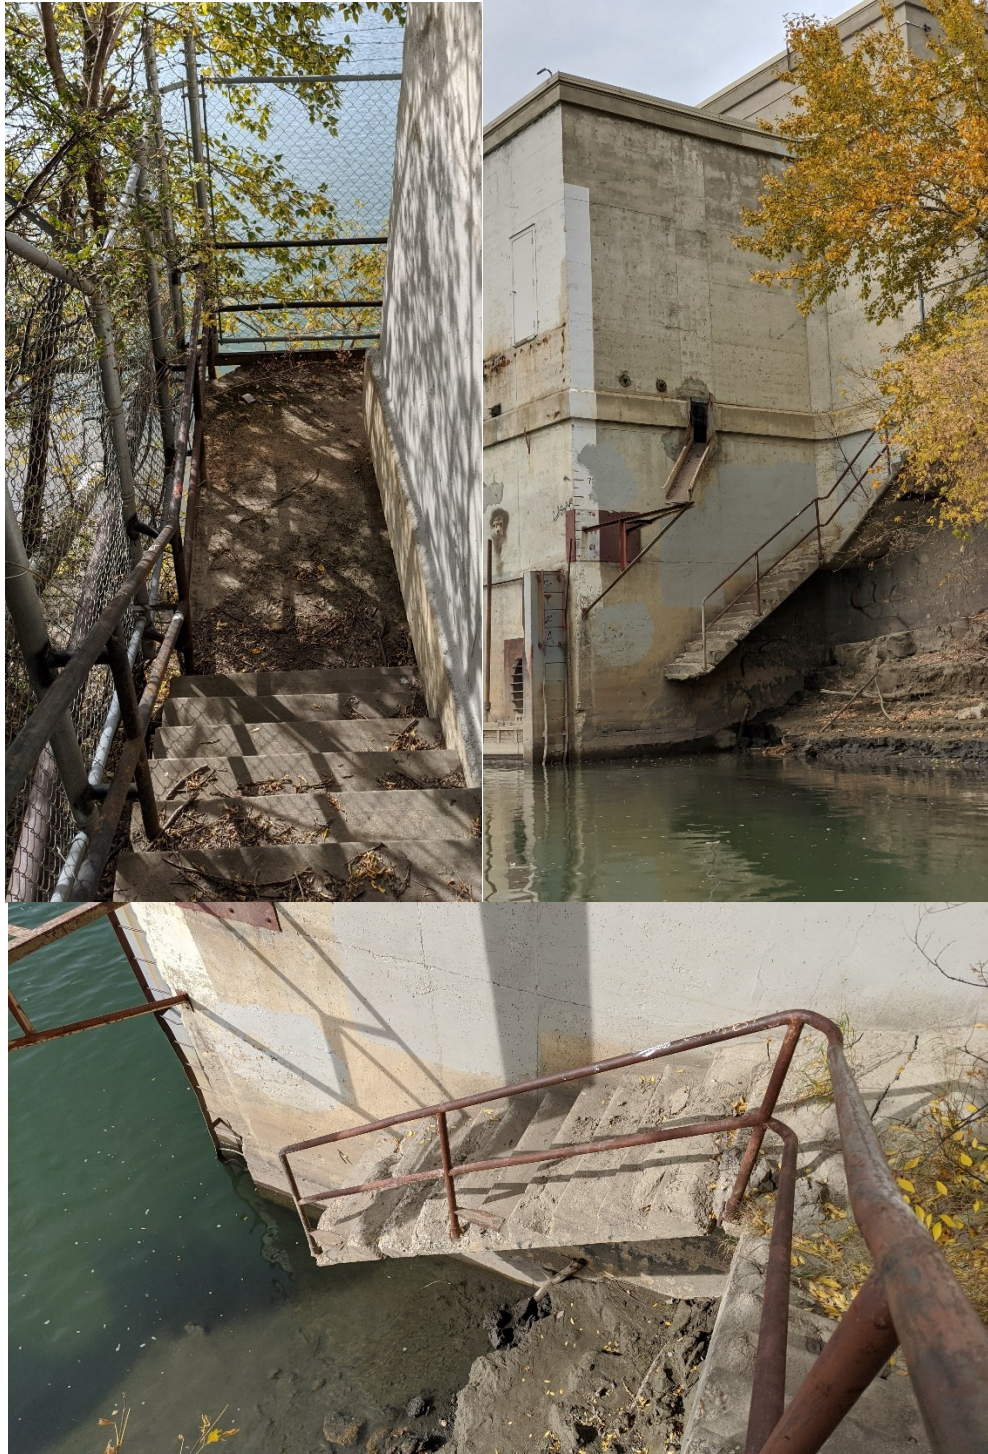
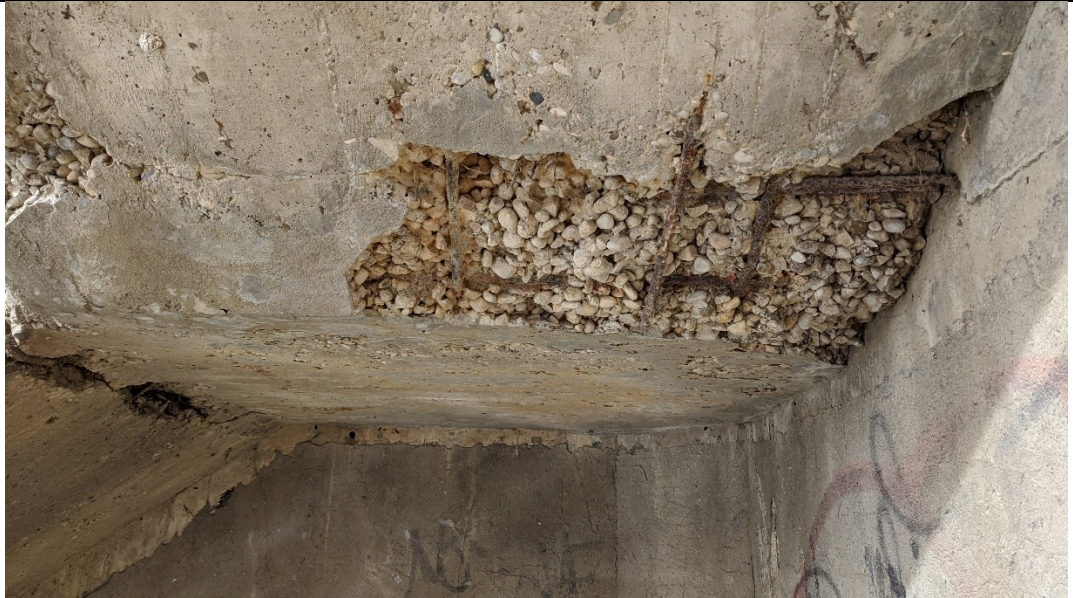
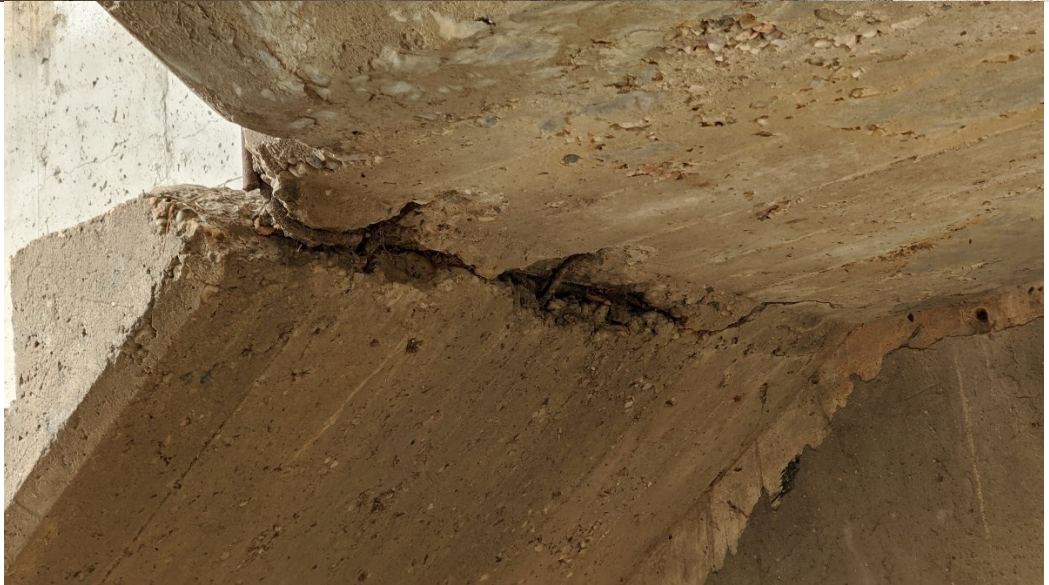
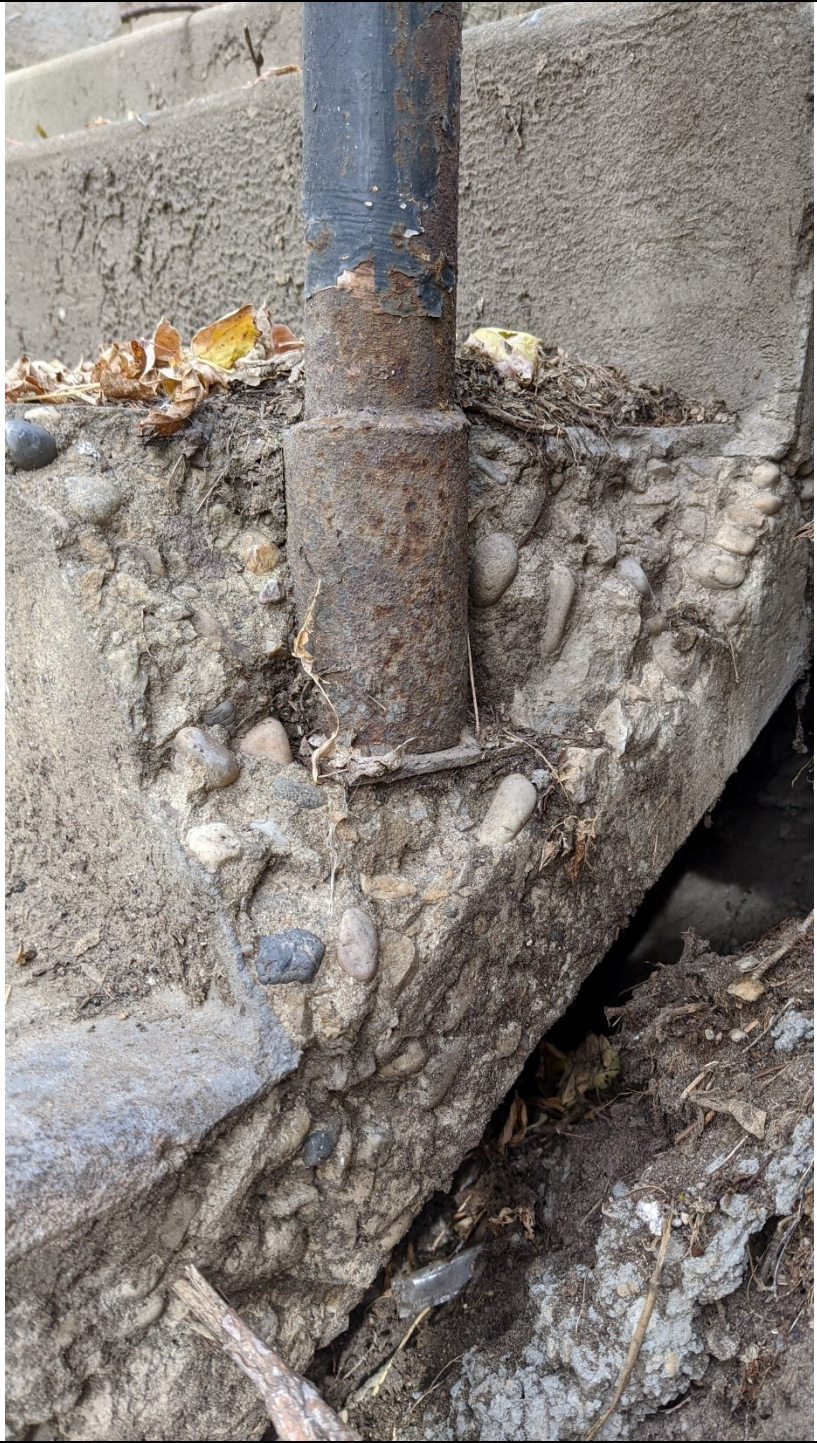
**MN-105,  
Wrapping**

**Staircase:** East elevation wrapping and descending staircase/railing is severely deteriorating near the water's edge. Deterioration patterns include corrosion packing of railing post fixtures and ferrous reinforcement and disaggregation of concrete.

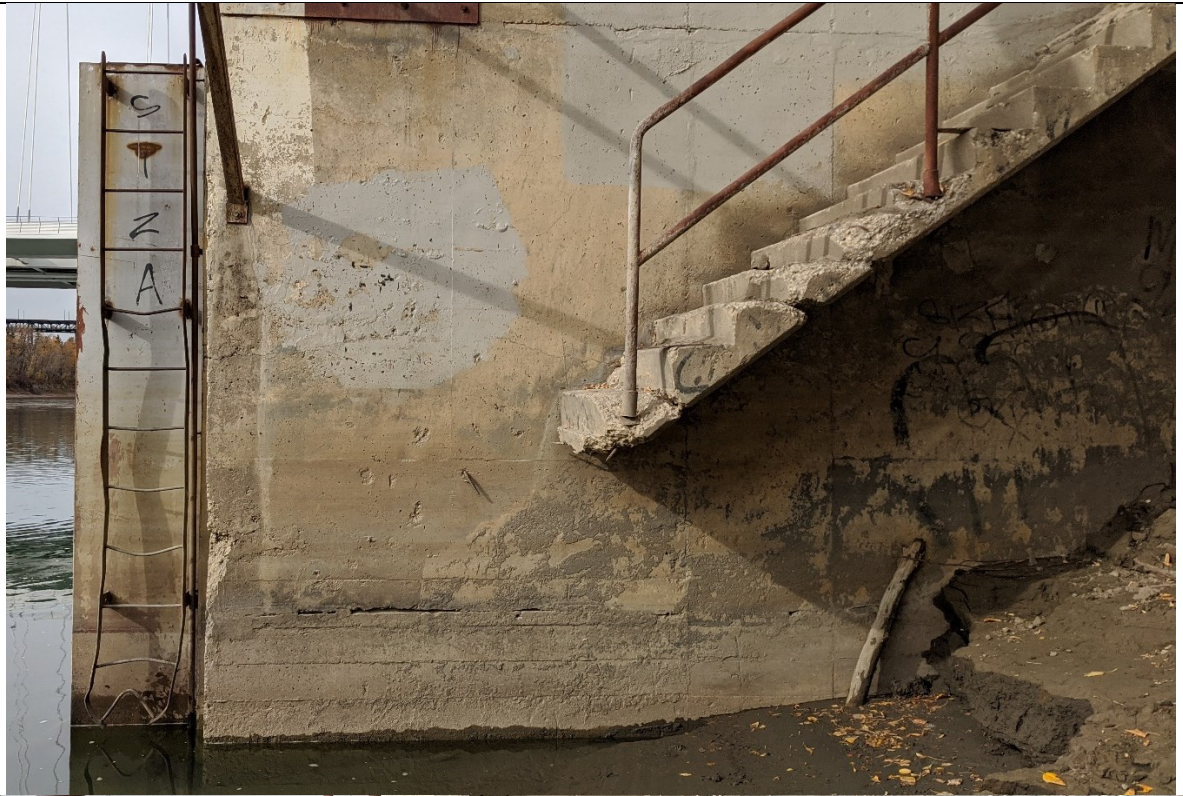
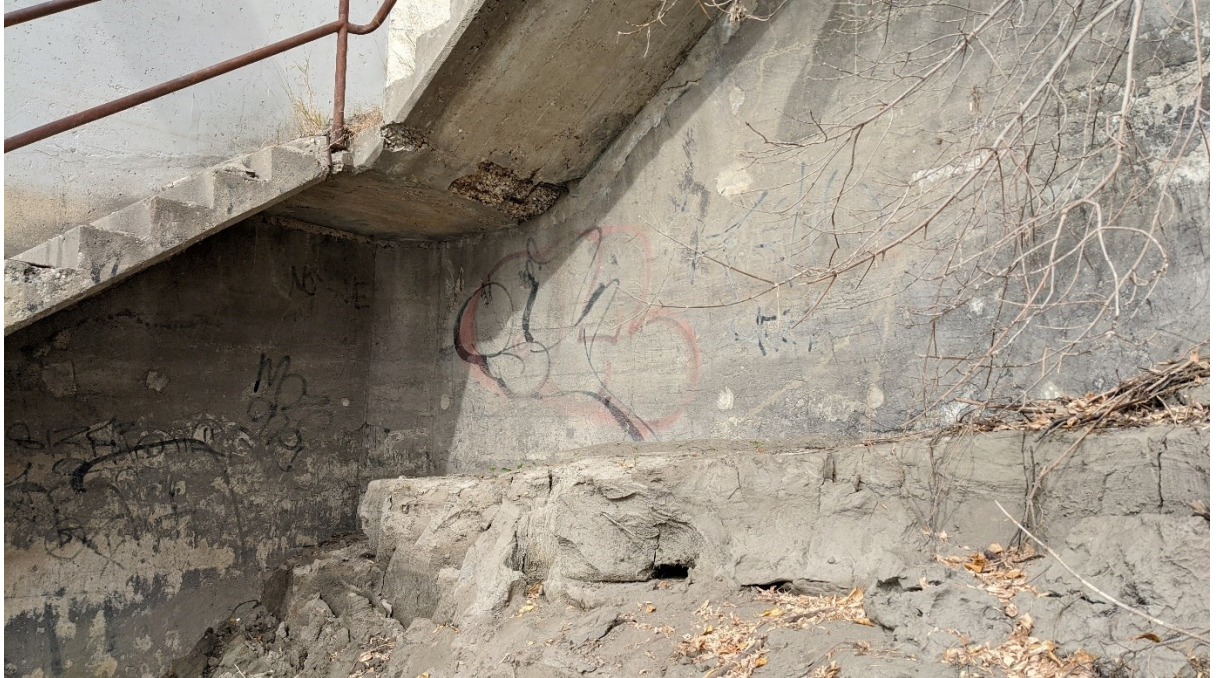
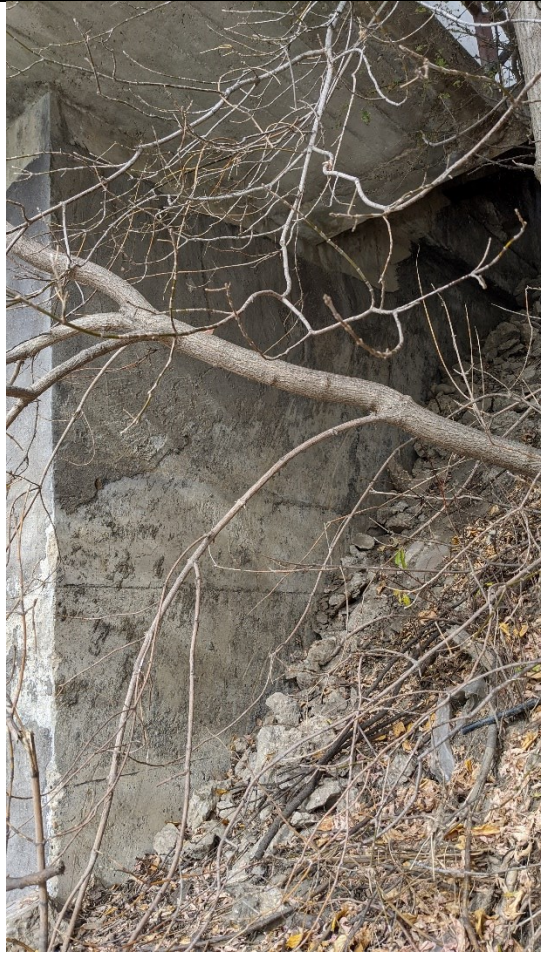
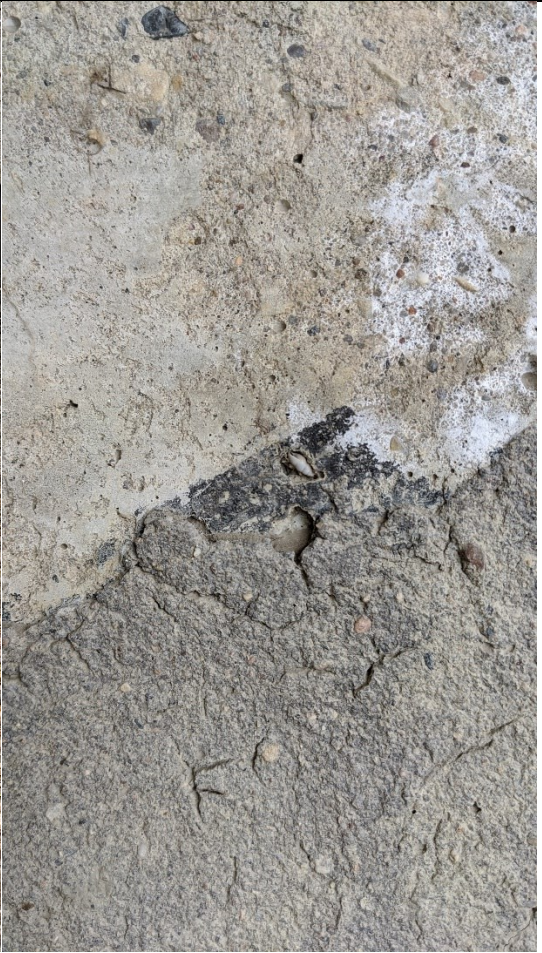
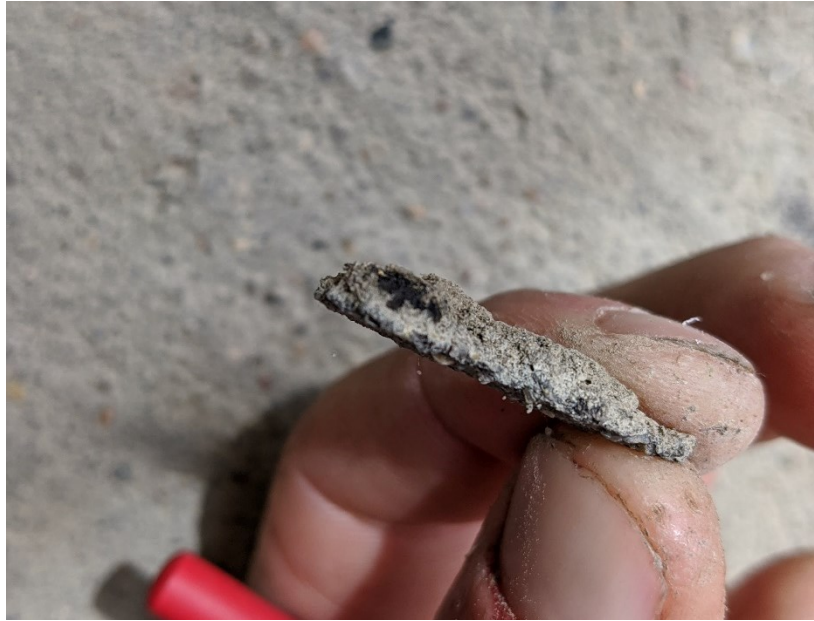
**Foundation Waterproofing:**  
Soiled bituminous foundation waterproof material is failing on lower sections where it is likely exposed to more cyclical river-level rise and fall events. Waterproofing terminates in extents just underneath the exterior wrap-around staircase.
