# Rossdale Power Plant Advanced Assessment and Priority Rehabilitation

## Pump House #2 Condition Assessment

**Submitted to: City of Edmonton**

**Date Submitted: 2021-03-15**

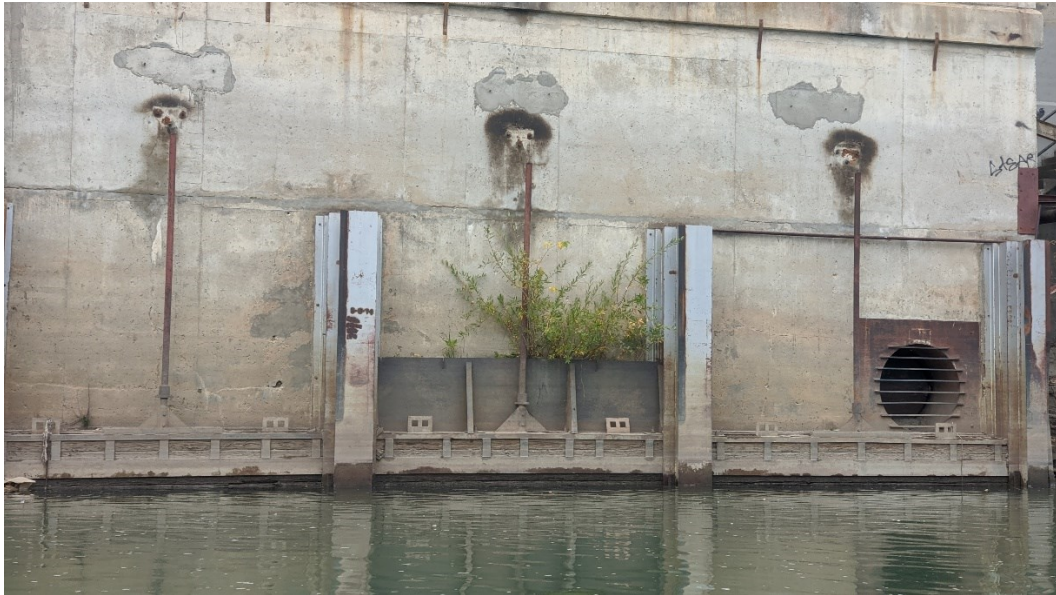
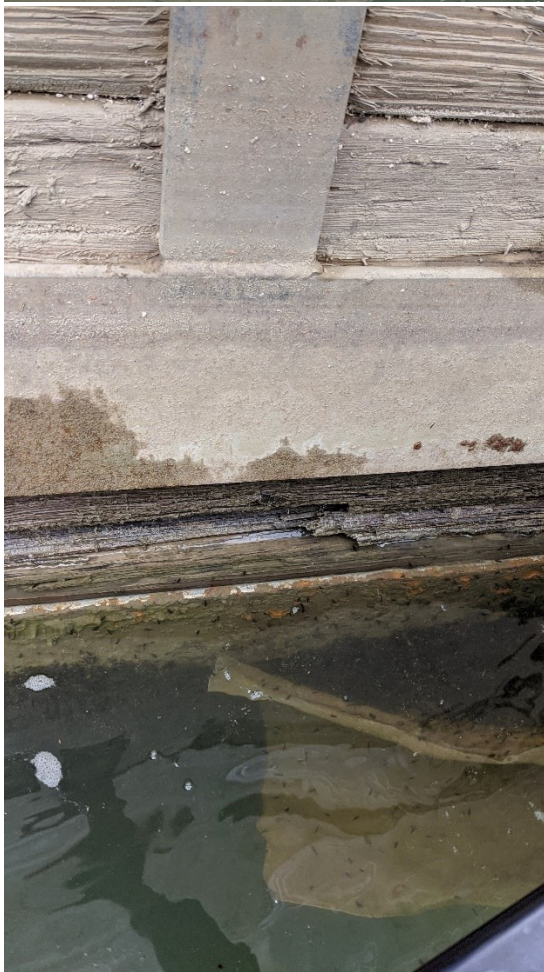
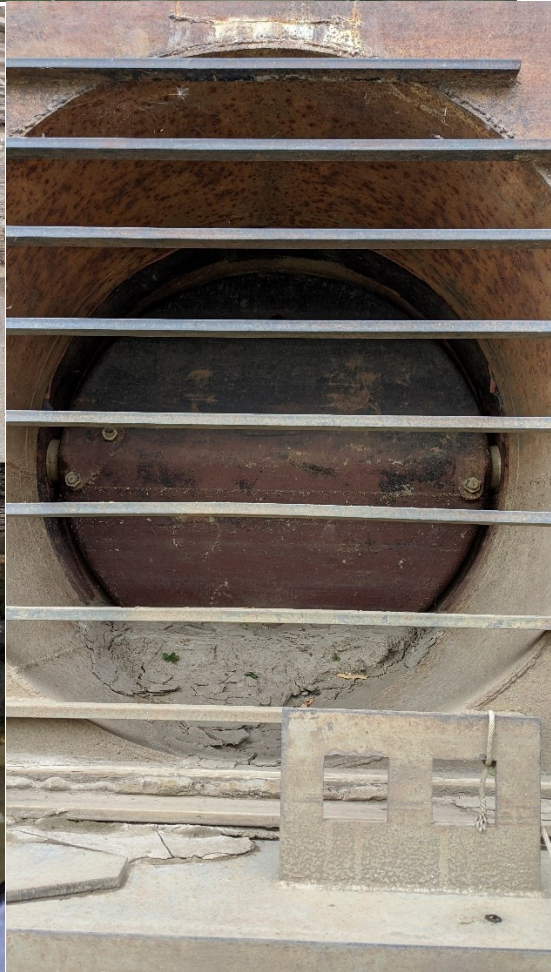
**High-Level Water In-Takes & Sluice Gates:** Relict sluice gates exhibit metal corrosion, wood decay, and active biogrowth.

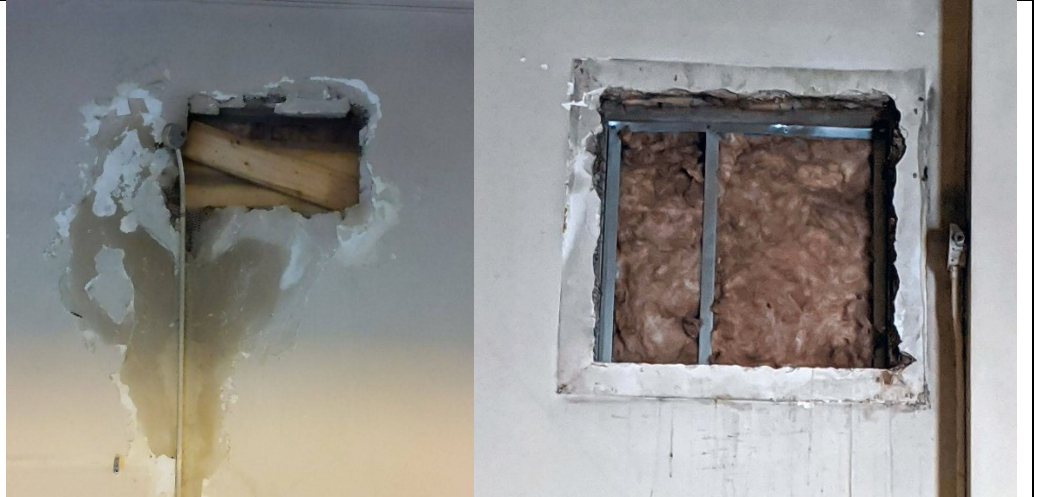
**Dry Wall:** Isolated areas of dry wall openings/Fan units, or ventilation, has been removed and sealed on the building exterior.

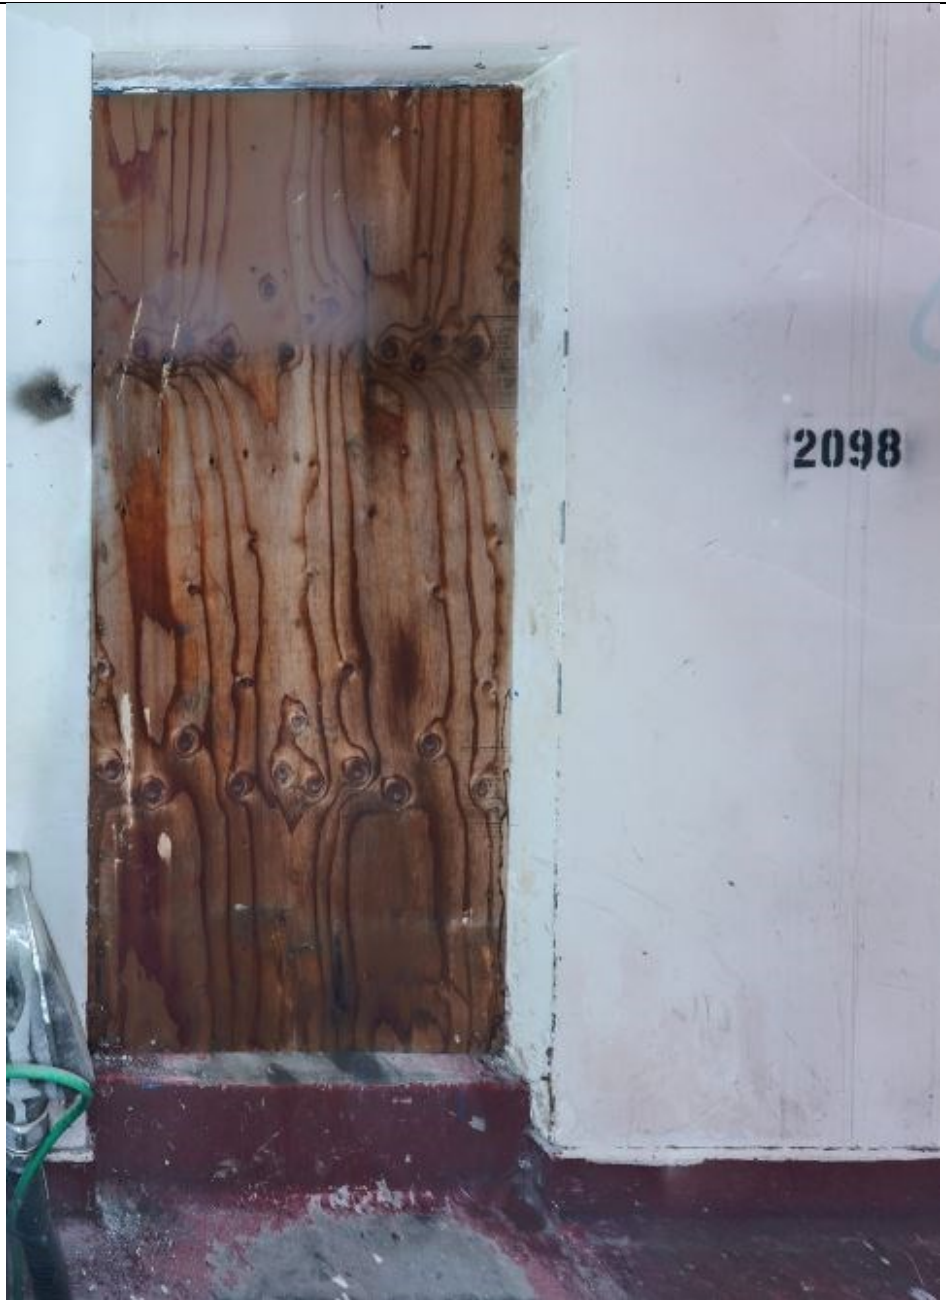
**Plywood Covered Door:** South Penthouse door leading to RF-101, is sealed with plywood on the building interior.

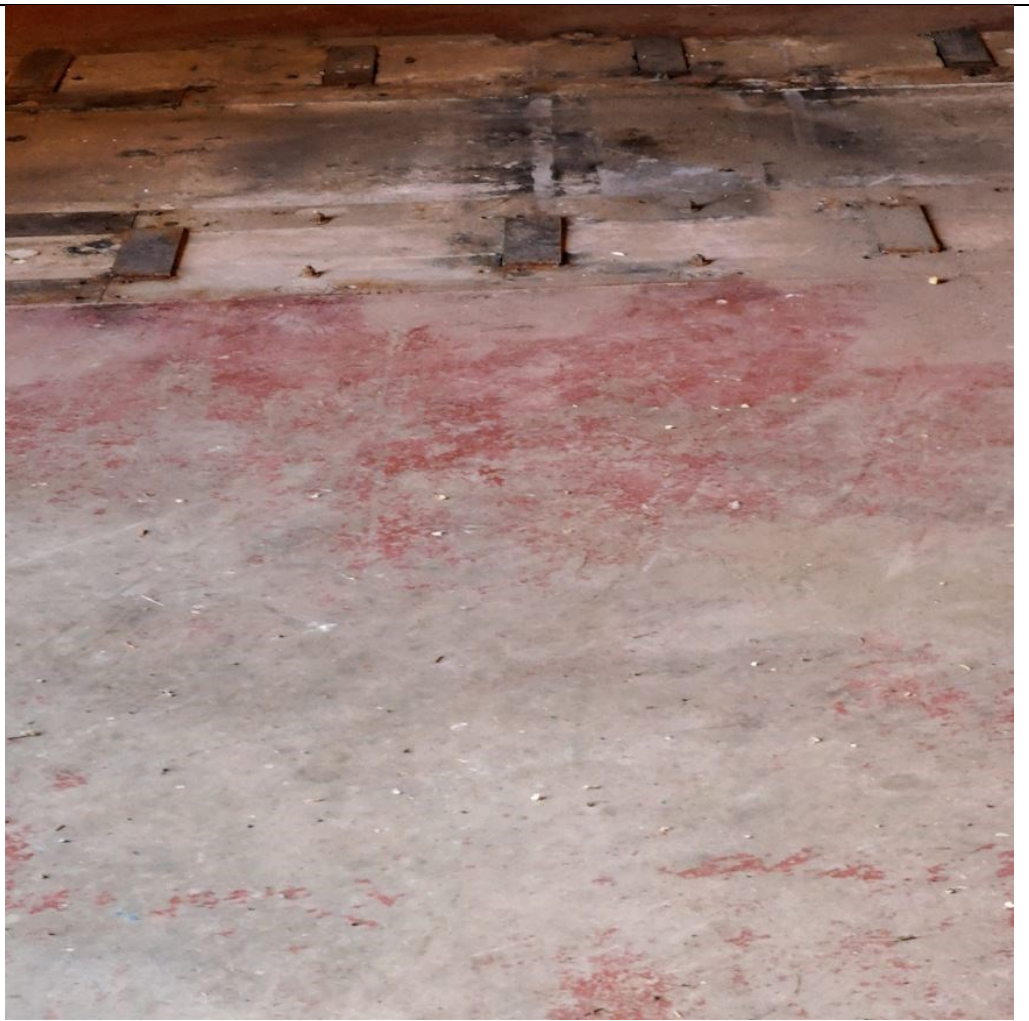
**Floor:** Floor coating, or red floor paint, is failing from mechanical damage/abrasion, and/or use. Relict fixtures remain that once serviced electrical equipment. There is an isolated minor settlement crack in the slab, of no structural concern.

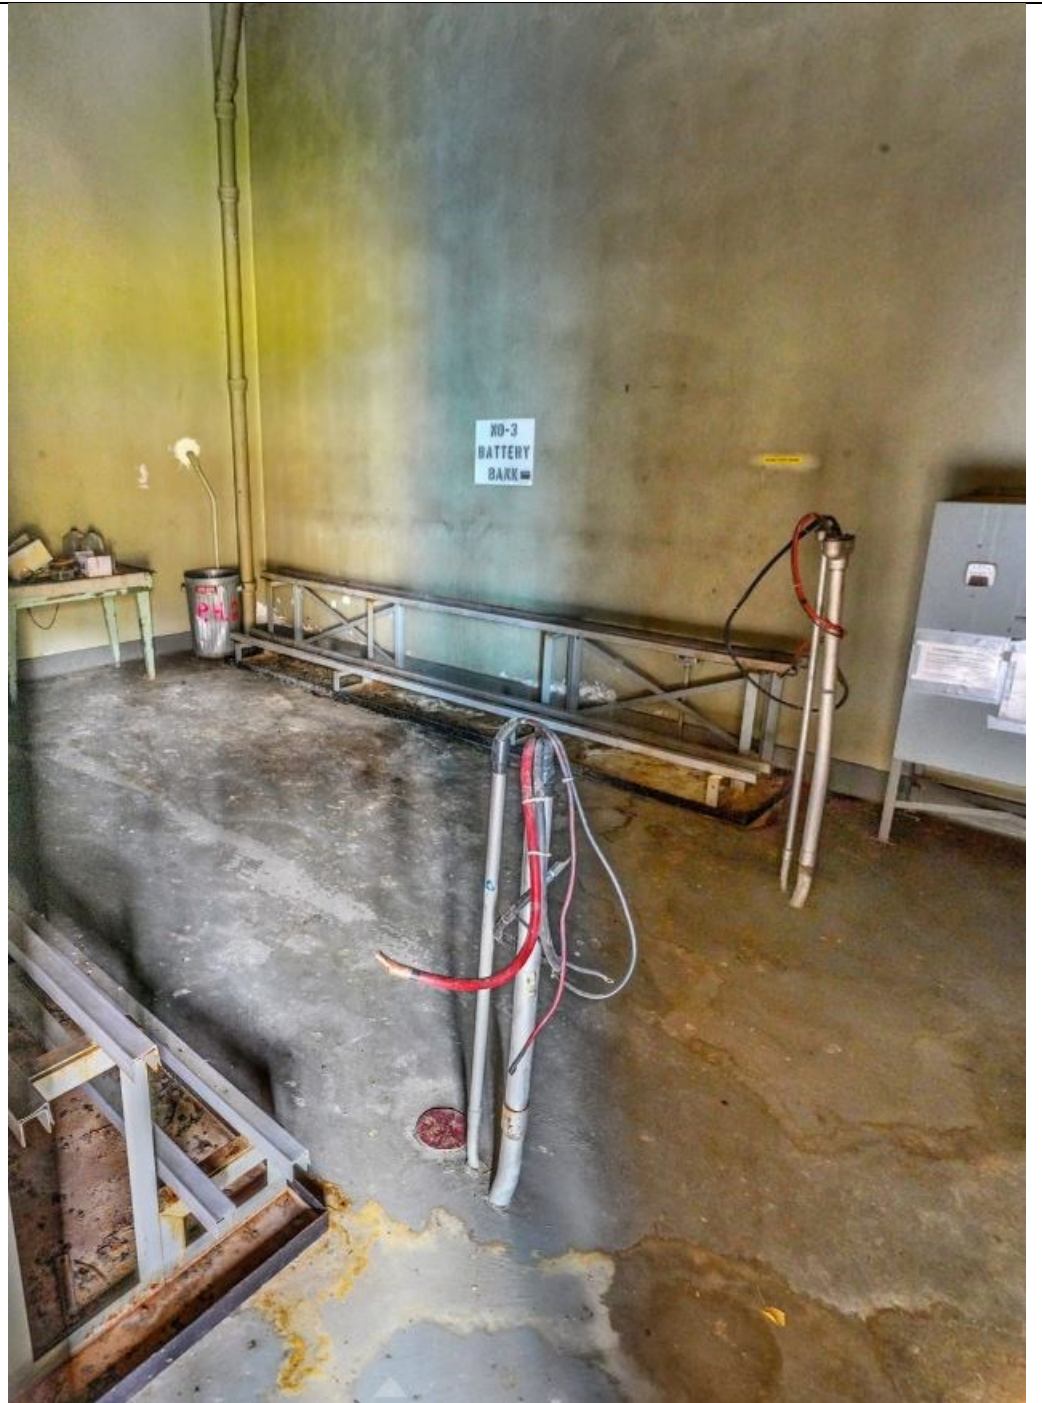
**Floor:** Overall in good condition other than soiling, including a battery related acid leak and stain.

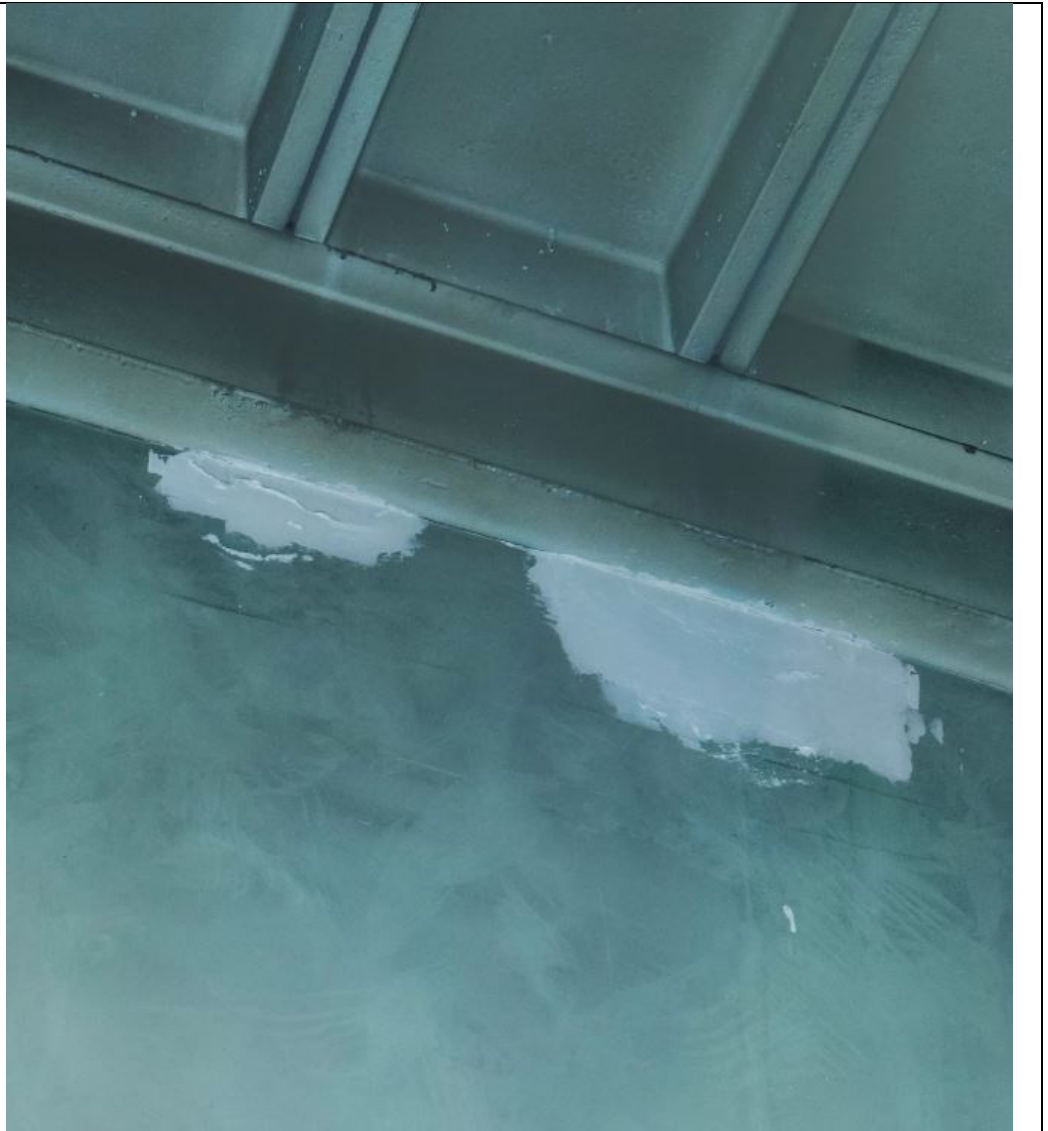
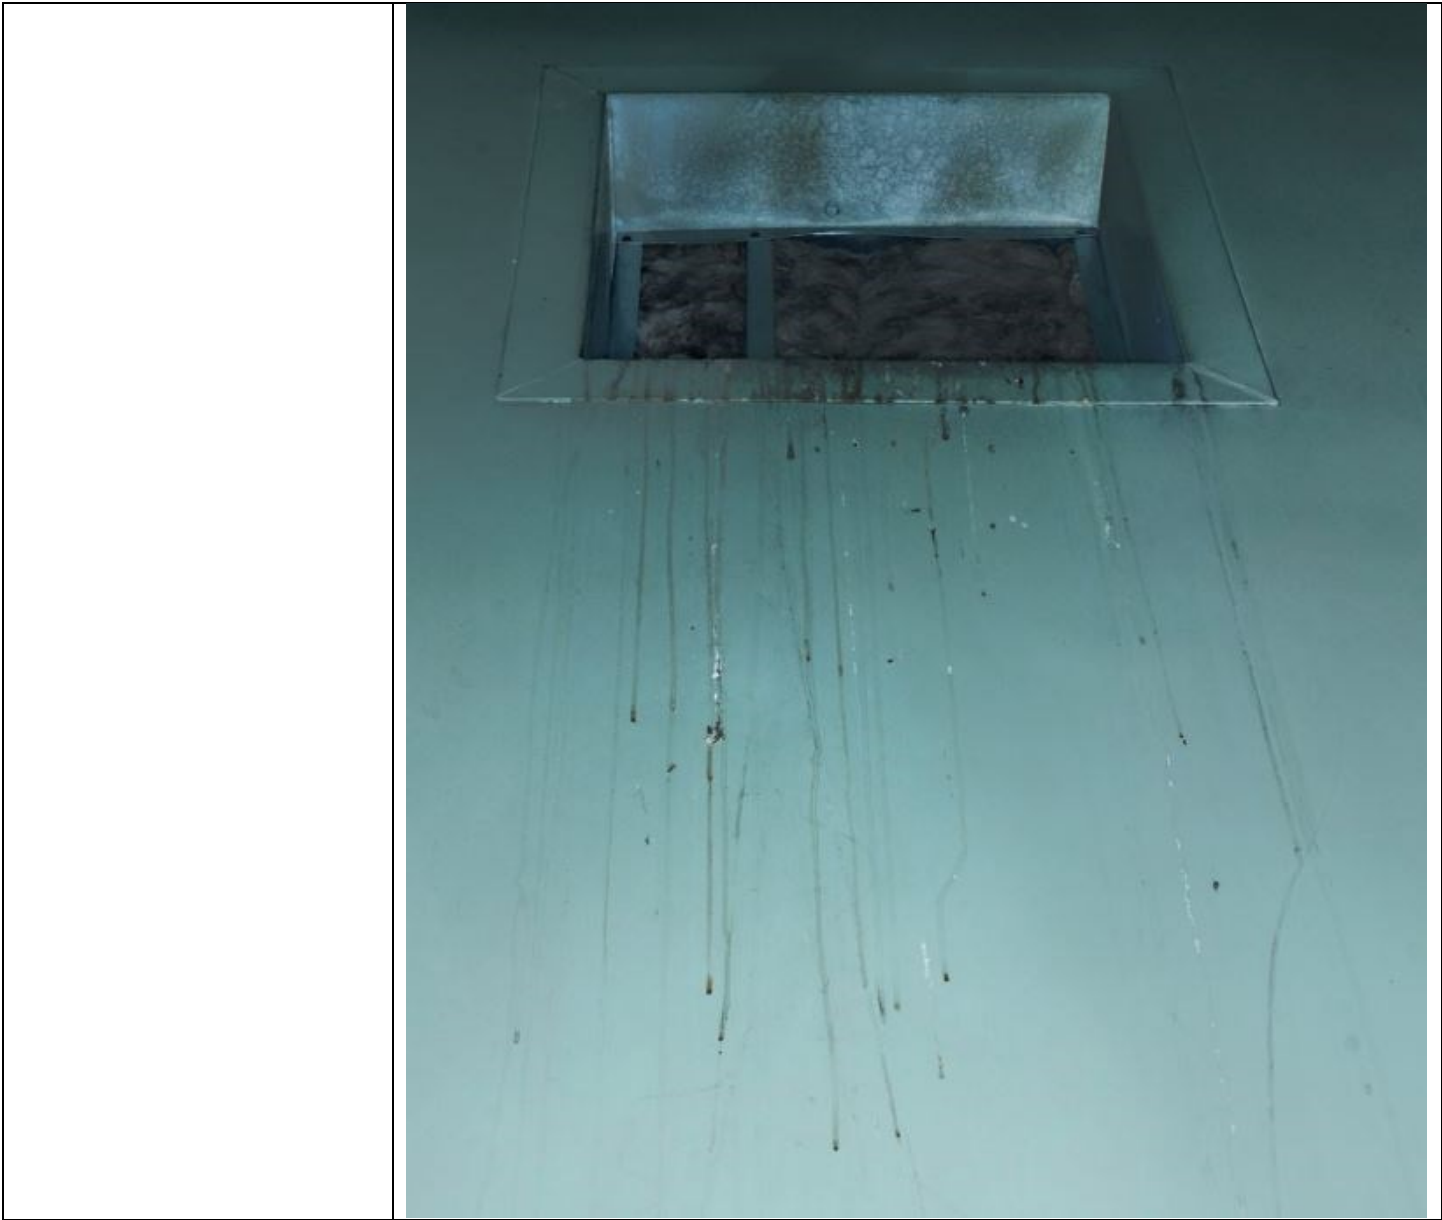
**Walls:** Overall in good condition, with exceptions being surficial soiling, isolated patches, and oily dripping from a now removed and sealed ventilation unit.

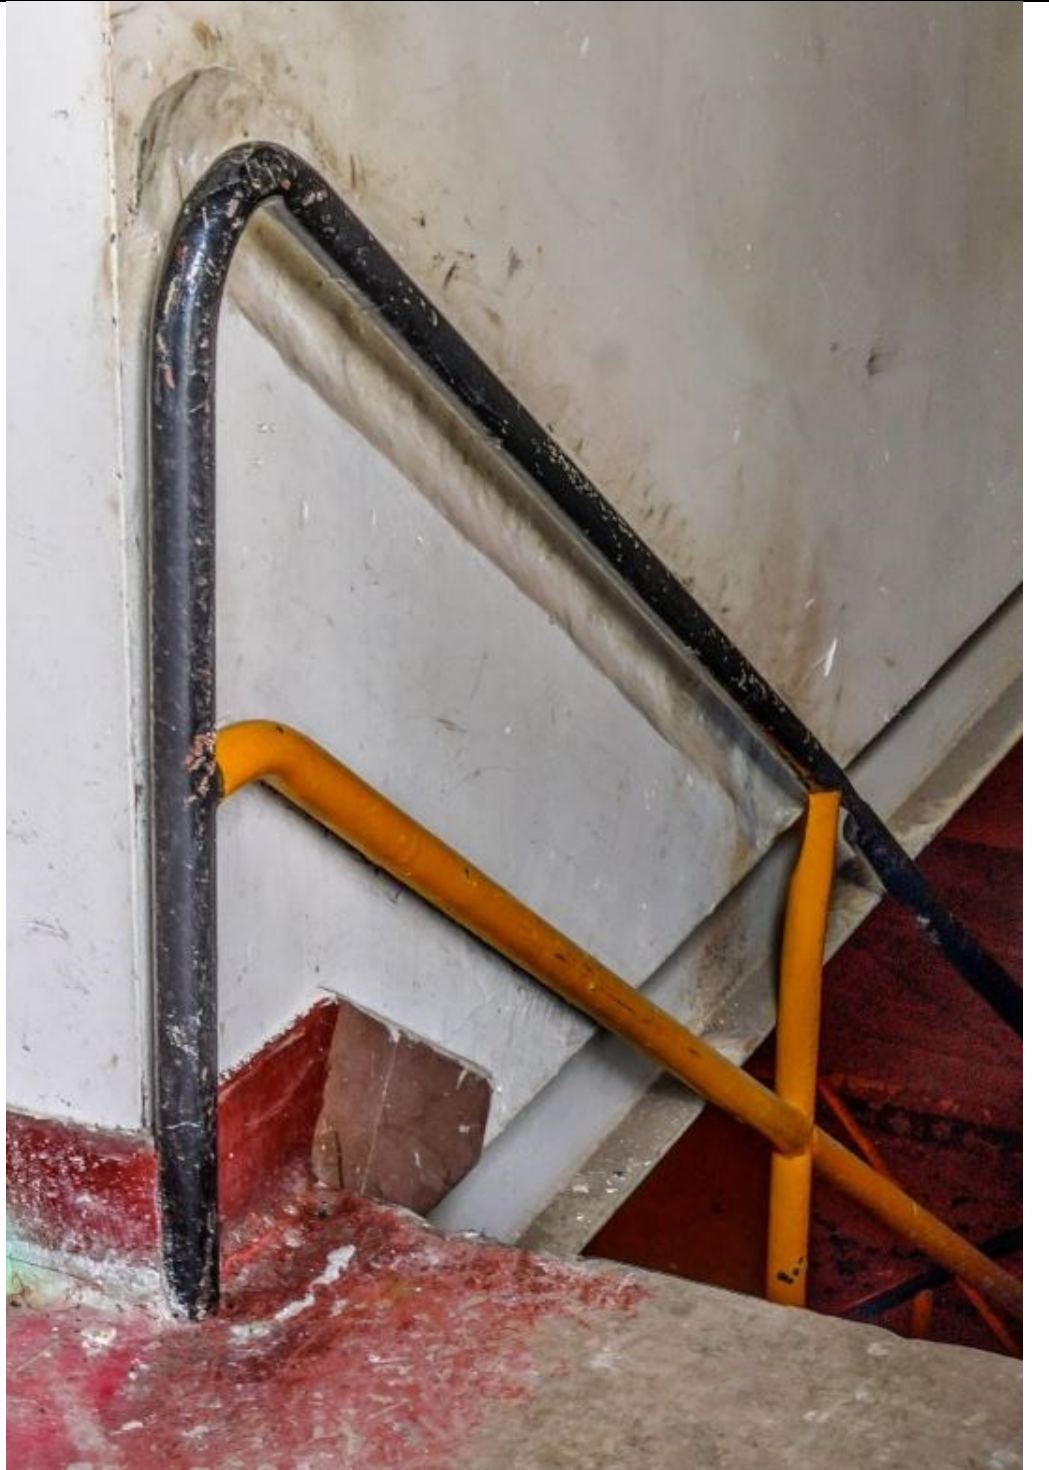
**Hand Rail:** An idiosyncratic space was carved out of a wall section to allow for hands to pass along the hand rail.

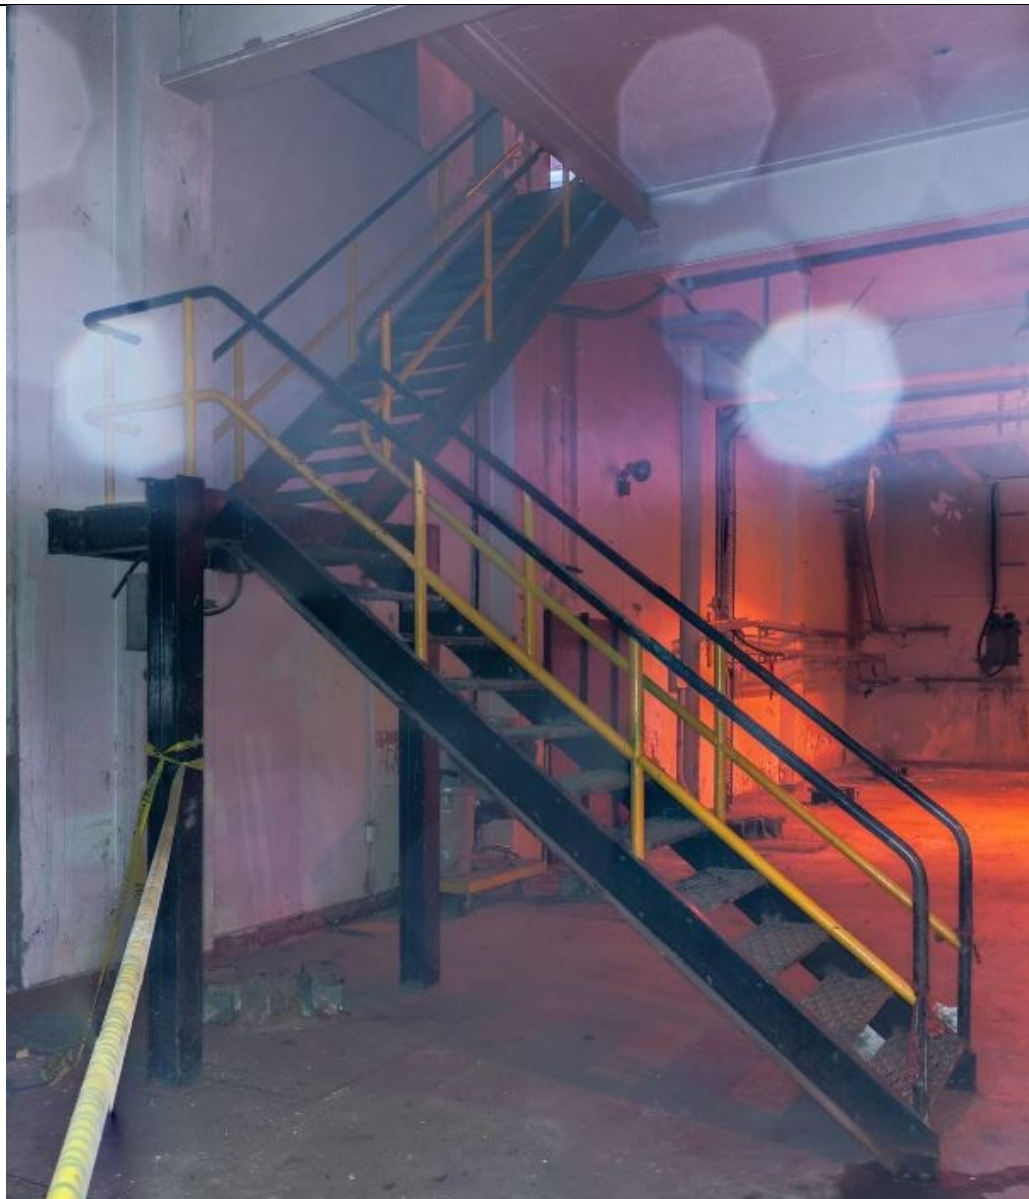
**Staircase:** In good condition despite wear of painted surfaces.

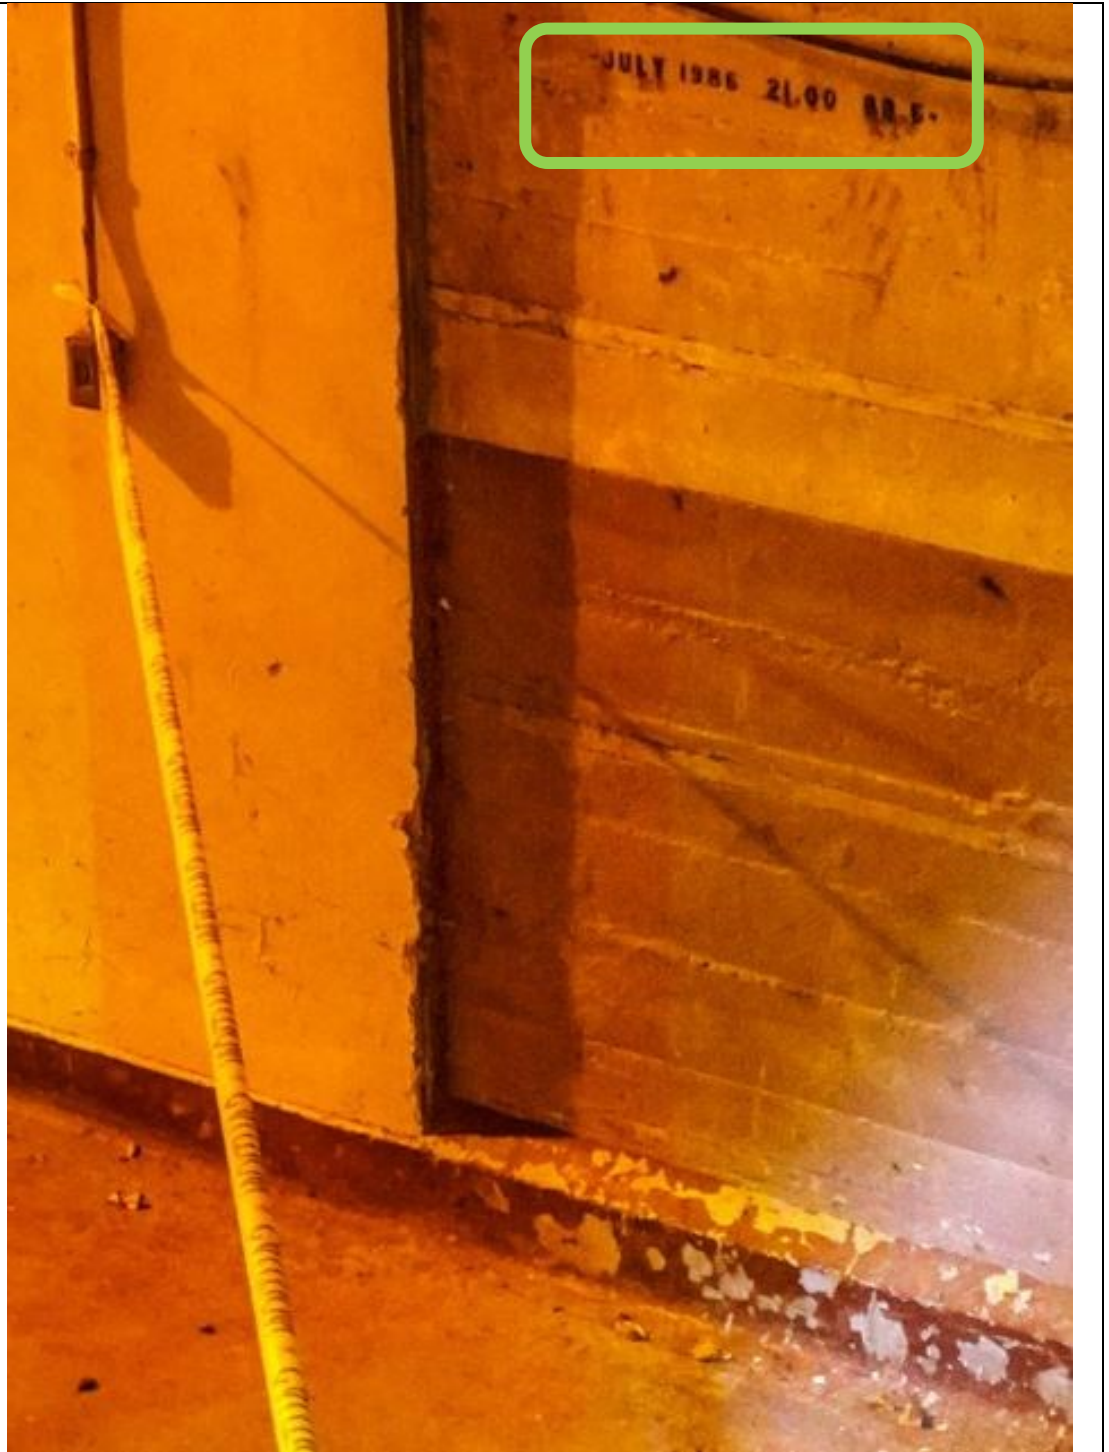
**Historic Marker:** High-water level recorded in July 1986 as reaching around 5' above the Main Operating floor — a poignant reminder of the strength and force of the surrounding river and importance of preparing this building for large flood events.

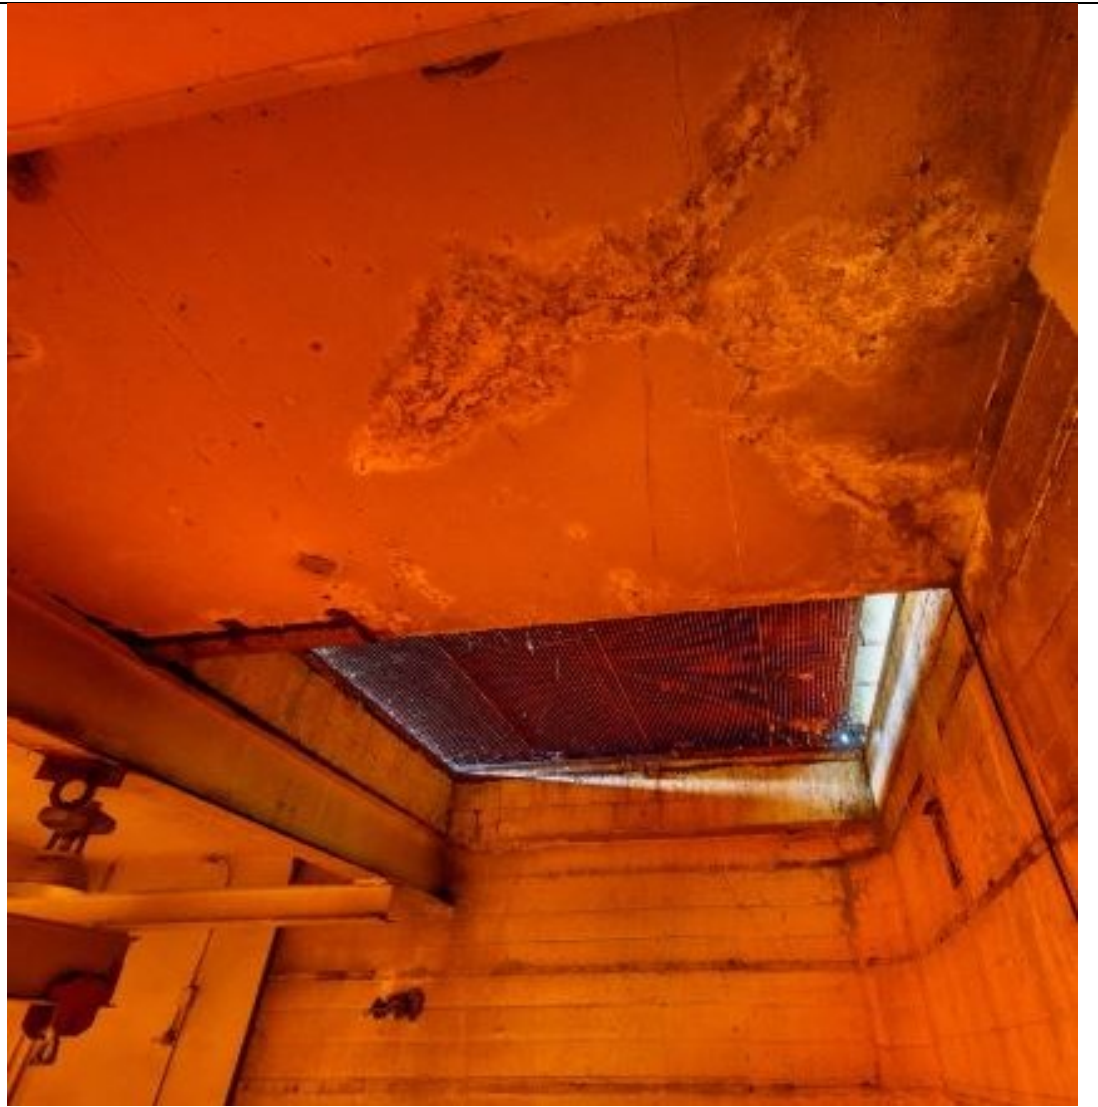
**Interior Access Hatch:**  
Poor weather sealing of the roof access hatch is evidenced by intruding daylight and ceiling efflorescence relating to free water ingress.

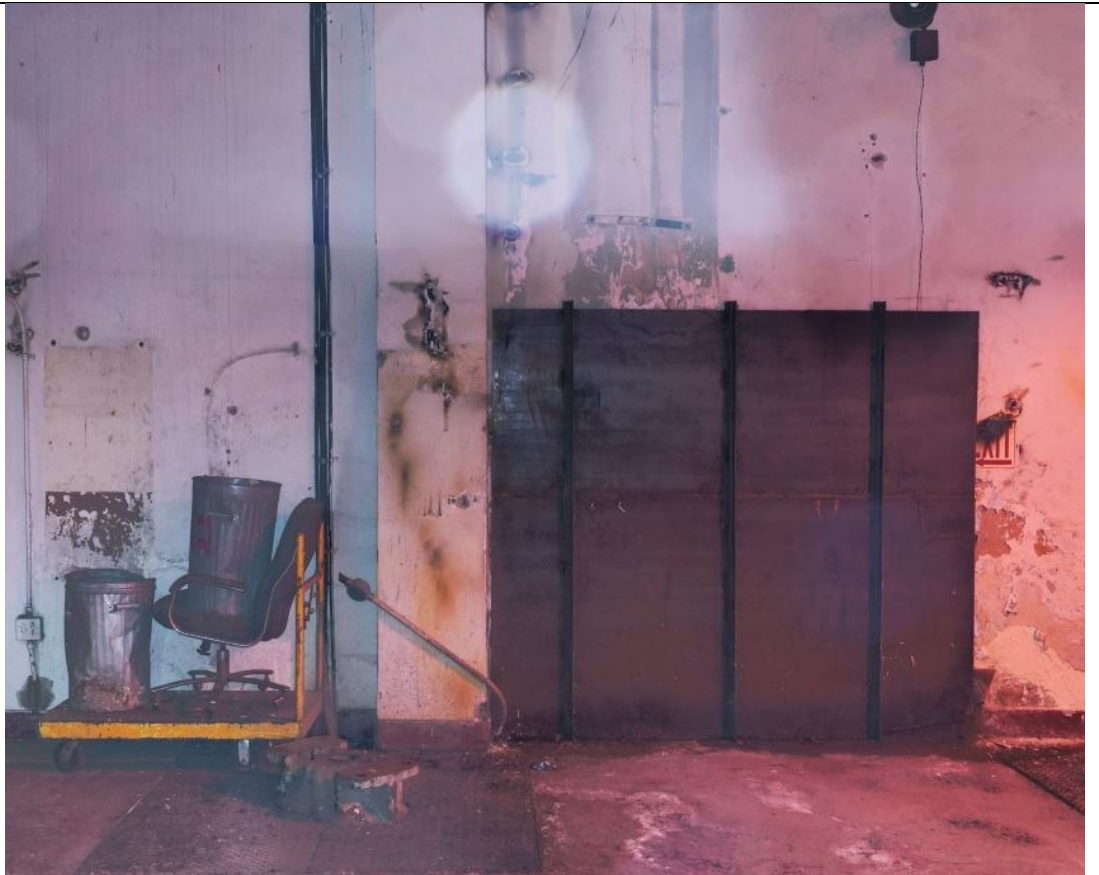
**Walls:** All walls are soiled, exhibiting paint failure, and plaster walls evidence different eras of decorative schemes over time: greens/pinks/off-whites/red dados and bare concrete variously abound from different campaigns. The metal panel in photo centre seals the tunnel that provided access to the now demolished High Pressure Plant (HPP) Control Room.

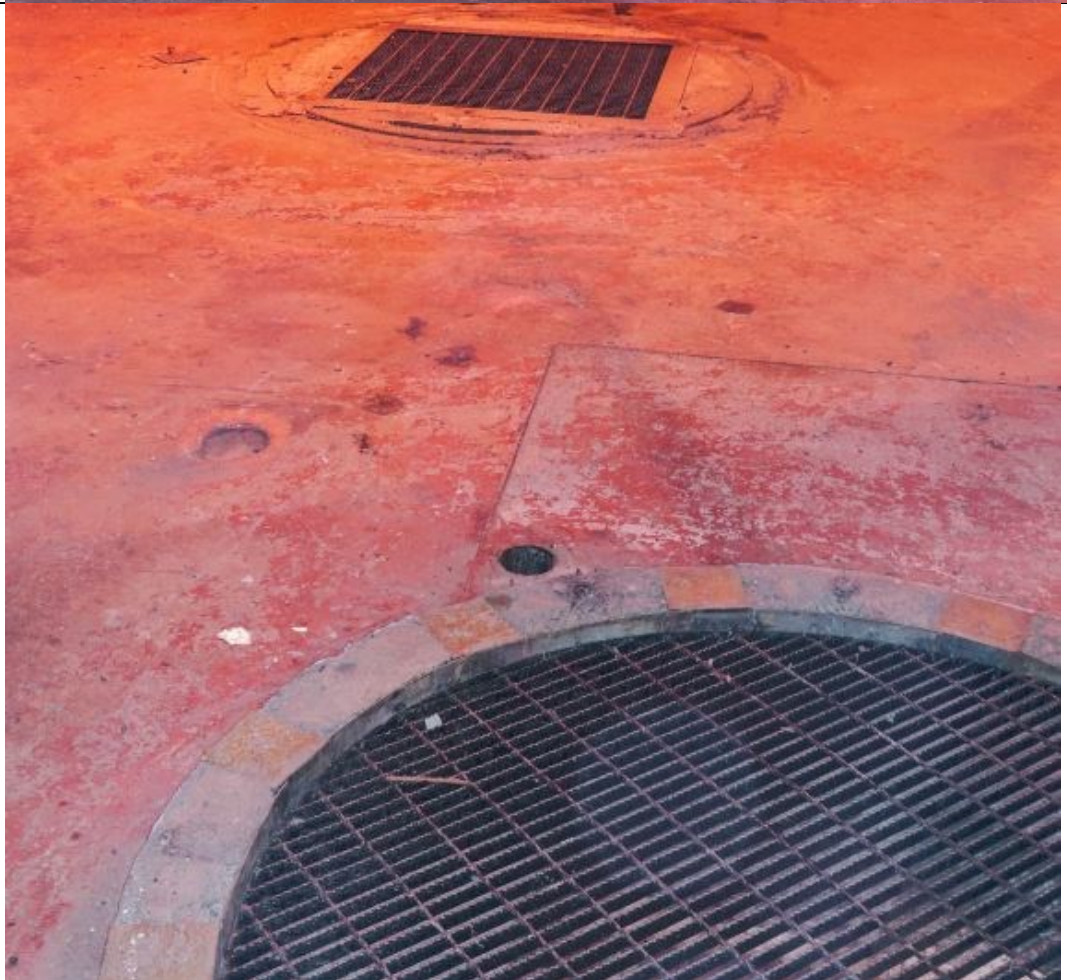
**Floors:** Paint failure and soiling abounds as through the rest of the building, and site generally.

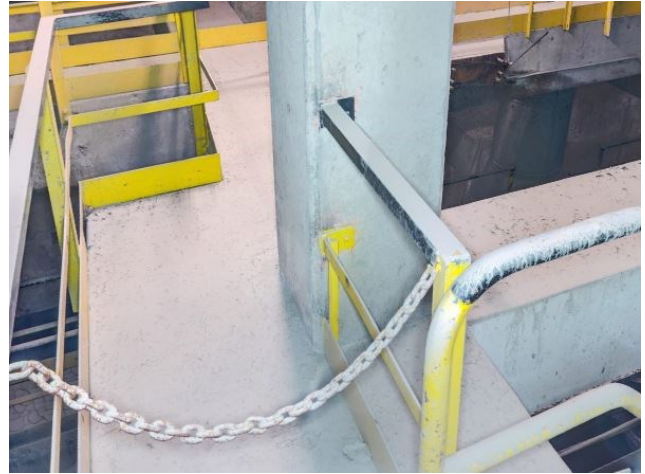
**Soil Deposition:** Soil deposition on all horizontal surfaces begins with finer grain/thinner amounts of sediment at level L3-101 and progressively becomes thicker and heavier on levels 4 and 5 below where it exhibits mud-flat or clay pan-like cracking. This is due to river water ingress, likely specifically from the high-level water in-take. During on-site inspections the basement floor was still saturated with water and there was heavy scum or bio-growth films on top.

**L3: Fine Sediment**

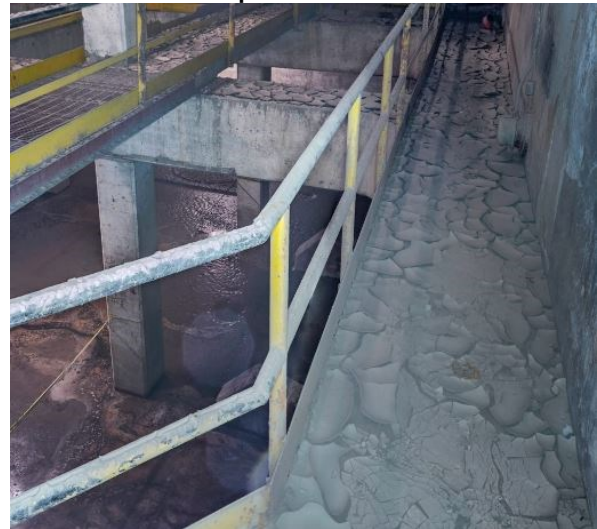
**L4: Thicker Sediment Deposits**

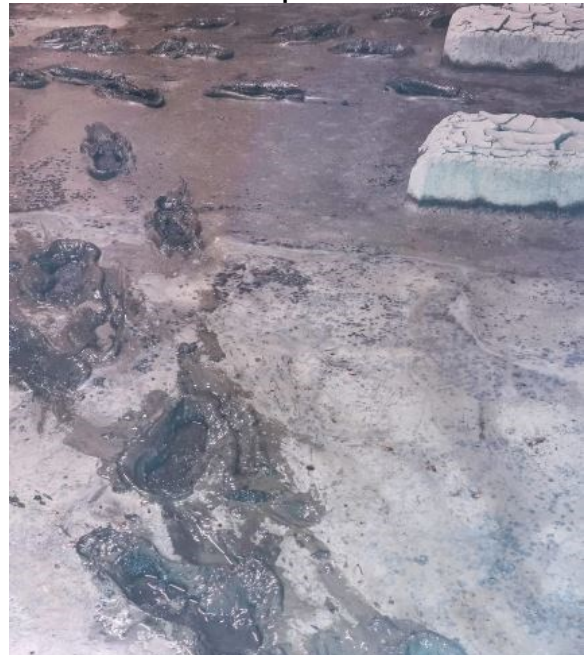
**L5: Basement Floor Thick Deposits**

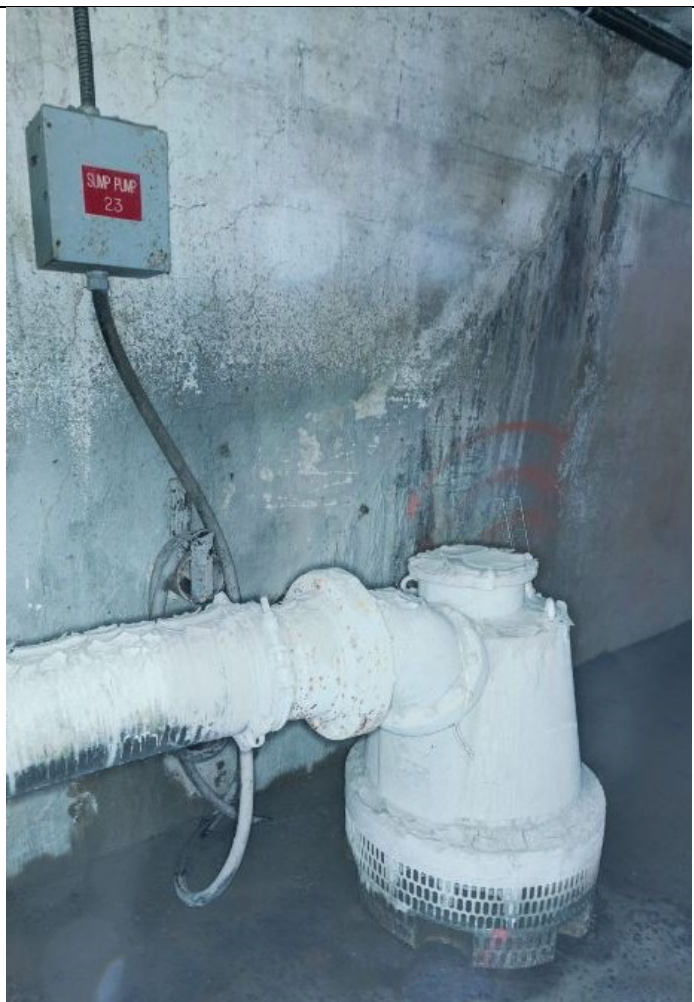
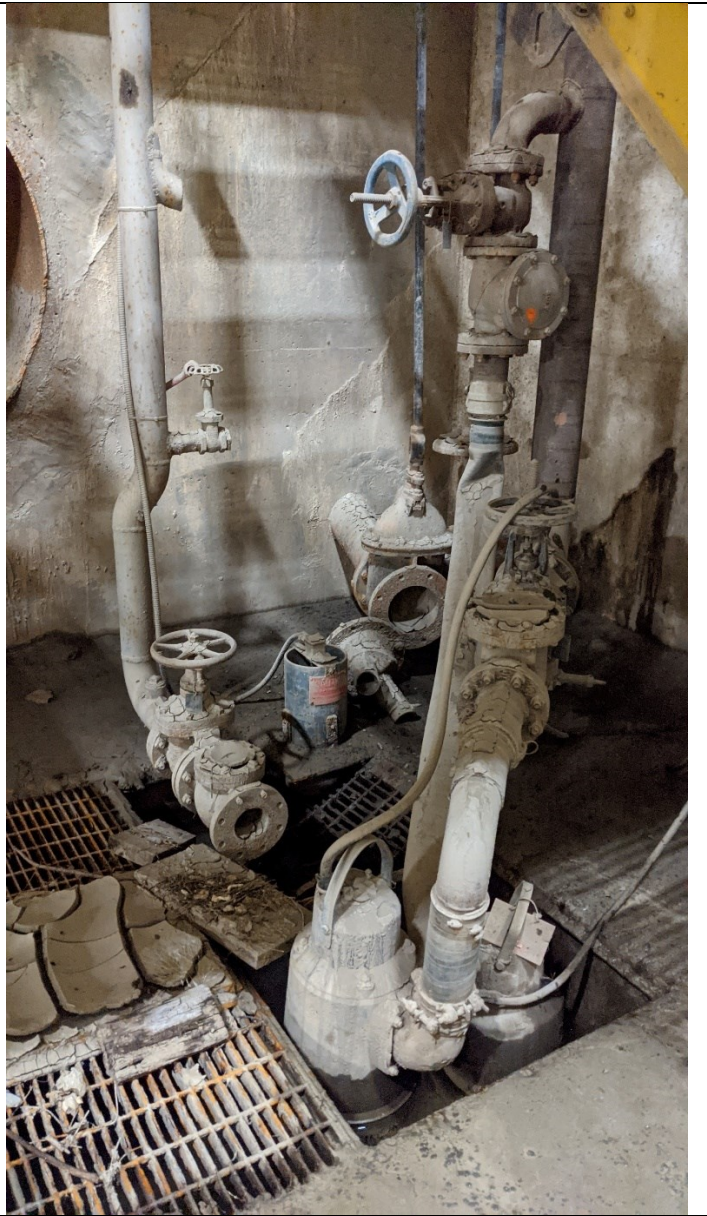
**Sump Pump:** Basement operating floor sump pumps will require maintenance to keep sediment deposit from clogging their operation.

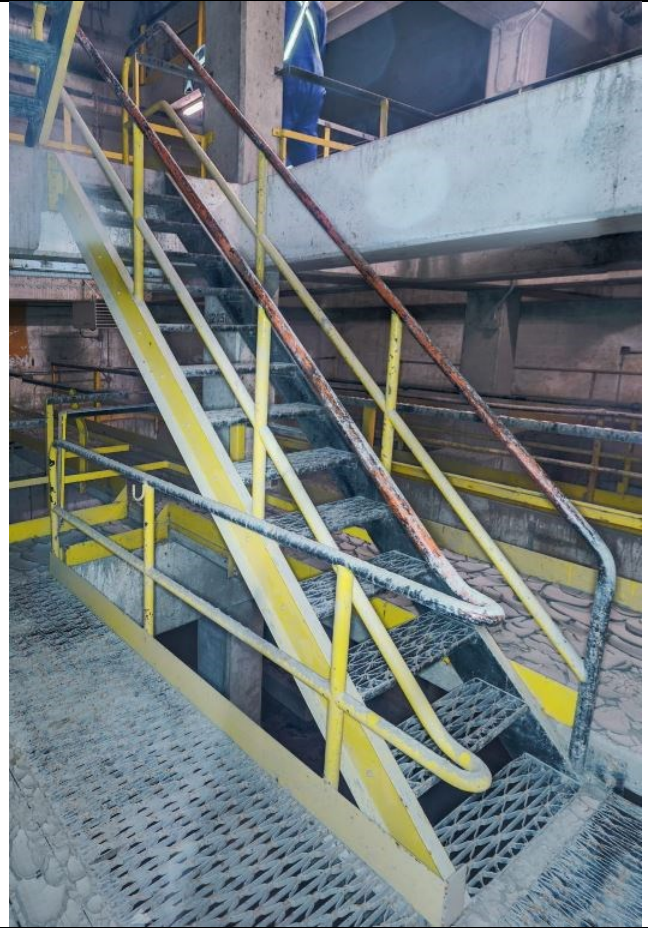
**Stairs:** All stairs are in generally good condition except for paint failure and the rare instance of passivated corrosion. Stairs do not meet contemporary building code requirements.

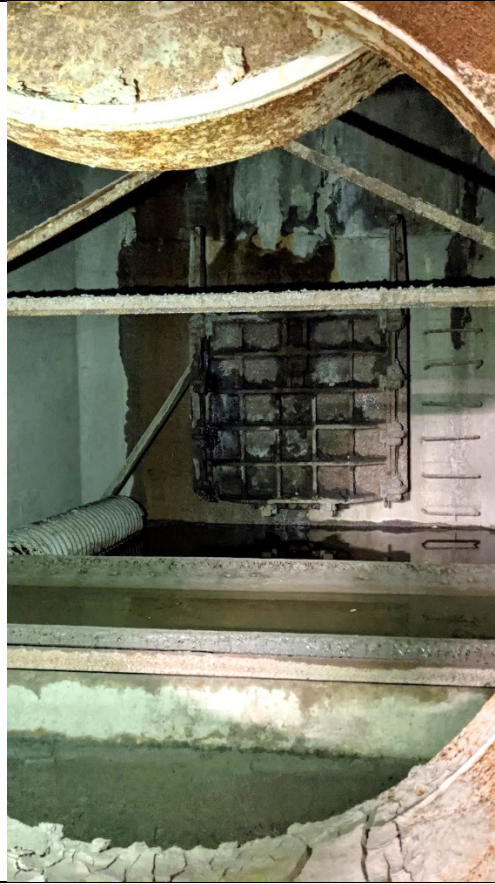
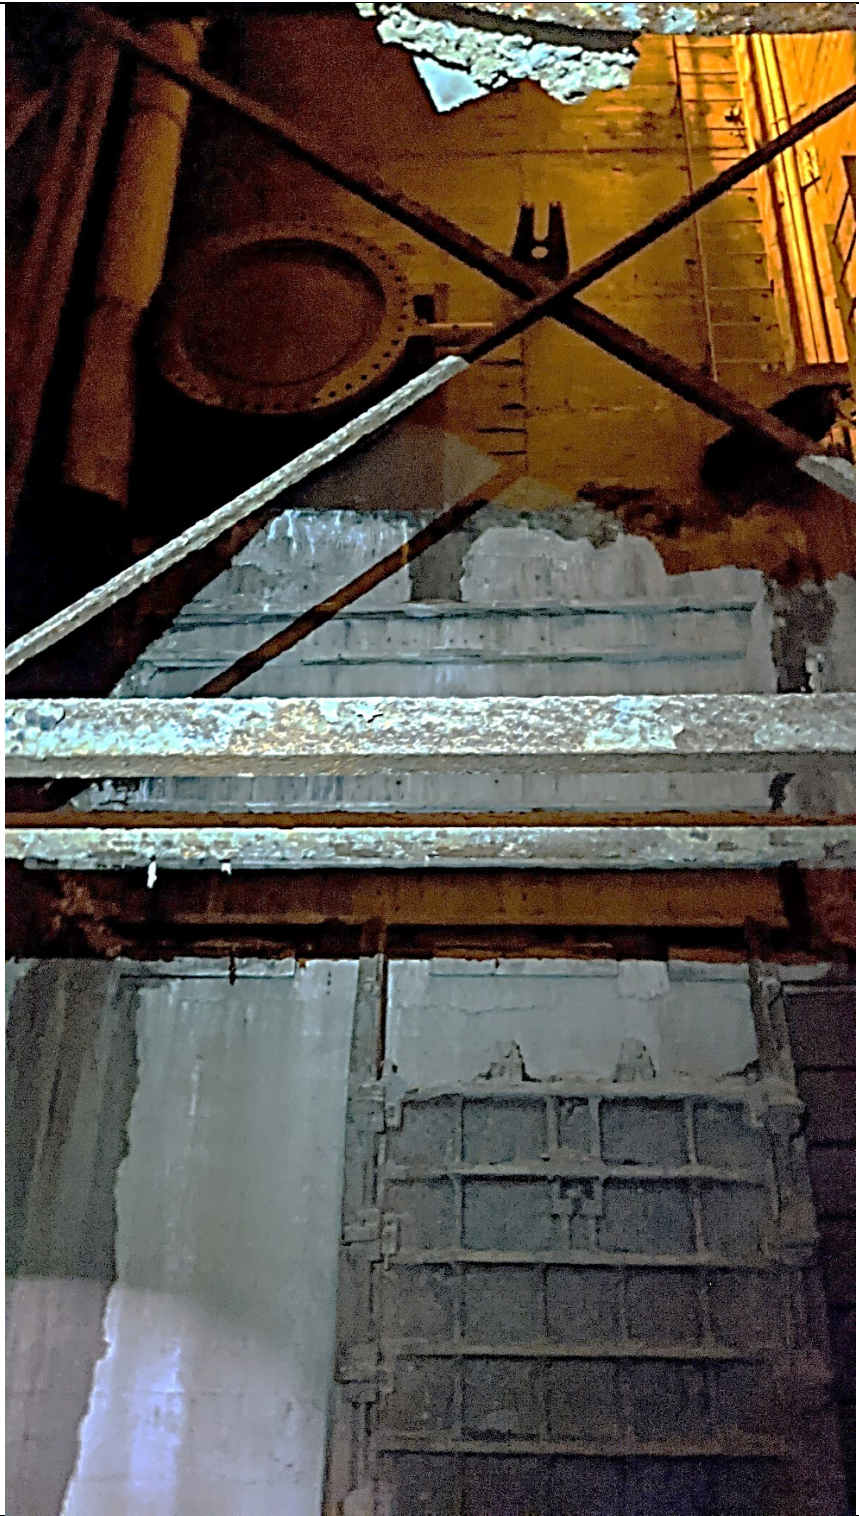
In this photo the viewer is looking into through the basement operating floor into one of the open valve heads leading into the wet well. Beyond, sealed metal valves are seen to be actively corroding as water from above, presumably from the high water level in take, is running over it. In the lower photo, more details of the corroding travelling water screen is visible. Further corrosion and water intrusion is evidenced by extensive soil deposition and flooding in the dry-wells. Based on visual assessment, it appears that the high water level intake, among potential other intake valves, are the source of water ingress. Metal water in-take seals, travelling water screens, access ladders and landings are exhibiting corrosion. Concrete is also exhibiting areas of spalling due to corroding reinforcement.
