# Rossdale Power Plant Advanced Assessment and Priority Rehabilitation

## Pump House #2 Condition Assessment

**Submitted to: City of Edmonton**

**Date Submitted: 2021-03-15**

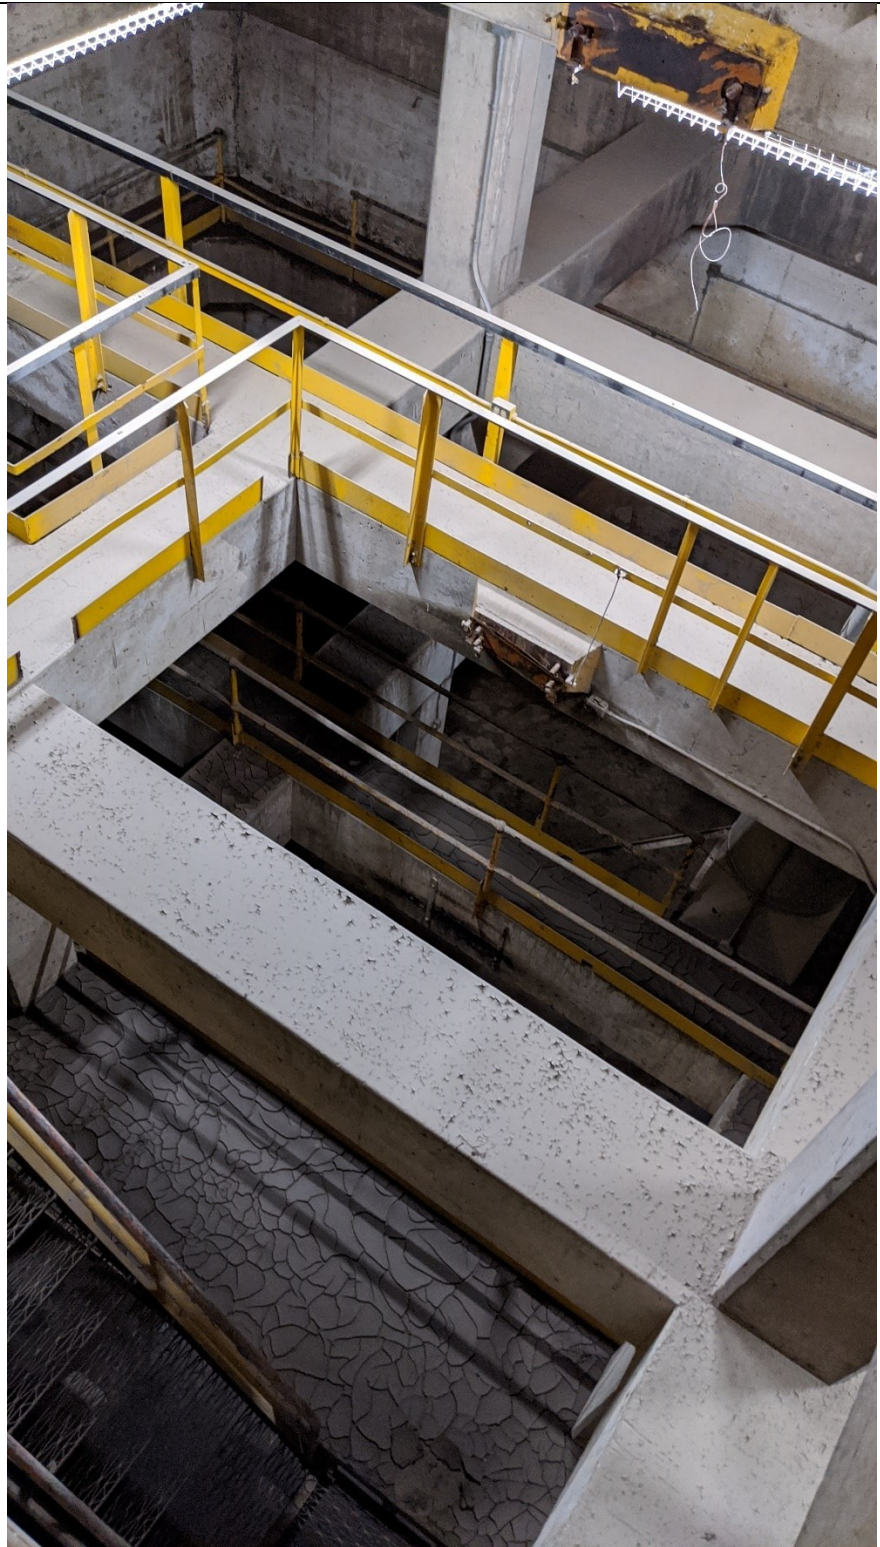
The water entering from high water intake is depositing soil in the building. Differential particle sedimentation has led to finer soil sediment deposit at the highest water levels, at Lower Level 3.

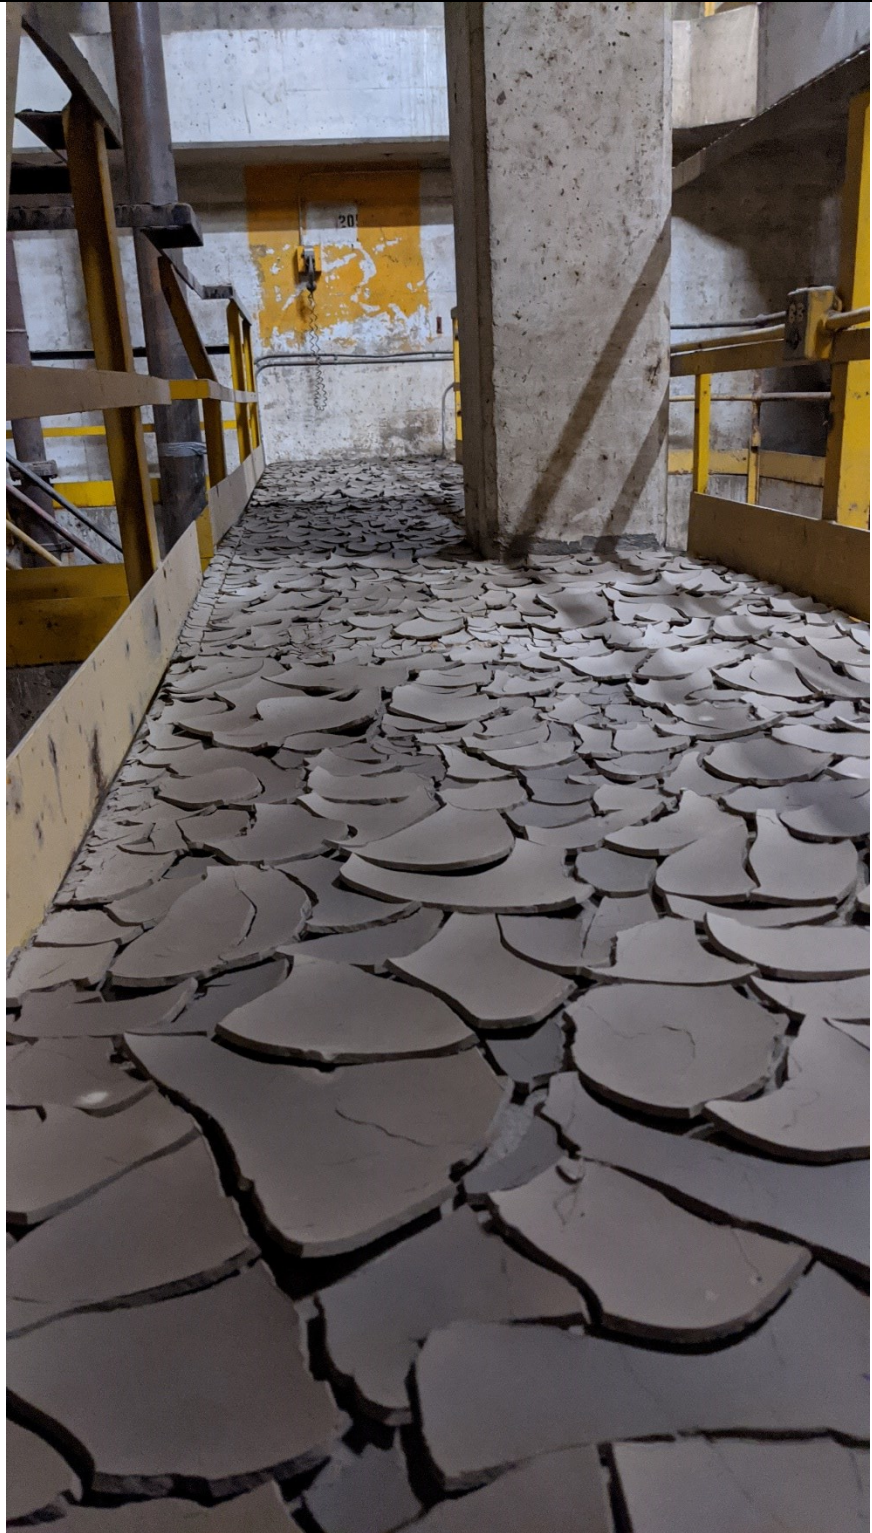
A larger volume of water ingress on Lower Level 4 is depositing increased quantities of soil. Differential particle sedimentation has led to mud flat cracking.

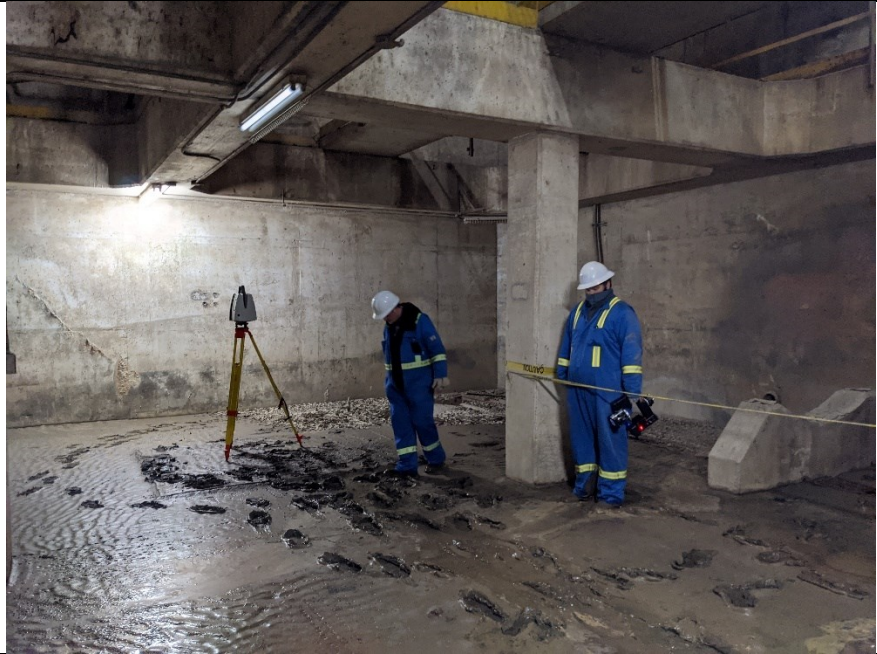
An advanced volume of water ingress on Lower Level 5 is depositing increased quantities/ degrees of soil. Differential particle sedimentation has led to wet mud deposits.

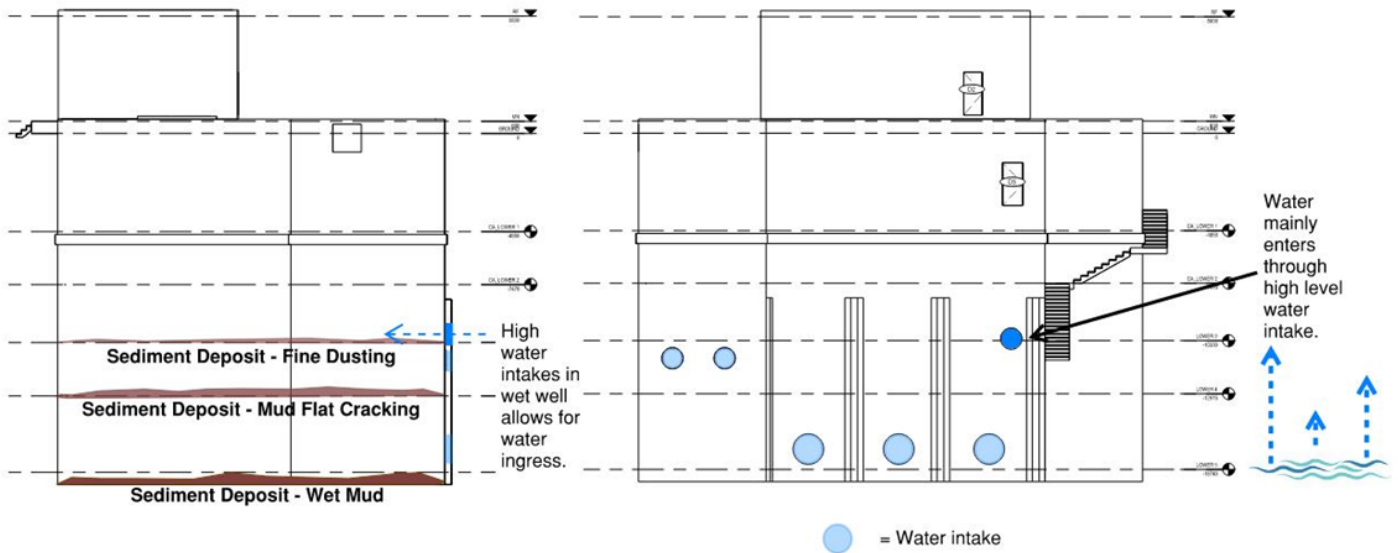
Pump House #2 Principal Deterioration Schematic

Water ingress in Pump House #2 will lead to similar deterioration patterns as in Pump House #1 if the water intake is unaddressed. Water entering through the high level intake is depositing varied amounts of sediment on Lower Levels 3 to 5. The lowermost level of the Pump House is subject to the most advanced sedimentation due to large quantities of water ingress.

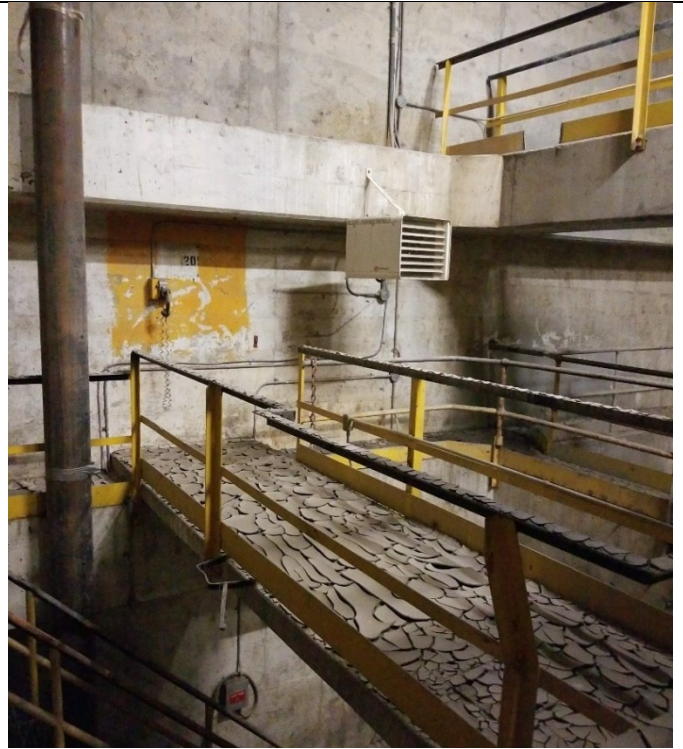
Above: Sediment deposits at the highwater mark

The basement level sumps should be cleaned, and solidified sediment removed. Verify that both pumps are functioning, replace both pumps if they are no longer functioning. It is critical that dewatering capacity remain in place and functional until the source of infiltration has been repaired.

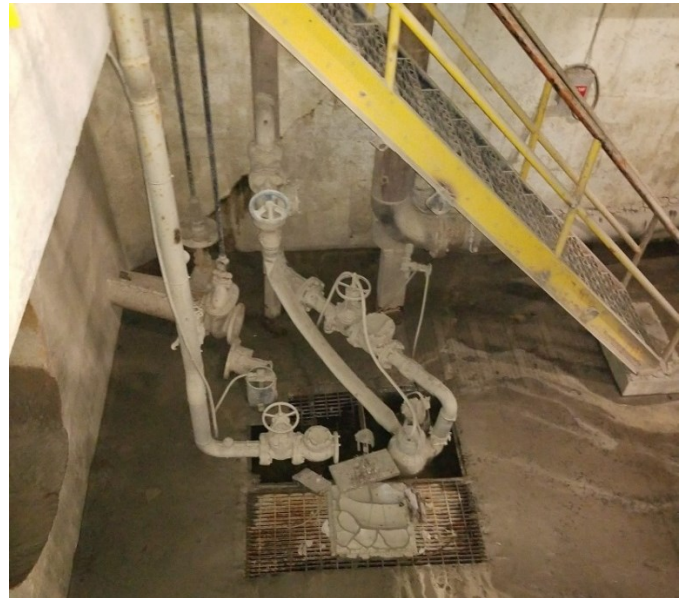
Above: Basement level sump and pump

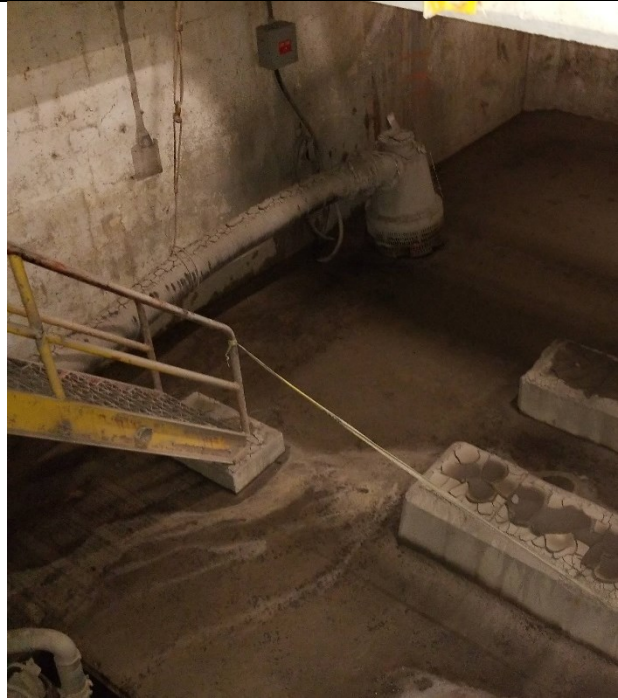
Above: Basement level dewatering pump

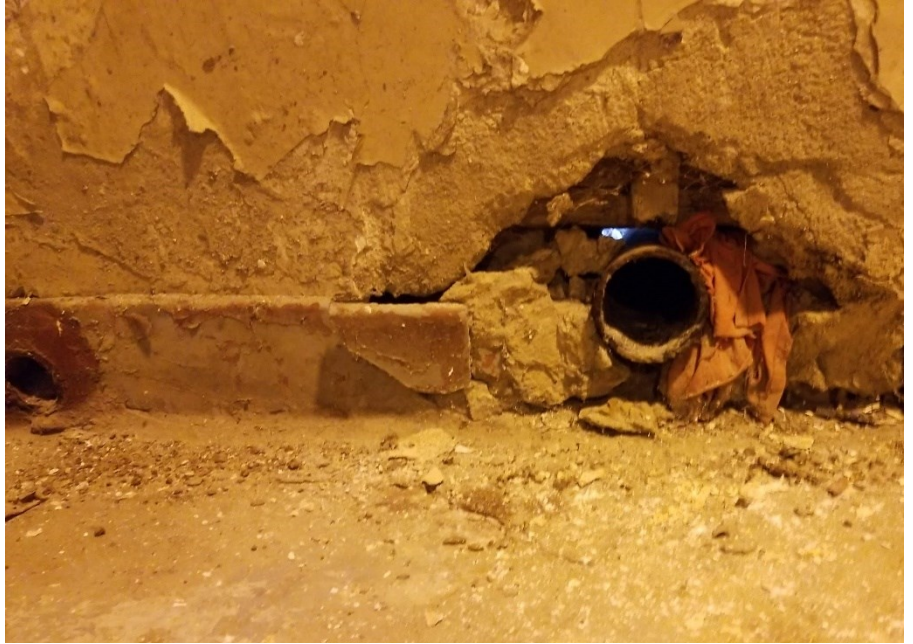
Existing small diameter (150mm or less) piping penetrations on the exterior walls have deteriorated and provide paths into the building for vermin and air or water infiltration. All of the associated systems have been de-commissioned and most if not all of the piping on the interior side of the wall has been removed.

Above: Abandoned piping penetration

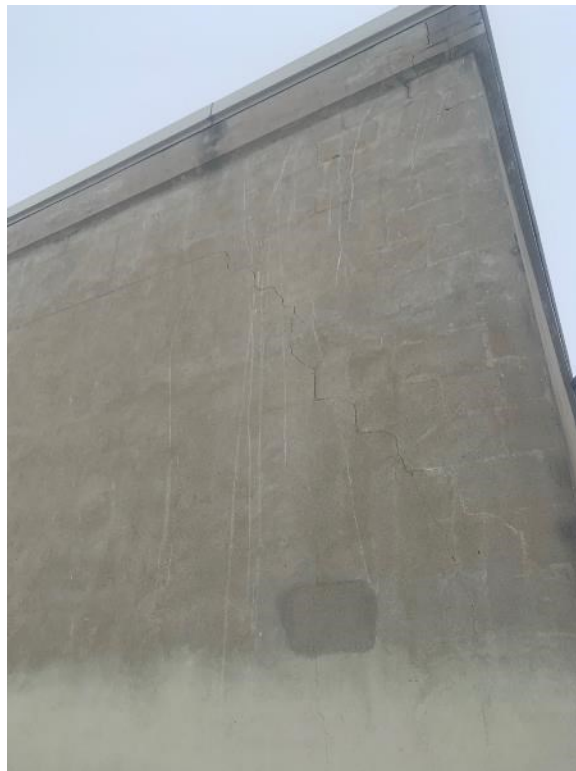
Above: PH2 - Exterior Cracking

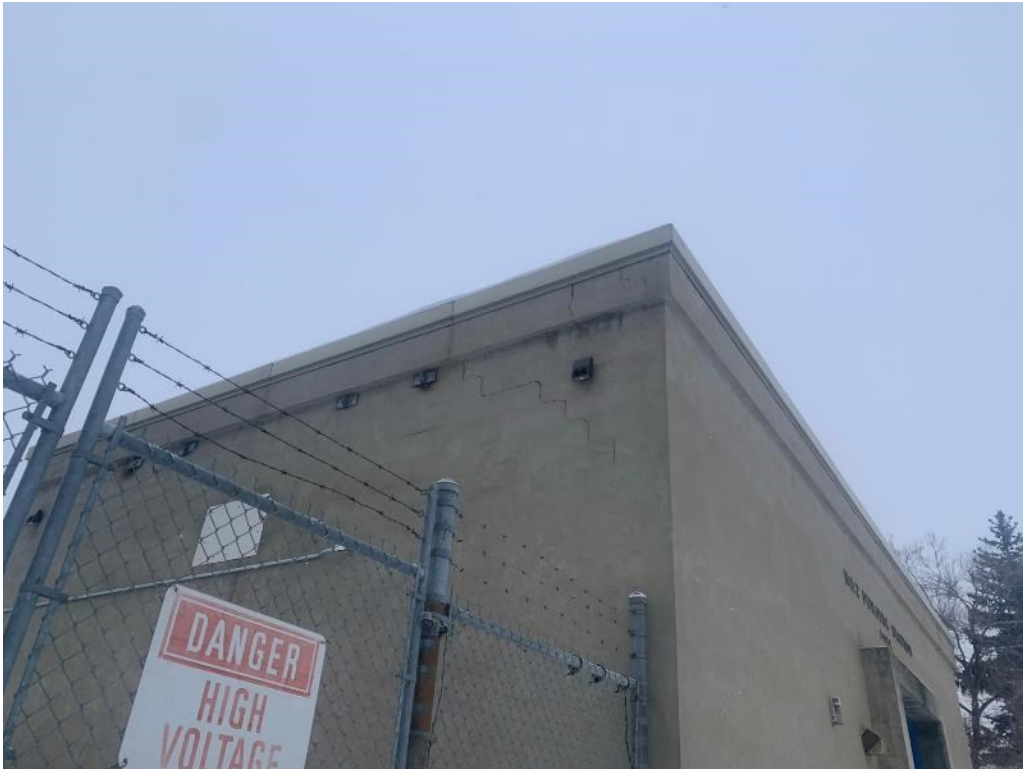
Above: PH2 – Exterior Cracking

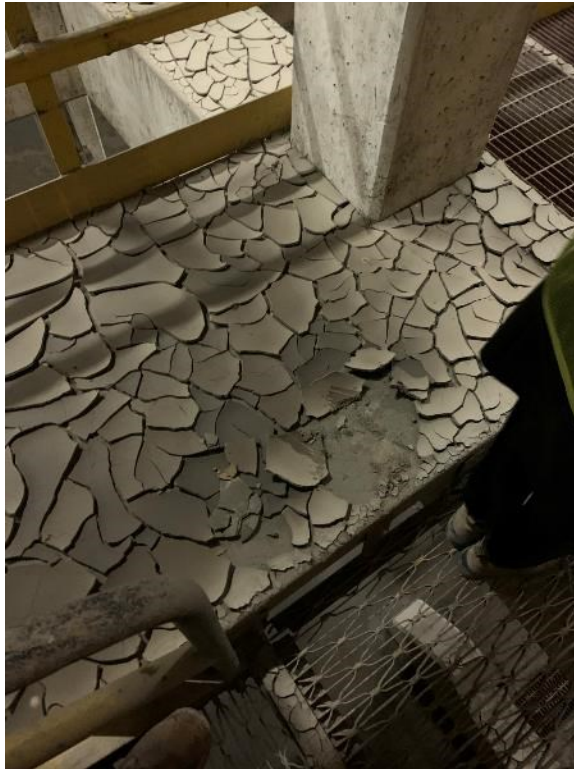
Above: PH2 – Lower Level Structures (Sediment on Structure)
