# Rossdale Power Plant Advanced Assessment and Priority Rehabilitation

## Turbine Hall Condition Assessment

Submitted to: City of Edmonton

Date Submitted: 2021-03-15

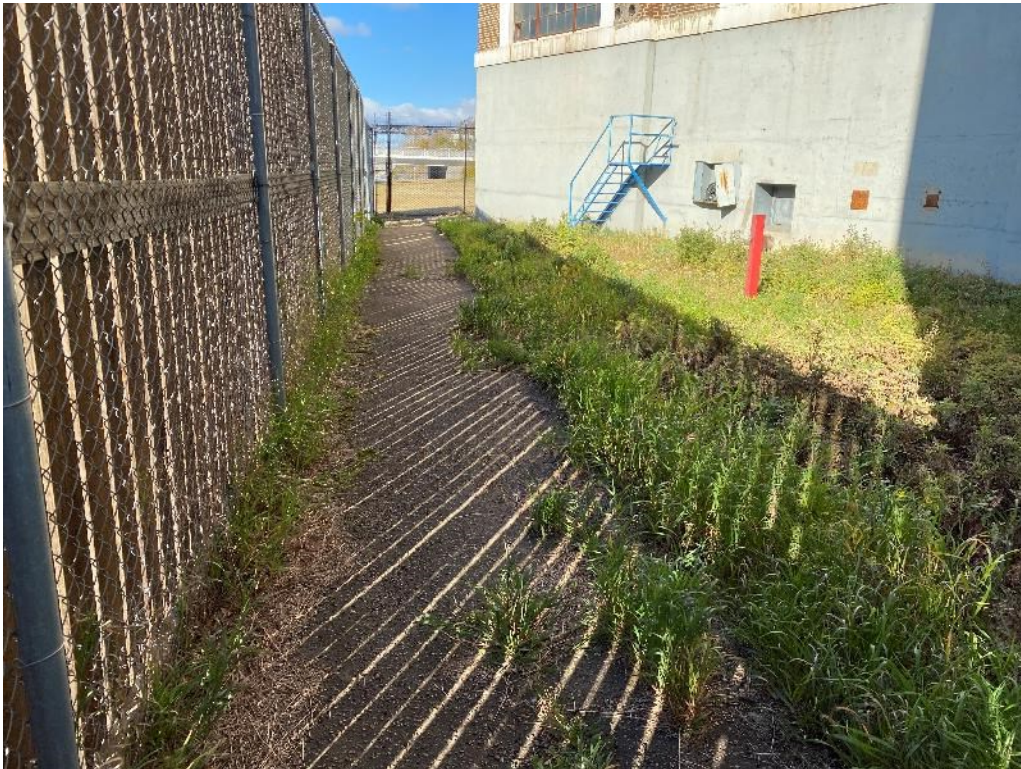
**Above: Negative drainage and flow restriction cause by path**

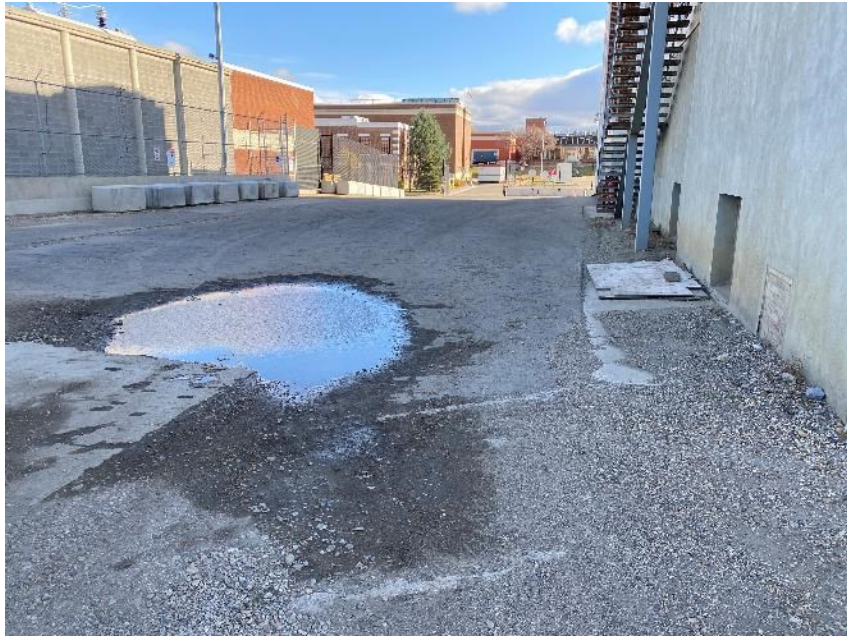
**Above: Water pooling in settled asphalt area north of the Low Pressure Plant**

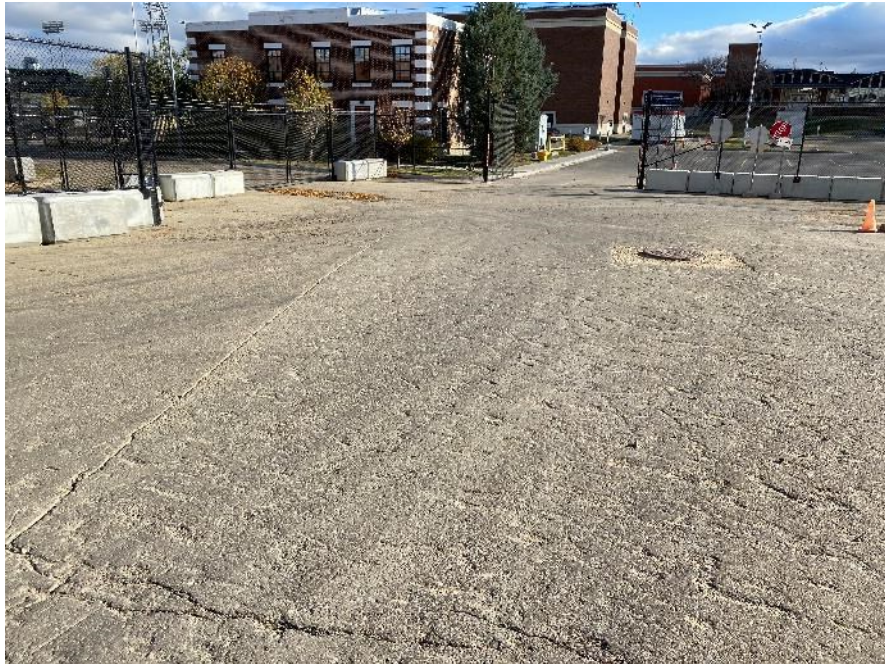
**Above: Damaged asphalt from heavy equipment**

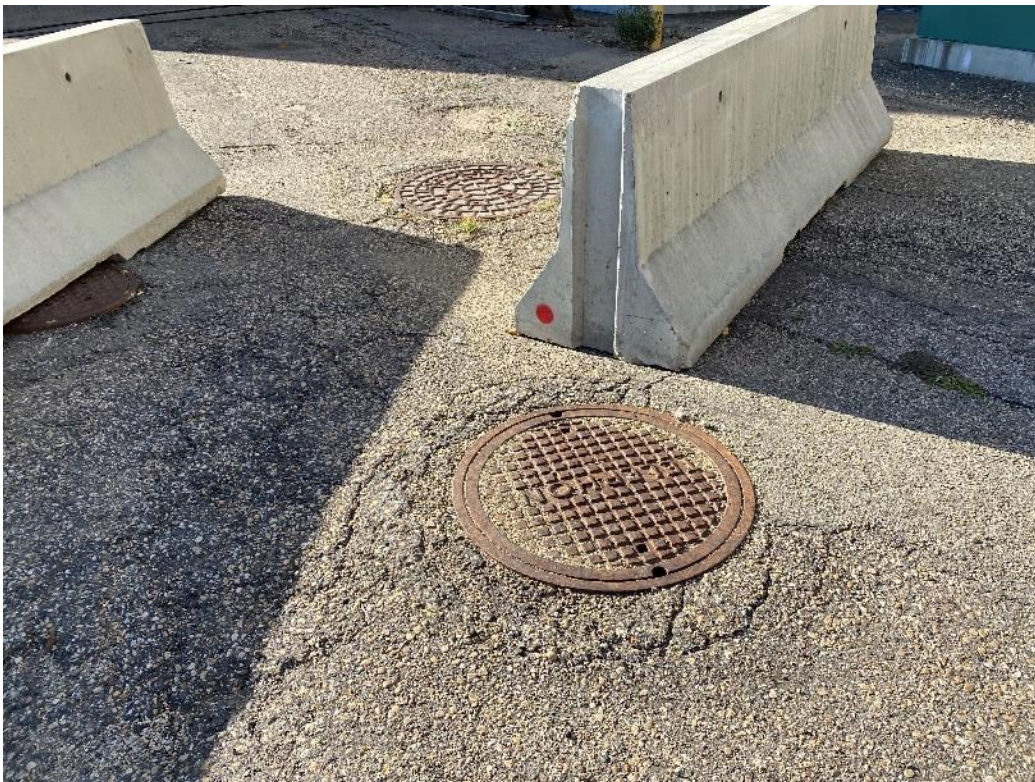
**Above: Settlement and cracking around Manholes and vaults**

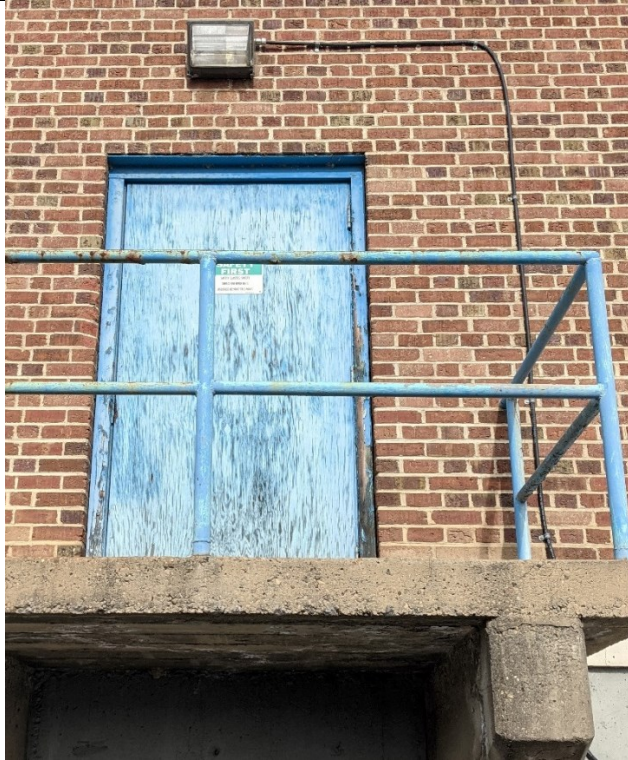
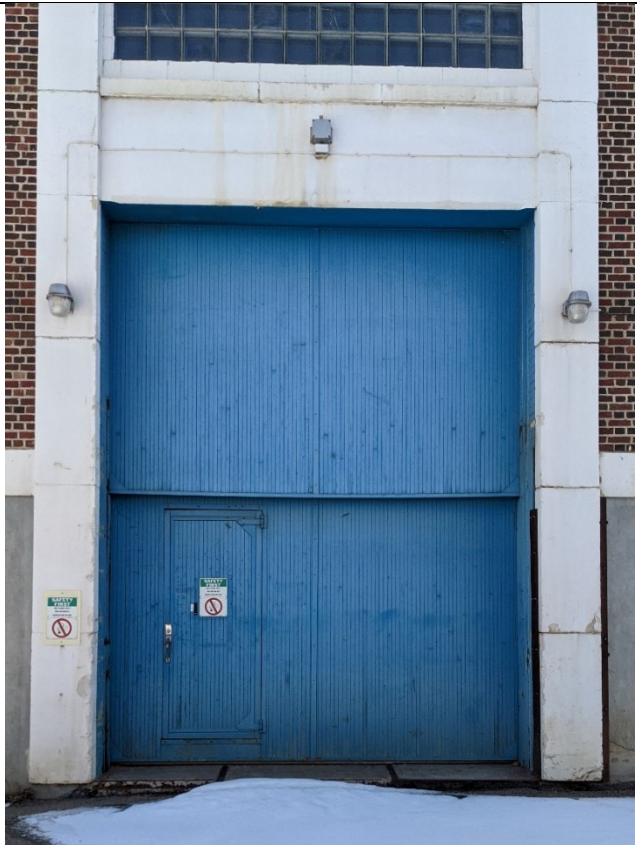
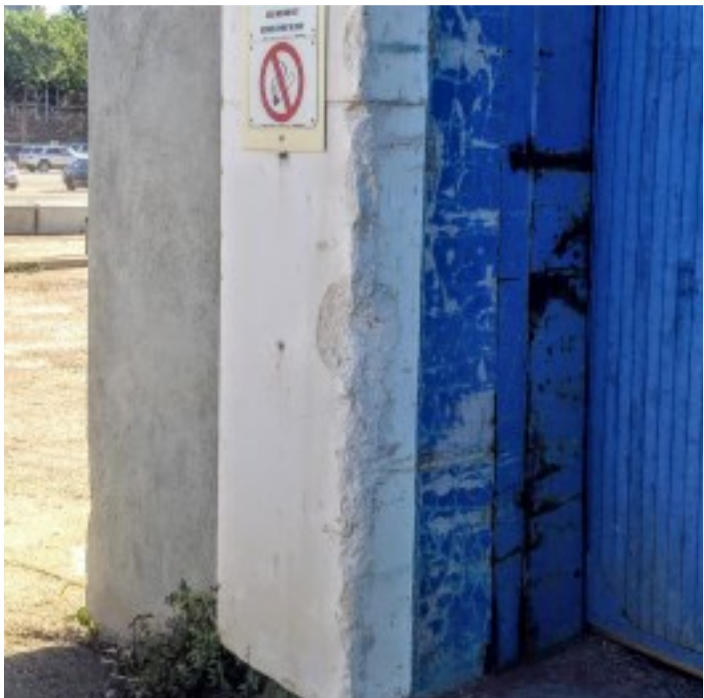
Paint is failing on exterior doors, as expected with deferred maintenance over time. There is also impact damage on the exterior cast-concrete door jambs surrounding D10.

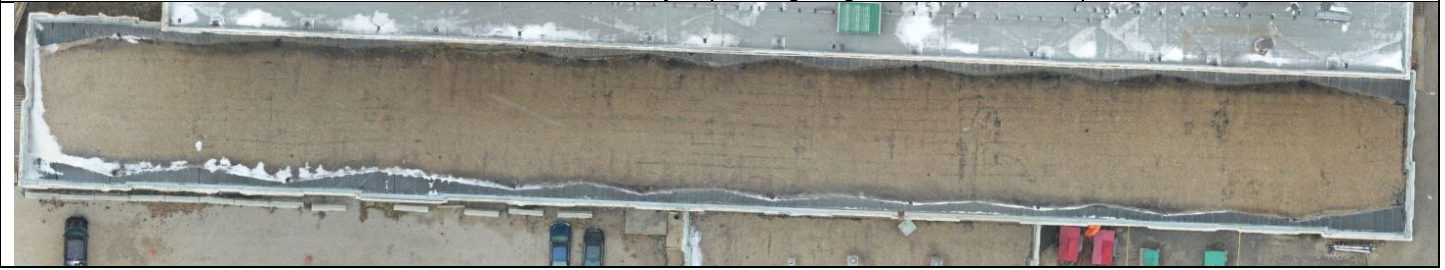
Membrane has exceeded its serviceable life and is currently in planning stages for near-future replacement.

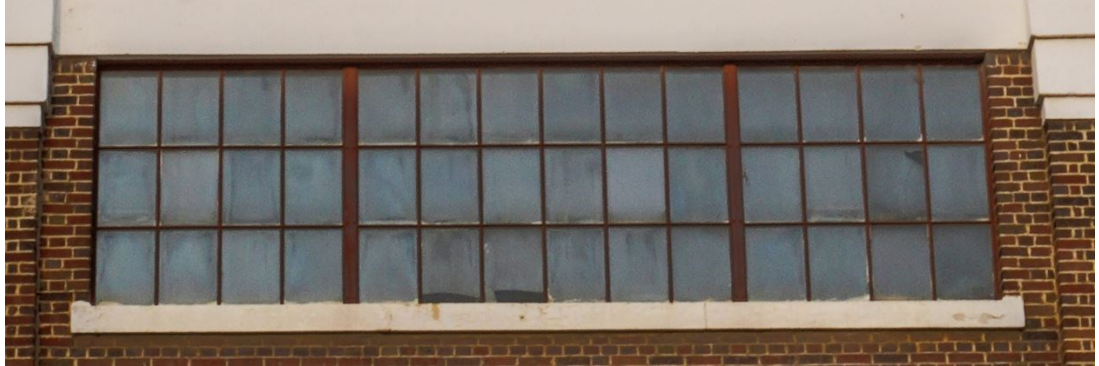
The multi-light rolled steel windows are in fair condition. Glazing units are all soiled, some are broken or missing, and glazing putty is generally hardened and failing.

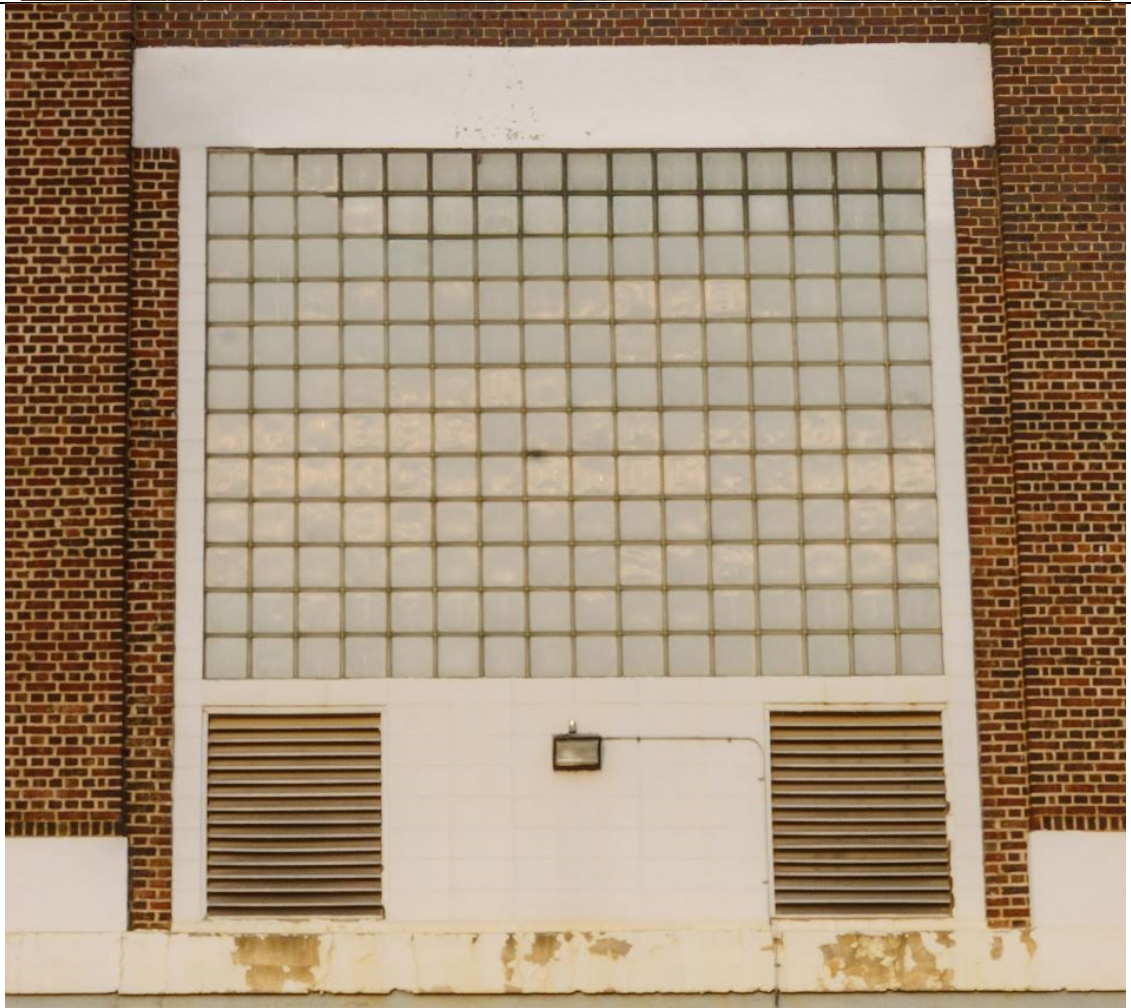
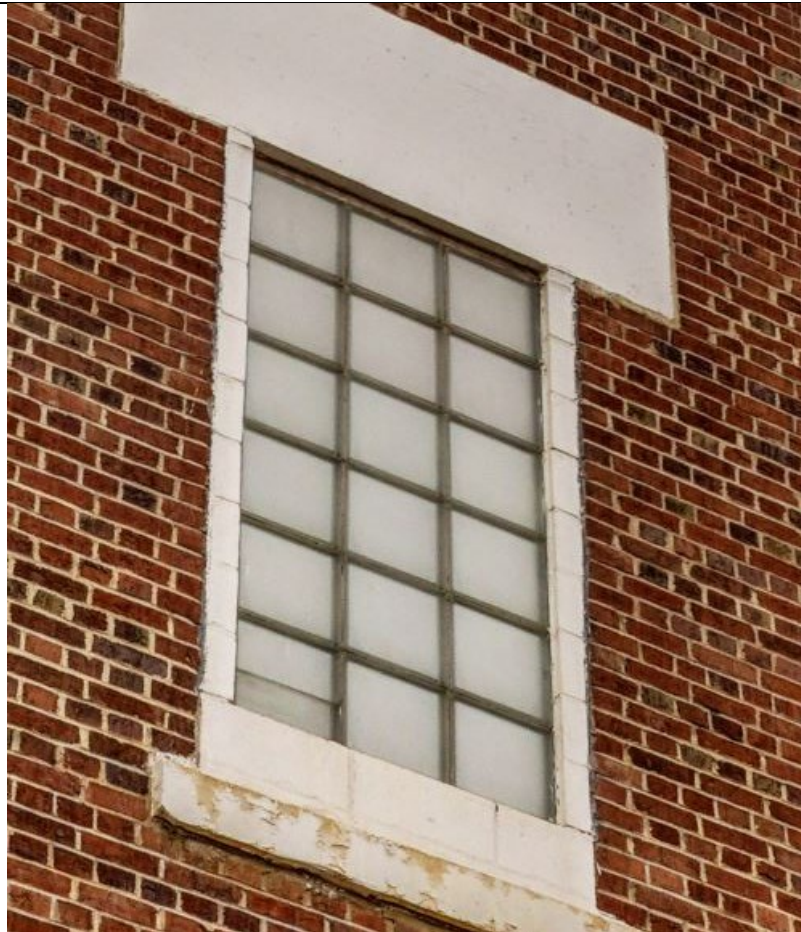
Good condition generally, some block units are broken, as in lower photo.

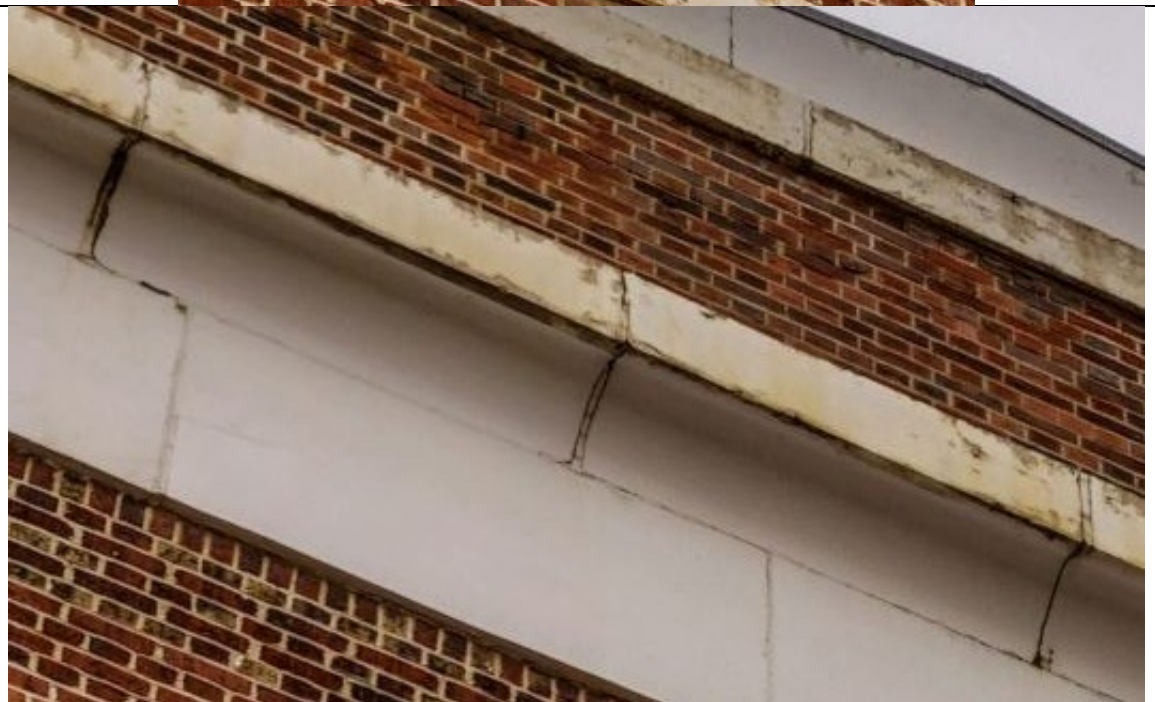
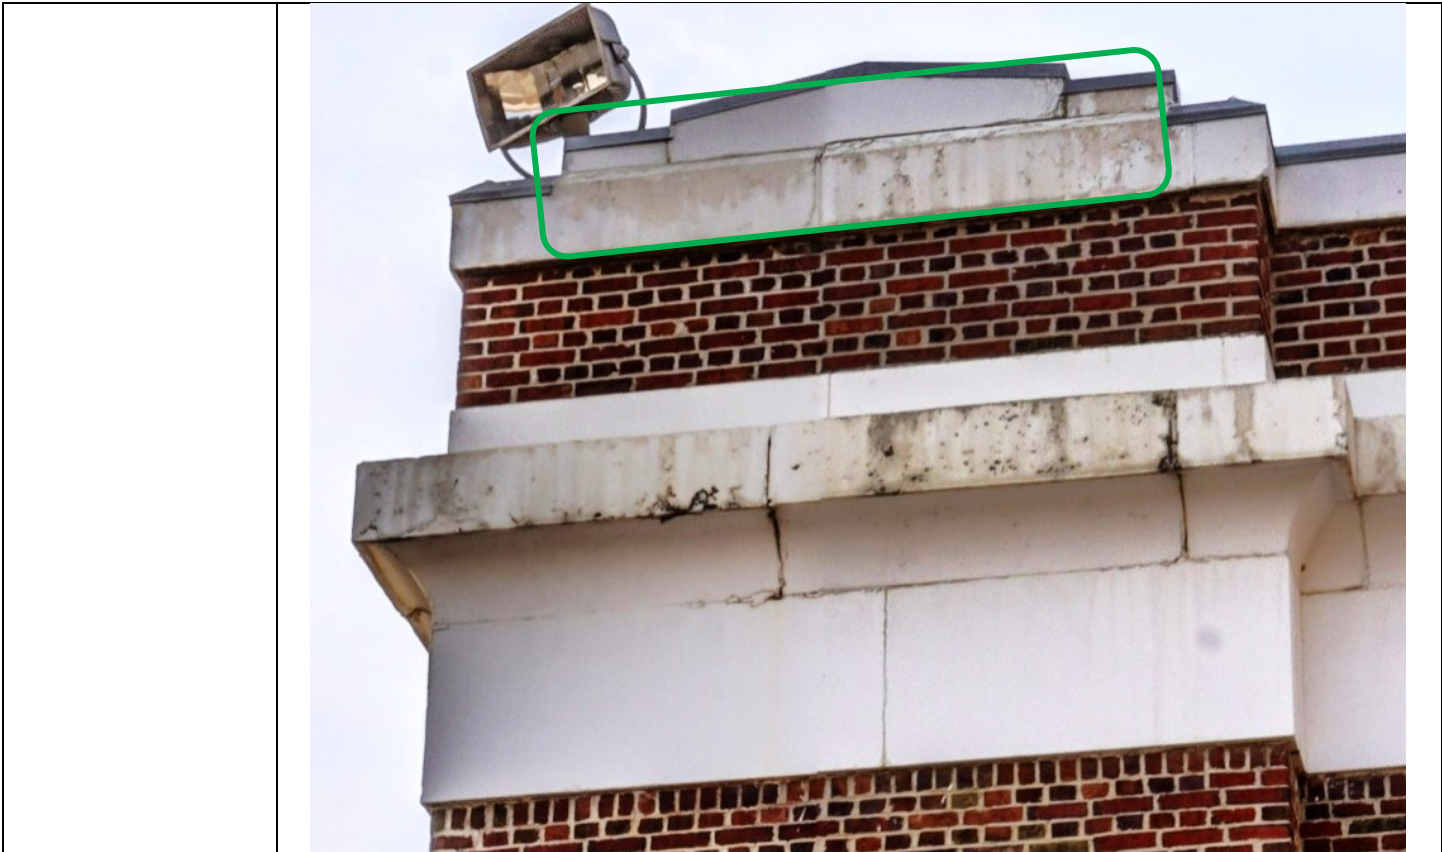
All perpendicular mortar joints in cavetto formed cornice band are failing. This is the same for some perpendicular joints of coping and pediment units as well.

Pediments are exhibiting mortar failure where flashing does not span across at the coping level, highlighted in green. This extends to the exposed vertical joints between the three pediment units on top of the coping.

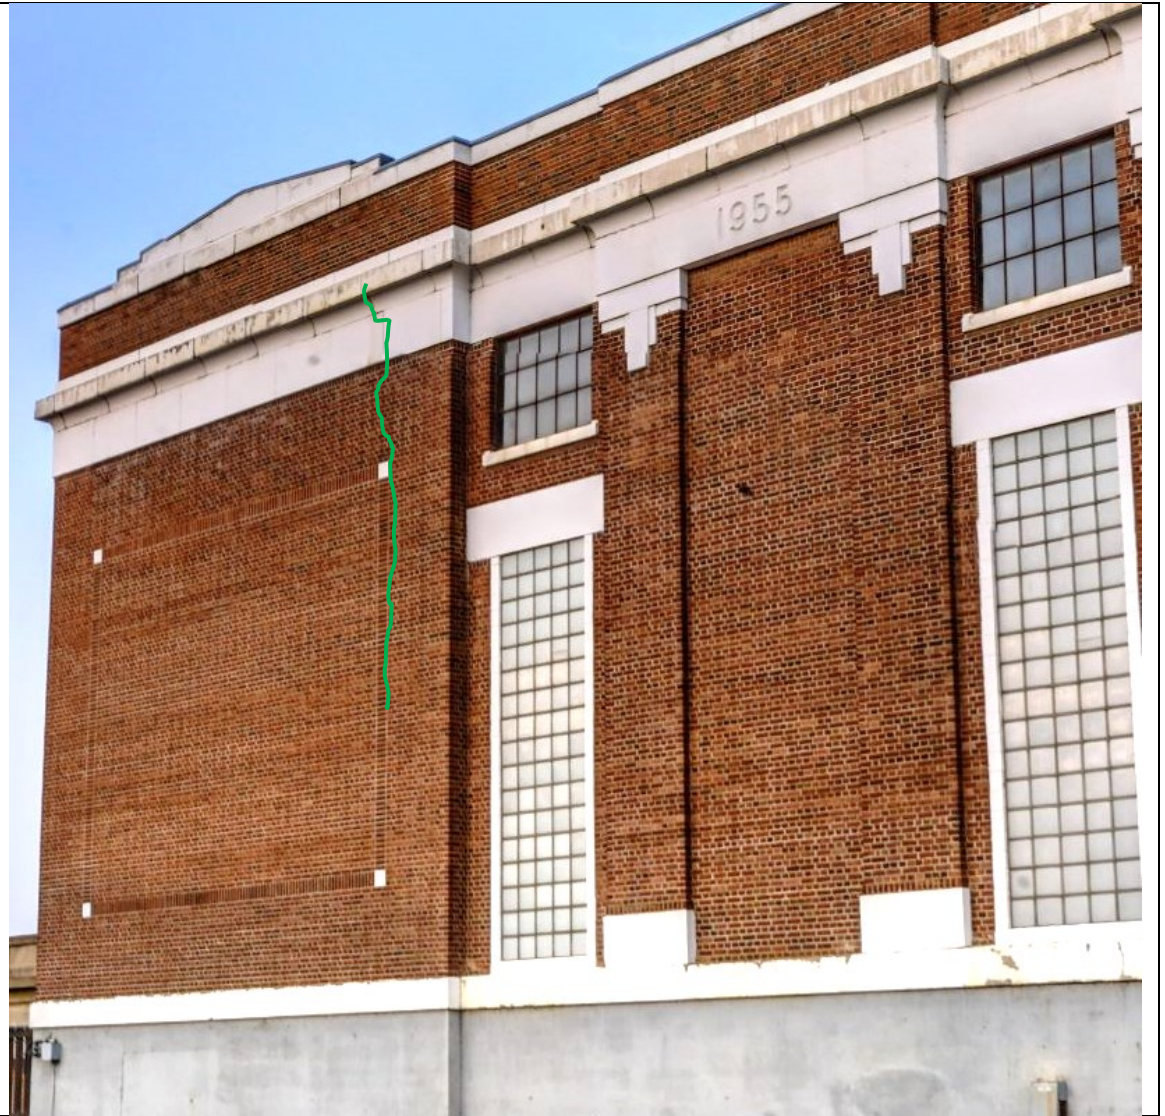
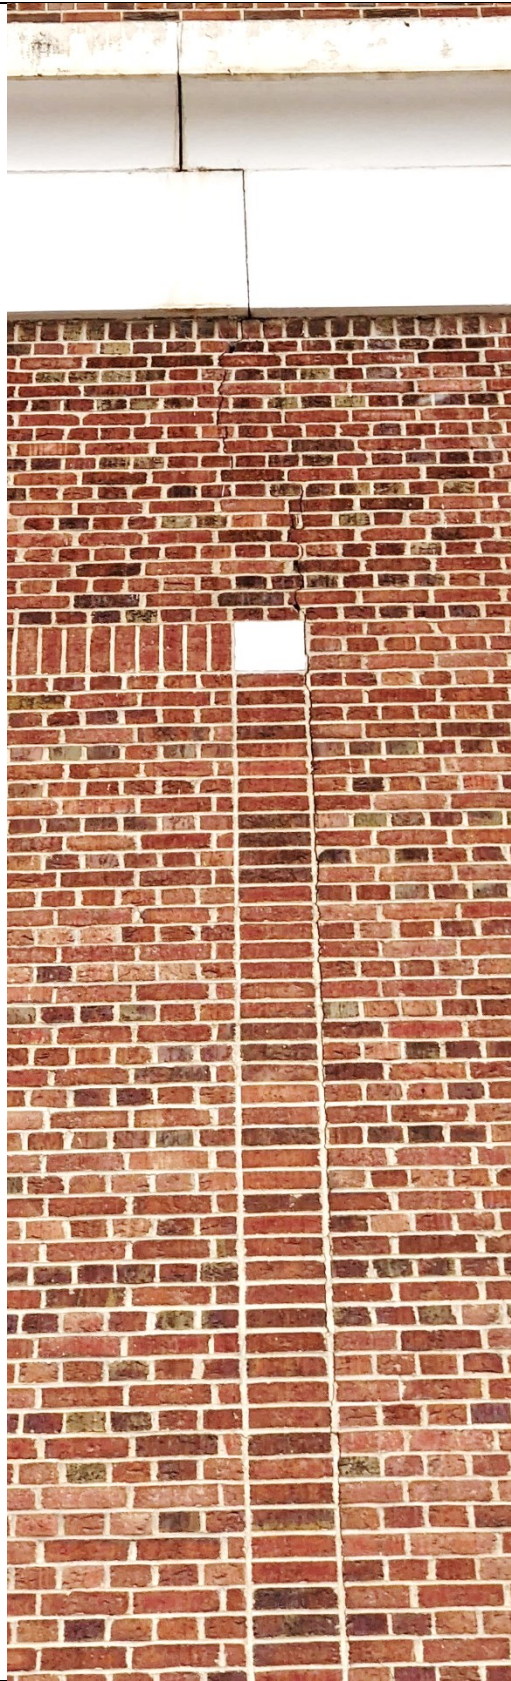
Crack in masonry  
propagating from  
cornice band zipper  
joint down to, and  
along, rectangular  
border stack joint  
highlighted in green.  
This crack does not  
appear to emanate  
through the parapet.

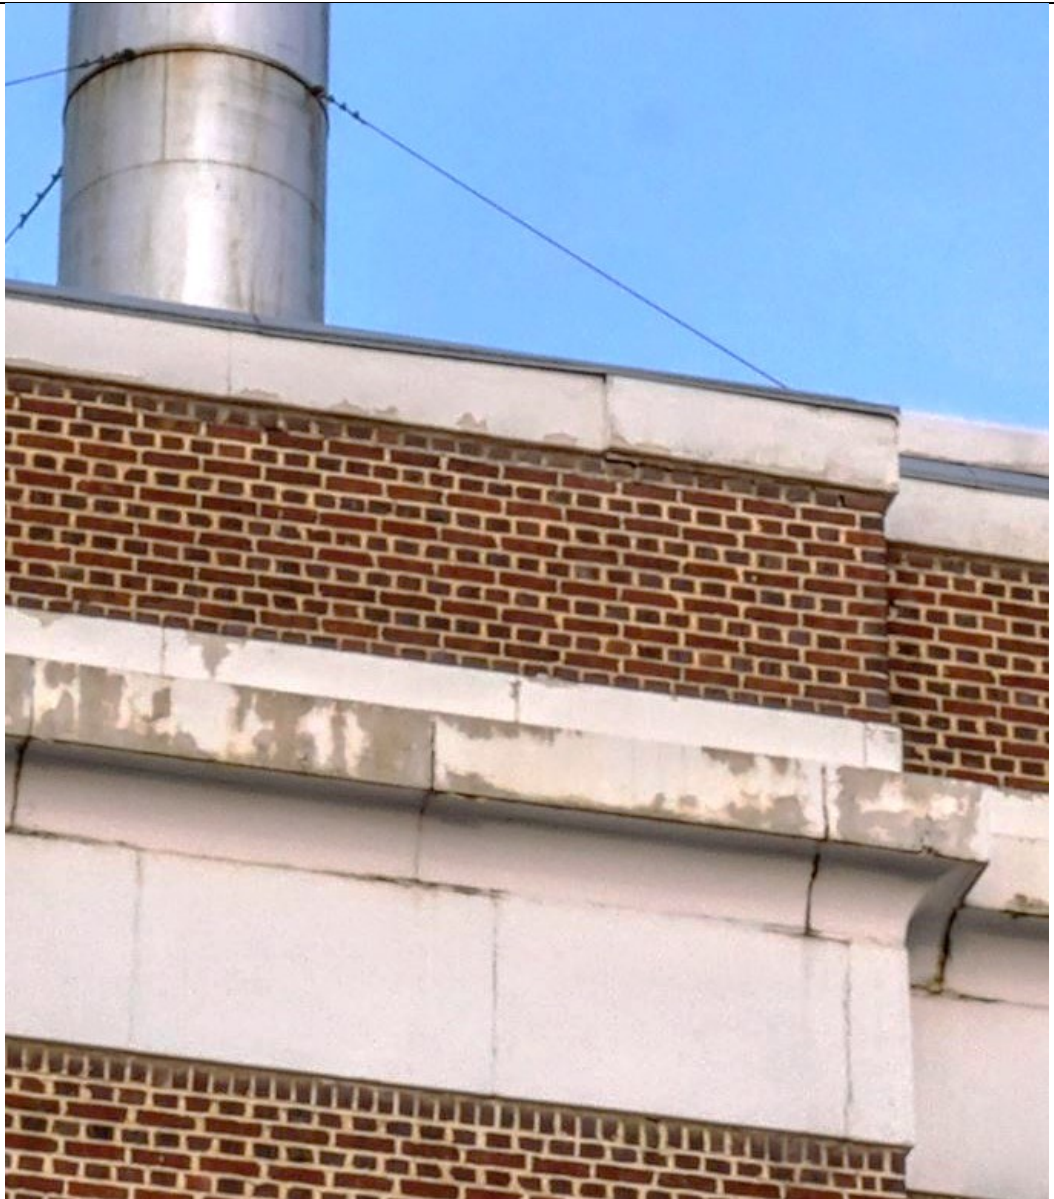
A corner parapet coping unit on the east elevation has exhibited movement.

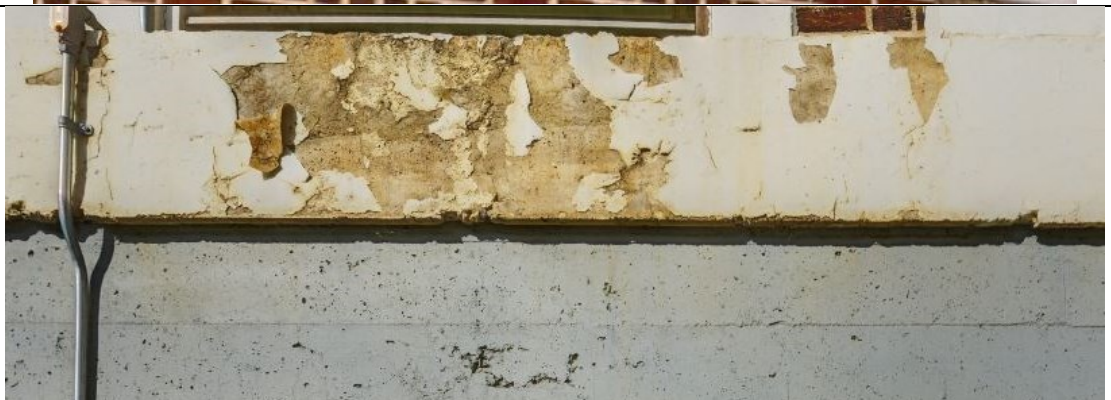
Non-original paint on cast-stone/masonry units is failing. Appears to be a type of Poly-Vinyl or Latex, or some combination thereof, due to the way it is peeling plastically.

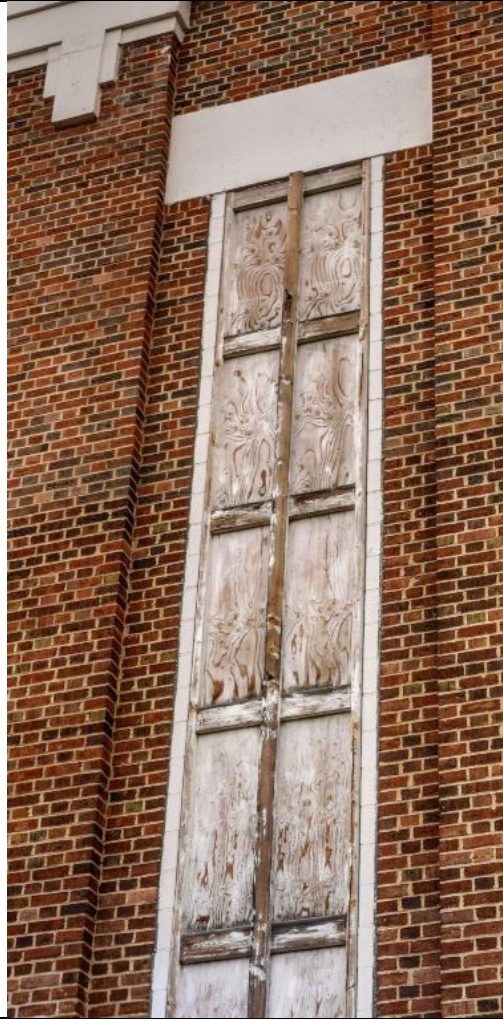
**Boarded Window:**  
Plywood boarded window at south elevation, likely due to EPCOR efforts to avoid vandalism.

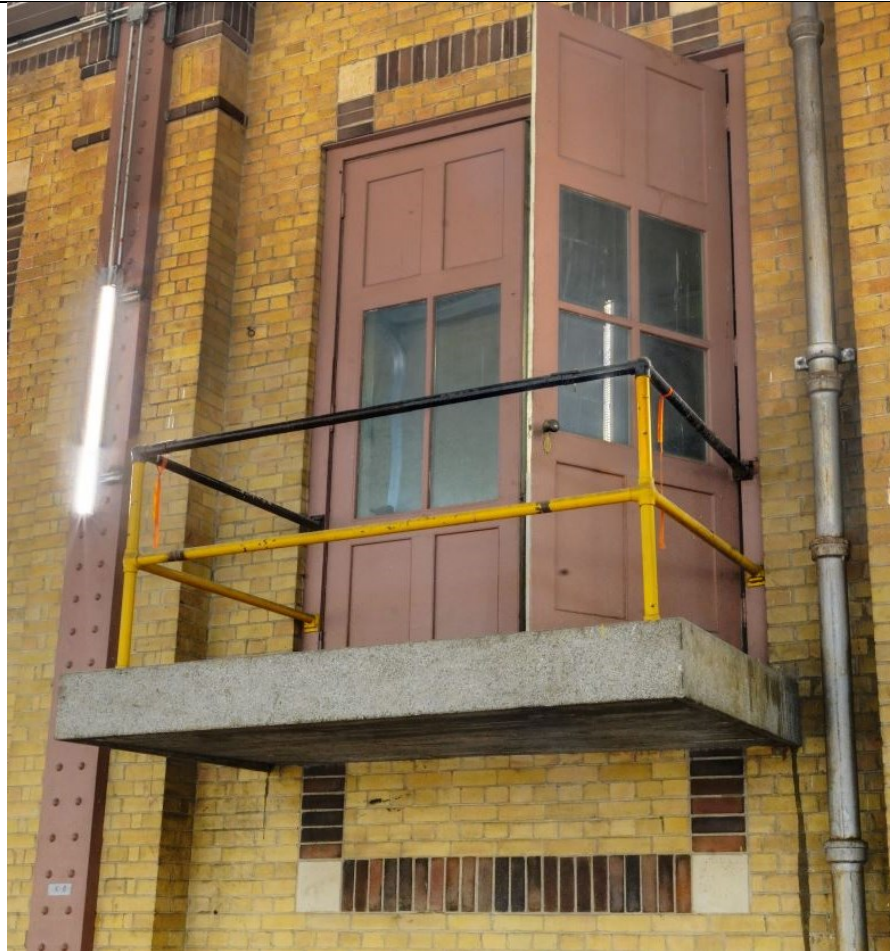
**Railings / Juliet Balcony:**  
Railings are loose and not fixed, and a high human health and safety concern.

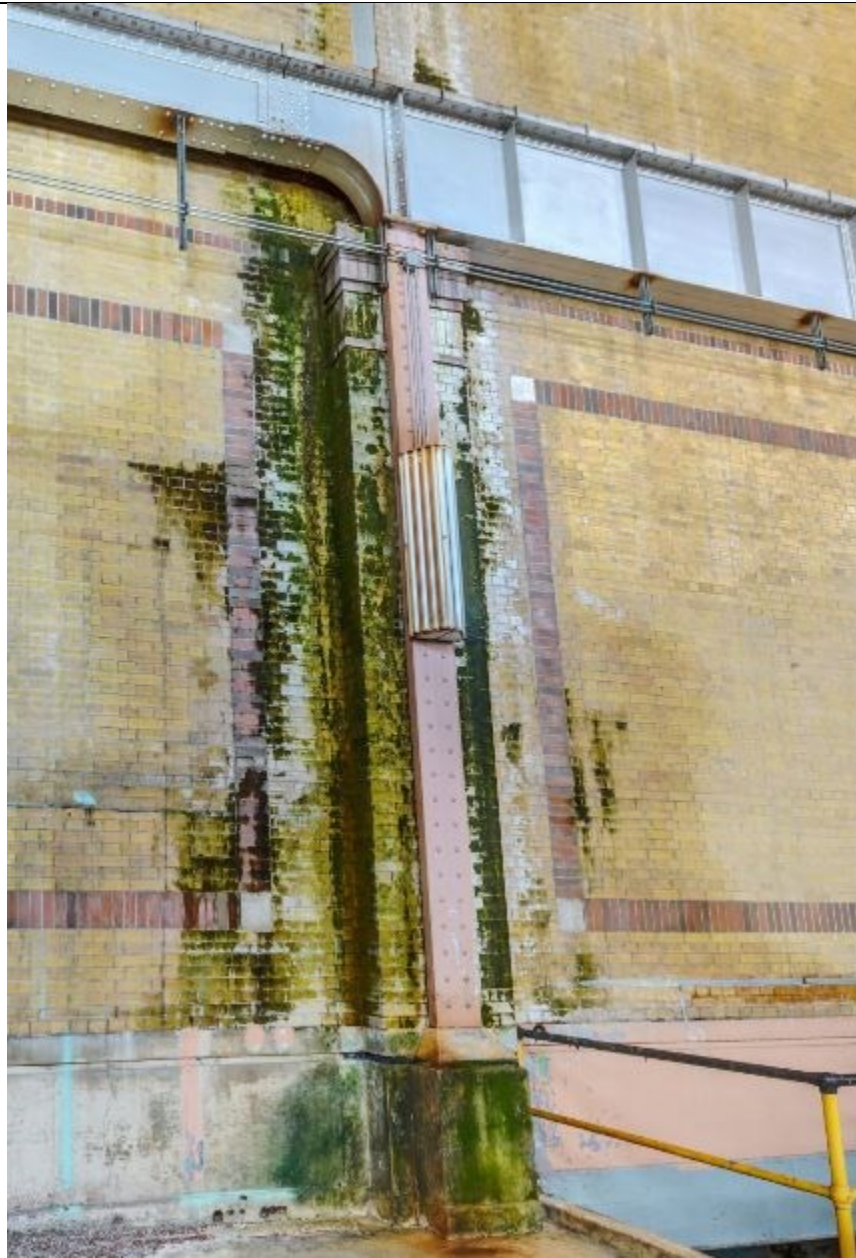
Algae stains and efflorescence due to large amounts, or constant, free water ingress from roof/rain leaders.

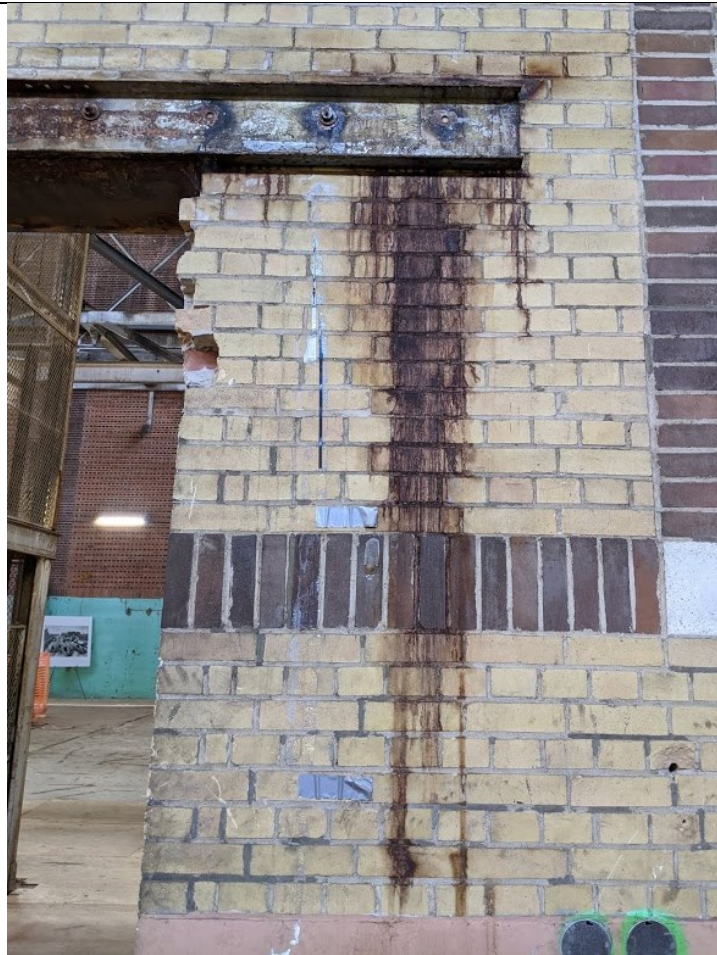
**Ferrous Stain:**  
Orange brown iron-based

stains, typically appearing as streaks below steel fasteners or cast iron elements. In the example showcased the staining has been exacerbated by water infiltration.

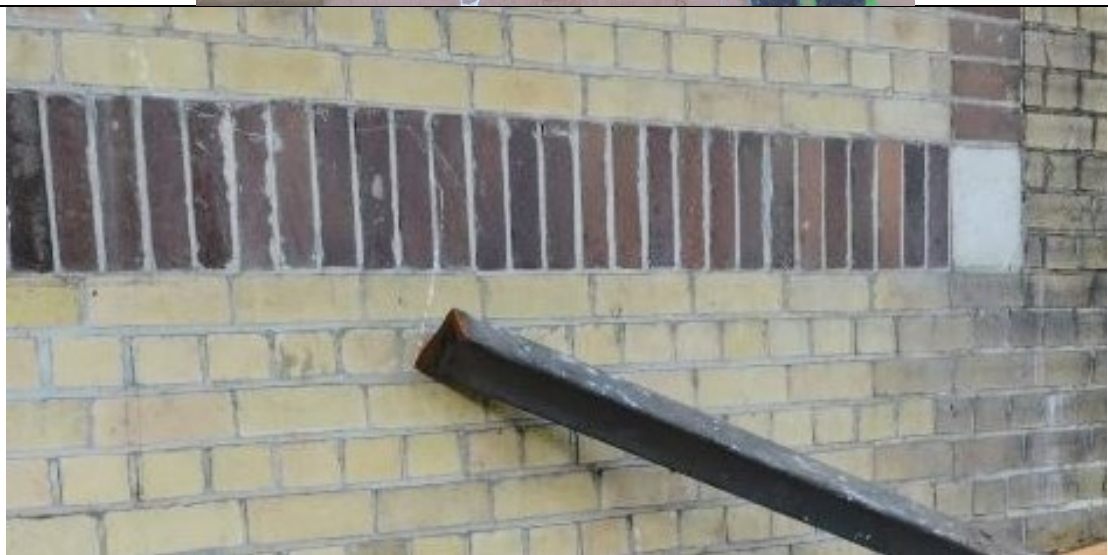
**Mechanical Damage:**  
Mechanical scratches on masonry due to demolition and abatement processes, such as unfortunate leaning of demolished structural units against interior masonry.

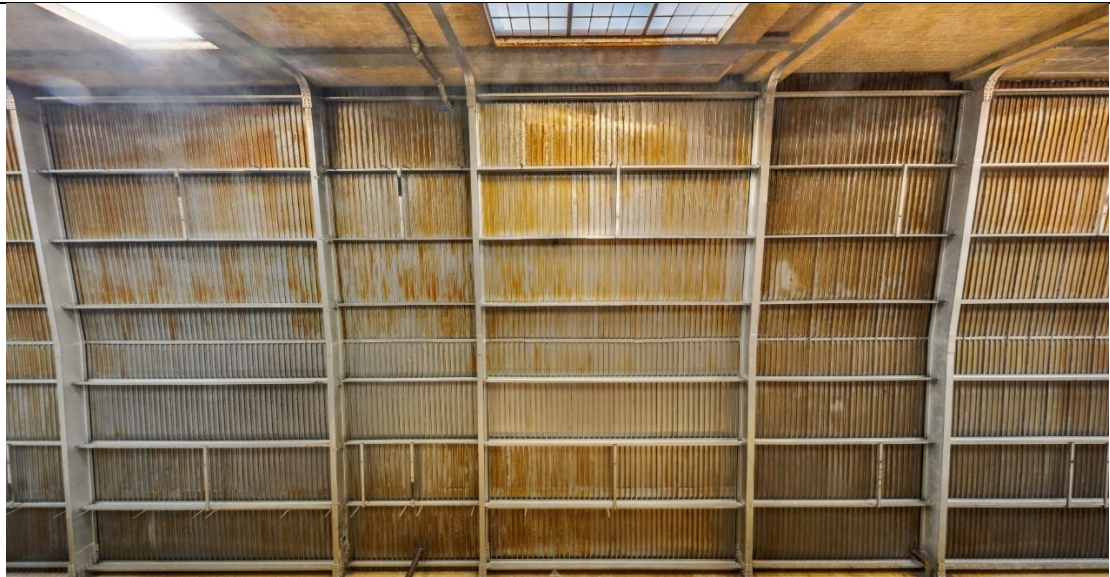
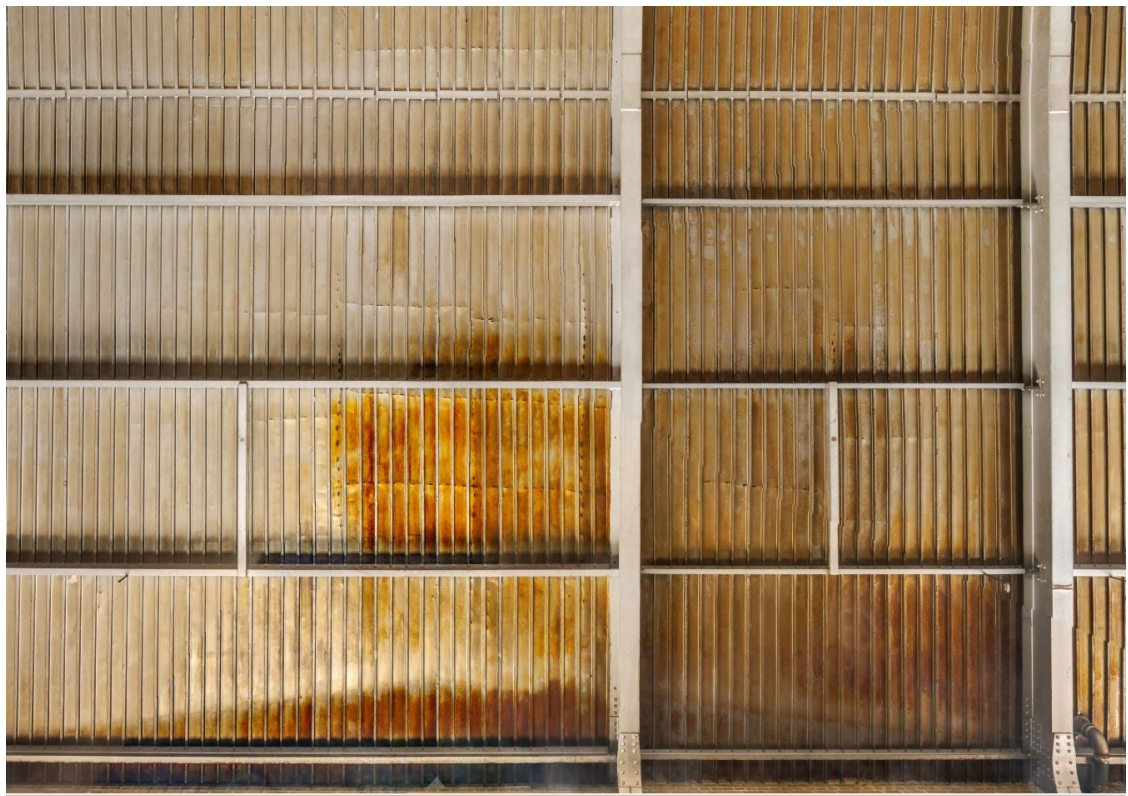
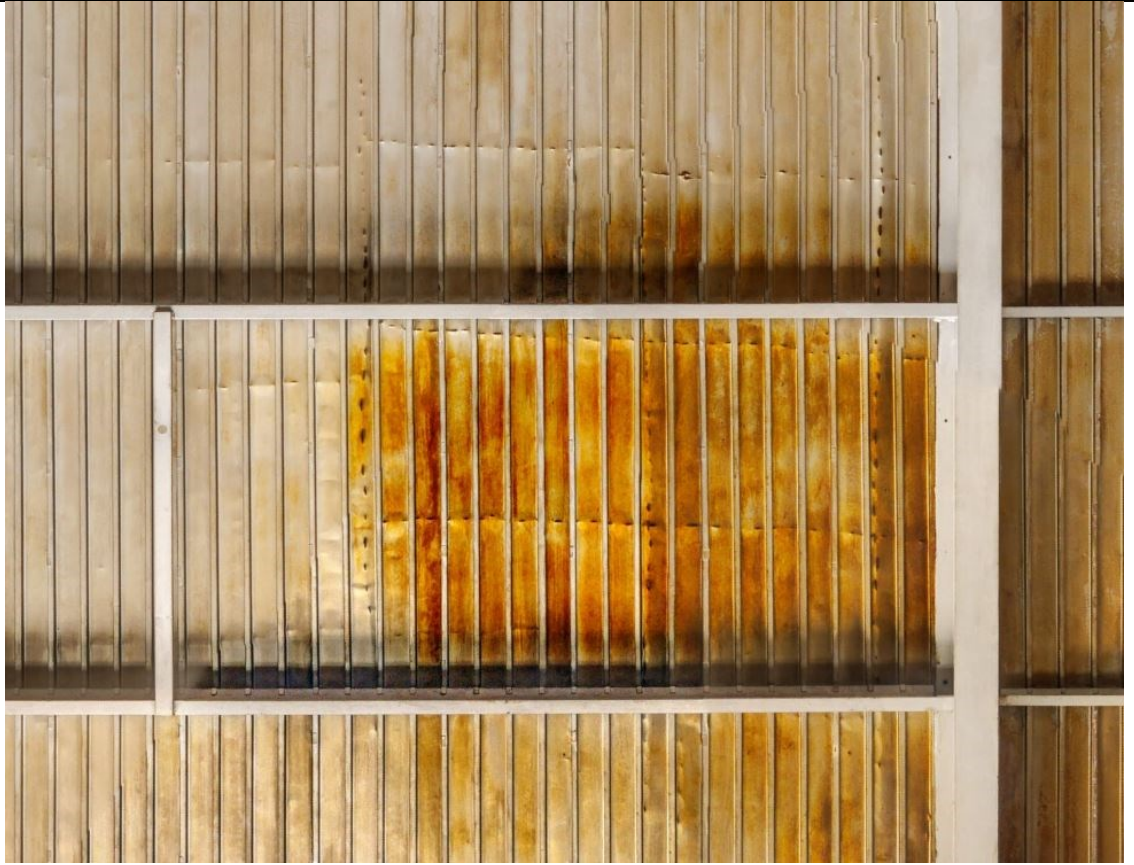
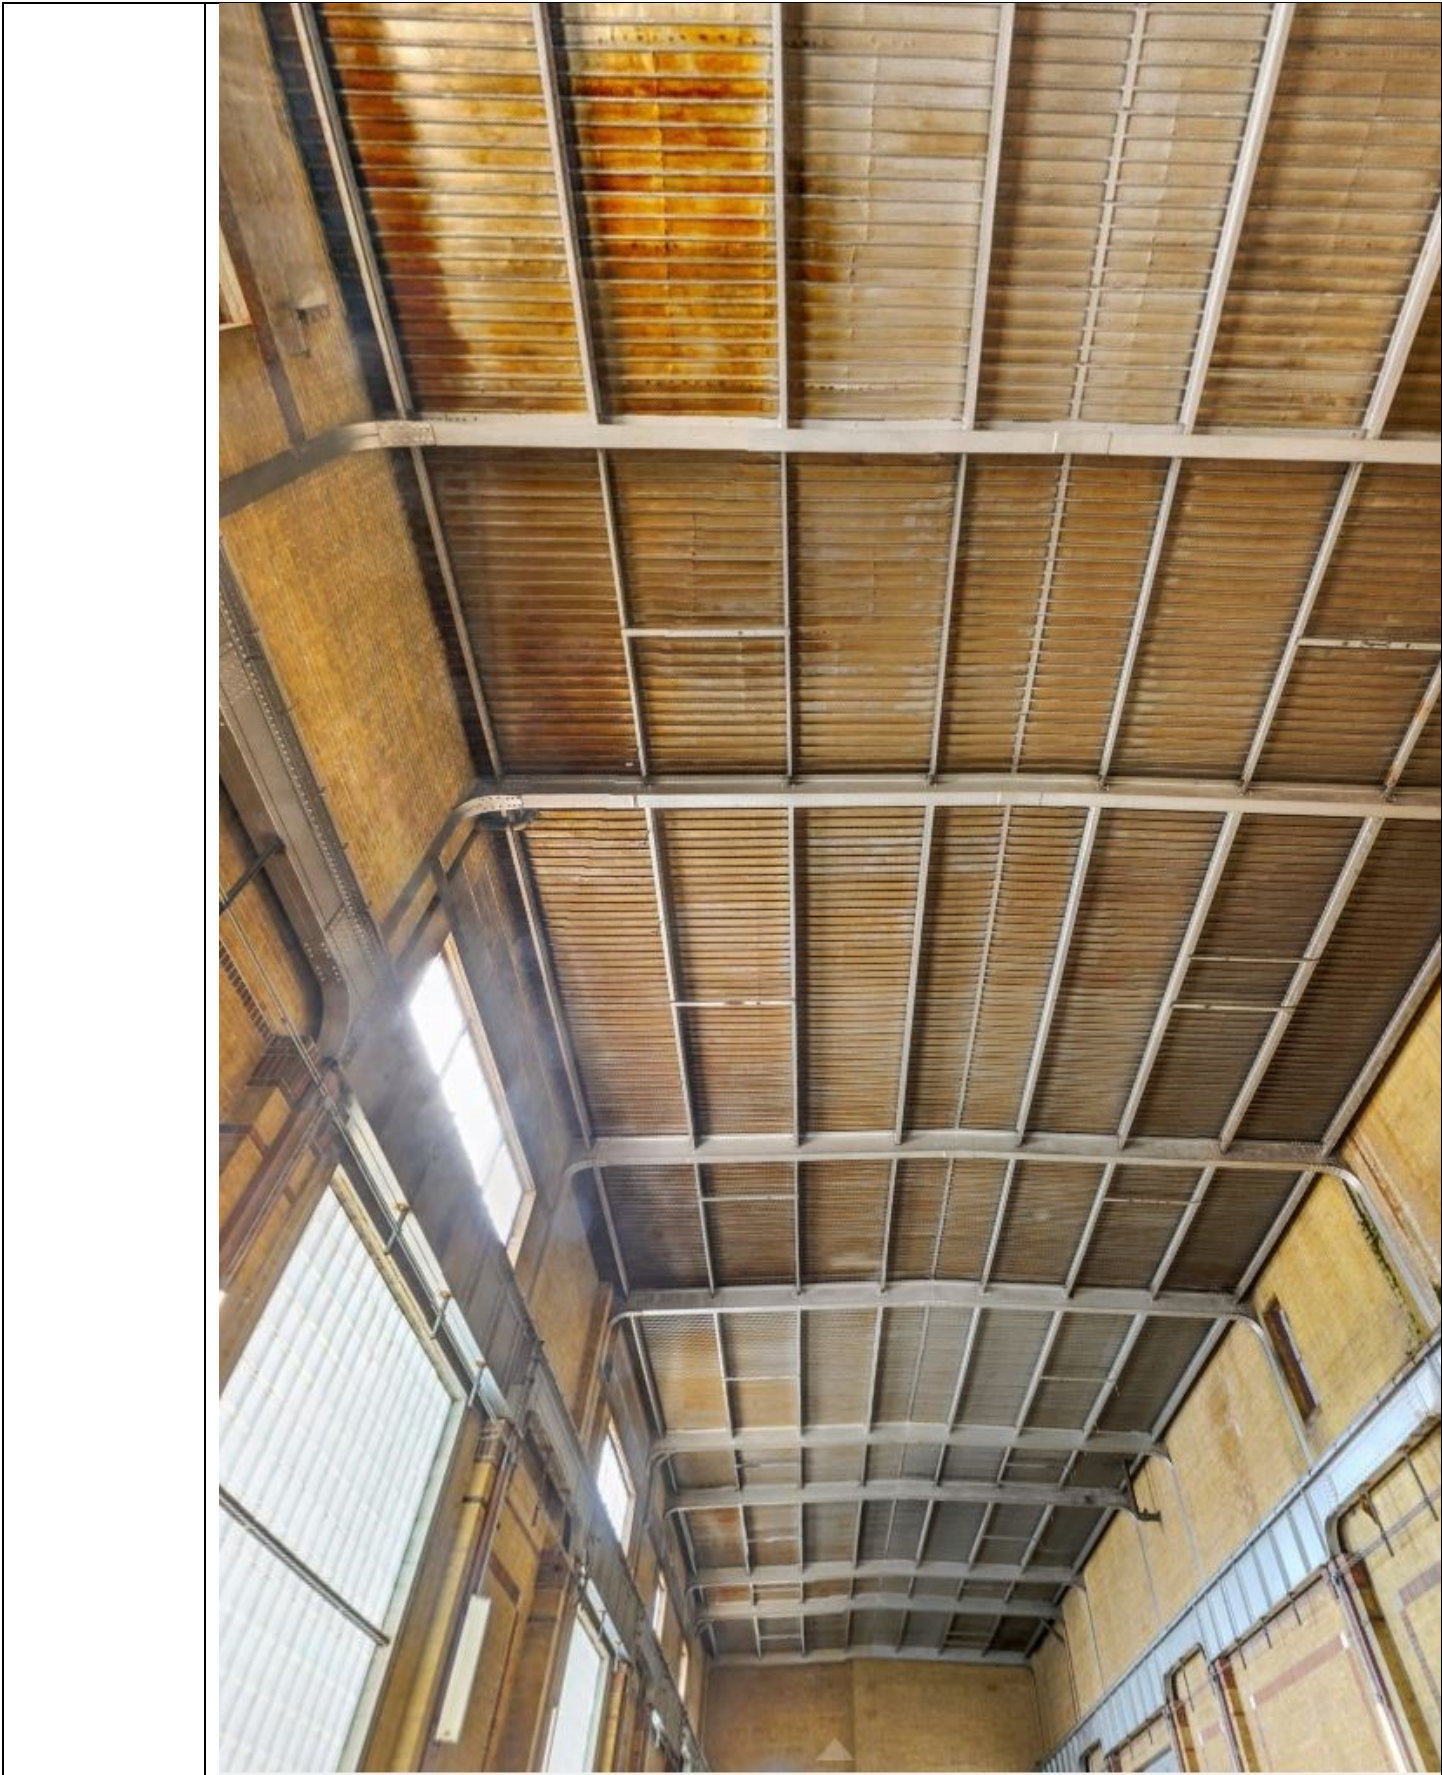
The Turbine Hall ceiling exhibits corrosion, generally of low concern, likely surficial corrosion associated with condensation.

The era of construction for locations of these areas of higher deterioration coincide with the earliest Turbine Hall construction period, dating from 1938. Bottom-most photograph compares the oldest section, foreground, with the newest, dating from 1955, in the background. Please note the relative difference in
