# Rossdale Power Plant Advanced Assessment and Priority Rehabilitation

## Turbine Hall Condition Assessment

Submitted to: City of Edmonton

Date Submitted: 2021-03-15

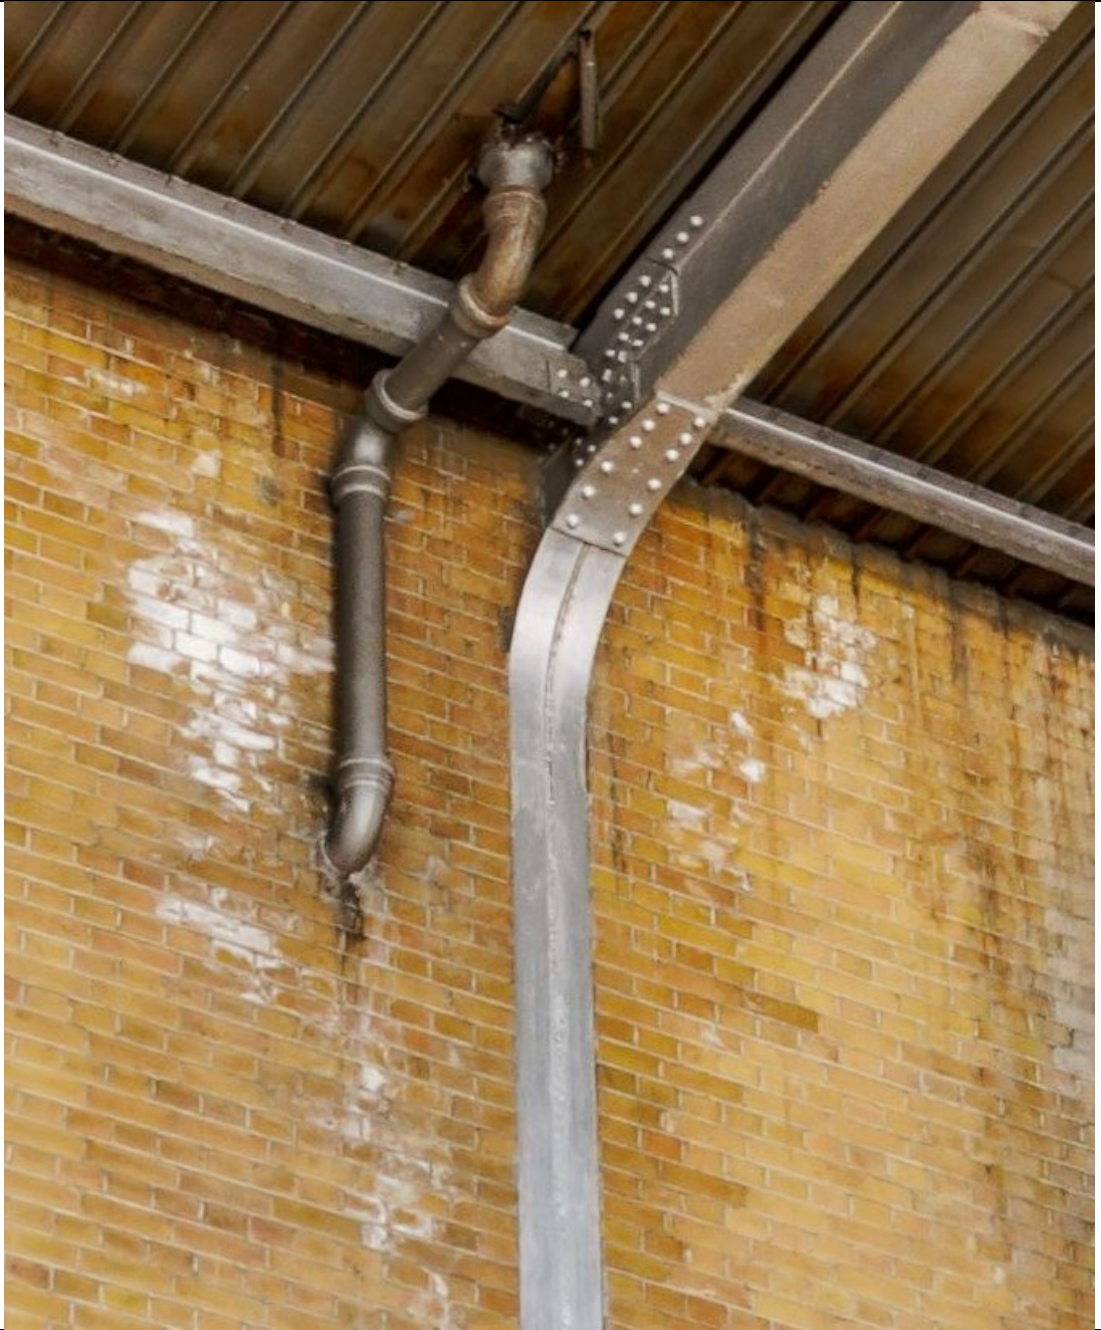
**Rain Leaders:**  
Some rain leaders exhibit evidence of past water ingress, such as efflorescence, water, rust, and bio-growth stains.

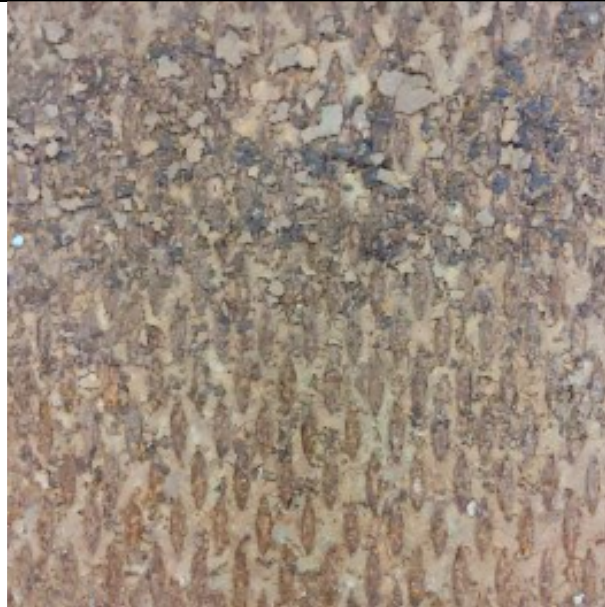
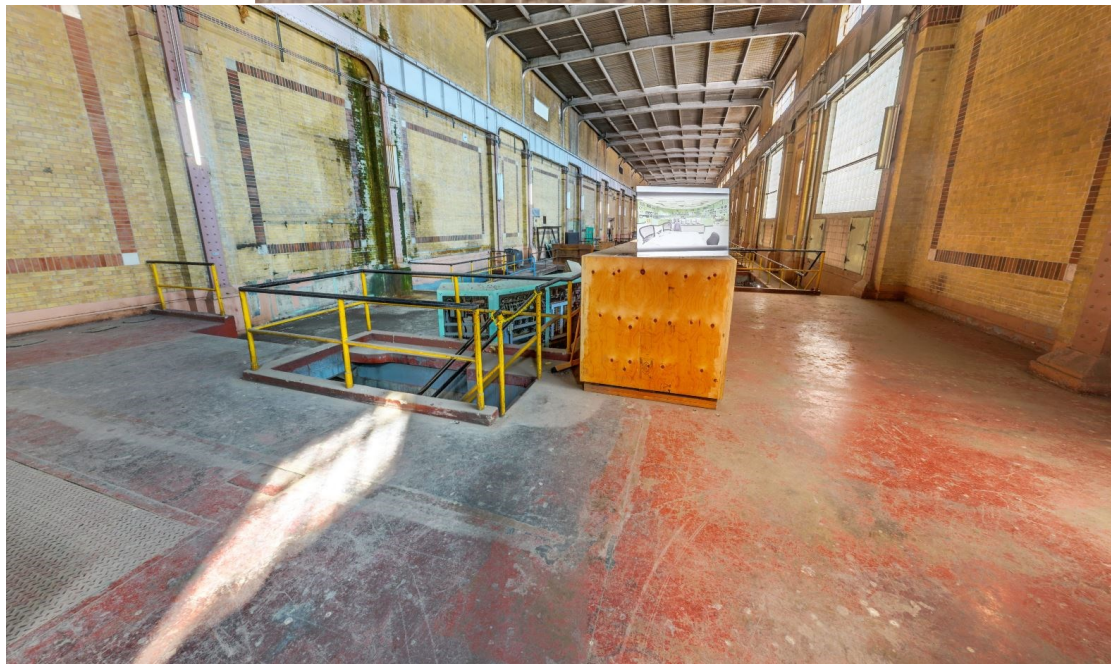
Paint failure on concrete floors due to human erosion along with various scrapes and spalls likely due to construction and industrial activities. Corrosion of metal grating is likely due to presence of moisture (atmospheric moisture or liquid phase).

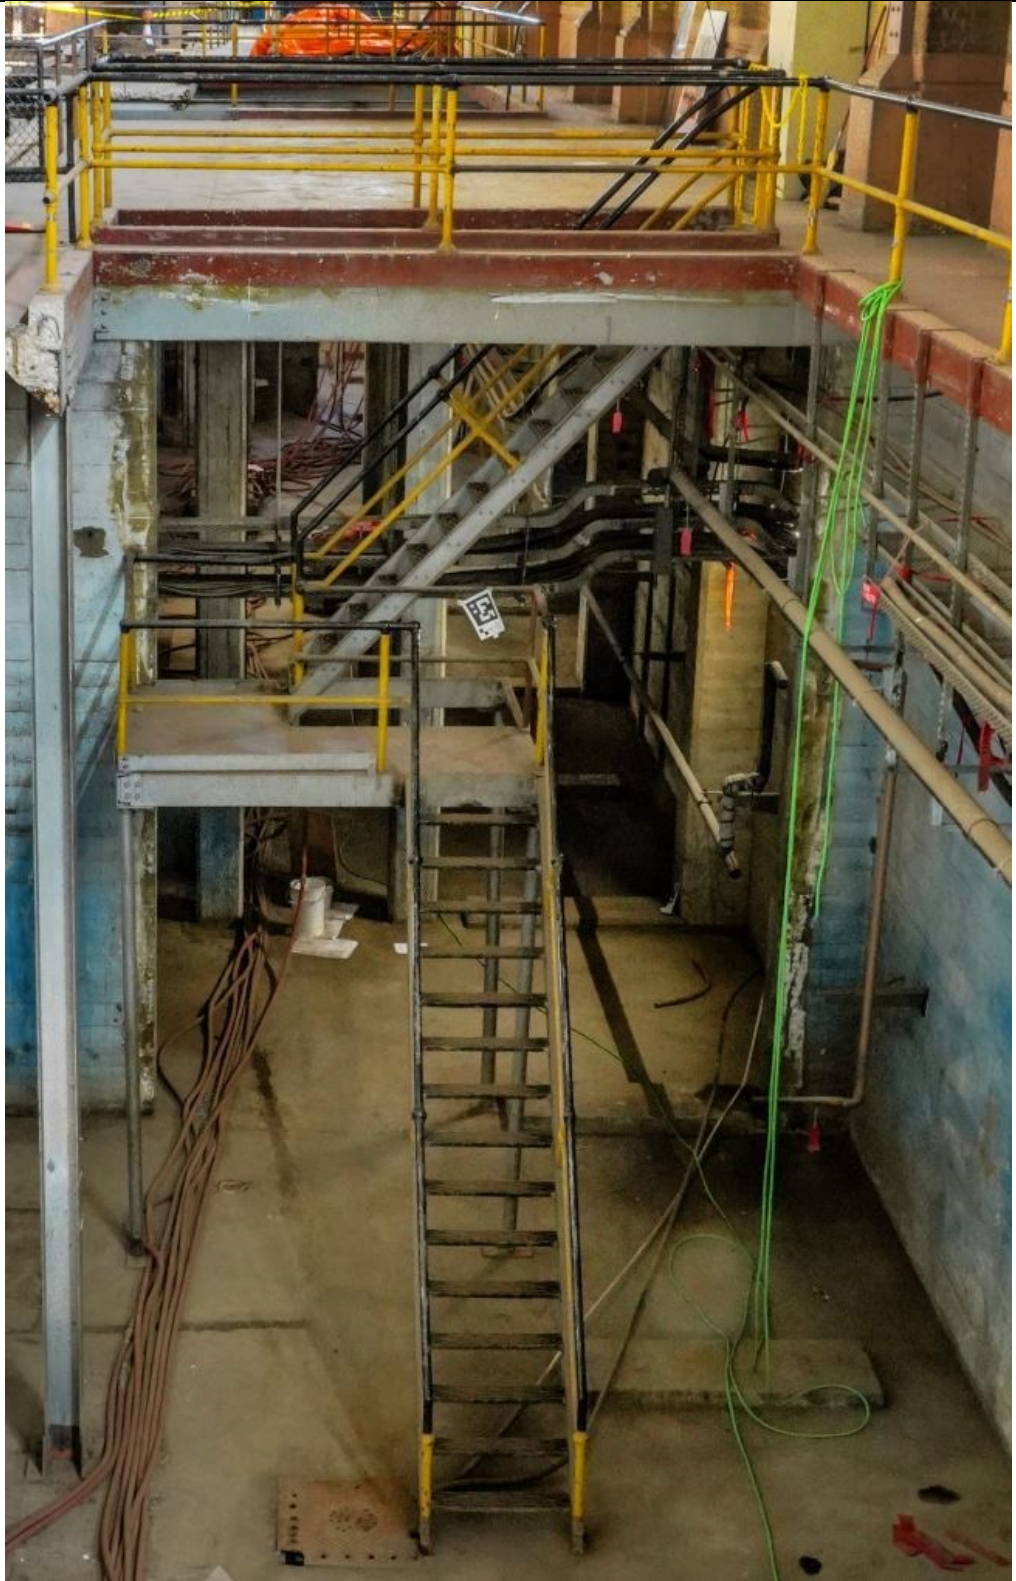
**Stairs:** Stair material is in generally good condition with expected minor paint failure and rare spots of passivated corrosion. However, rails are sometimes loose, kick plates are missing, tread depths are short, and geometry is very steep. This means that stairs are generally not conforming to contemporary building code.

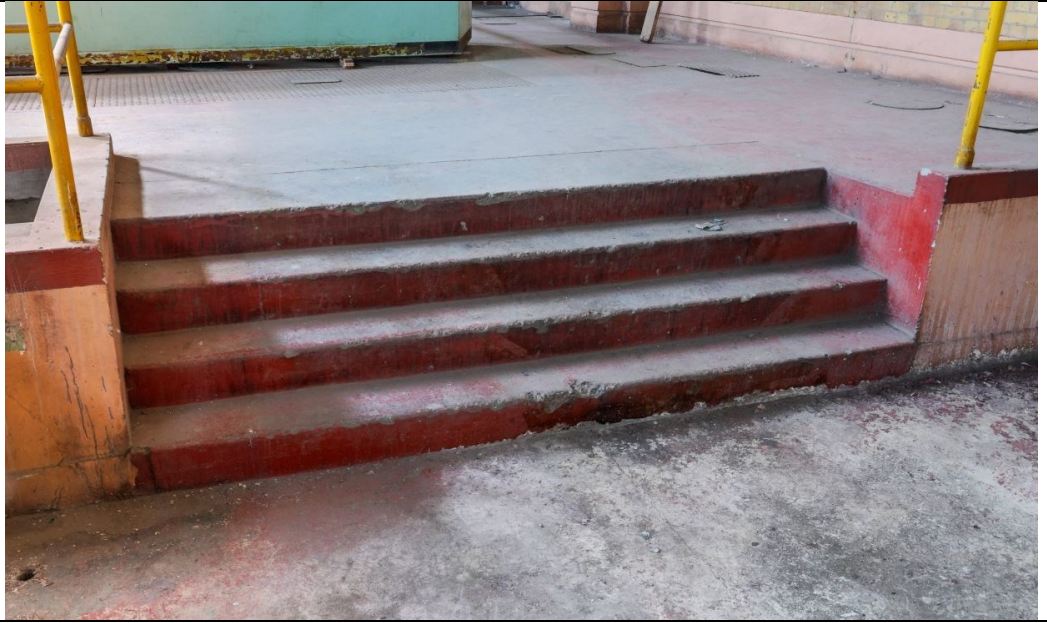
**Concrete Stairs:** Finish is in the same state as the floors generally, it is eroding from human traffic. Stair treads have chips and spalls, likely due to mechanical impact damage associated with industrial use and construction activities. Overall, they are in good working condition.

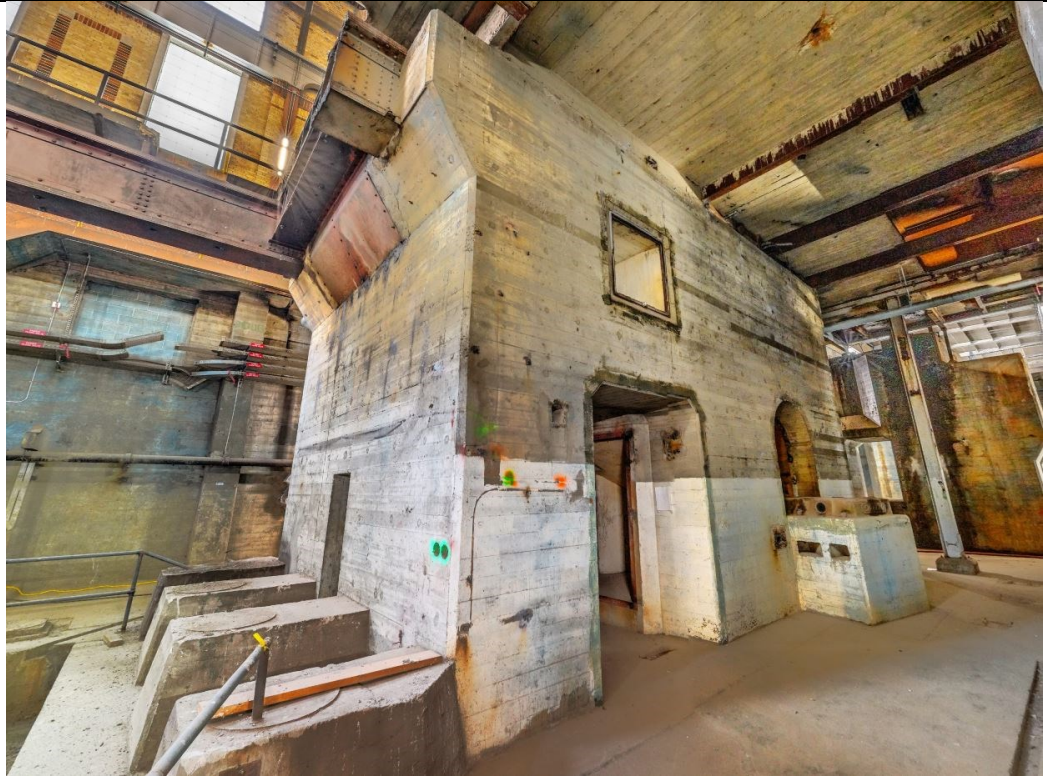
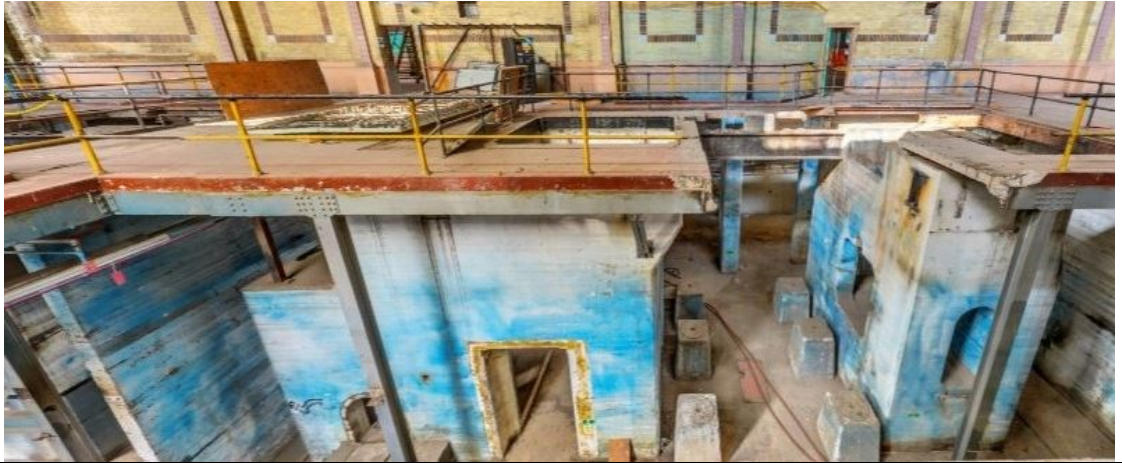
Variously covered in blue stain from abatement & demolition processes. Structural steel and slabs surrounding turbines was variously cut to allow machinery removal including condensers. Minor cracks, spalls, corrosion stains, and chips exist on each pedestal.

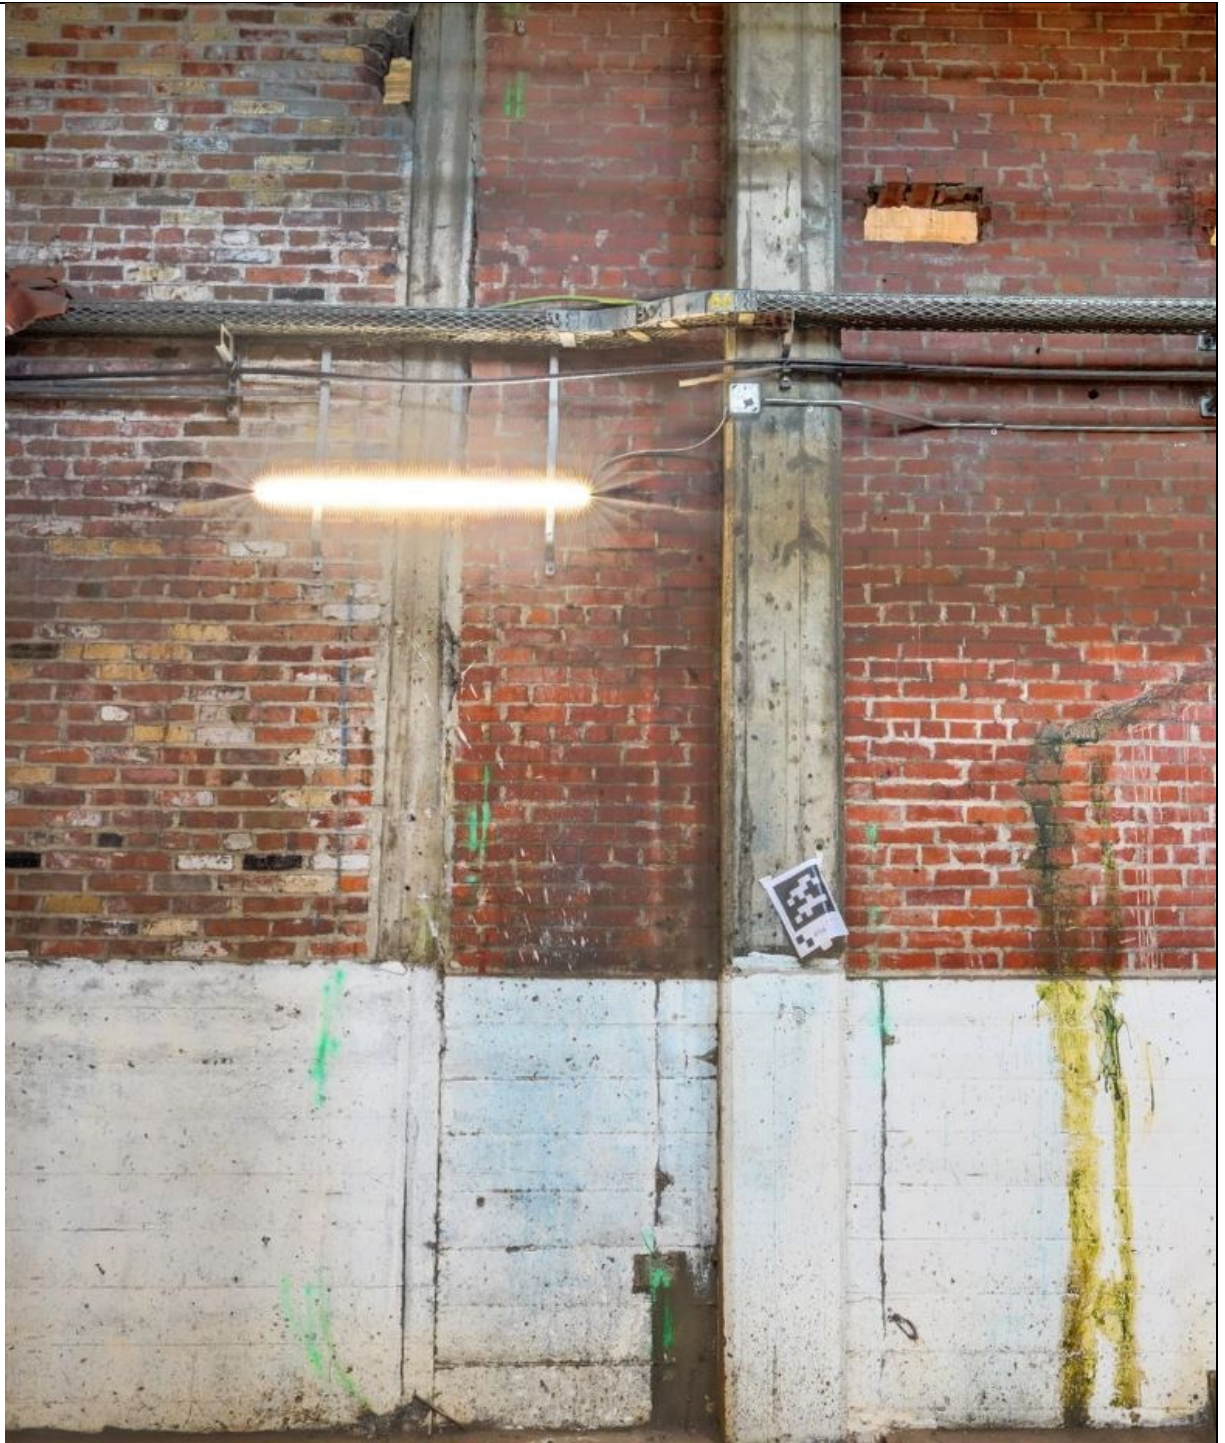
Partition brick walls between Turbine Hall and Boiler Hall basements are variably composed of newer red brick at their southern and northern most extents of the later additions of the 50s, seen at topmost photo right). The sections from the 30s and 40s reused brick from earlier power plants, as seen at photo left.

All walls have various degrees of soiling, overpaint, stains, and missing section due to holes being punched through walls for electrical or mechanical servicing over time. All are in generally good serviceable condition, except for some areas of missing sections that should see repair.

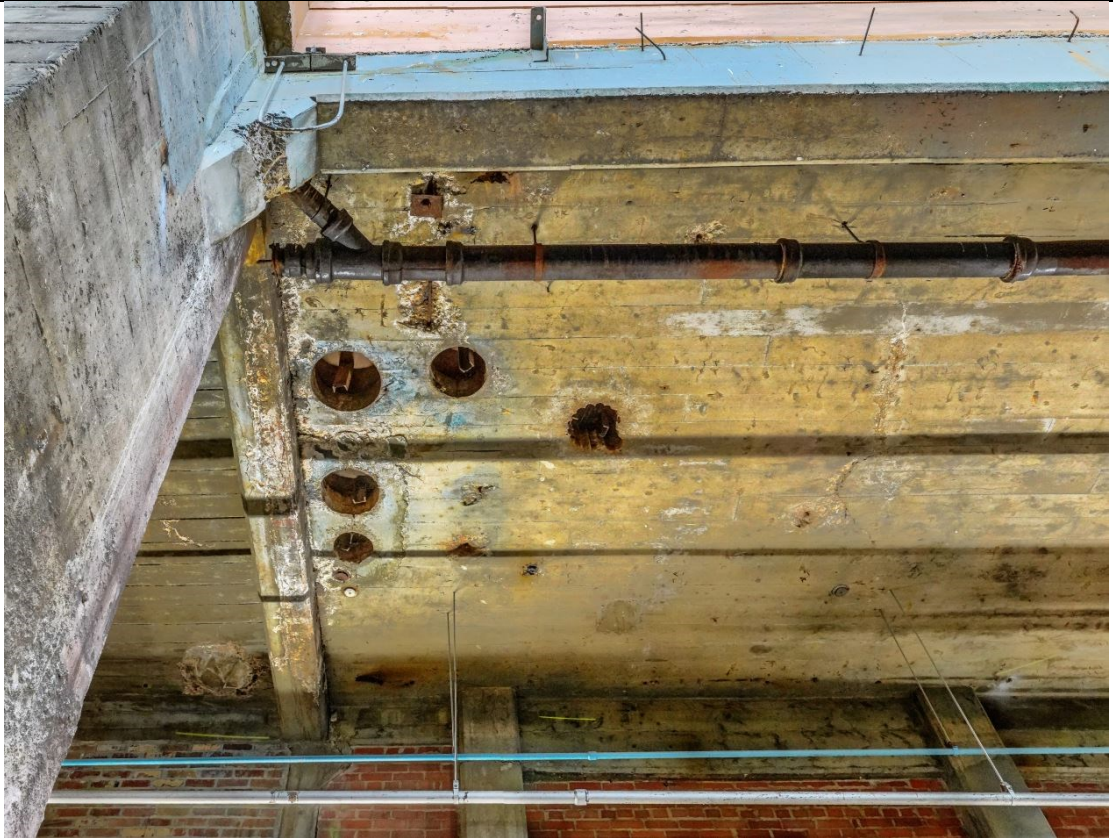
**Concrete Ceiling:** Various levels of soiling, scratches, chips, stains, patches, mechanical interventions (core holes), and spalls due to various construction activities and industrial usage.

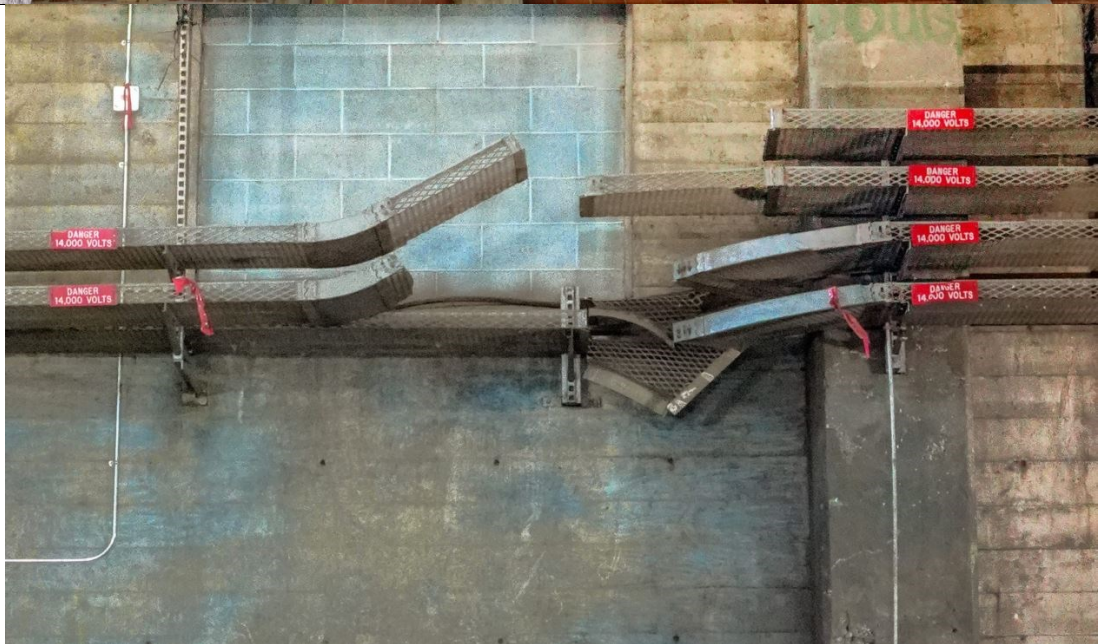
**Cable Trays:** Some cable trays are missing sections or have failed.

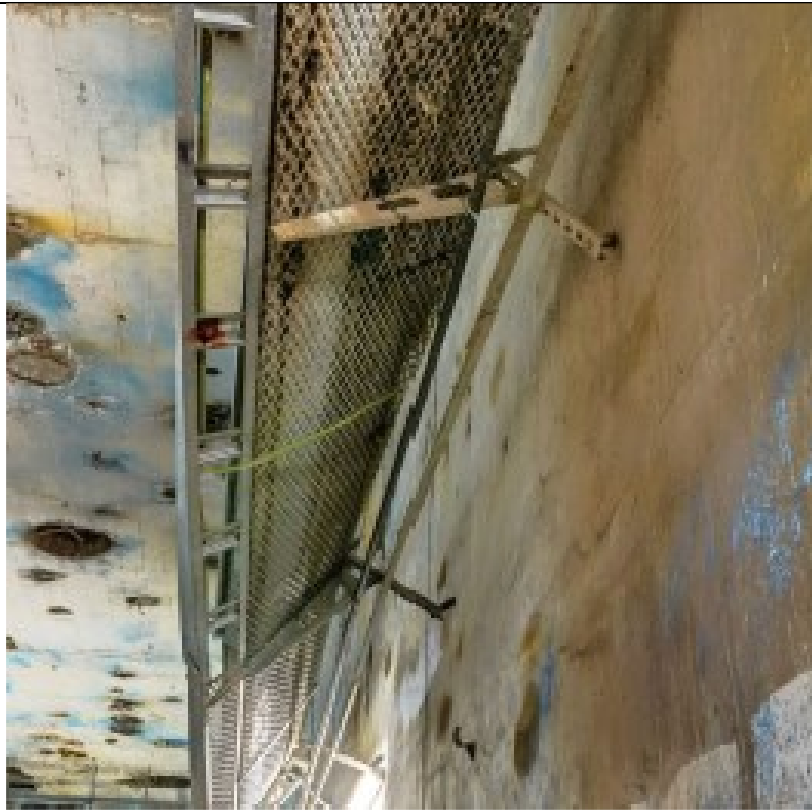
Mechanical fixture for an object has failed, could include plastic deformation, fracturing, or failed anchors. This poses a hazard to human health and safety.

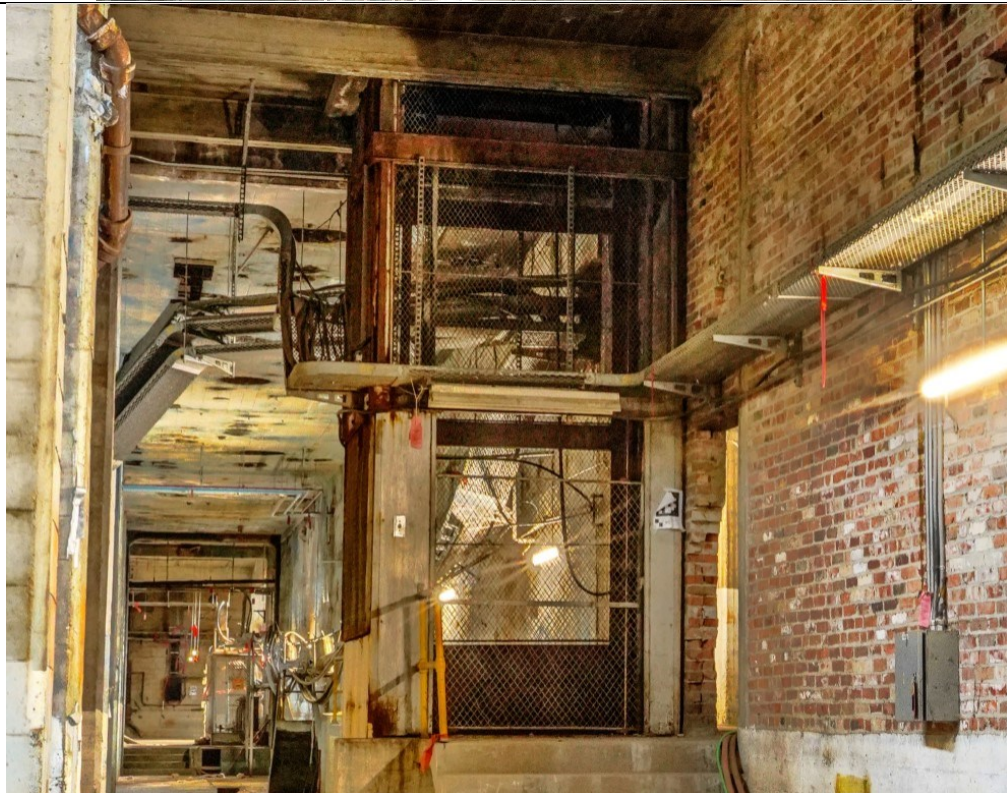
Still operable. Surficial metal corrosion is evident. Requires more detailed assessment for human health and safety.

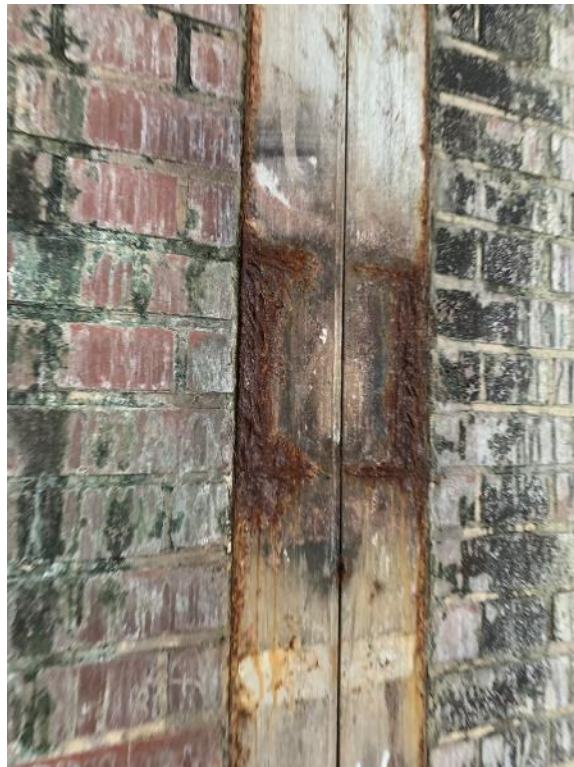
Above: Boiler/Turbine Hall – Column Rust on shared Wall

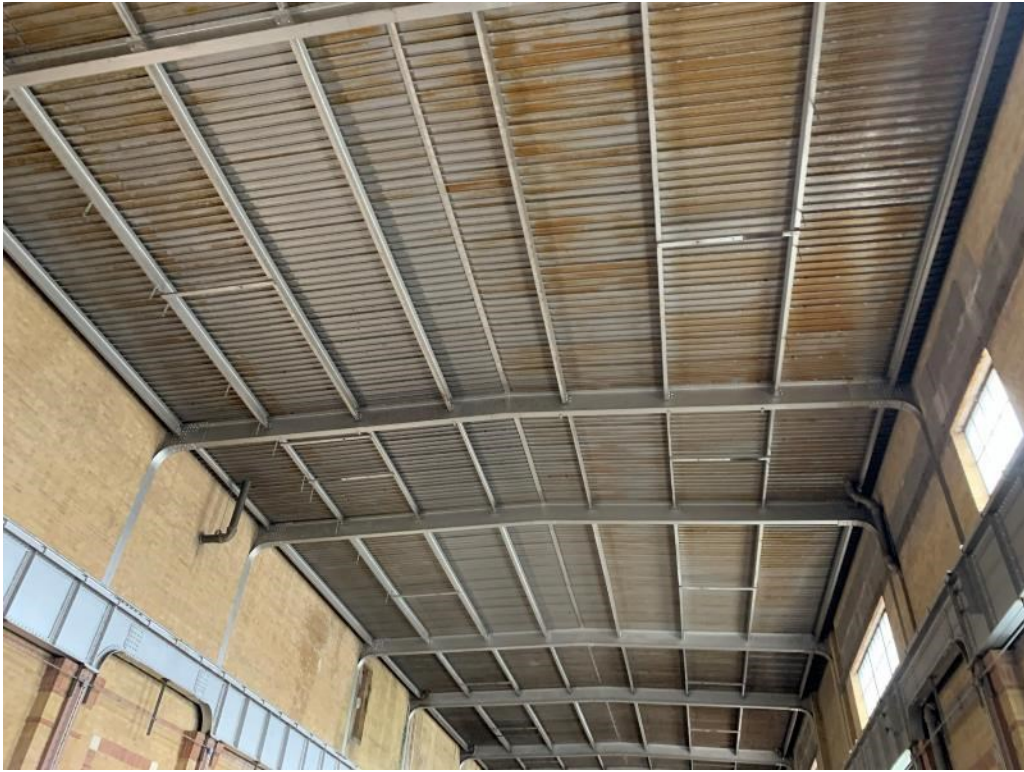
Photo 1: Turbine – Roof Structure – Rusting of Deck

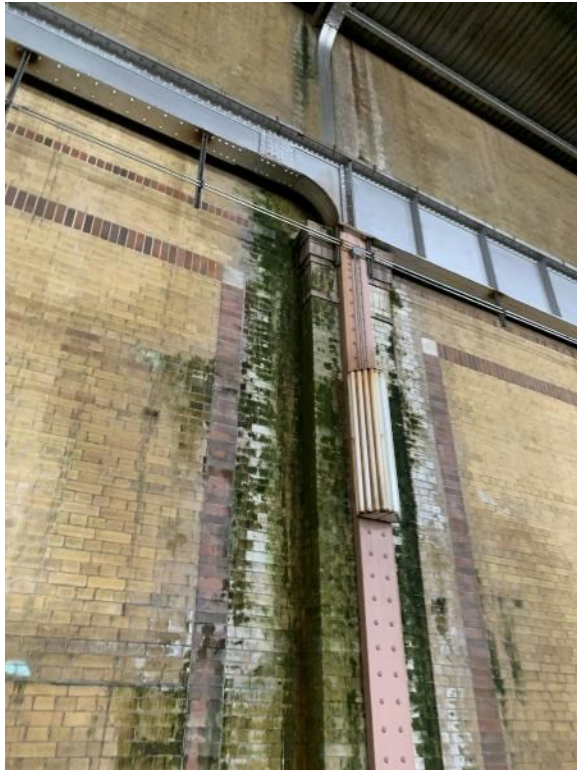
Above: Turbine –Column with Organic Growth
