# Rosdale Power Plant Advanced Assessment and Priority Rehabilitation

## ATCO Gas Building Condition Assessment

**Submitted to: City of Edmonton**

**Date Submitted: 2021-03-15**

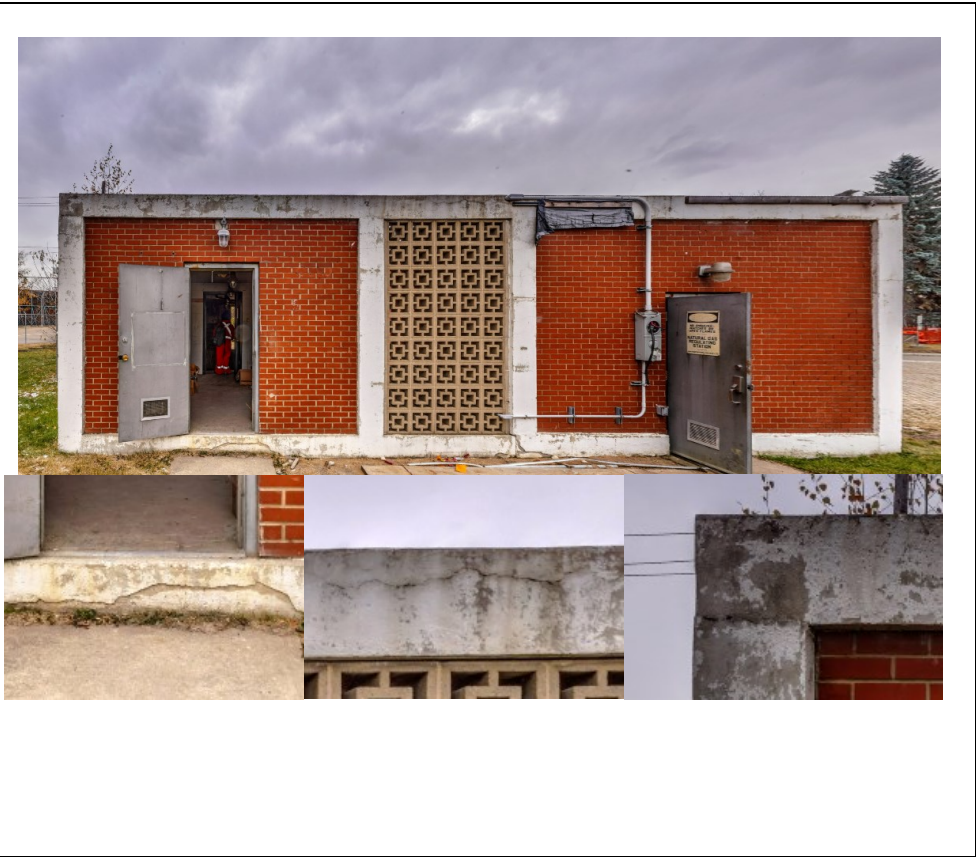
2.2.1 Concrete Framing

**Concrete Framing and Finish:**  
Weathering has led to the deterioration of the ring-beam coping, pilaster and base boarder elements on all exterior walls of the ATCO building. In some areas, spalling (left) and cracking (middle) are evidenced in the concrete structure. Delamination is evident in the plaster finish as depicted in areas where the concrete is exposed (right - grey markings).

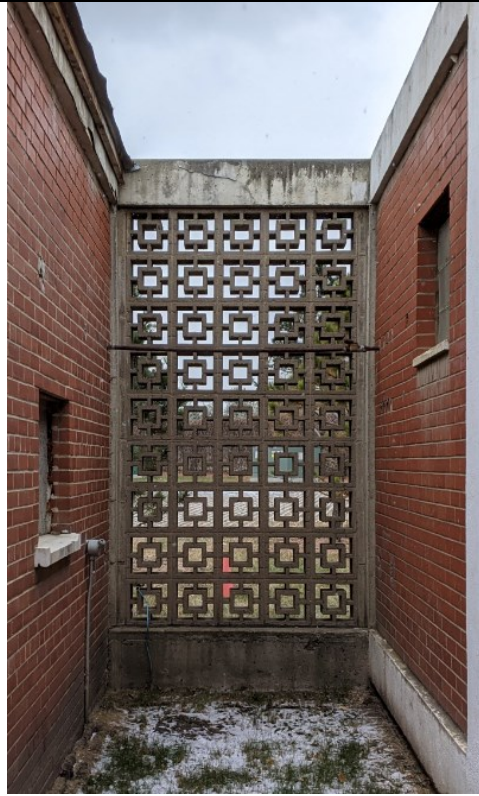
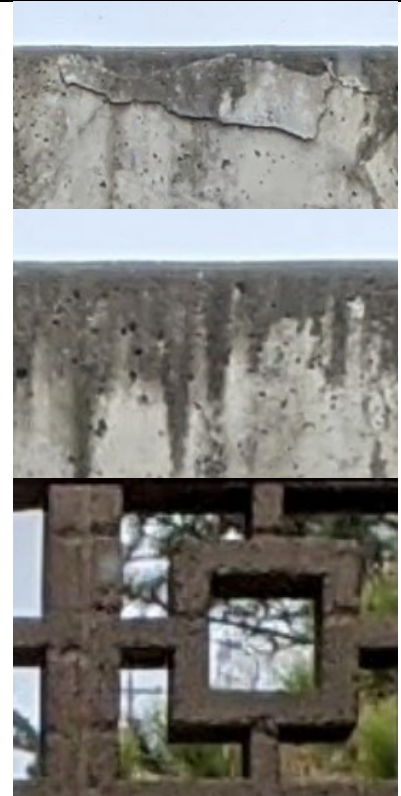
### 2.2.2 Ornamental Wall

Spalling of the concrete ring-beam coping (top), delamination of the plaster finish (middle) of the coping and base boarder and cracking of the decorative feature (bottom) are evidenced on the west elevation of the ornamental wall.

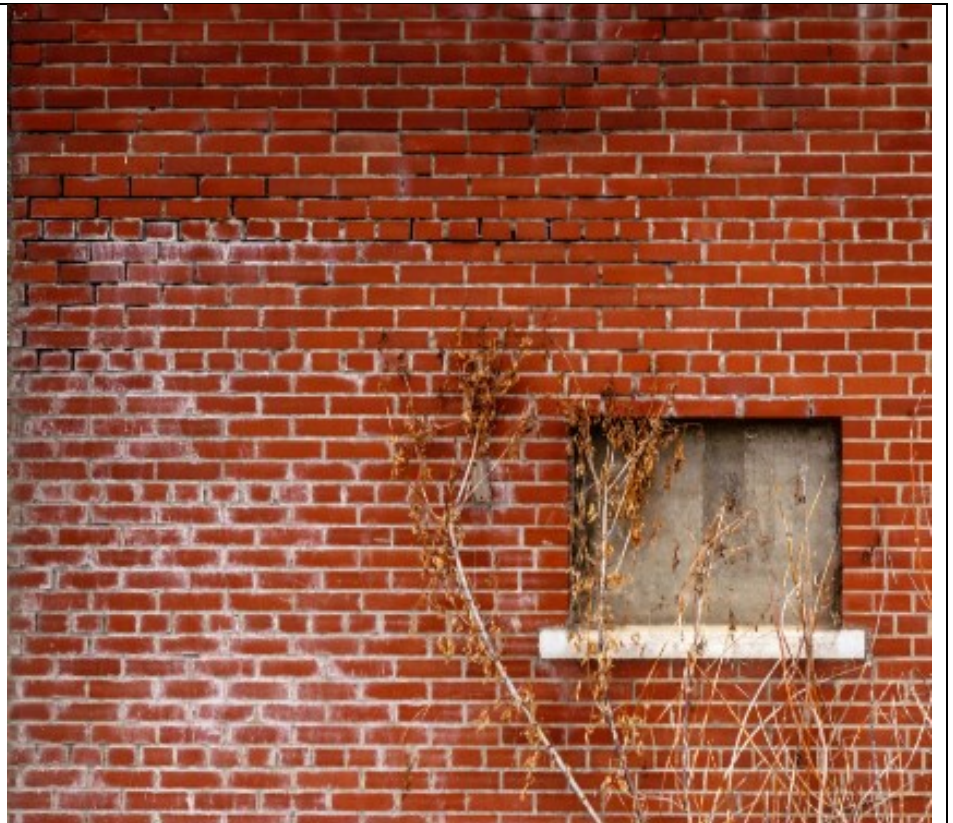
### 2.2.3 Exterior Masonry – Brick Walls

**Masonry - Brick:** Lime blooming (white residue in photo) is evident on each exterior wall excluding the west and north elevations, possibly due to precipitation and sun path patterns. Failing joint mortar is visible in areas dappled with black spacing between bricks, alluding to areas of missing mortar throughout the exterior. Various missing sections of masonry and loose bricks are evidenced and, in some cases, caulking or foam patch repairs were done to temporarily fix these issues.

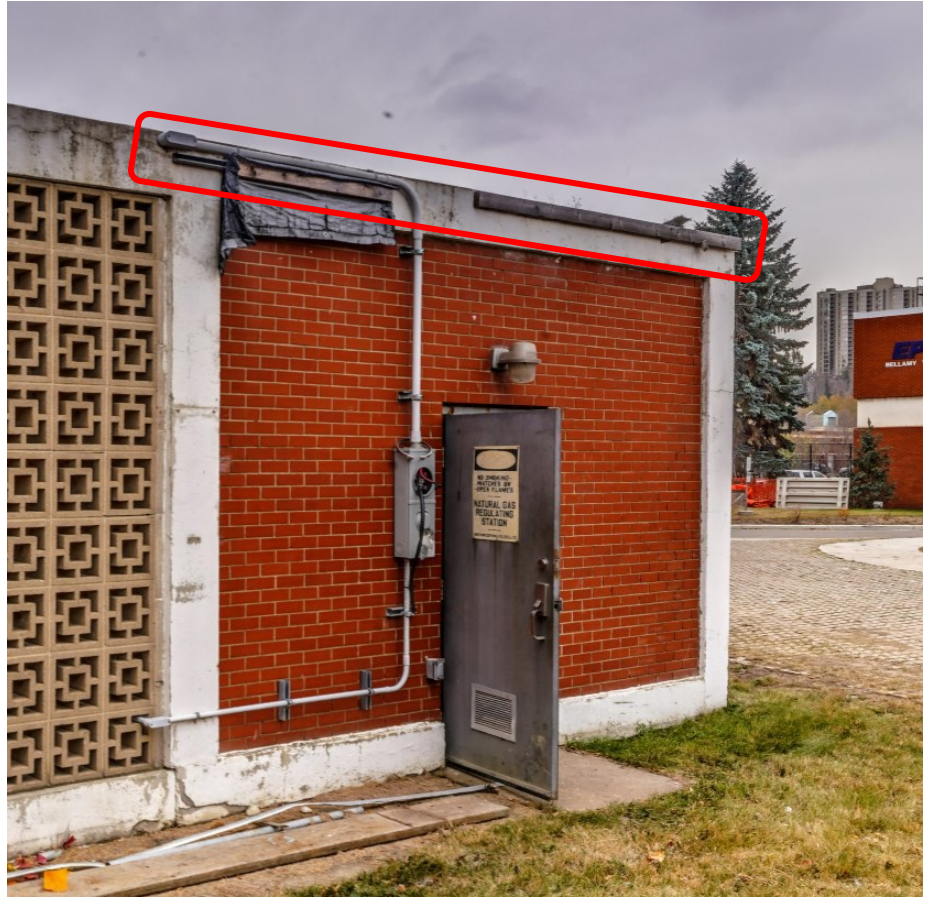
**Wooden Elements:** Wood members have been added to the building exterior for unknown reasons, possibly as ad-hoc supports for exterior elements.

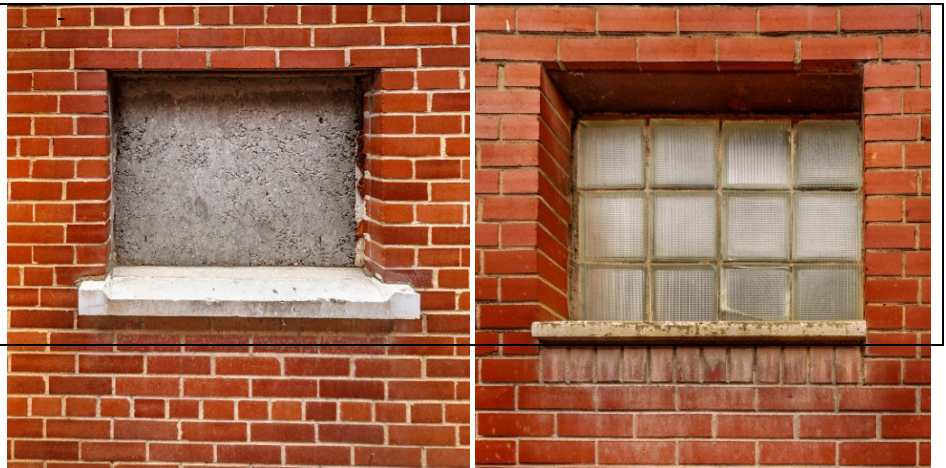
## 2.2.4 Windows

**In-filled Windows:** All windows associated with the ATCO building have been variously in-filled with concrete and plywood for weather proofing and insulation purposes. Possible replacement of the windows and or of the in-filled elements are necessary in some cases for security and to avoid further deterioration due to weathering.

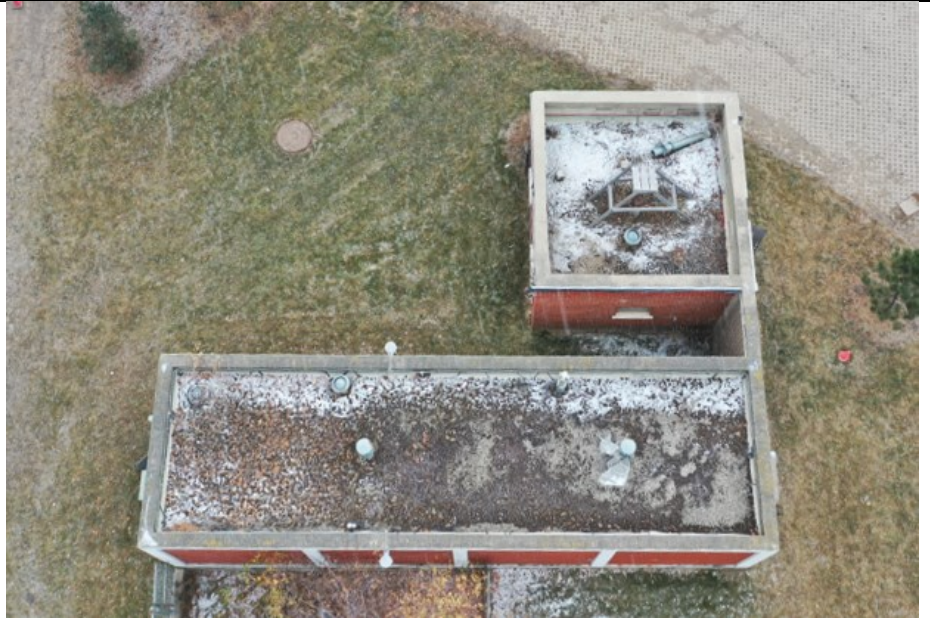
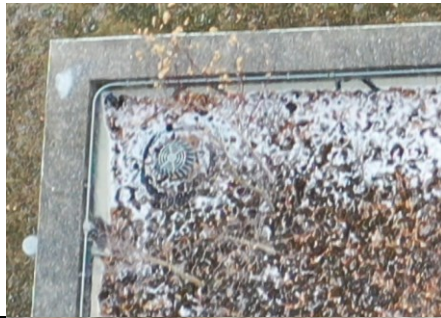
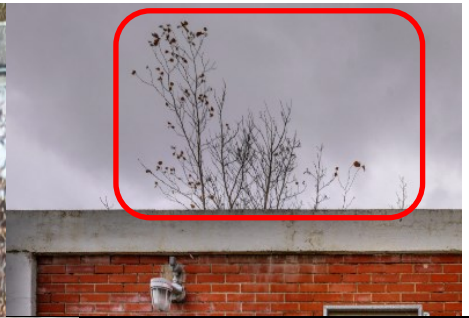
### 2.2.5 ATCO Roof

**Roof:** Routine general maintenance is required to prevent the acclimation of biological growth and safety issues related to detached mechanical piping (circled on Gas Metering House Roof). The presence of detritus and probable woody perennials are of concern. The corrosion of the rain leader in the Relaying Station due to moisture travelling between ceiling membranes may be caused by perennial presence.

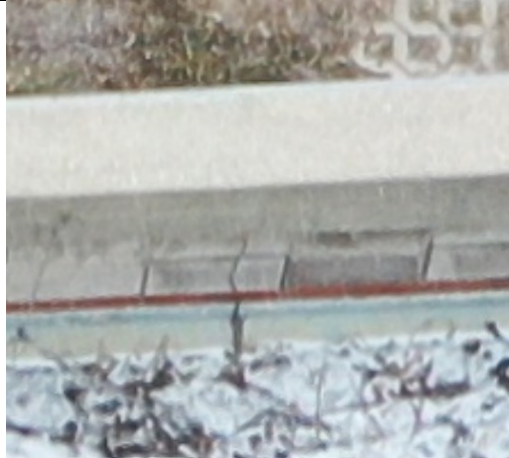
**Parapet Walls:** Roof flashing is very low and overwhelmed by winter snow emulation. Thus, the parapet wall with exposed bricks, CMU (concrete masonry unit), and mortar joints likely provide an avenue for free moisture ingress (particularly during spring thaw events).

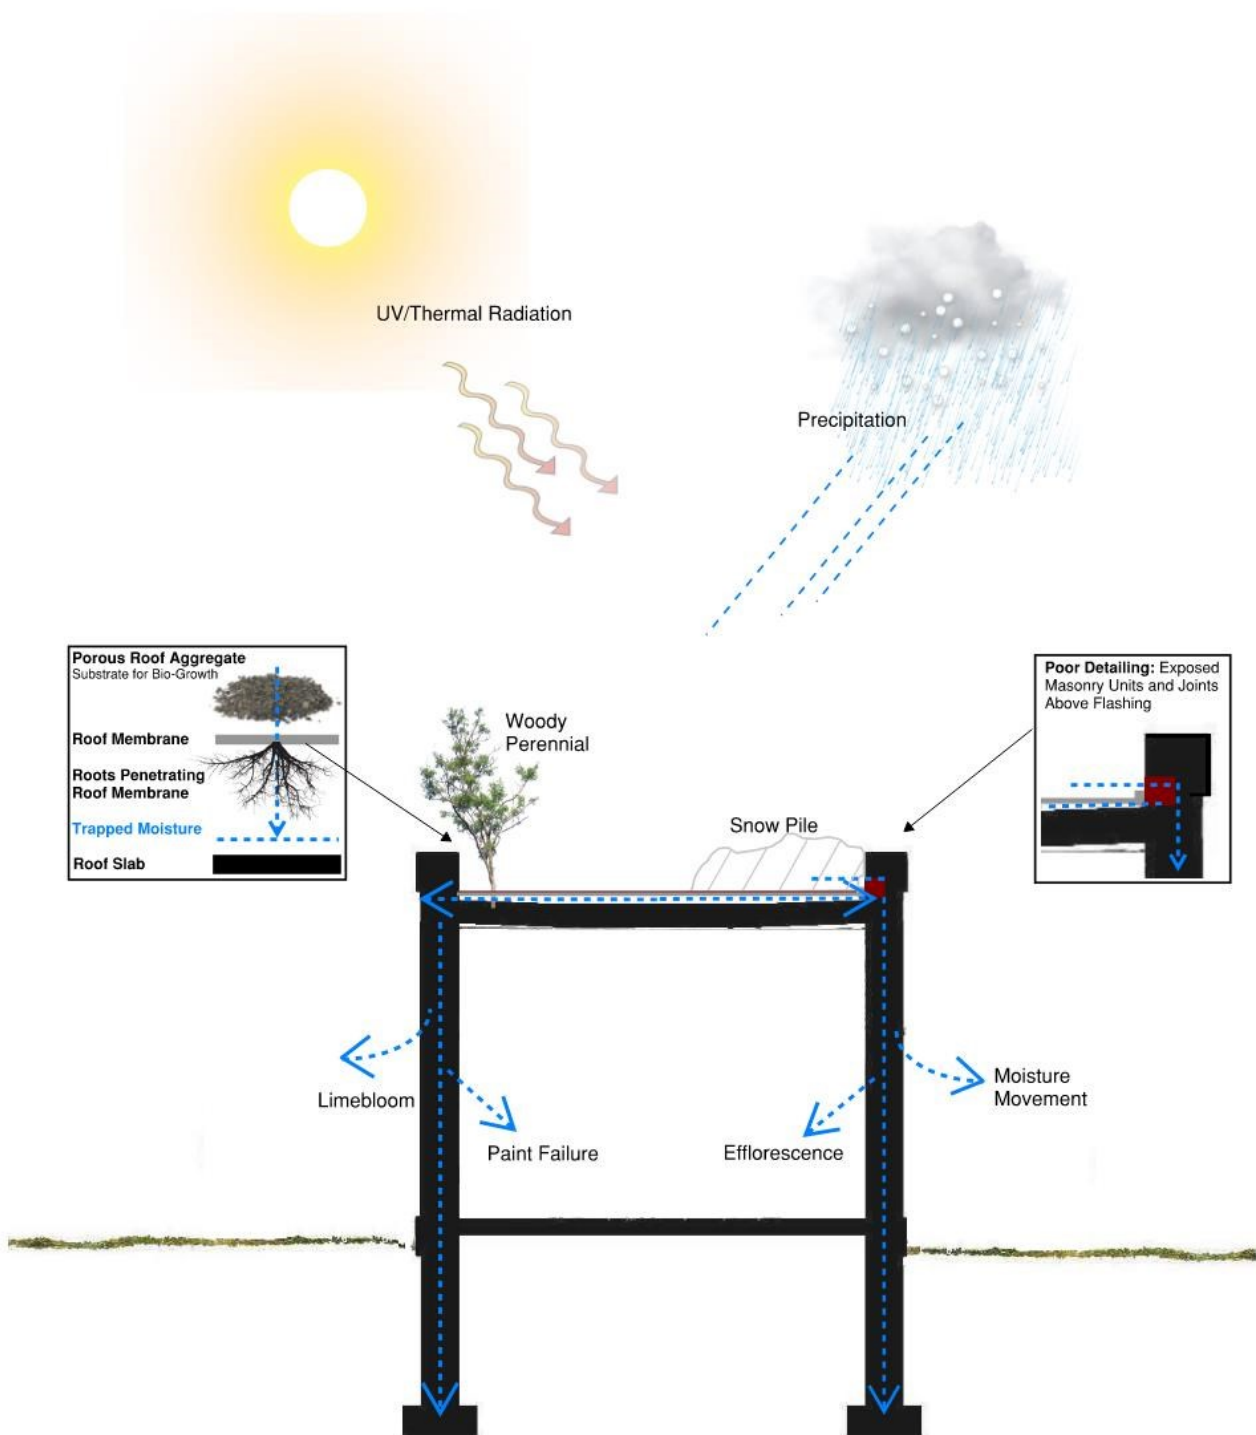
# ATCO Gas Building Principal Deterioration Schematic

Weathering and poor detailing exposing masonry units and joint above flashing has led to water ingress from the roof. An excess of detritus and the presence of woody perennials suggests routine general maintenance is required to reduce biogrowth.

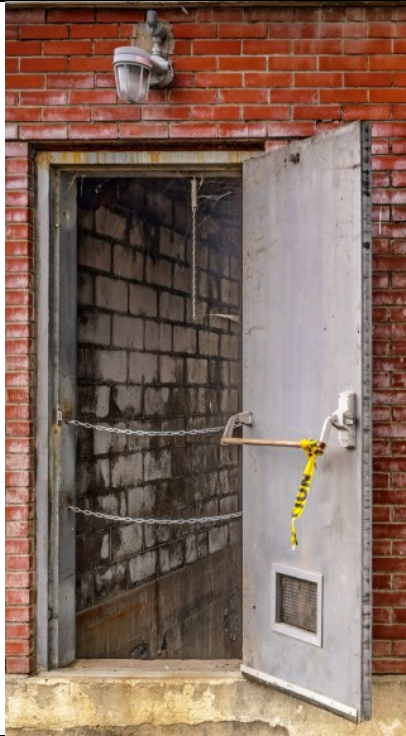
The overall state of the exterior doors is fair; however, there is slight metal corrosion (as depicted in the picture at the door's lintel of the west wall). The exterior lights of the ATCO building appear to be in good condition with evidence of soiling on the light shade. In addition, an inspection of the lights by a Hazardous Material Specialist may be necessary to identify any materials such as asbestos, lead, etc. that were sometimes used in construction at the time.

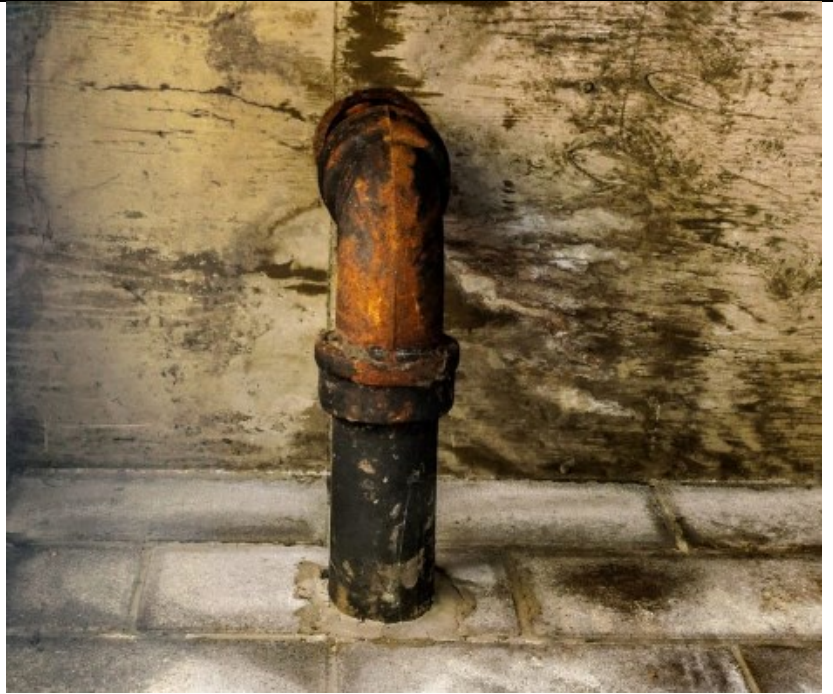
The pipes regarding roof draining in the Relaying station and the Gas Metering House evidence metal corrosion.

Refer to **Roof** for the possible connection between the corrosion of the rain leader in the Relaying station (pictured) and perennial presence.

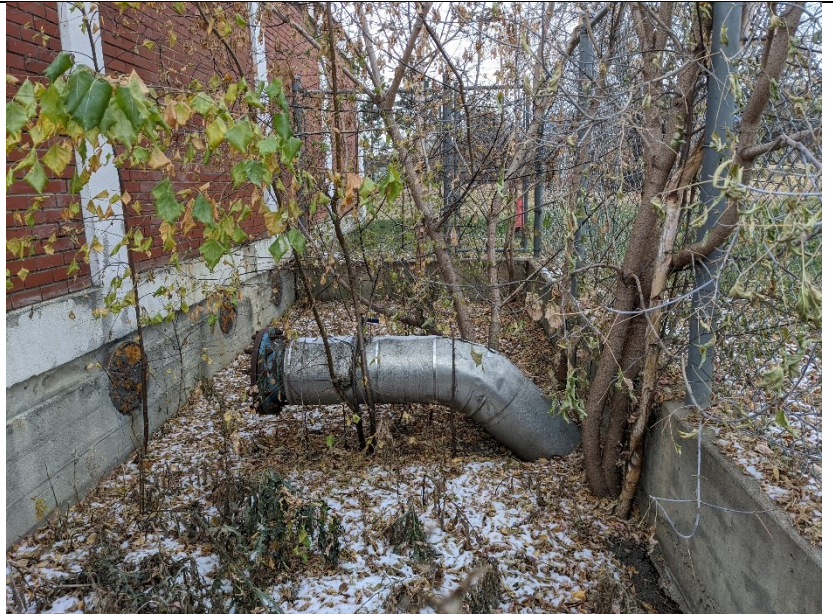
**Obsolete Gas Pipe:** An original pipe that brought gas to the ATCO building is evident. In the photograph, the pipe shown has been capped and separated from the building. The pipe has minimal deterioration. However, the dry well/pipe enclosure requires maintenance to remove trees, bio growth and leaf litter.

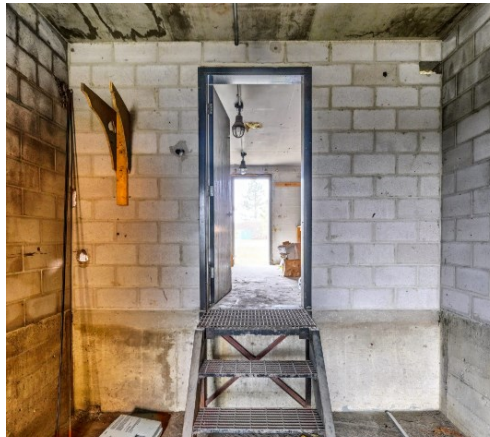
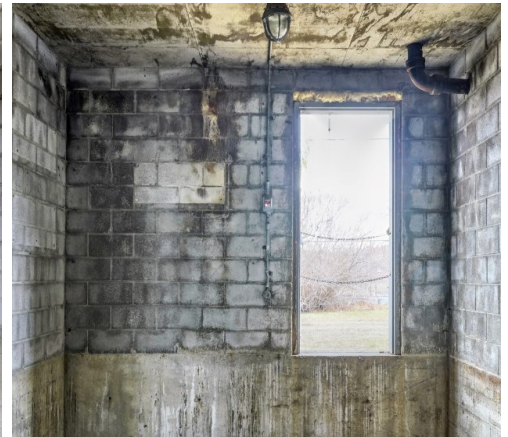
**Staircases:** The MN-102 staircase is in good condition but there is the absence of a railing and the tread, riser and width are not to code.

With regards to the MN-103 exit, the lack of stairs poses danger to those entering and exiting the building from the East.

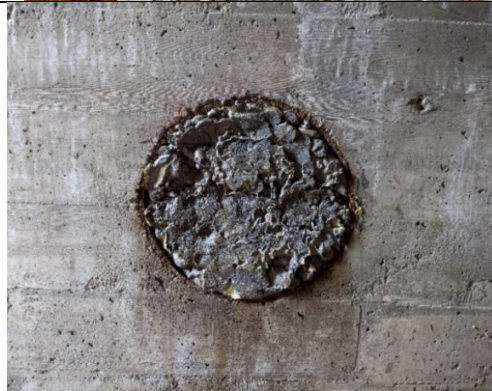
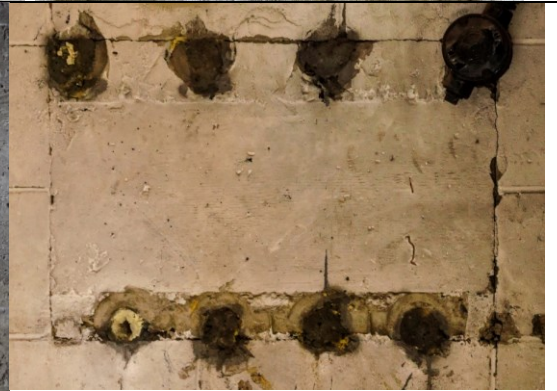
**Relict Mechanical/ Electrical Systems:** Relict systems have been variously filled with foam or exposed. Some of these holes go through the building to the exterior and some do not. Any pipe end or mechanical system that perforates the wall assembly to the exterior is sealed.

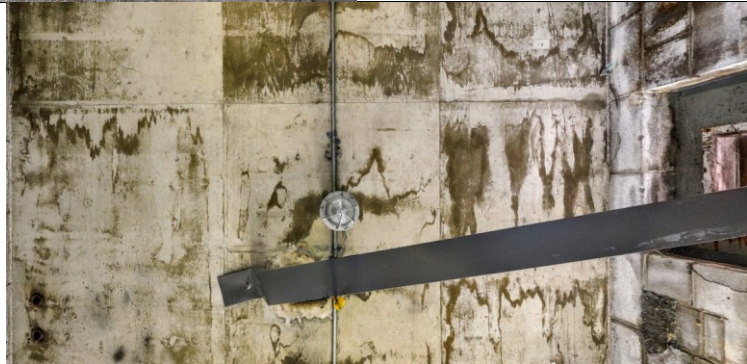
**Ad Hoc Water Collection Funnel:** There are tide lines that suggests roof leakage, and that the sheet aluminum water collection chute might be used to funnel water drips out of the building.

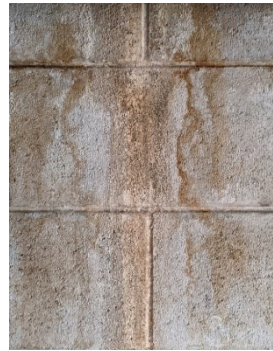
**Walls and Ceiling:** The walls of the Relaying Station evidence mild ferrous staining (especially on the south wall — as shown in the left photo) and efflorescence (east elevation).

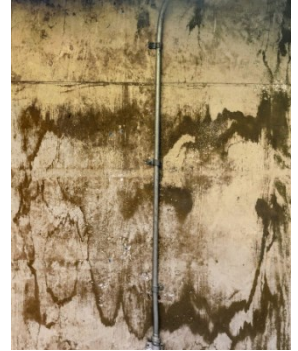
The ceiling shows evidence of the plywood forms that were used. Over time, discoloration and soiling has resulted due to migration of water, likely from roofing failure (as depicted in the photo to the right).

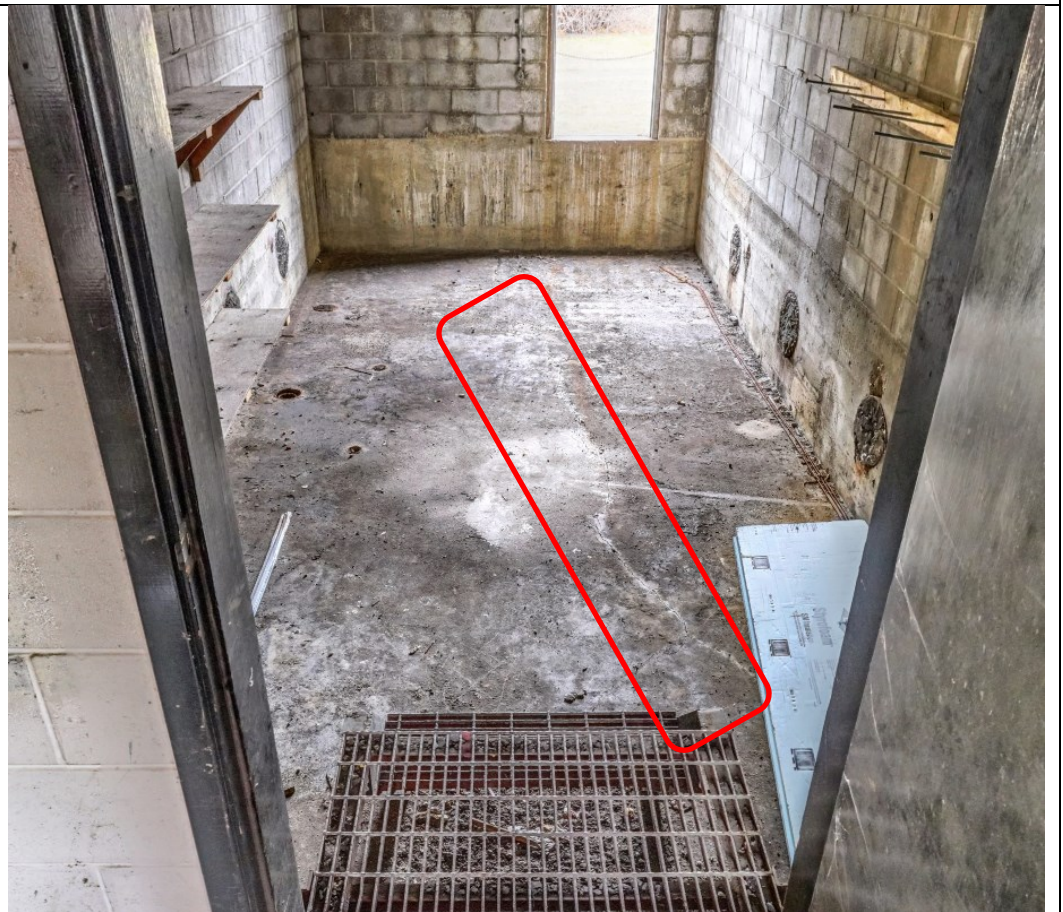
**Concrete Floor:** As depicted in the photo of the floor of MN-103, there is a crack along the center, it is not of great concern. There are a few instances of relict mechanical/electrical systems that line up with the travel path of the gas lines (possible valve meter supports).

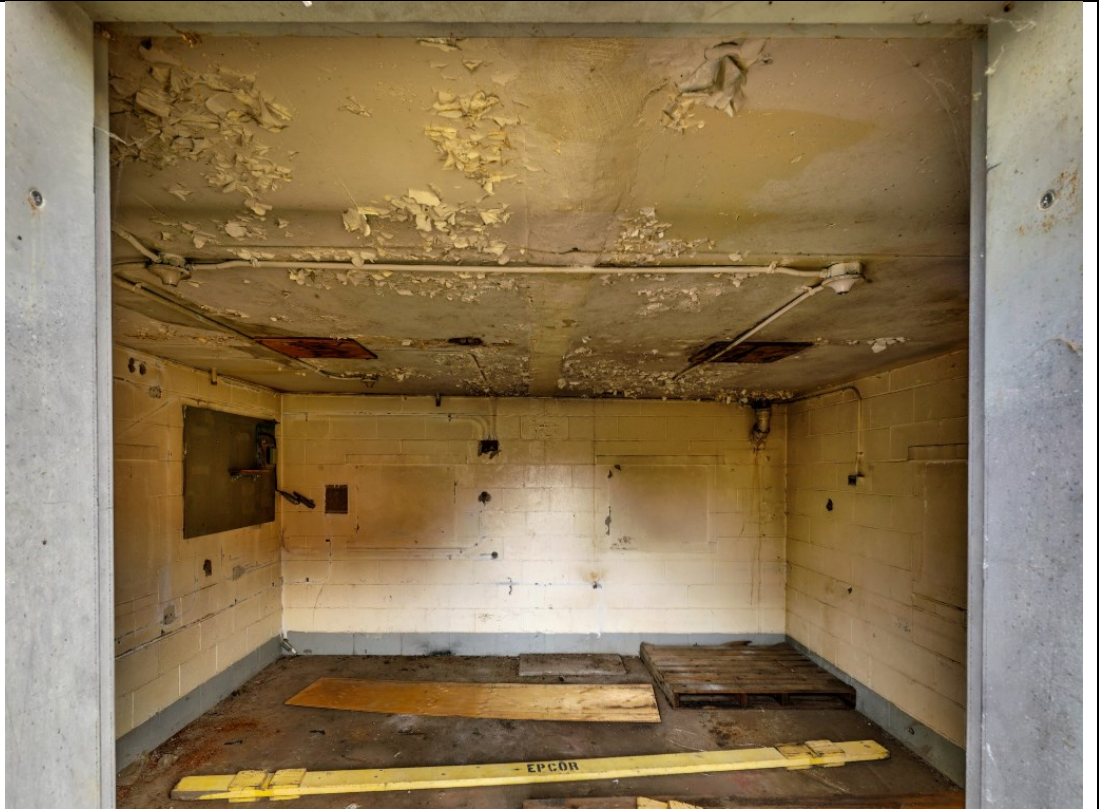
### 2.3.2 MN-104 Gas Metering House

**Walls and Ceiling:** In contrast to the Relaying Station, the Gas Metering House possesses a paint finish over the wall masonry and concrete ceiling. The finish exhibits paint failure, most likely due to moisture. The ceiling has two plywood covers that evidence water damage.

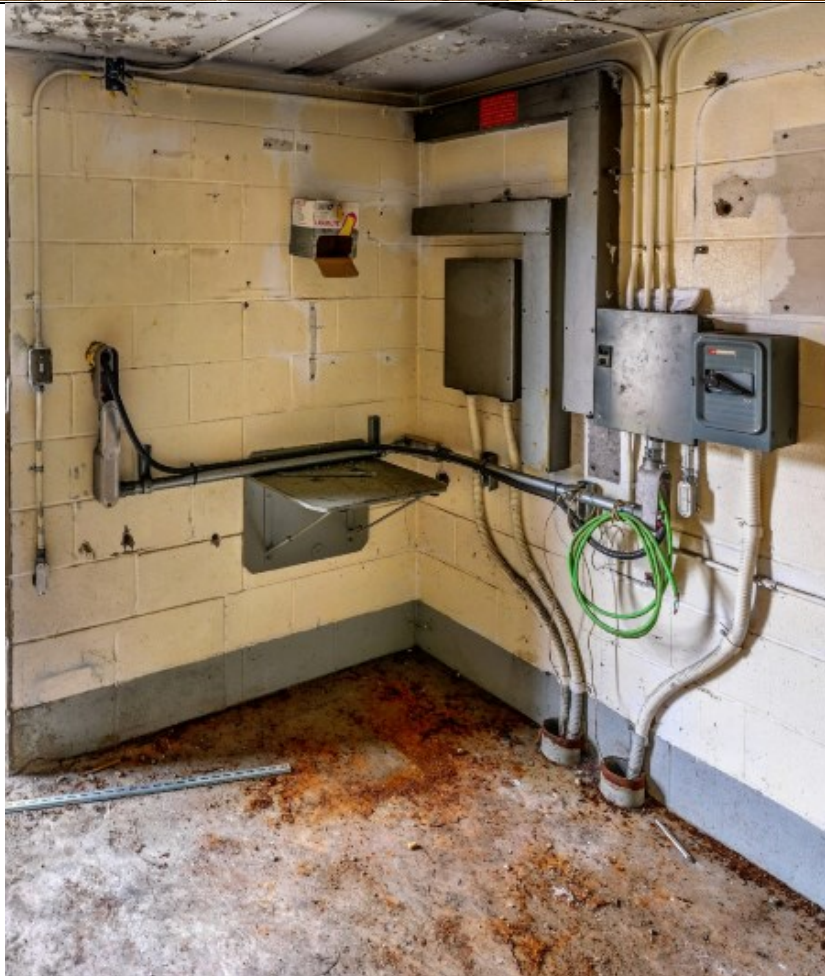
**Concrete Floor:** There is light ferrous staining just under electrical equipment where equipment could have been.

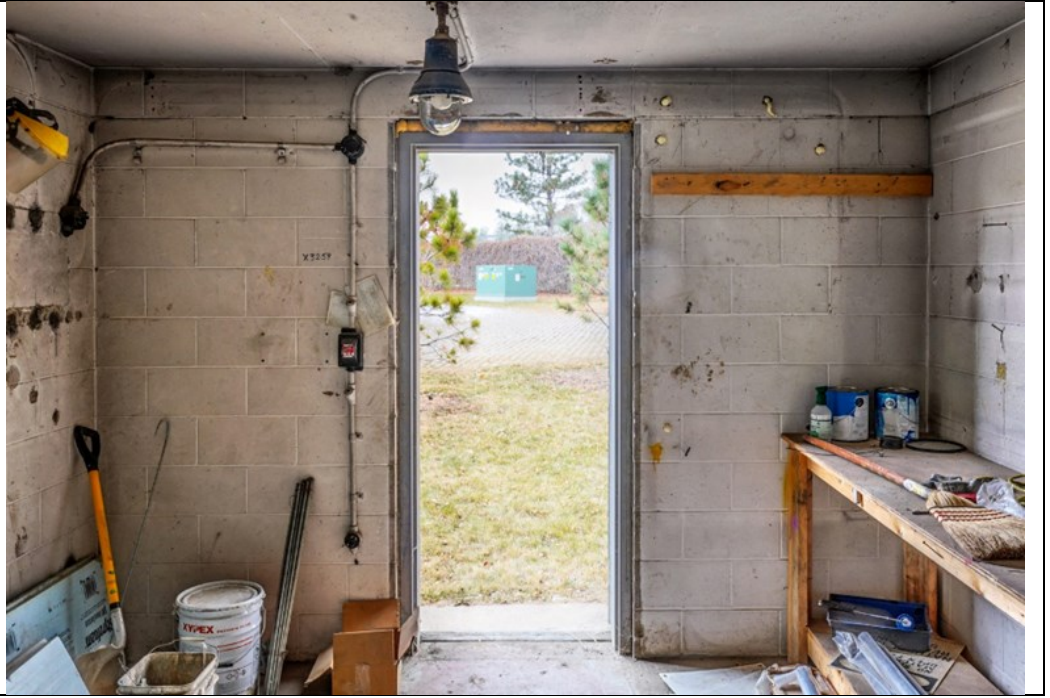
### 2.3.3 ATCO Building

**Doors and Lights:** All the doors of the ATCO Building are in fair condition. However, there is slight metal corrosion in some areas.

The lights in the interior of the ATCO building seem to be in operable condition with evidence of soiling on the lamp shade.
