The City of Edmonton

the marc boutin architectural collaborative inc.

#### 2.0 Conditions Assessment

RJC has completed a Civil condition assessment on the Rossdale Power Plant site located in downtown Edmonton, Alberta. The following report includes a summary of the documentation available for review, the site conditions observed and what can be expected for the site going forward.

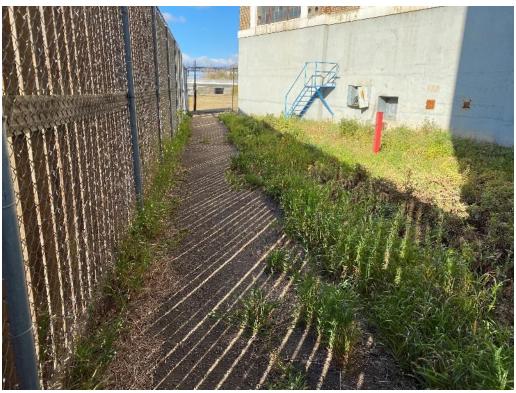
Above: Negative drainage and flow restriction cause by path

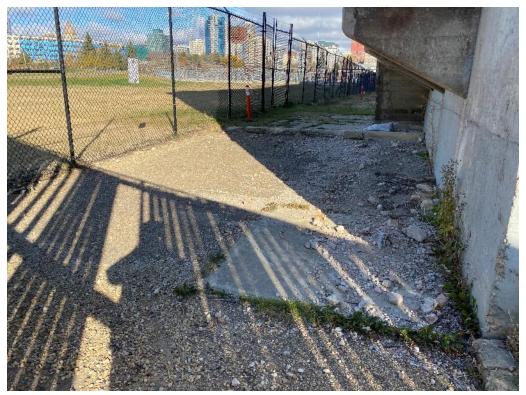
The concrete landings around entrances and curbs are cracked and spalled, some areas had visible reinforcement that was corroding.

Above: Exterior concrete landing and curb deterioration

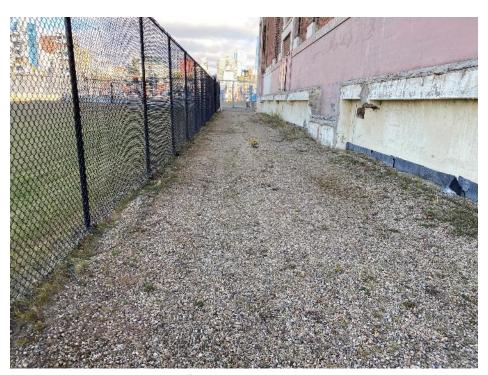
Above: Low slope away from the Low Pressure Plant West Elevation

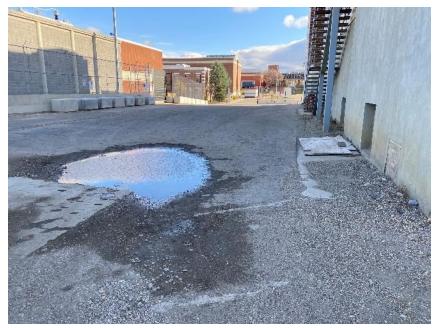
Above: Water pooling in settled asphalt area north of the Low Pressure Plant

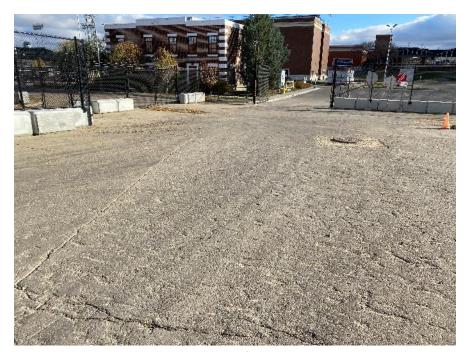
Above: Damaged asphalt from heavy equipment

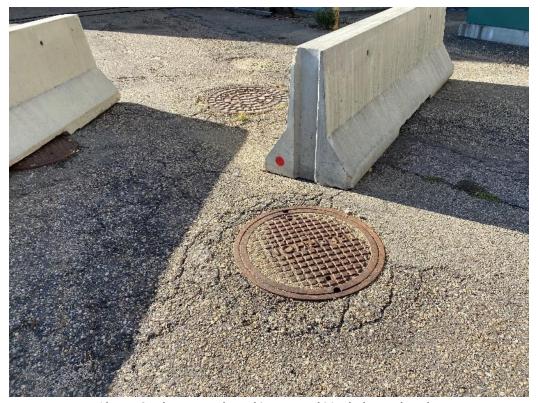
Above: Settlement and cracking around Manholes and vaults

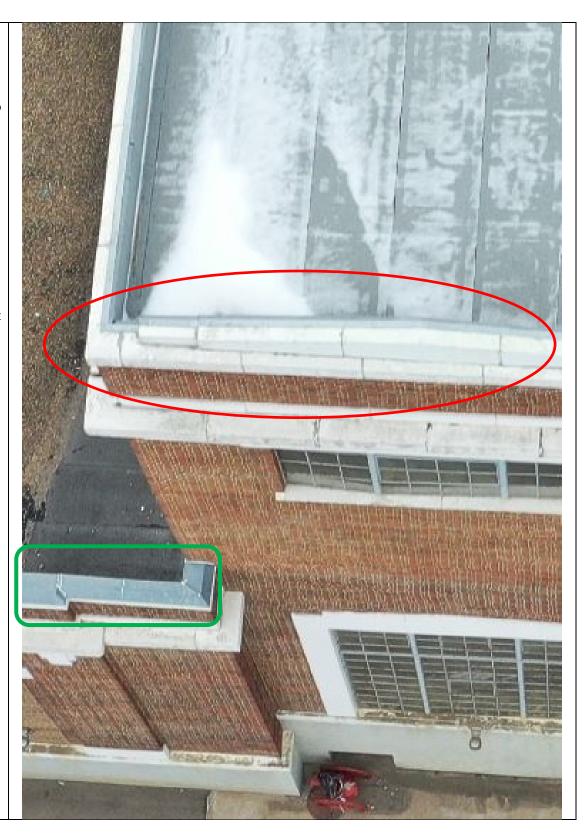
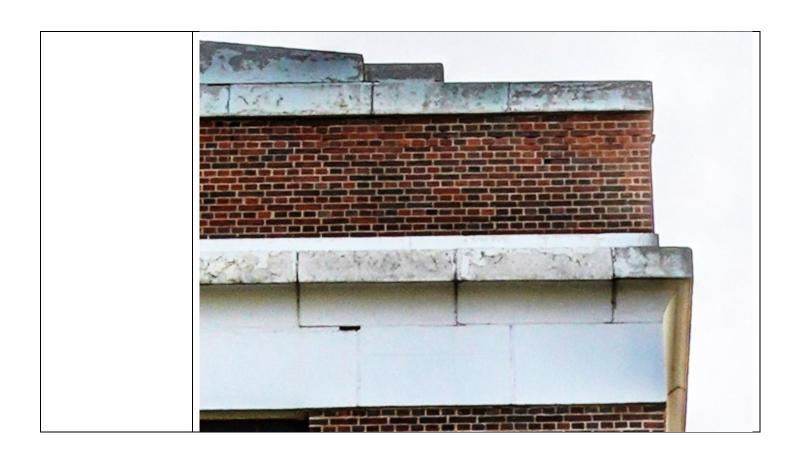
In addition, the pediment flashing stops at the 45 degree bevel at the centre of the pediment units, these too also have failing mortar failing. These areas are encircled in red.

Please note the zinc galvanised coping completely covering the top of the coping of the Turbine Hall's parapet is encircled in green.

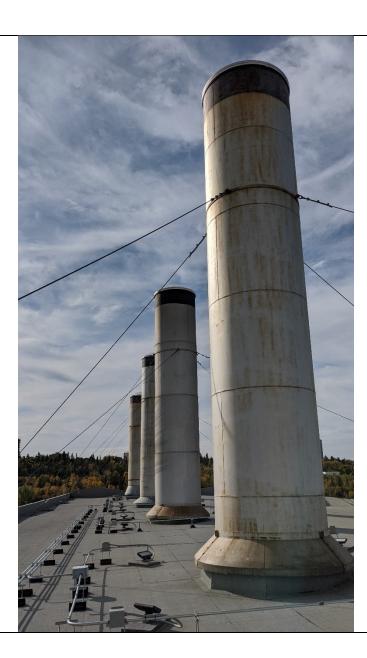
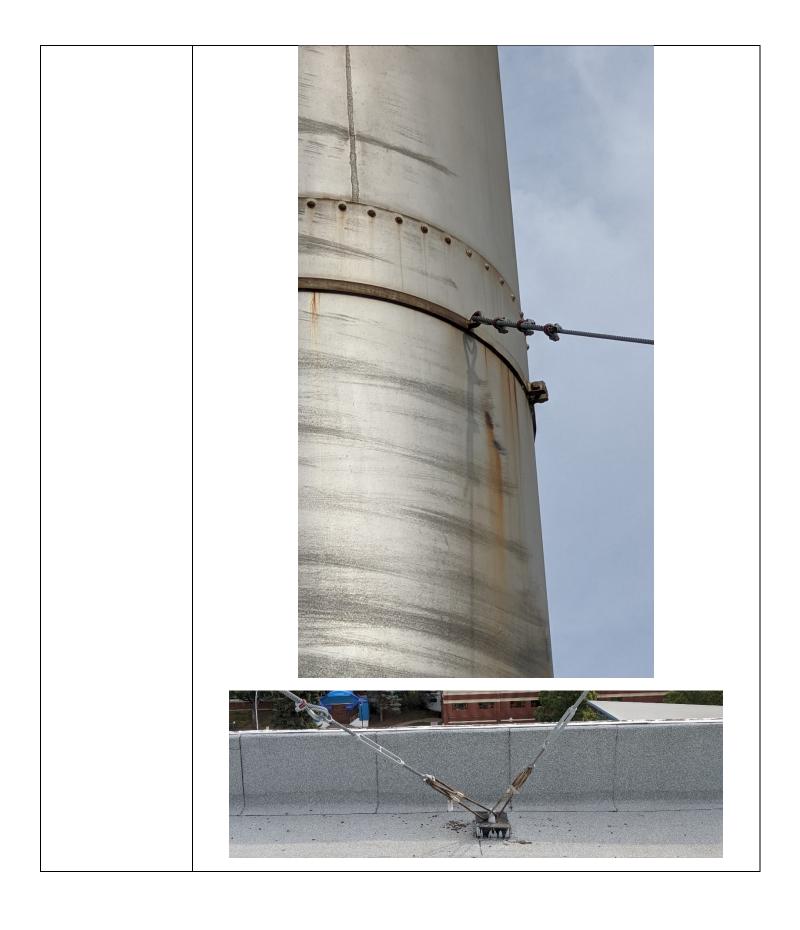
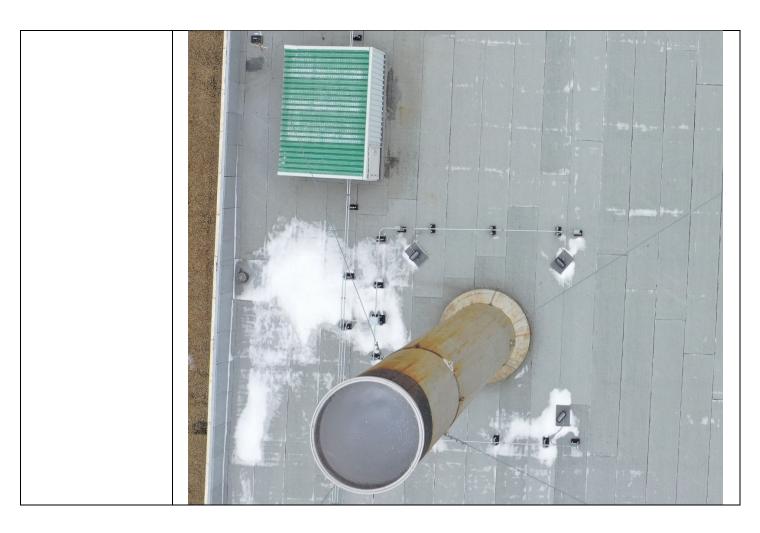
**Chimney Stacks:** There is a leaking chimney stack corresponding to Boiler Unit # 1 (the third chimney stack from the south end of the Boiler Hall). Unlike the other stacks, which are welded, this particular chimney stack is rivetted. Deficiencies in the assembly of the metal lapping may be the cause of this leak. There is varying levels of corrosion across all stacks, and is most notable on the stack associated with Boiler Unit # 5 (the second chimney stack from the north end). Snow and ice is accumulating and is evident due to surficial corrosion present on guy lines.

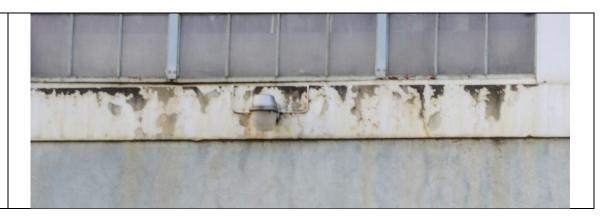
Failing Paint on
Concrete Surfaces
and Cast Masonry
Units, Throughout:
Non-original paint on
cast-stone/masonry
units is failing.
Appears to be a type
of Poly-Vinyl or
Latex, or combination
thereof, due to the
way it is peeling.

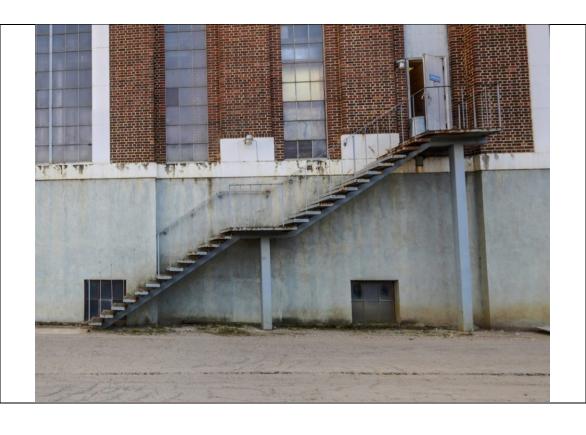
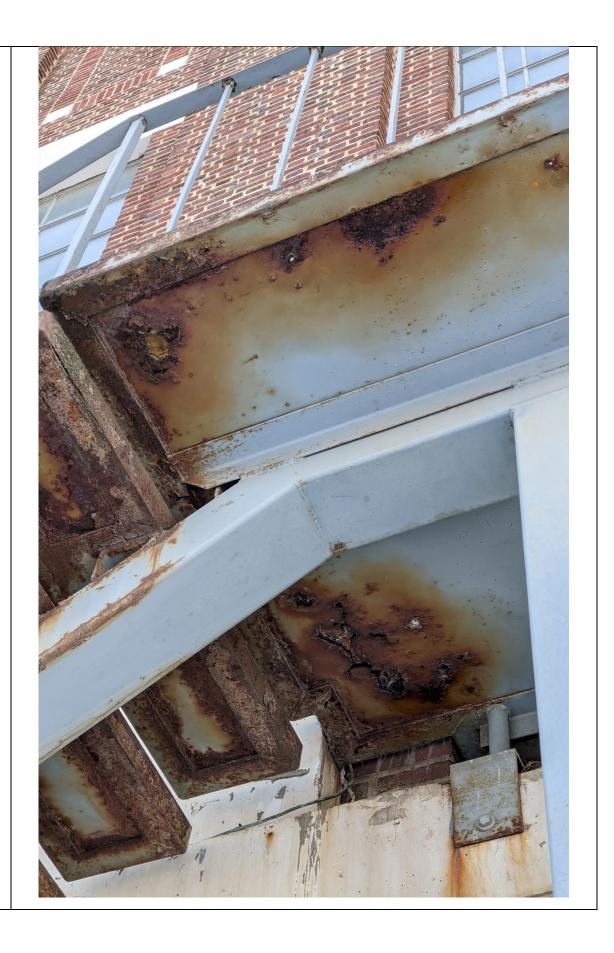
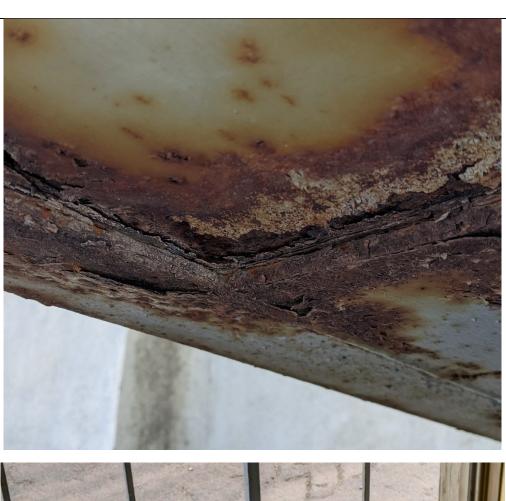
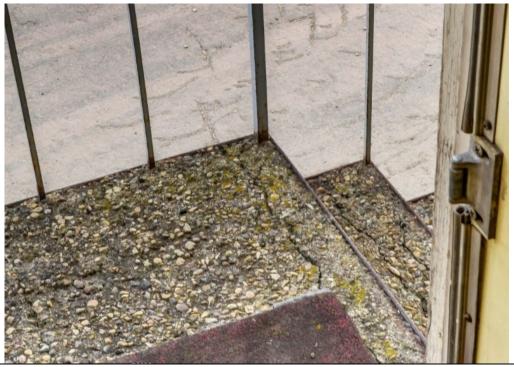
# Exterior Steel Staircase, 02-304, North Elevation: Steel tread supports are evidencing advanced stages of corrosion packing and pitting. This is due to concrete tread cracks, concrete water absorption, and the basin-like water containment effects of the flat sheet steel support under the concrete tread. There is bio-growth

(moss and lichens) and cracks present on concrete treads. Steel stair structure is generally fine, with some paint failure and minor amounts

of corrosion.

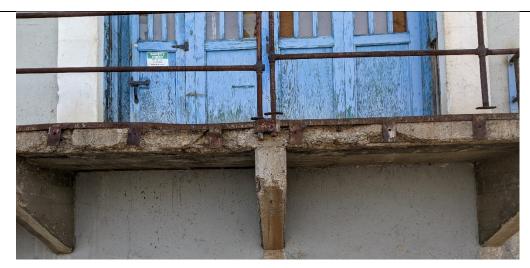
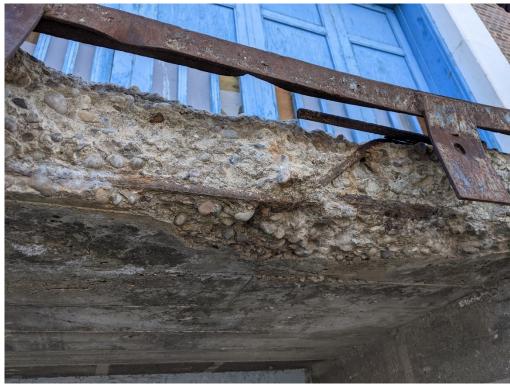
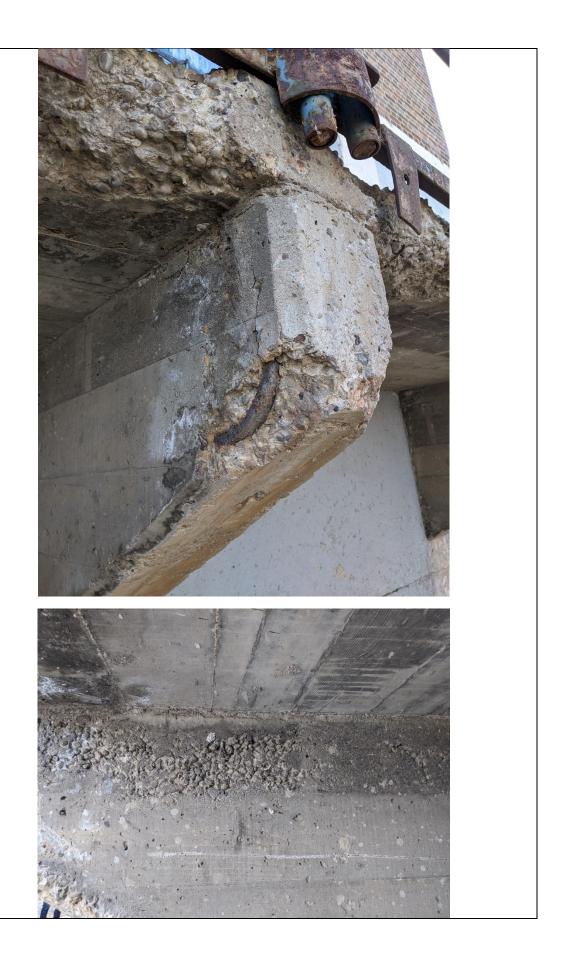
#### Exterior Concrete Staircase, MN-375, West Elevation: Railings are deficient.

Railings are deficient.
On the landing,
concrete is pitting
and spalling from
exposed rebar. A
section of concrete is
missing on the west
elevation of the
landing due to the
presence of rebar
too close to surface.
One large piece of
reinforcement on the
horizontal ferroconcrete struts too
close to the surface
causing ferrous
corrosion jacking and
concrete spalling.
Honey-combing is
evident on concrete
struts as well as
evidenced by
bottom-most photo.

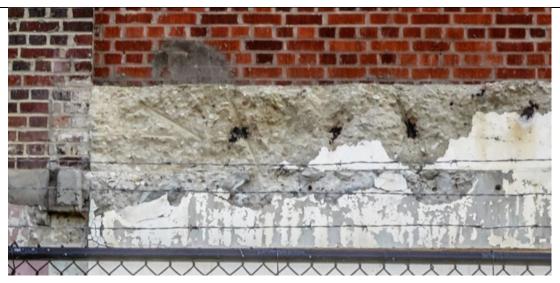
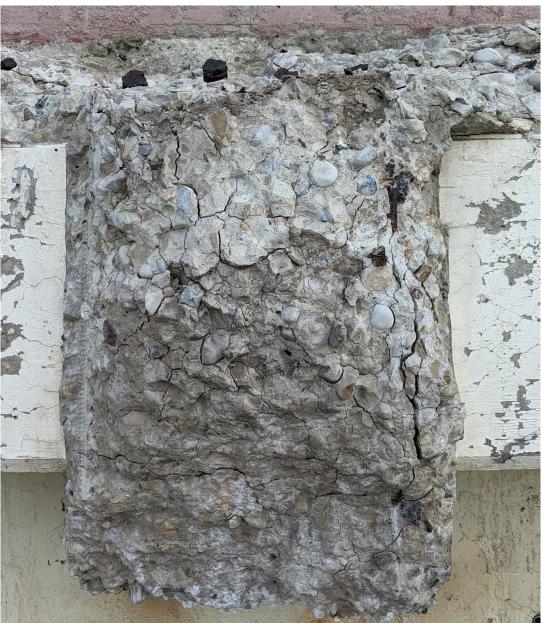
# Character Defining Bituminous Stain on West Elevation: Relict bituminous connection point from historic High Pressure Plant is evident across west elevation. Efflorescence, West Elevation: Elevation: Efflorescence stains are present on loading dock/ window brick infill located on the north end. This condition is possibly due to precipitation and sun path patterns.

# Concrete Disaggregation, Relict Concrete TieIn between HPP & LPP, West Elevation:

Disaggregating material should be raked back to sound material and these elements capped.

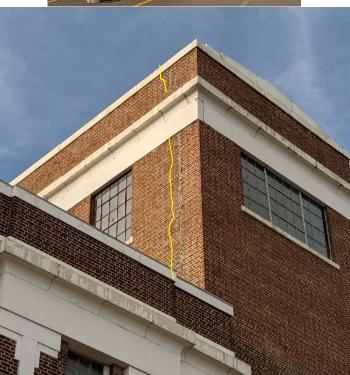
#### Displaced Cast Masonry Unit and Associated Crack, North East Corner:

North East Corner: Crack in masonry propagating from parapet band zipper joint down to turbine hall roof highlighted in yellow. Cast masonry unit below cornice is displaced, highlighted green.

There is a similar crack on the south east corner, perhaps not as distinguishable.

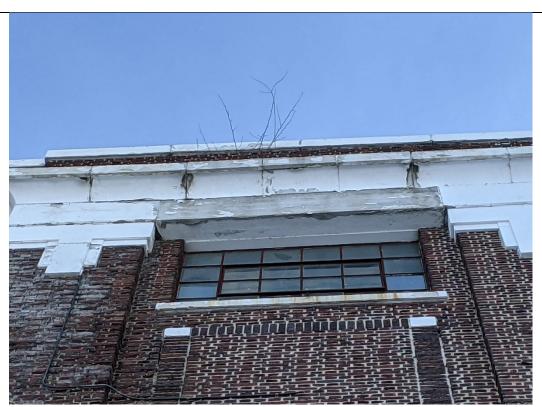
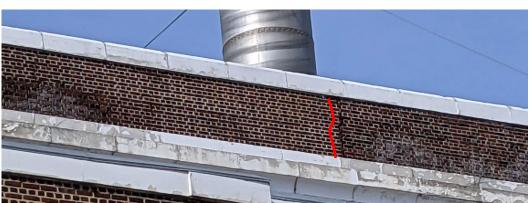
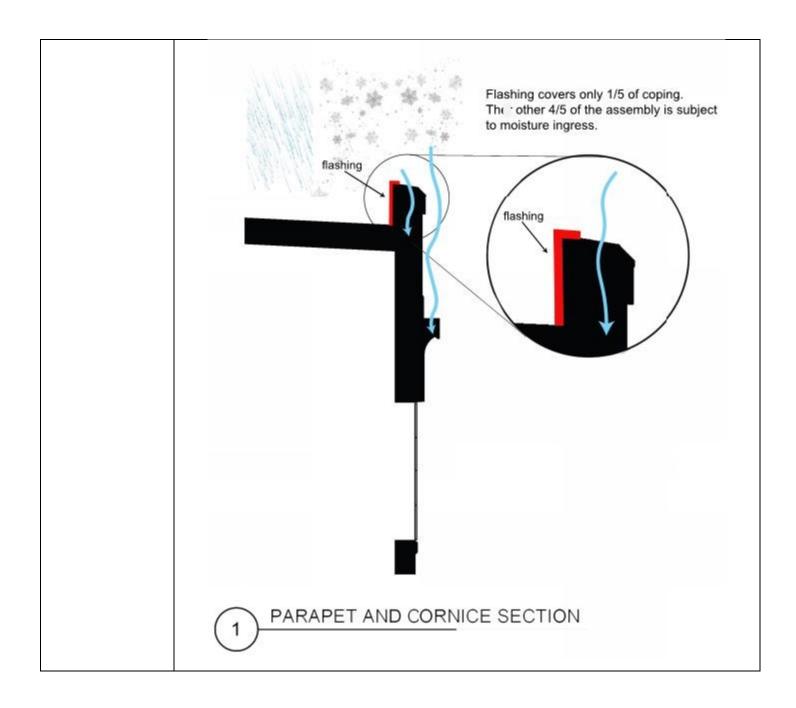
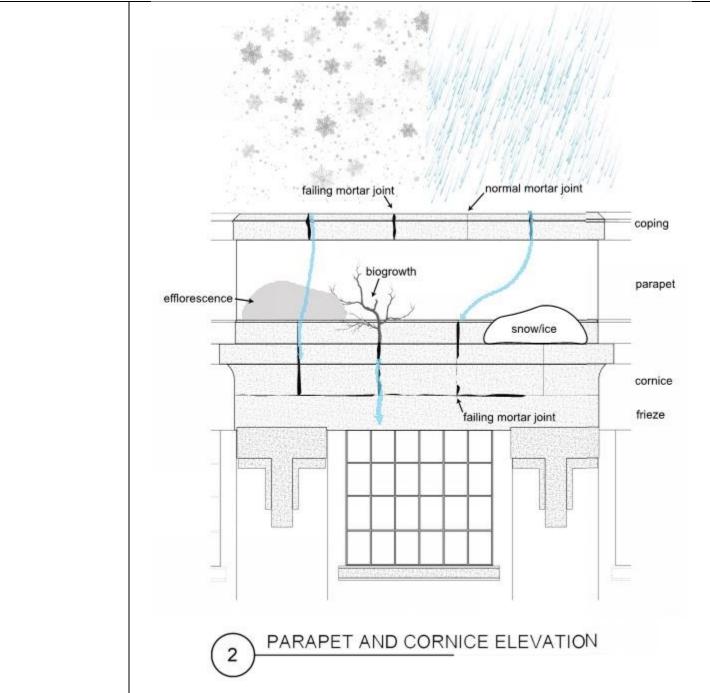
## Cornice and Parapet Deterioration: See illustrative

See illustrative deterioration schematics below. Basically, water ingress from open joints, deficient flashing, and past roofing failures is causing various deterioration patterns.

Middle photo: crack on the east elevation parapet.

Bottom diagrams: Cornice & Parapet deterioration schematics

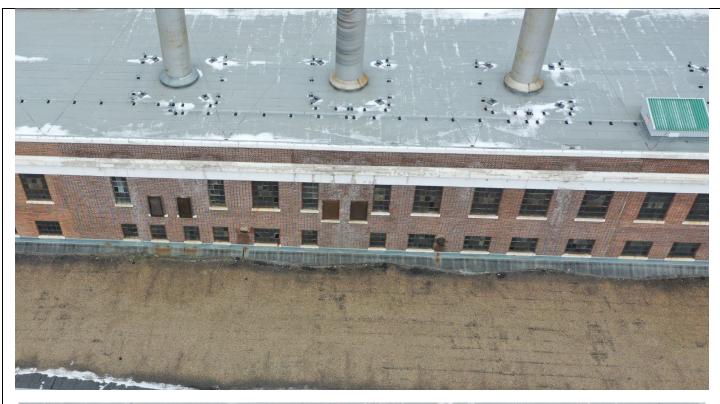
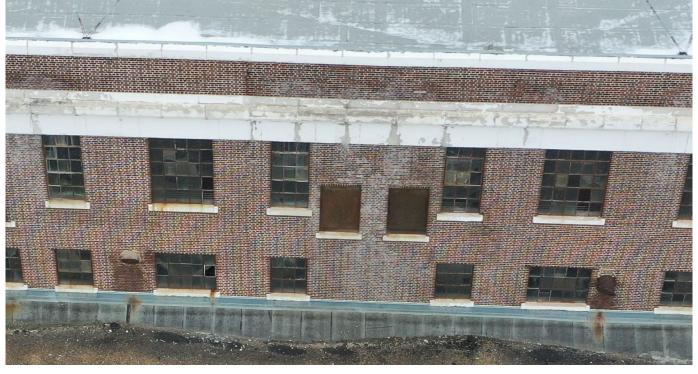
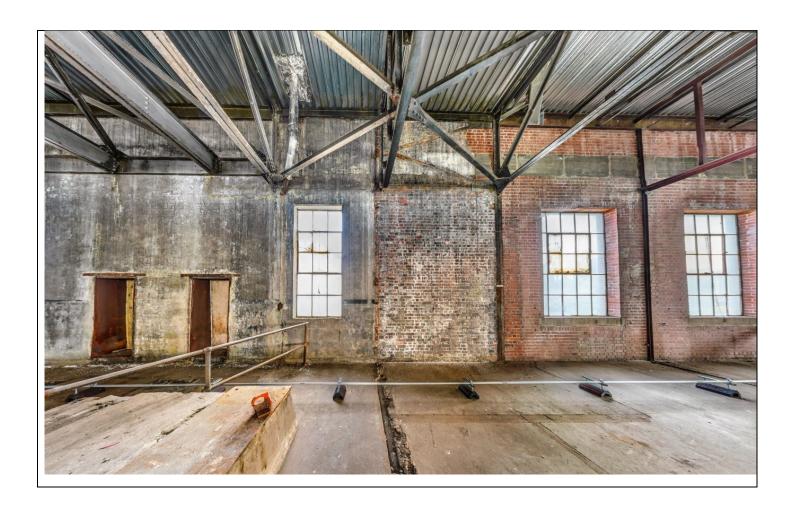
#### Boiler Hall East Elevation Deterioration:

There is widespread effloresence, deteriorating mortar, more intensive cast masonry unit paint deterioration, and an isolated case of woody perrenial growth at the east elevation of the Boiler Hall, see first two photographs below. This is focussed on the 1932 and 1938 Boiler Hall expansions, the oldest part of the extant LPP.

Deterioration is likely due to a number of different pathologies, including: 1) Water ingress into the masonry assembly as per cornice and parapet pathology as described above; 2) historic roofing failures and water ingress, which also would have solubilised and transported the gypsum composed decking to masonry assembly 3) water and vapour mechanics of a masonry assembly at the mezzanine level that would encourage moisture drive out the exterior masonry because of cementitious-rich plasters (again, only seen in the mezzanine interior levels in the 1932 & 1938 expansions — see lowest photograph). Any water or moisture vapour absorbed/adsorped by the masonry assembly would be preferrentially driven to the exterior of the masonry because of the warm temperatures of the Boiler Hall. The saturation and dessication cycling of the masonry would cause any soluble salts to work their way to the exterior. Gypsum salts are well known agents of masonry deterioration, and should be remediated. 4) atmospheric pollution can lead to deposition of free ions that often precipitate/nucleate deleterious salts. This wall is down wind of predominant westerlies, and suggests that this may also have been a source of salt.

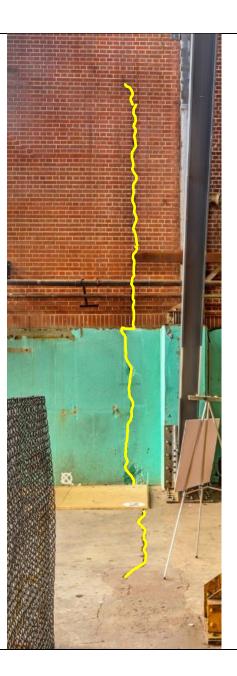
Original Construction Settlement Cracks, MN-370 Boiler Unit # 7, West Interior Elevation, South of D8 (pictured to the right); and MN-360 Boiler Unit # 2, West Interior Elevation, North of D8: Crack in concrete floor, concrete foundation, and partially up the length of the masonry wall. These cracks demarcate where one Boiler Hall addition was built onto another.

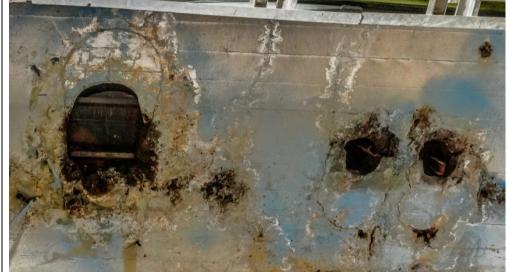
#### Mechanical Core in Concrete Floor:

Core holes have been covered with plywood for human health and safety. This condition spans all bays — Boiler Units # 1 to # 7. Photograph displays holes from underside of floor assembly and is visible from the basement level of the Boiler Hall.

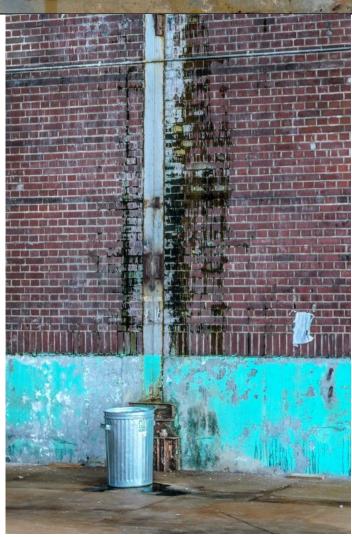
Algae Staining & Efflorescence, Boiler Unit #2, MN-360: Algae stains and efflorescence due to large amounts, or constant, free water ingress from roof/rain leaders on the east elevation of MN-360. Some rain leaders are still leaking meaning this is an active decay pattern.

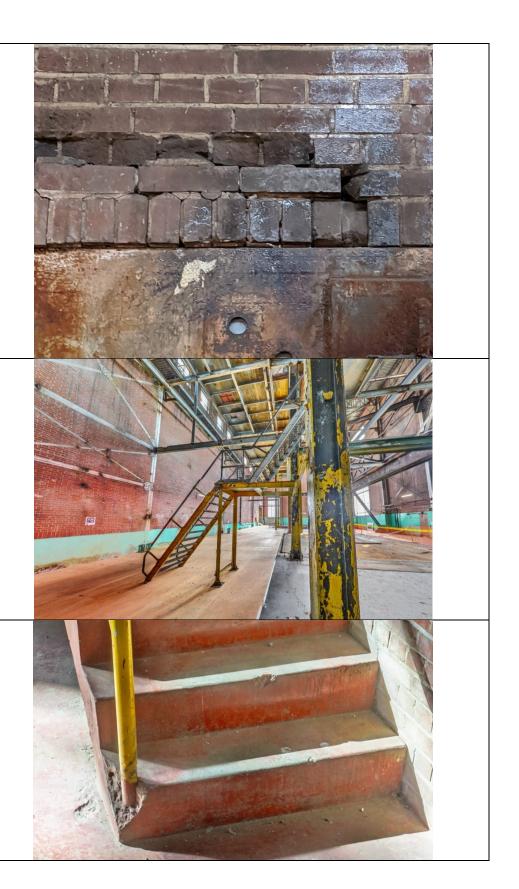
2.3.11 MN-303 (BM-303), MN-307, Interior Concrete Stairs:
Chipping, and spalling, and paint failure evident in both MN-307 and MN-303 (BM-303). Pitting is also present in MN-303 (BM-303). These conditions are due to construction activities, industrial usage, erosive force human traffic.

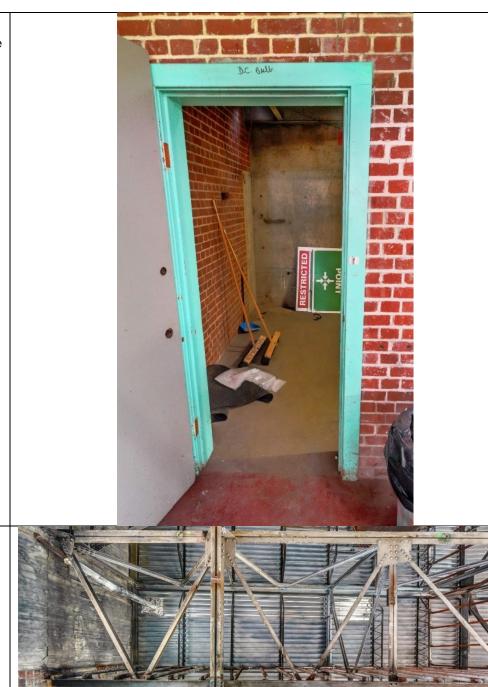
# Missing Door, MN-305 Common Office:

Evidence of missing door hardware is present. Other doorways in the Boiler Hall should be investigated for evidence of missing door panels and door hardware.

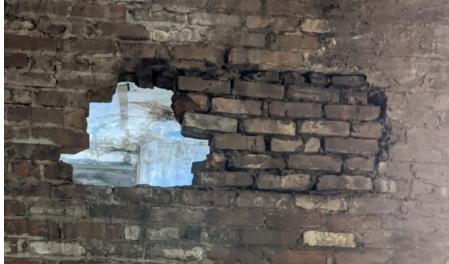
Missing Brick Section:
Missing section is located on the east elevation of the wall between the Turbine Hall and Boiler Hall Basement. There is an area of masonry where a void is visible at the surface due to missing brick units. Void may be due to preexistence of equipment chase. Infilled section is poorly constructed and may be incomplete.

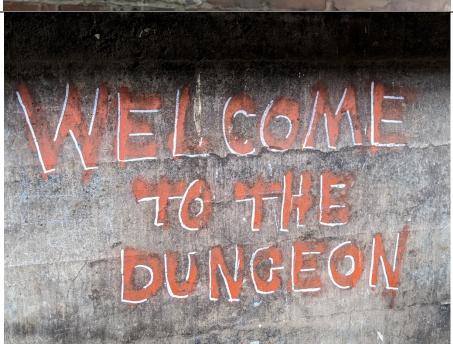
### Graffiti:

Graffiti has been painted over top of original concrete surfaces, of various designs, texture, colour, and material.

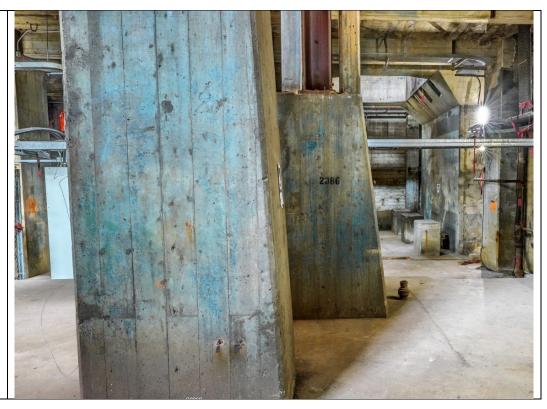
### **Blue Abatement Stain:**

Stains are present in North Corridor, South Corridor, and Material Transportation spaces. Blue staining is indicatory of post-abatement marking of areas where hazardous materials have been removed.

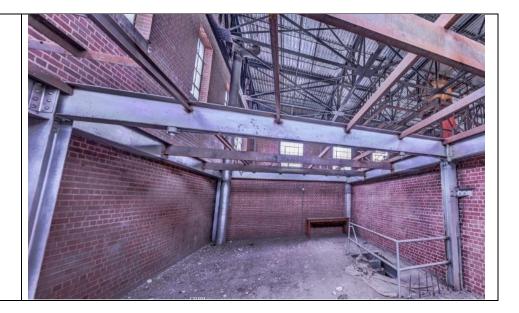
### Rooms 03-301 to 05-301:

Rooms 03-301 to 05-301: Ceiling is missing from Room 05-301, Paper Record and Storage Room (as seen in image to the right). Debris and bird droppings are present on floors of level BM, 03, 04, and 05, including the interconnecting stairs. Relict furniture and equipment is present on level 03, and 04.

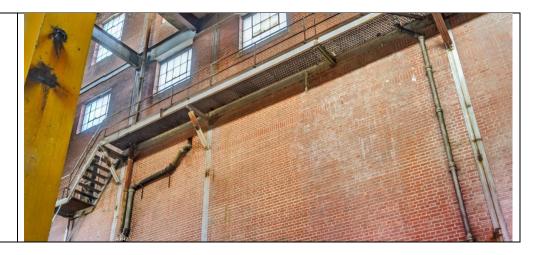
### CW-333 Catwalk:

Entire assembly poses a human health and safety hazard. Railings are loose and too short. Vertical reinforcement has been cut. There are no kick plates, holes in grating, some vertical support rods have been cut, and the grate flooring bounces.

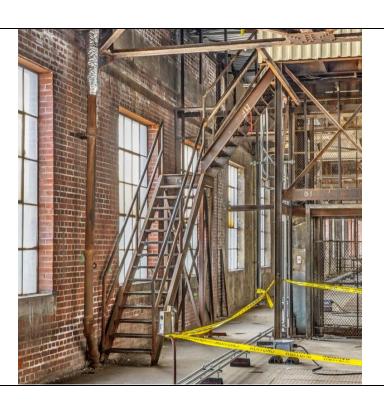
### 2.3.21 MZ - 305 Interior Stairs to Roof Hatch:

Metal stairs are steep and not to modern code. Otherwise the stairs are in good material condition.

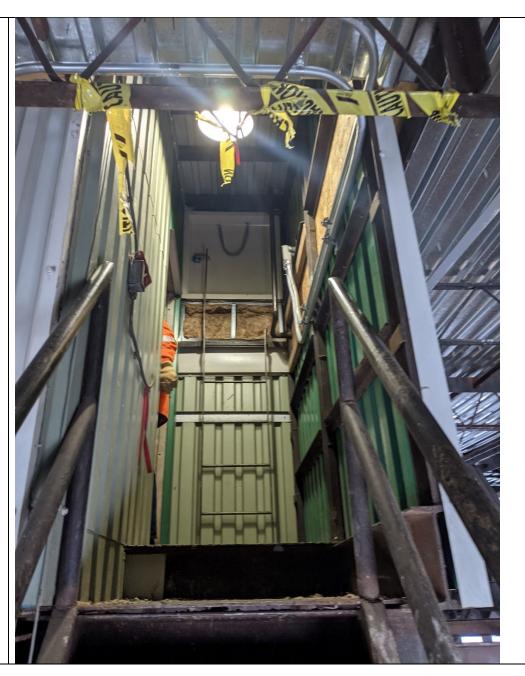
# Roof Hatch Access, RF-302: Access to RF 302 and RF 303 is subject to low head clearance due to the location of a structural roof truss. This low clearance is distinguished with caution tape as seen in the photo to the right. There is exposed insulation in Elevator Mechanical room and could be a skin irritant.

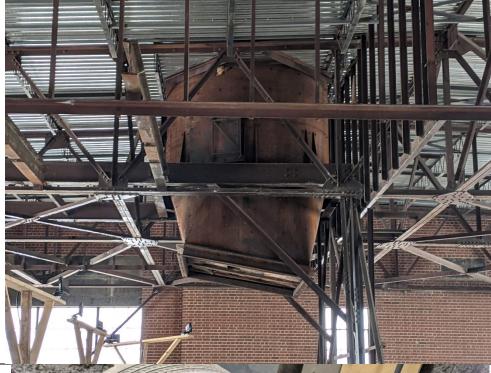
### Chimney Stacks: All steel members evidence paint failure, passivated corrosion.

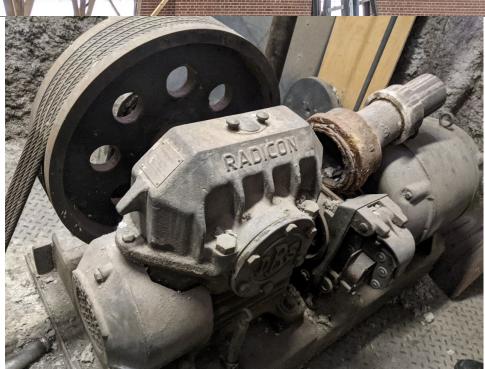
Relict Equipment in Elevator Mechanical Room, RF-303: Equipment is dirty and metal components evidences some corrosion.

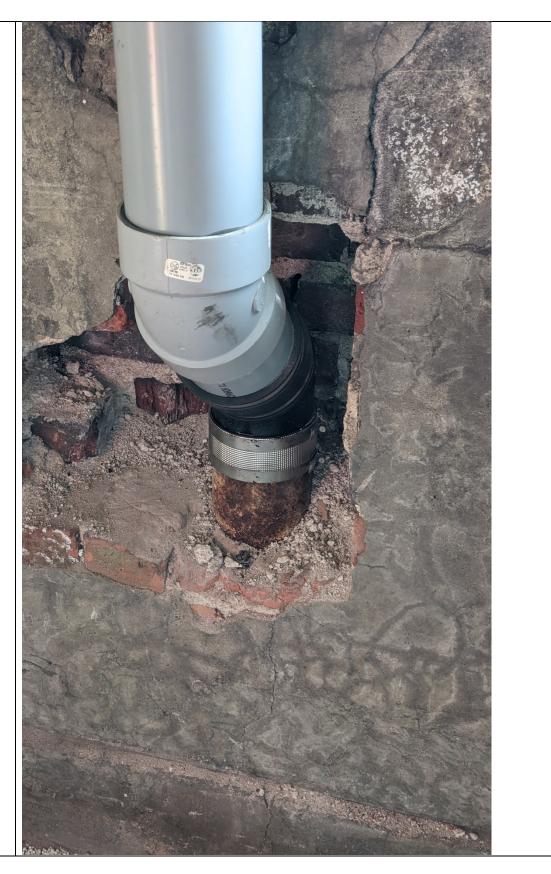
# Air Intakes: The four oldest openings in the mezzanine, corresponding to the earliest periods, 1932/1938, have been boarded up with plywood. All metal framing evidences corrosion.

Loss of Brick Section, Mezzanine: Loss of brick section associated with rain leader upgrades during Boiler Hall Roof replacement.

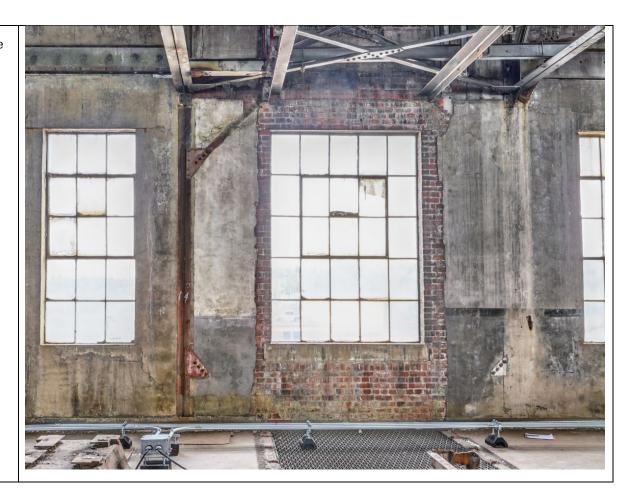
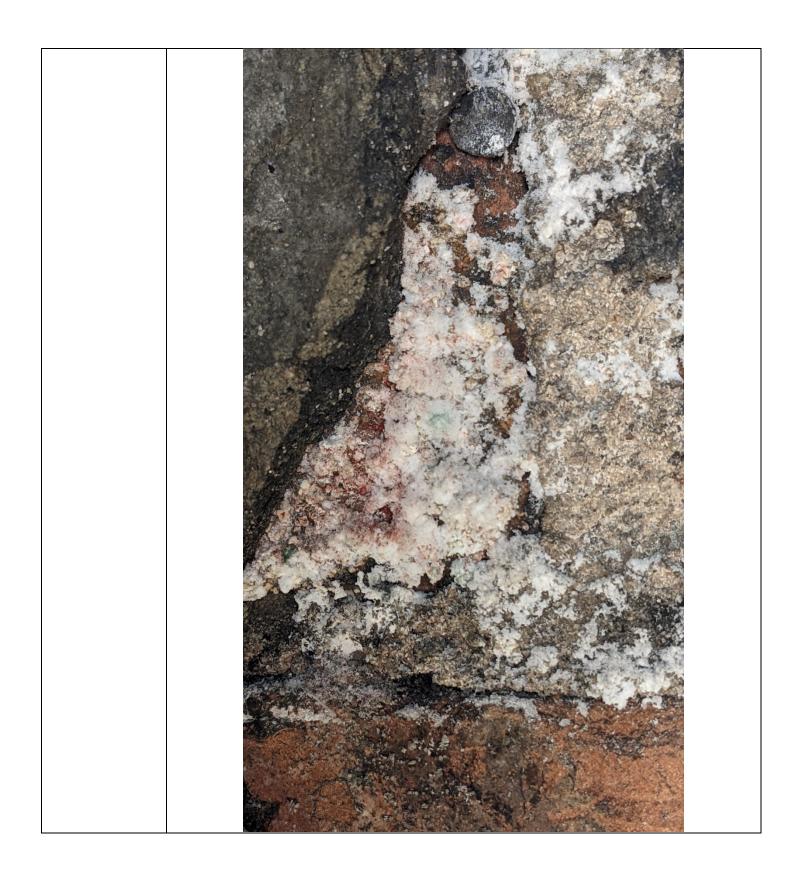
Plaster Walls:
Plaster walls in the 1932 & 1938 extensions are delaminating in isolated areas.
Original paint scheme is original paint scheme is evidenced and corresponds to known historic photography of these spaces. There are small sections that has sections that have been stripped as evidenced by ragged plaster edges and salt-laden (efflorescence) brick and mortar substrate.

Detail photograph of salt crystallisation as below.

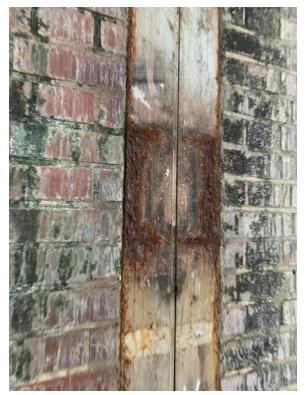
Above: Boiler/Turbine Hall - Column Rust on shared Wall

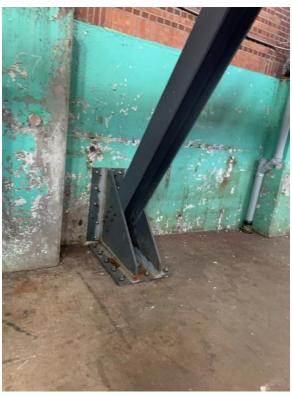
Above: Boiler Hall - Reinforcement of West Wall
