# Rossdale Power Plant Advanced Assessment and Priority Rehabilitation

## Switch House Condition Assessment

**Submitted to: City of Edmonton**

**Date Submitted: 2021-03-15**

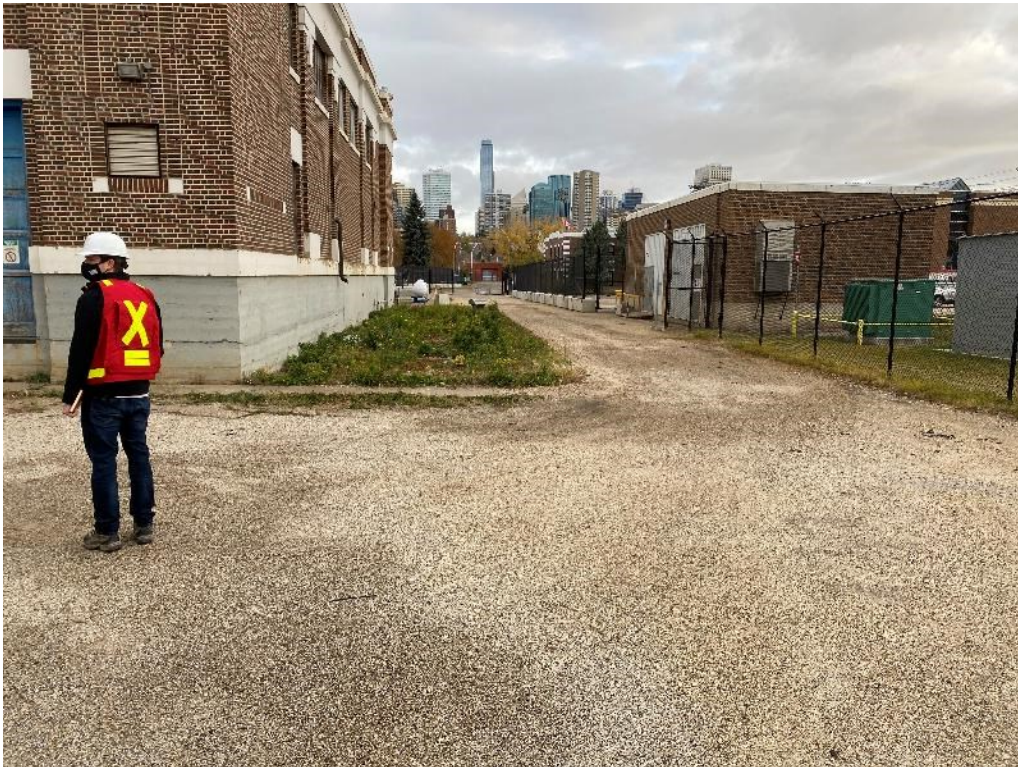
Above: Water ponding in drive lane east of the Switch House

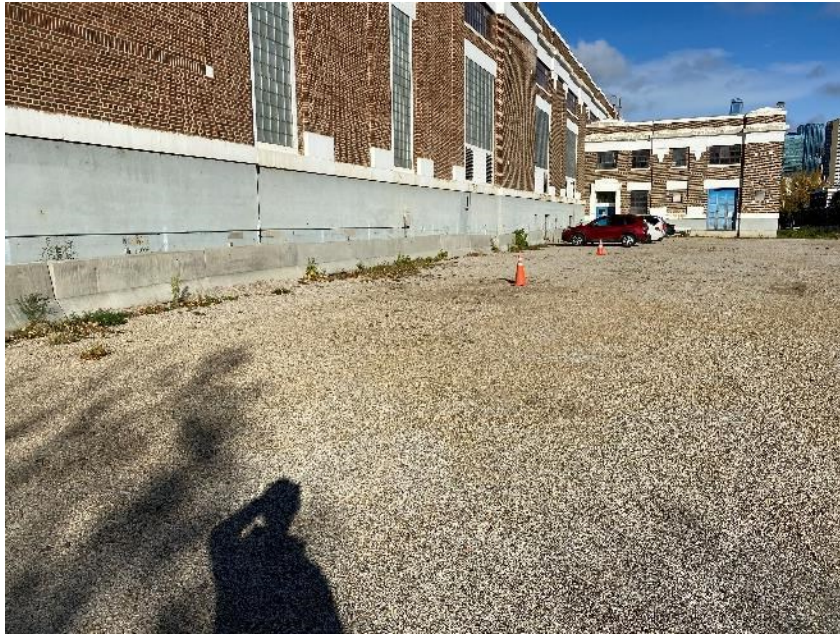
Above: Parking lot local low spots and negative drainage

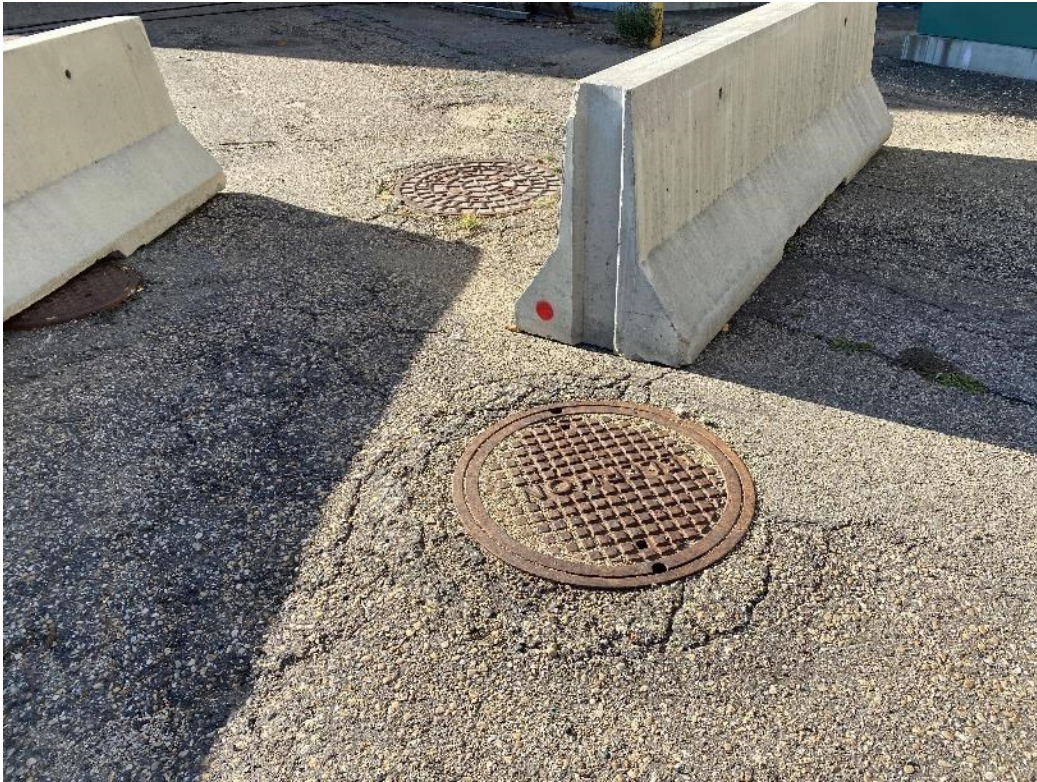
**Above: Settlement and cracking around Manholes and vaults**

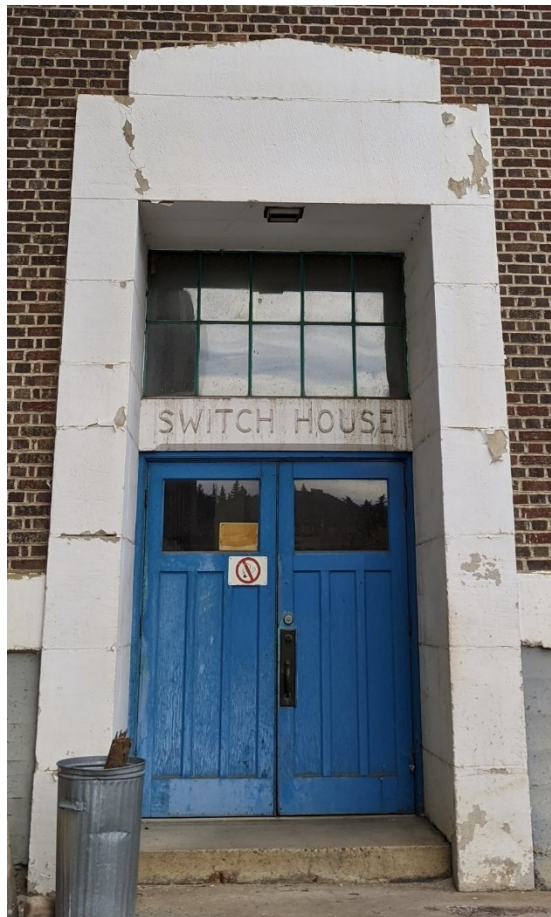
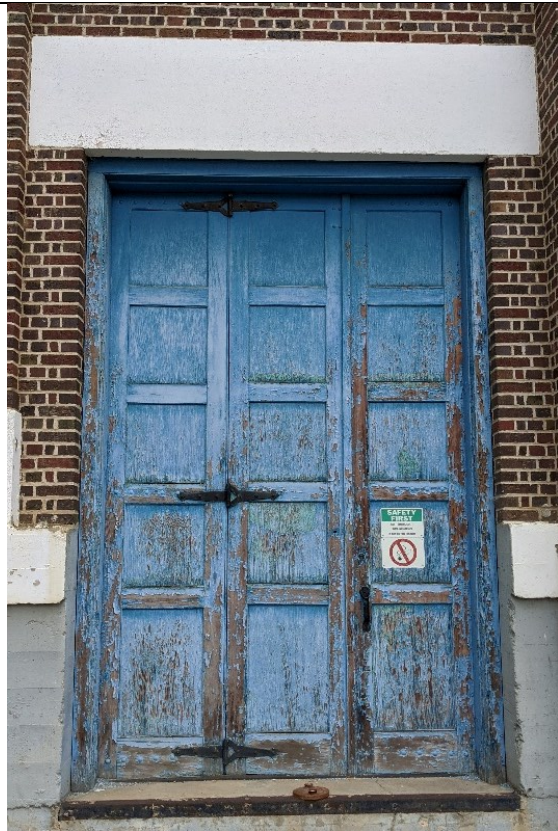
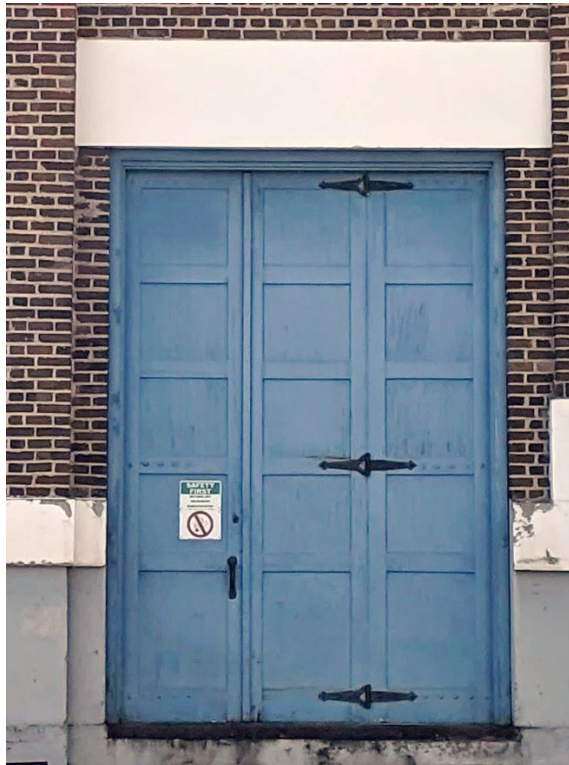
**D1-D3 (Photos of doors ordered top to bottom); Building Entrance, South & North Loading Dock Doors:**  
Doors are operable, but moving parts could still use maintenance. Paint failure is extensive in some cases, and all require conservation to avoid further deterioration.

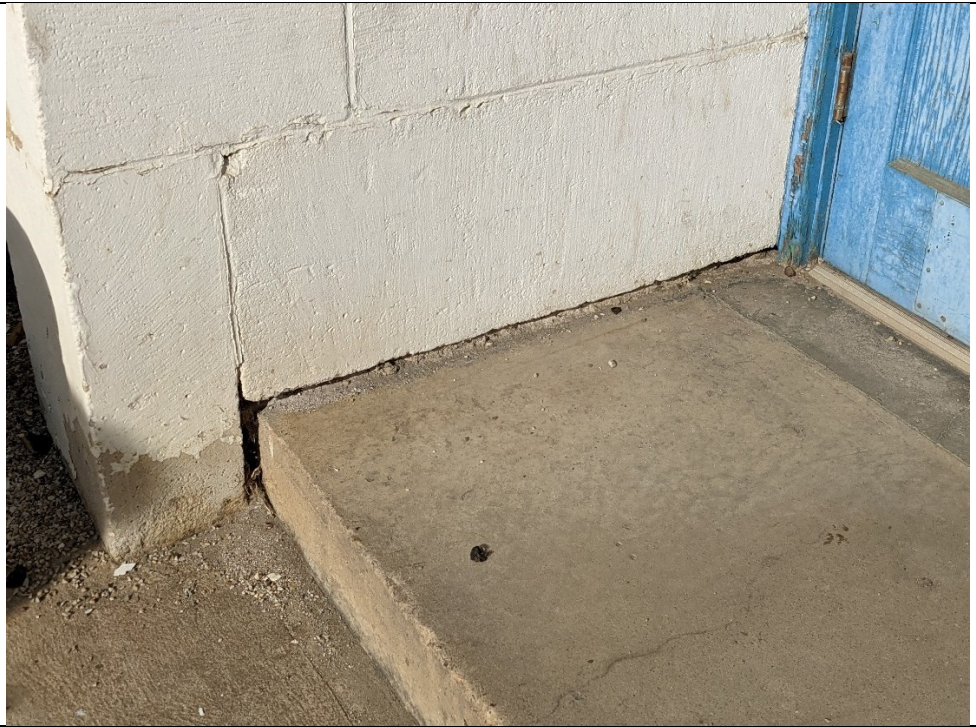
**D1, Building Entrance:**

Horizontal mortar joints have eroded along the base course of cast masonry units at door entrance way, likely due to de-icing salts.

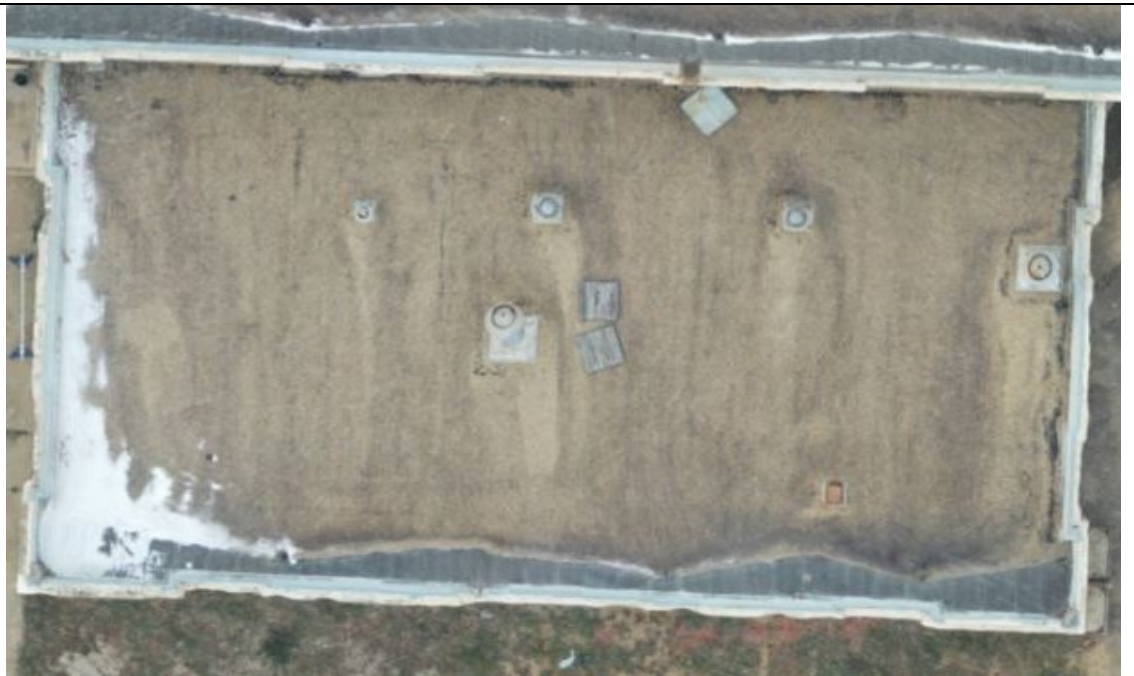
Membrane has exceeded its serviceable life and requires replacement as evidenced by various leaks on the building interior. Various debris such as un-used wood pallets and metal sheeting is also present.

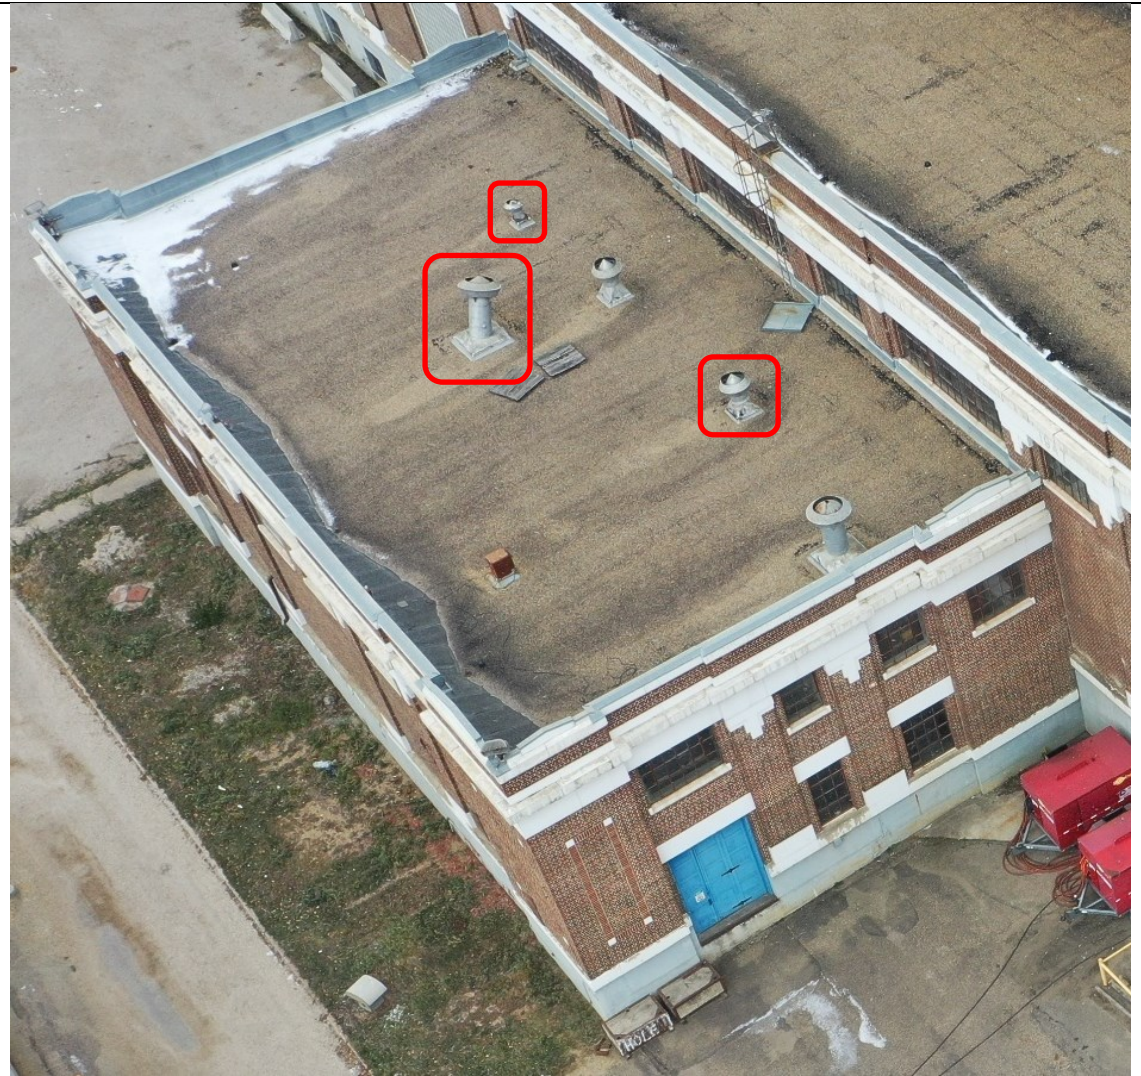
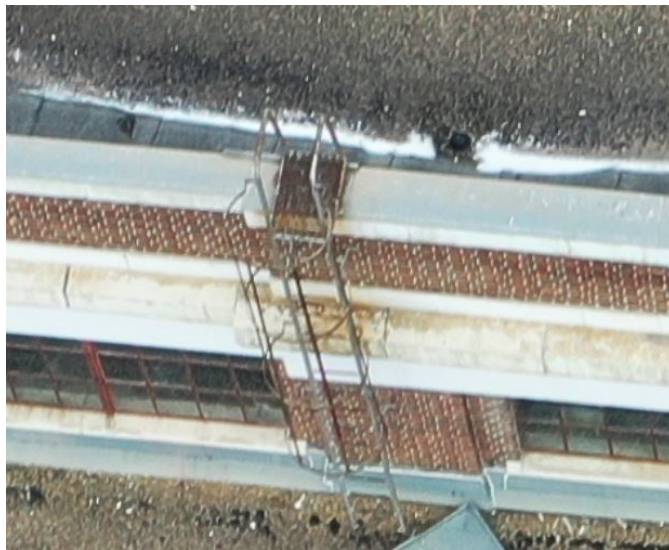
Some roof vents are leaking as evidenced by corresponding leaks inside, some are exhibiting amounts of corrosion, and the aerial drone survey has demonstrated that at least three vents have deformed and are leaning out of plumb.

The roof ladder from the Switch House to the Turbine Hall roof is exhibiting an unknown level of corrosion. Limited access has limited the level of detailed assessment.

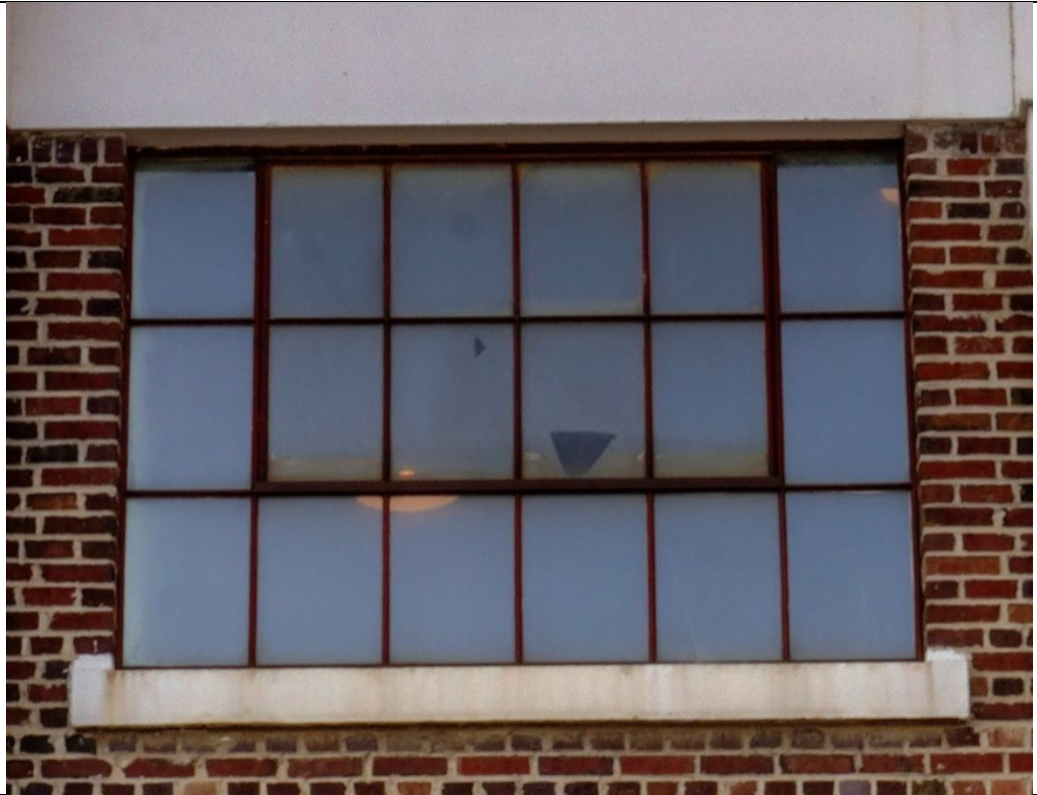
**Windows:** The multi-light double-glazed rolled steel windows are in fair condition. Glazing units are all soiled, some are broken or missing, and glazing putty is generally hardened and failing, suggesting a need for resetting the lights and replacing those that are broken. Frames are in good condition, exhibiting no corrosion packing, but may require refinishing to increase their useful serviceable life.

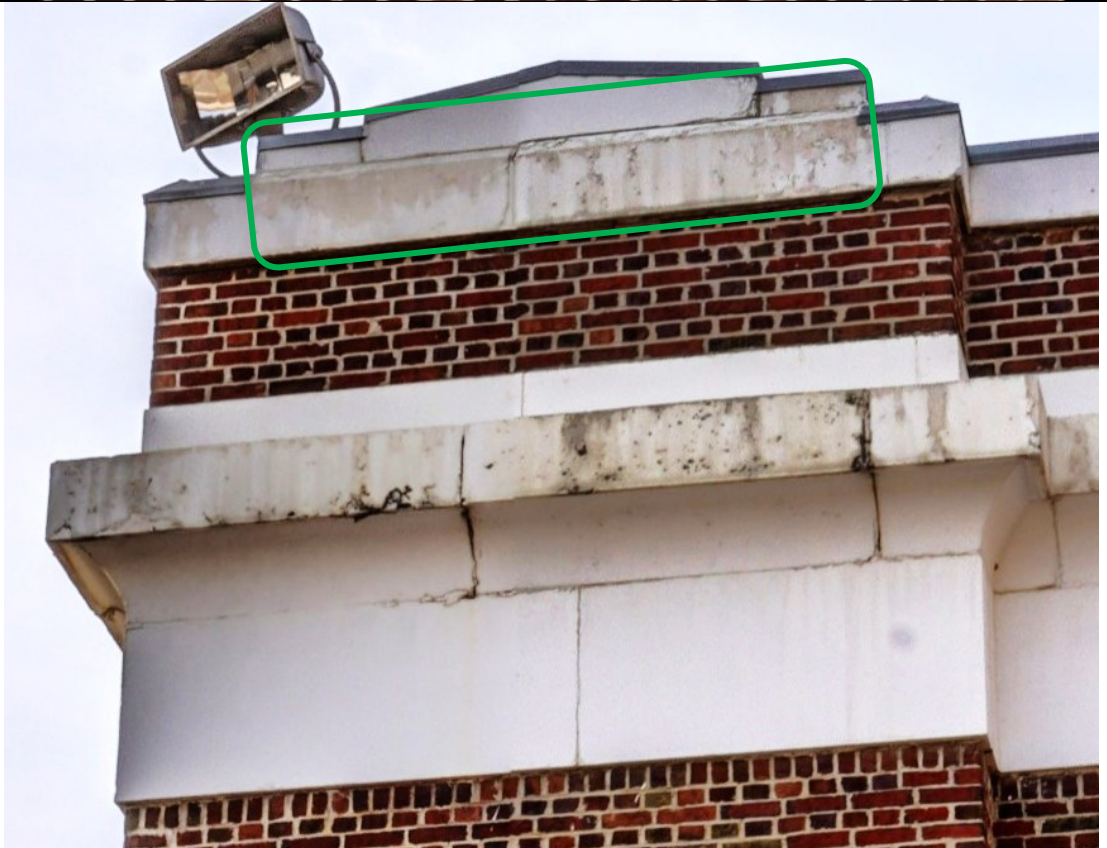
All perpendicular mortar joints in cavetto formed cornice band are failing. This is the same for some perpendicular joints of parapet and pediment units as well. Paint is also failing in these areas because of higher moisture contents.

Pediments are exhibiting mortar failure where flashing does not span across at the coping level, highlighted in green. This extends to the exposed vertical joints between the three pediment units on top of the coping.

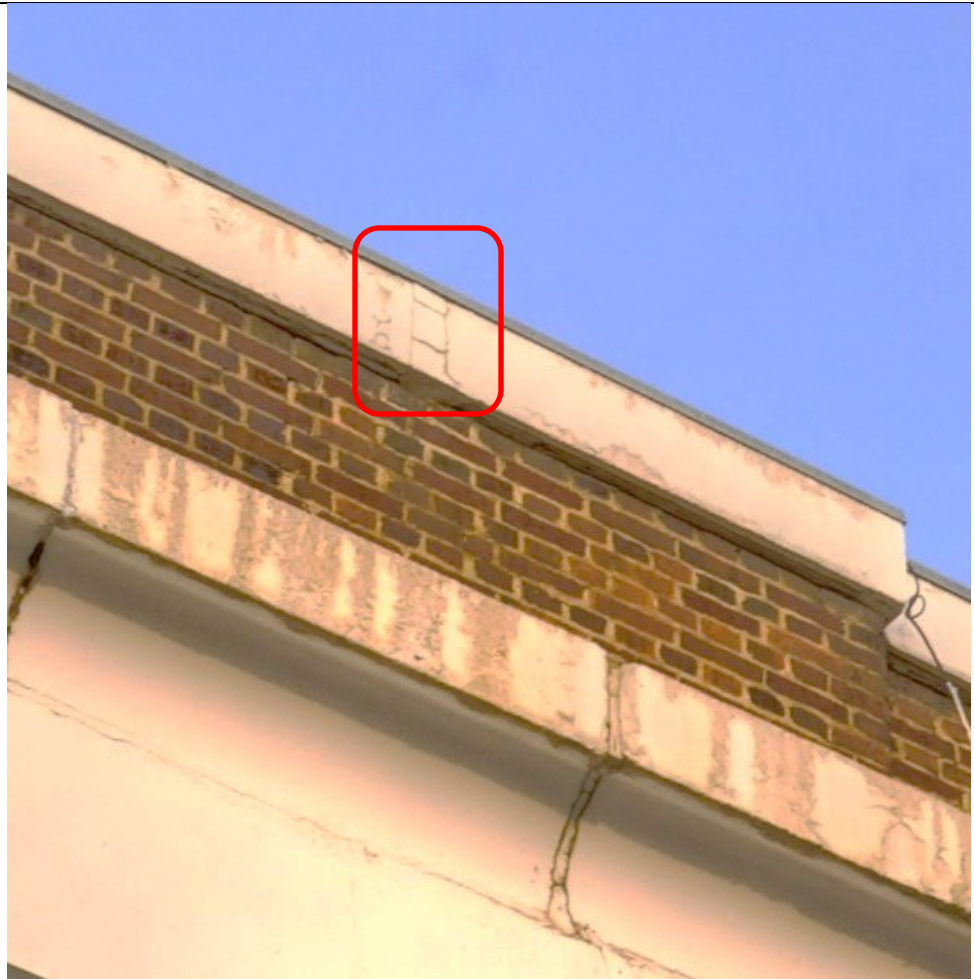
**Coping Cracks:** Cracks located on east elevation coping cast masonry unit could pose a human health and safety concern. Cracks may be due to moisture ingress. This is an isolated occurrence.

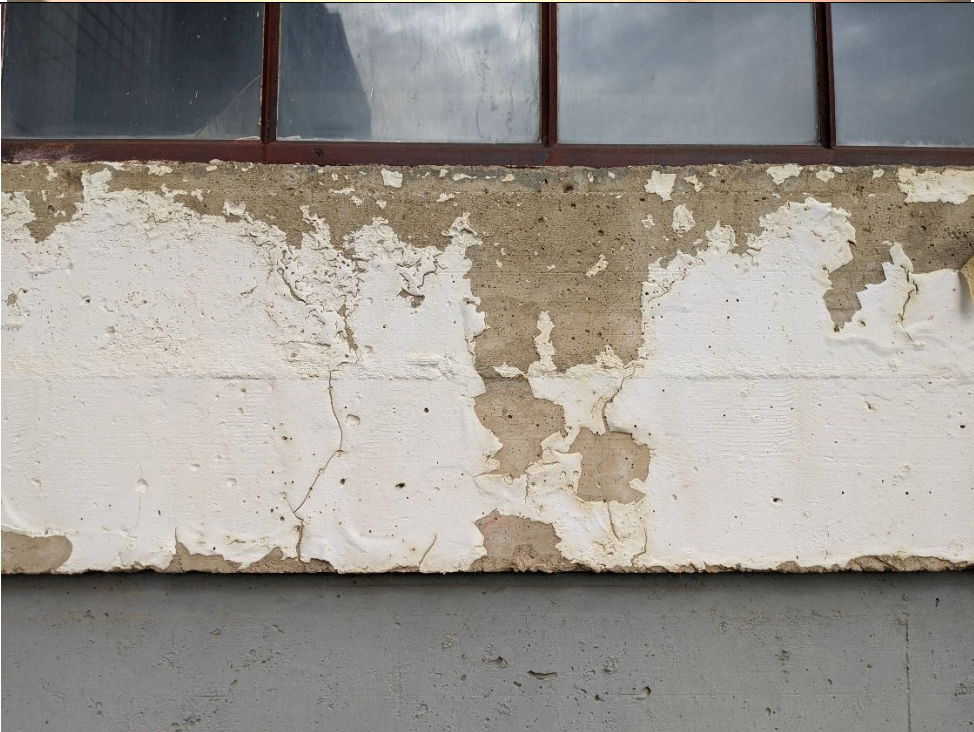
**Failing Paint on Concrete Surfaces and Cast Masonry Units:** Non-original paint on cast-stone/masonry units is failing. Appears to be a type of Poly-Vinyl or Latex, or combination thereof, due to the way it is peeling.

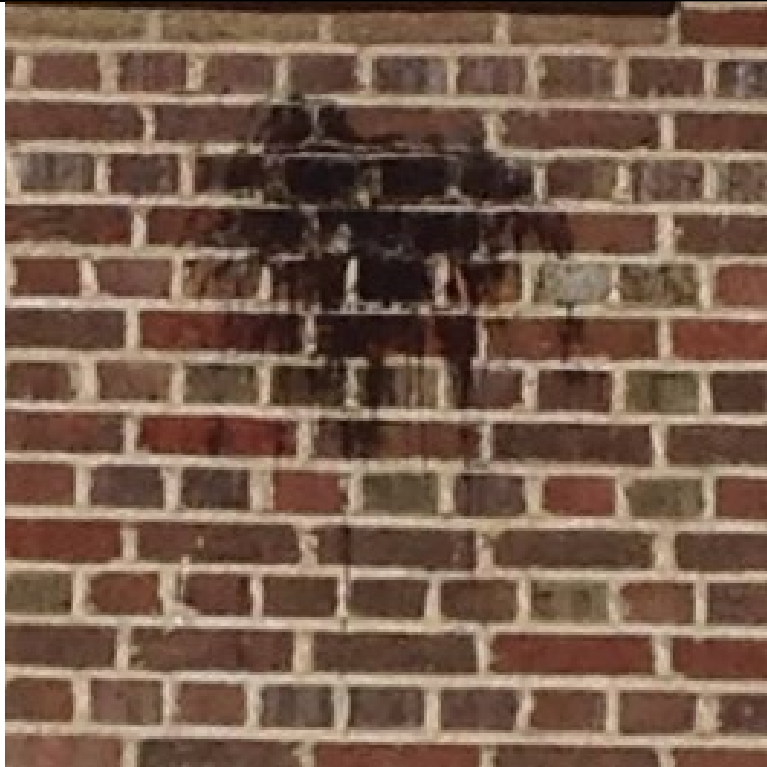
**Bituminous Stain:** The south elevation brickwork has a blotchy bituminous stain.

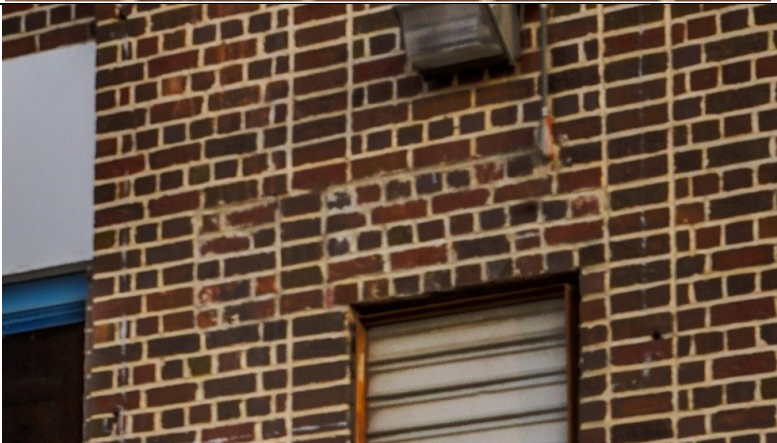
**Poorly in-filled Brick Patch, South Elevation:**  
A poorly executed or non-matching brick-infill patch.

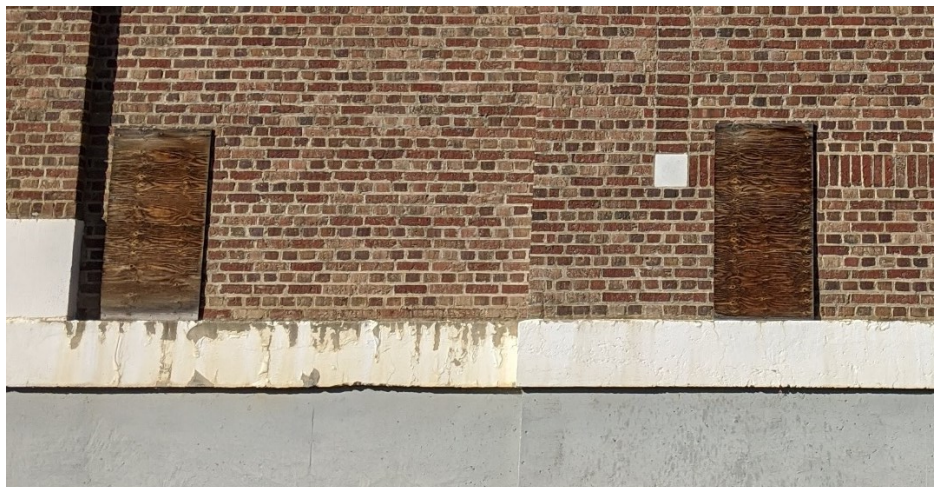
**Boarded-Up Elements, East Elevation:**  
It is likely that various relict services have been boarded-up with plywood on the east elevation.

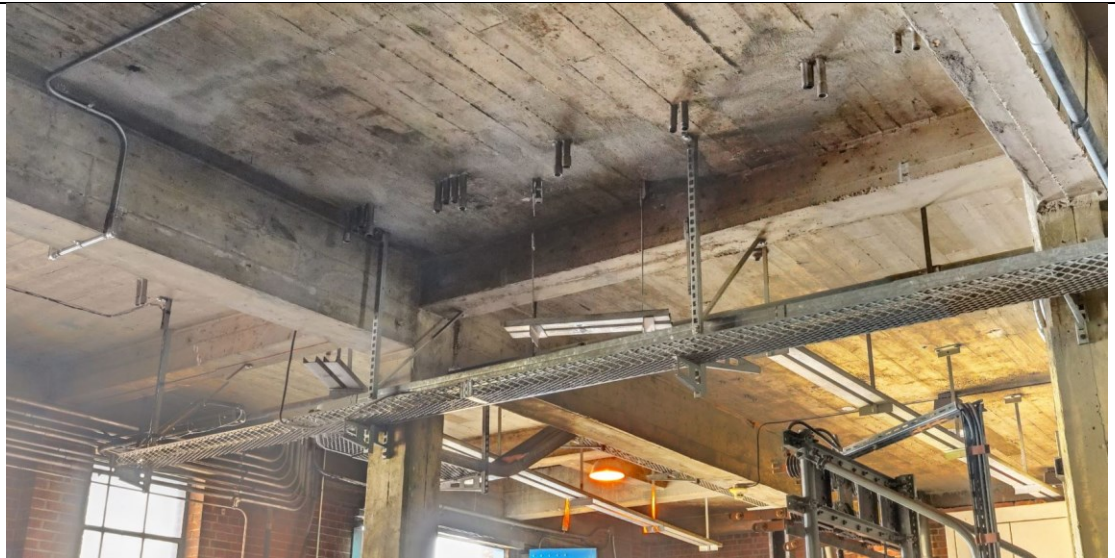
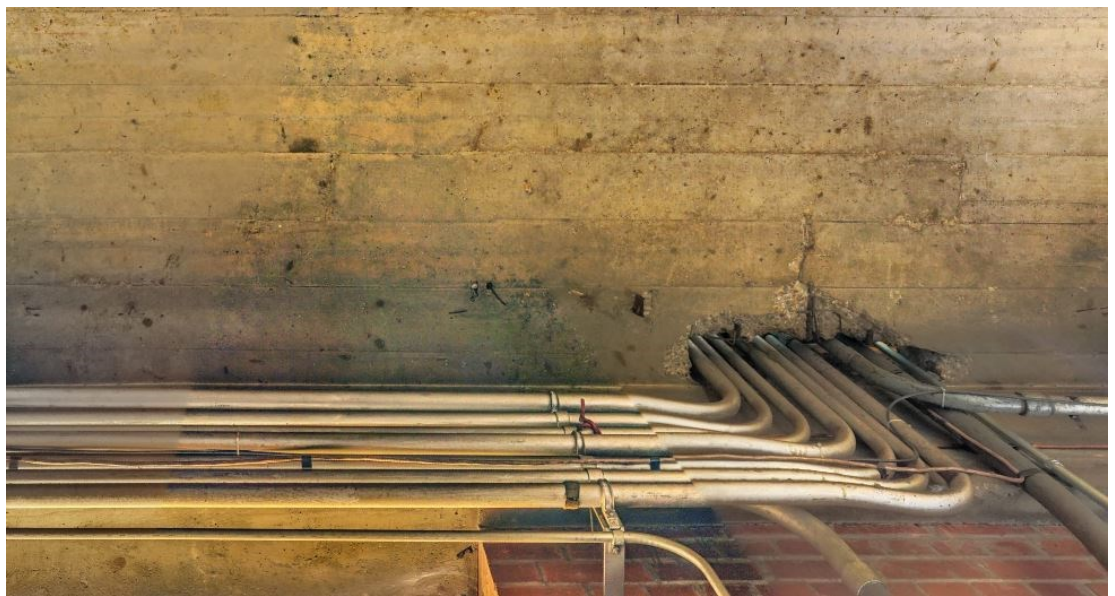
**MN-101, Cable Trays and Relict Hangars:**

All cable trays and the myriad of relict hangers and various fixtures are all in good shape, presenting no observed hazards.

Ad-hoc electrical chases have been made through walls and floor slabs, but have not overly affected heritage or architectural fabric in an adverse way (minor crack/spalling as seen in lower photo).

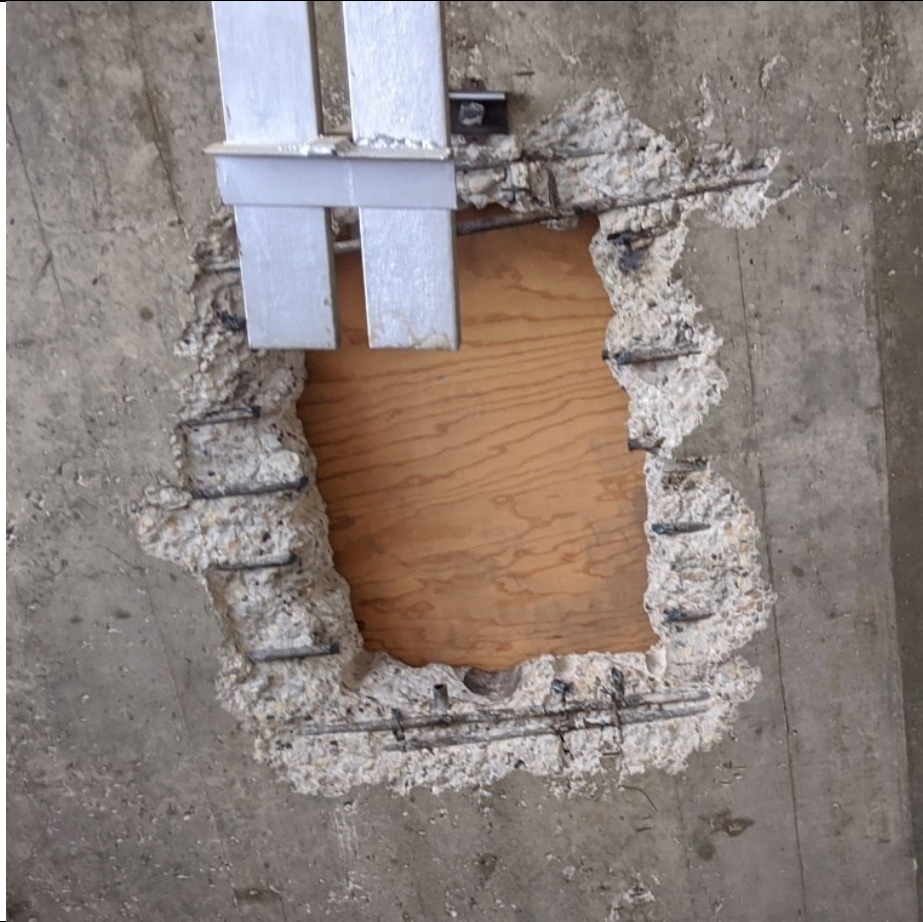
**MN-101, Main  
Operating Floor  
Ceiling/Rectification  
Room Access:**

Access/mechanical/electrical opening roughly made, so that floor slab reinforcement has been exposed.

Openings have been covered with plywood for human health and safety. Photograph displays opening from underside of floor assembly, visible from the main floor of the Switch House.

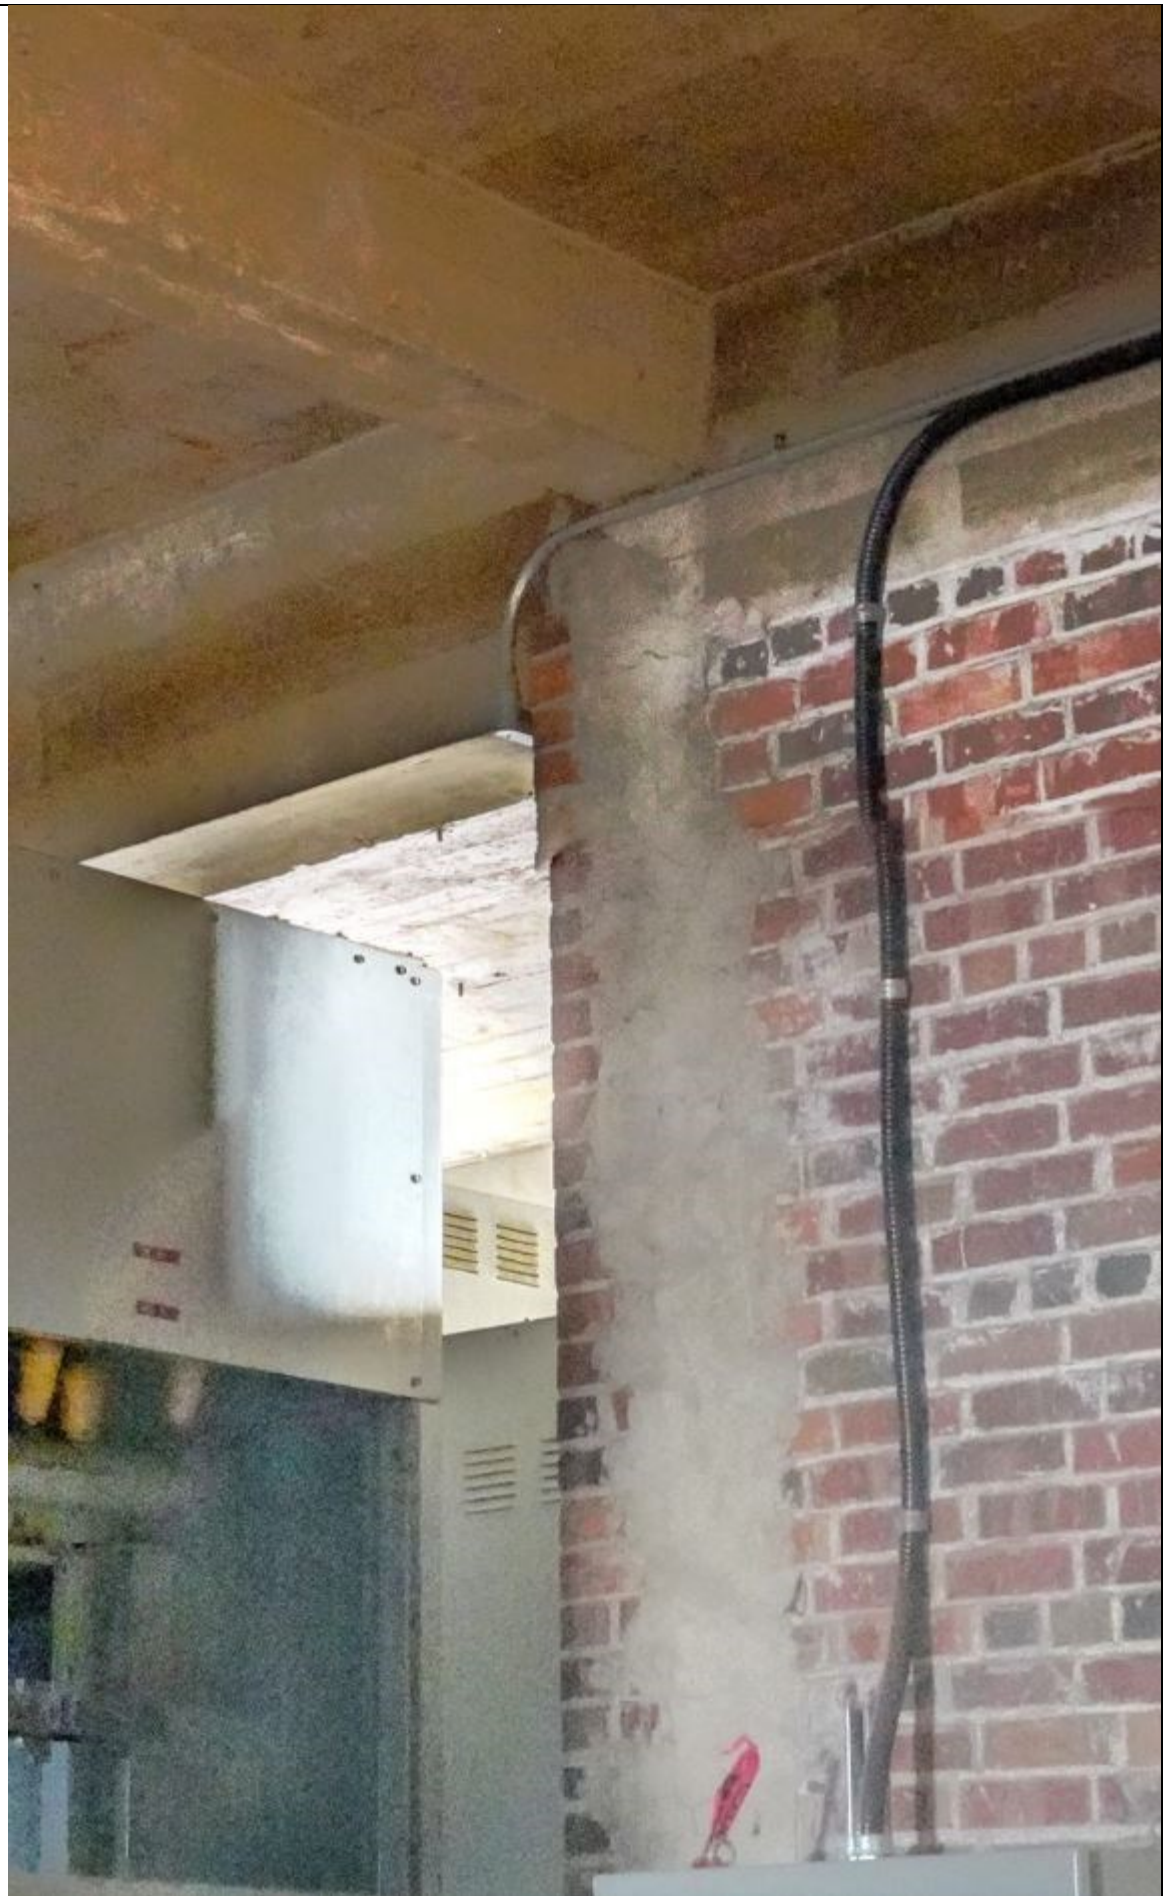
**MN-101, Main  
Operating Floor,  
South Elevation  
Cementitious Patch:**

Reason for patching is unknown. It is perhaps an infilled mechanical/electrical chase — but it is also possible that it relates to a previous repair of a masonry crack, particularly considering the location of a bearing beam directly above this location. This should be monitored.

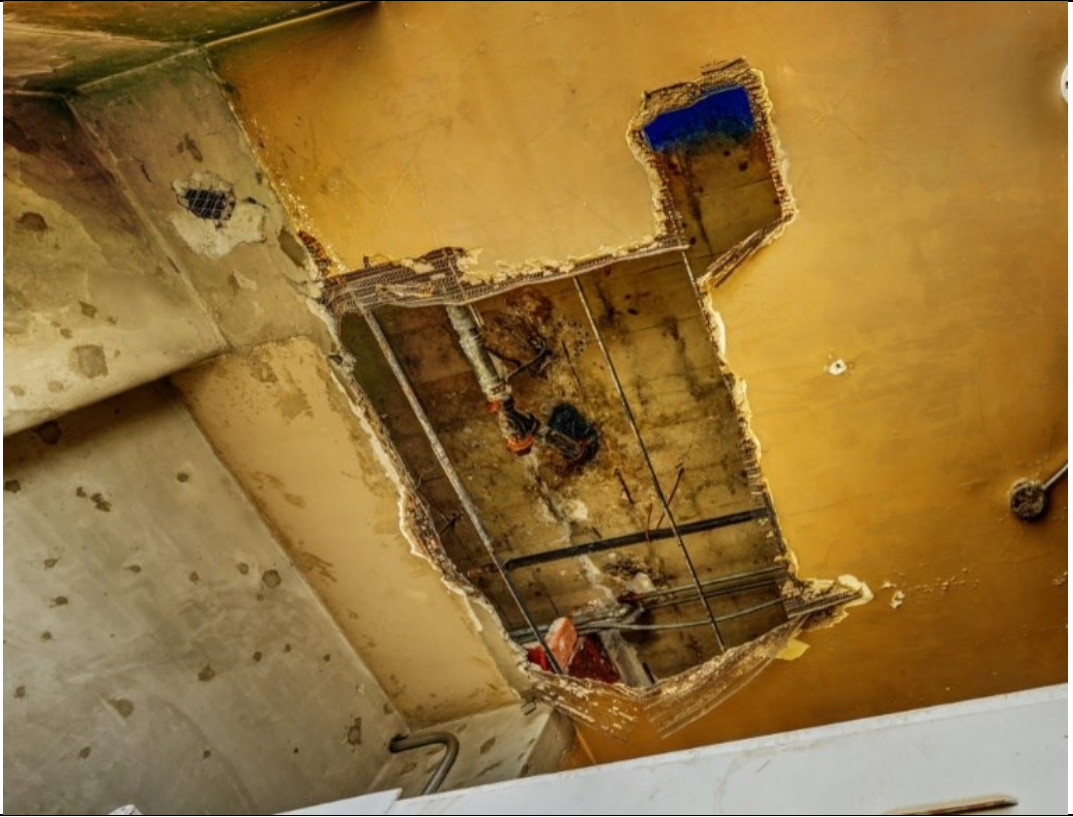
**Opening in Plaster Ceiling, MN-102:**  
Opening is likely a cut-out due to a mechanical failure of the plumbing system (the washroom being right above this location), but may also be from demolition and abatement (plant decommissioning) related investigation works.

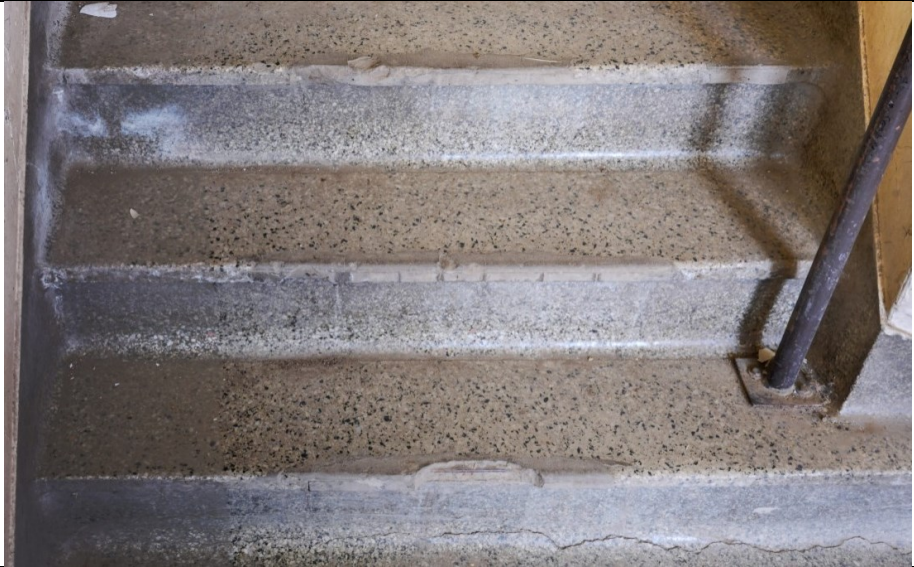
#### **MN 107, 02-103, 02-107, 1<sup>st</sup> to 2<sup>nd</sup> floor Stairwells, Terrazzo Tread Spalls:**

Leading tread arris' have spalled, likely due to human use, but may also be due to an inherent vice of lack of strength/design detailing. Many missing sections have been crudely repaired with unsympathetic cementitious patch material — this too is failing. Ferrous stair reinforcement is visible, and appears to be lightly corroded (passivated). There is soiling on all stairs, including some salt staining on the lowest few treads.

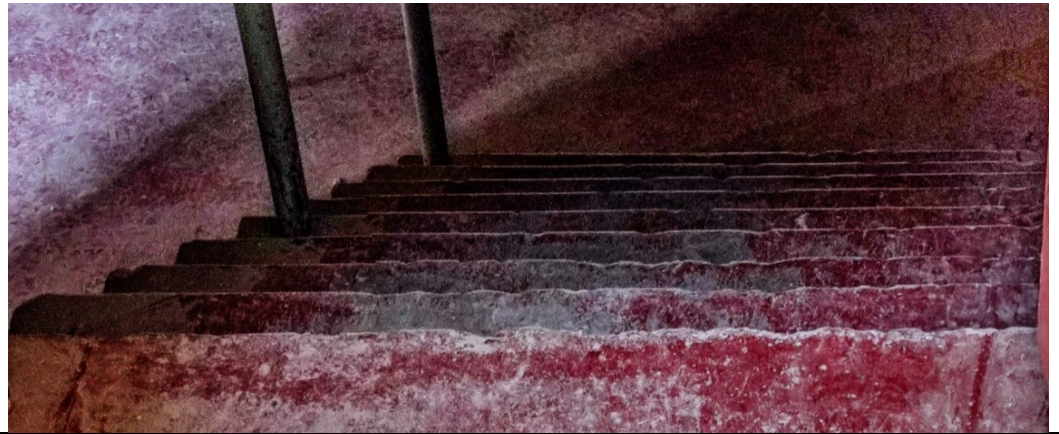
#### **MN-103, North Main Floor Stairs, Concrete Tread Spall:**

Leading tread arris' have spalled, likely due to human use, but likely also related to equipment transportation, industrial usage, and various construction activities over time.

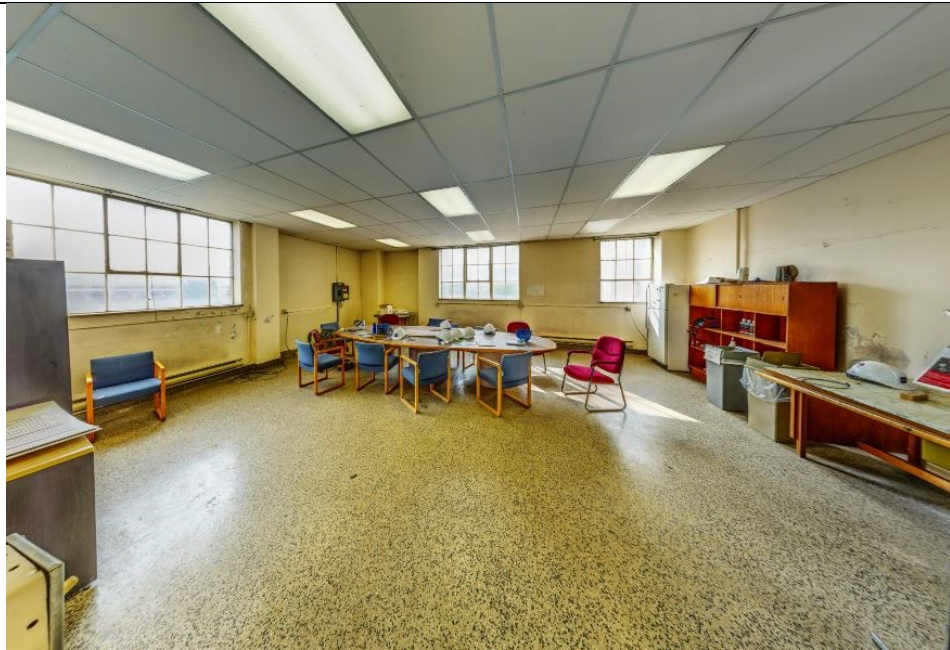
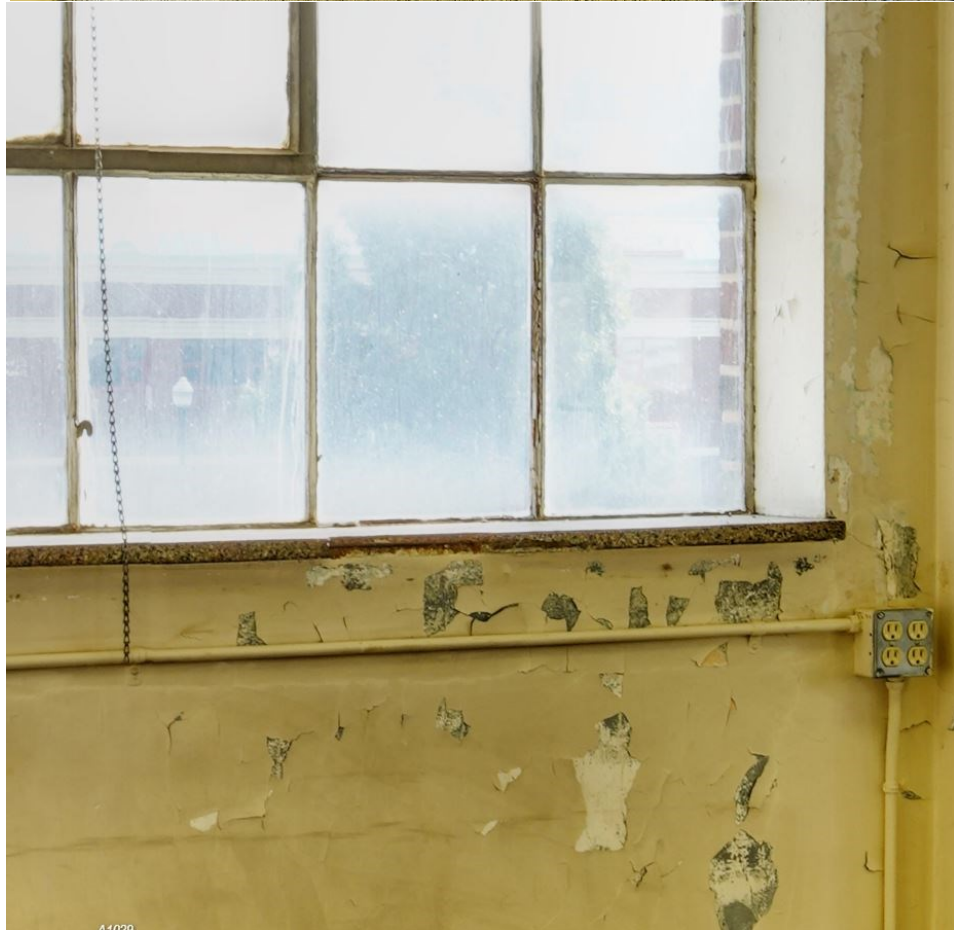
**02-104, Lunchroom:**

One window sill does exhibit a spall at its overhanging arris edge and lightly corroded metal reinforcement.

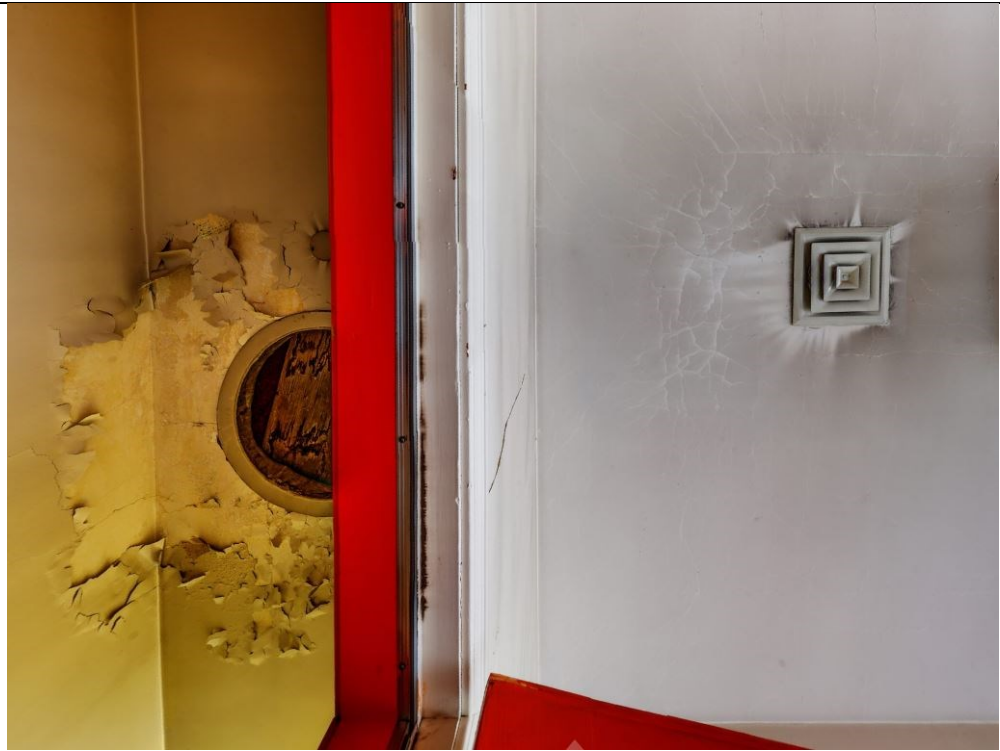
**02-108, Common Office, Finishes and Vents:**

Wall and ceiling finishes are in good condition, except for above the doorway. It appears that the vent unit has suffered from water ingress, much like the battery room. This is likely associated with water ingress at the location of an older ventilation unit, now gone, in the central corridor (02-114) which has strong evidence of water ingress as seen in the paint failure.

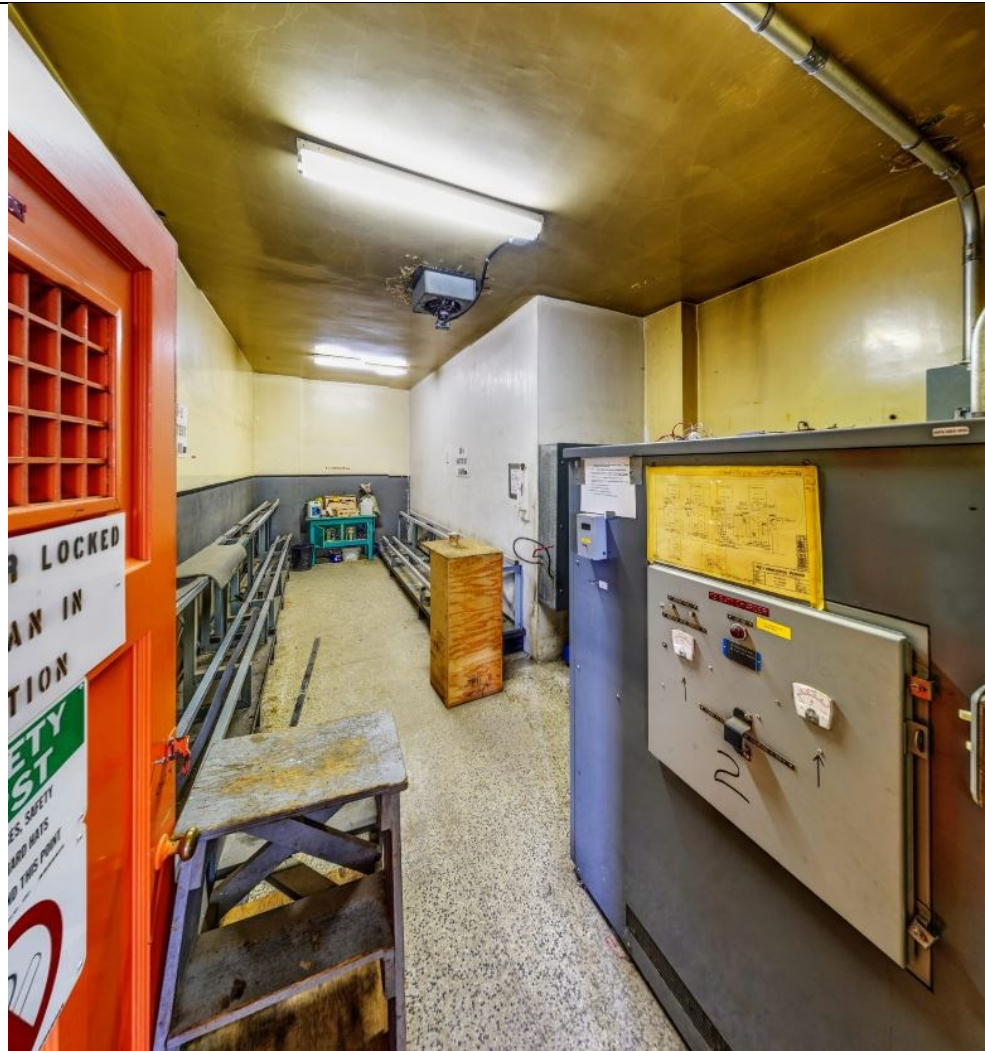
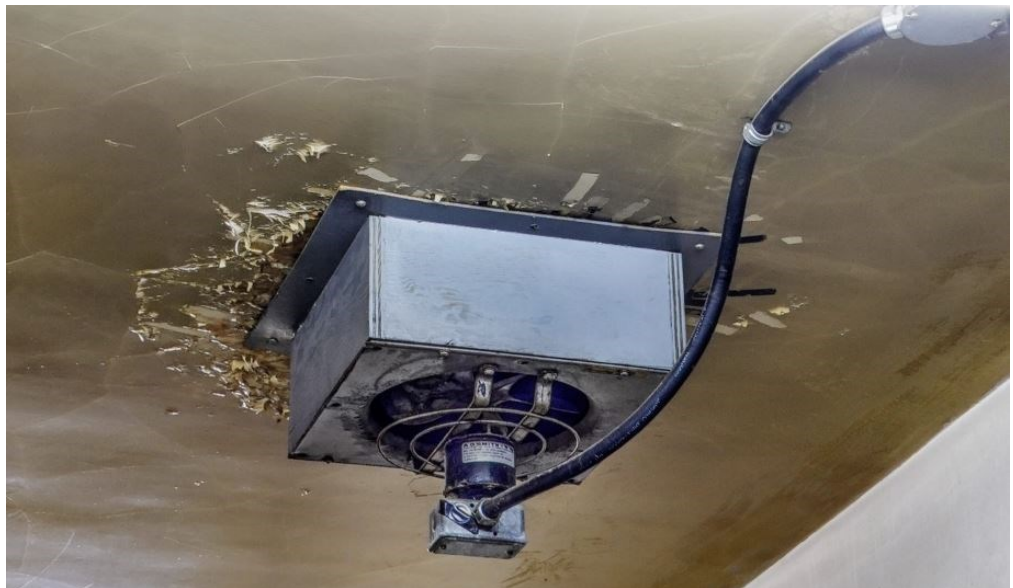
**02-105, Battery Room:**

The battery room is in good condition, its terrazzo floors and painted wainscoting is in excellent shape, along with most of the walls. All surfaces are soiled. The ceiling is in fair to poor condition. Of particular concern is the area surrounding the vent box, which is exhibiting some failure and finishes are beginning to show stress spider cacking emanating from the sagging fan unit. This may be due to vibration of the unit, water ingress, the load of the fan unit, or some combination therein.
