# Rossdale Power Plant Advanced Assessment and Priority Rehabilitation

## Switch House Condition Assessment

**Submitted to: City of Edmonton**

**Date Submitted: 2021-03-15**

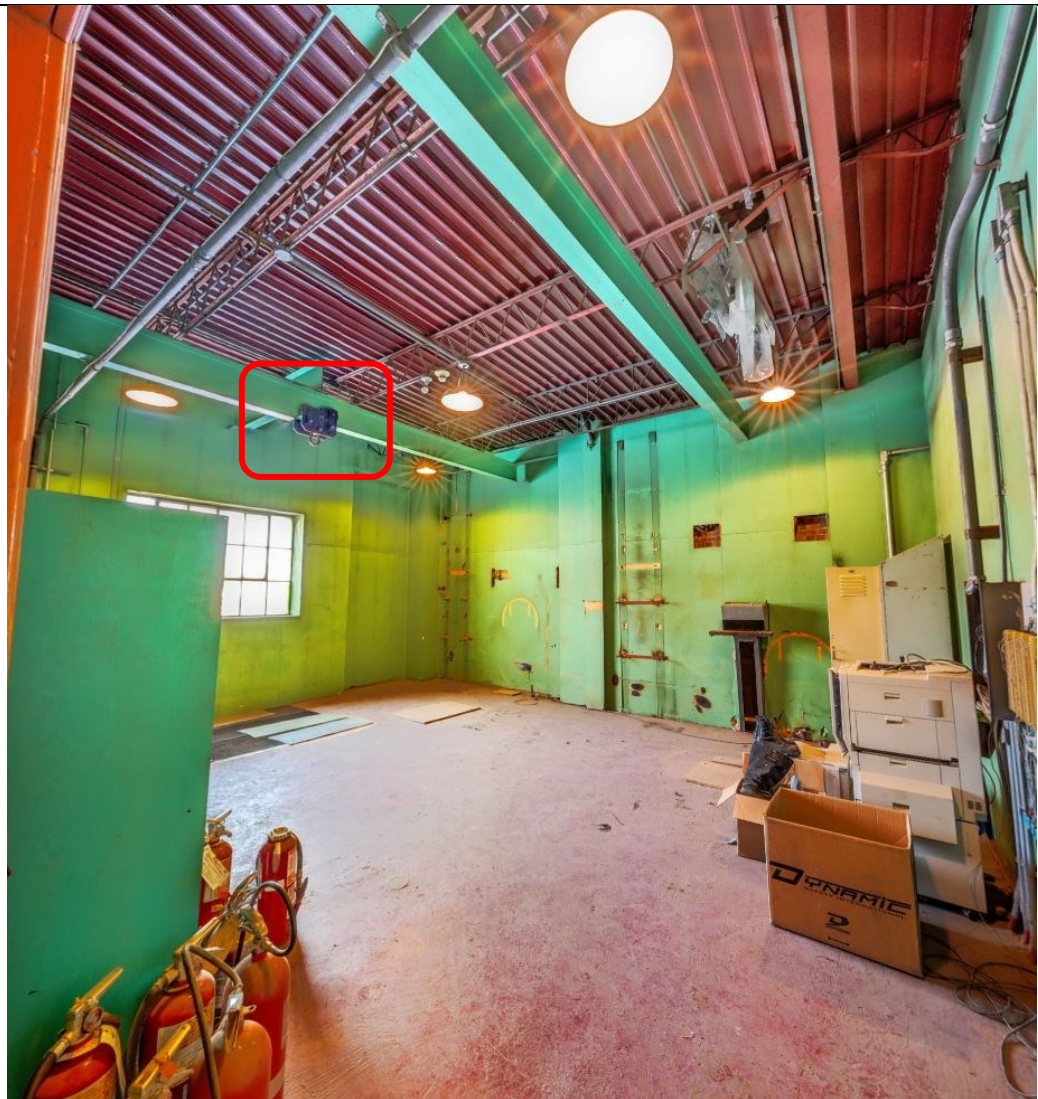
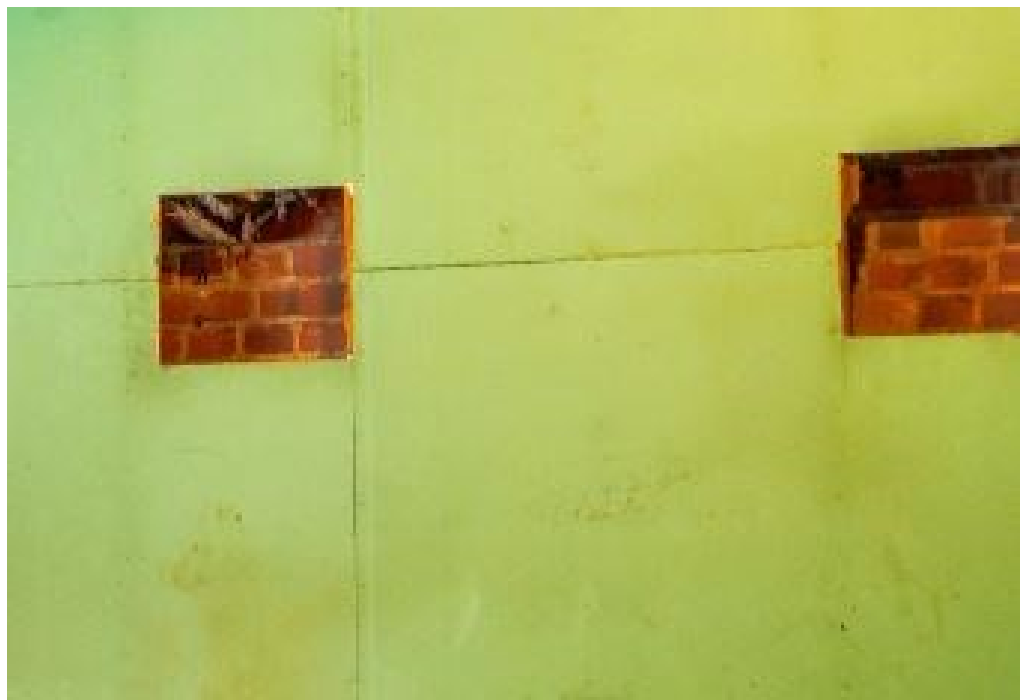
**02-113, Rectification Room:**

All in good working condition, however mechanical services cross the travelling pathway, and there is a notable lack of trolley stops. Trolley encircled in red.

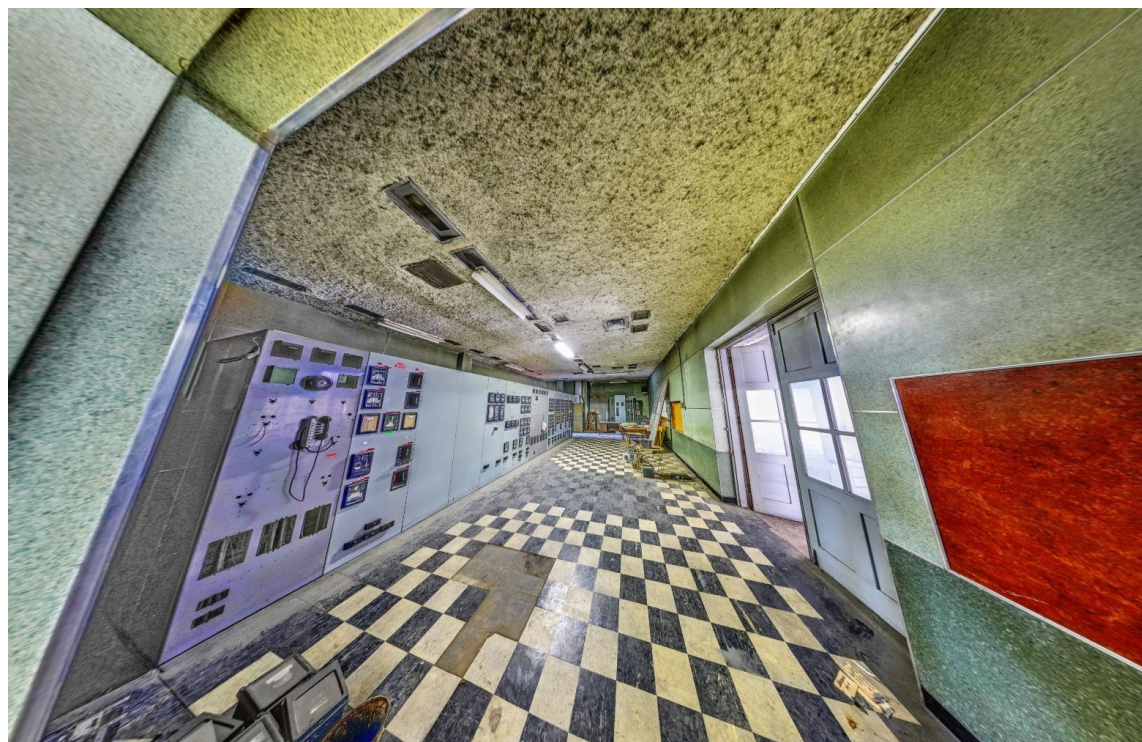
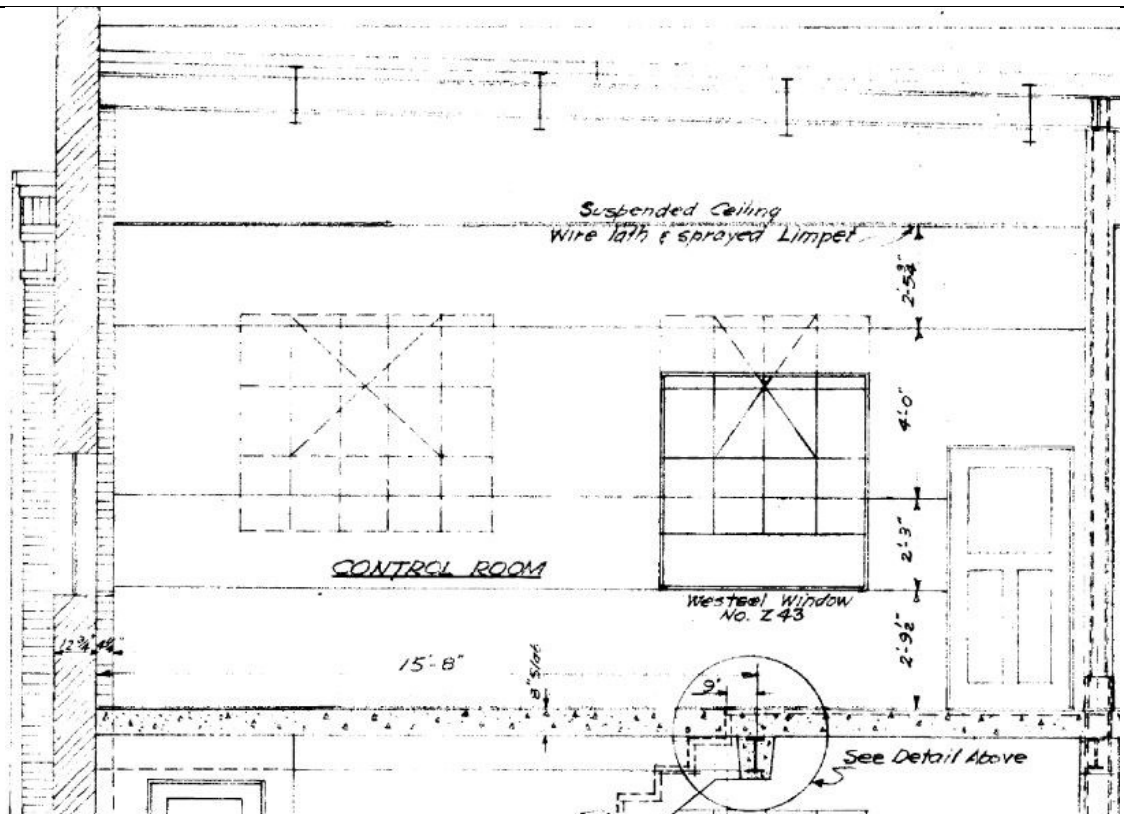
**02-110, Switch Room:**

The flooring is missing various checker board units, and some are damaged. All equipment is in excellent condition.

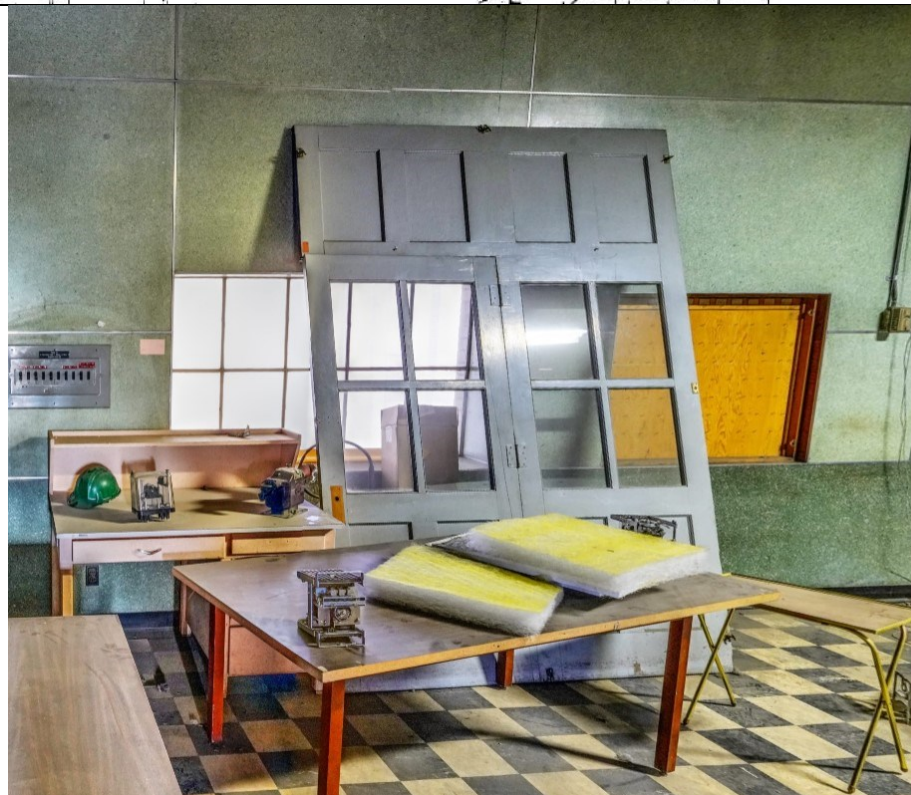
**02-111, Juliet  
Balcony,  
Disassociated Door:**

The inner set of the  
double french doors  
has been removed  
nearby to the Switch  
Room.

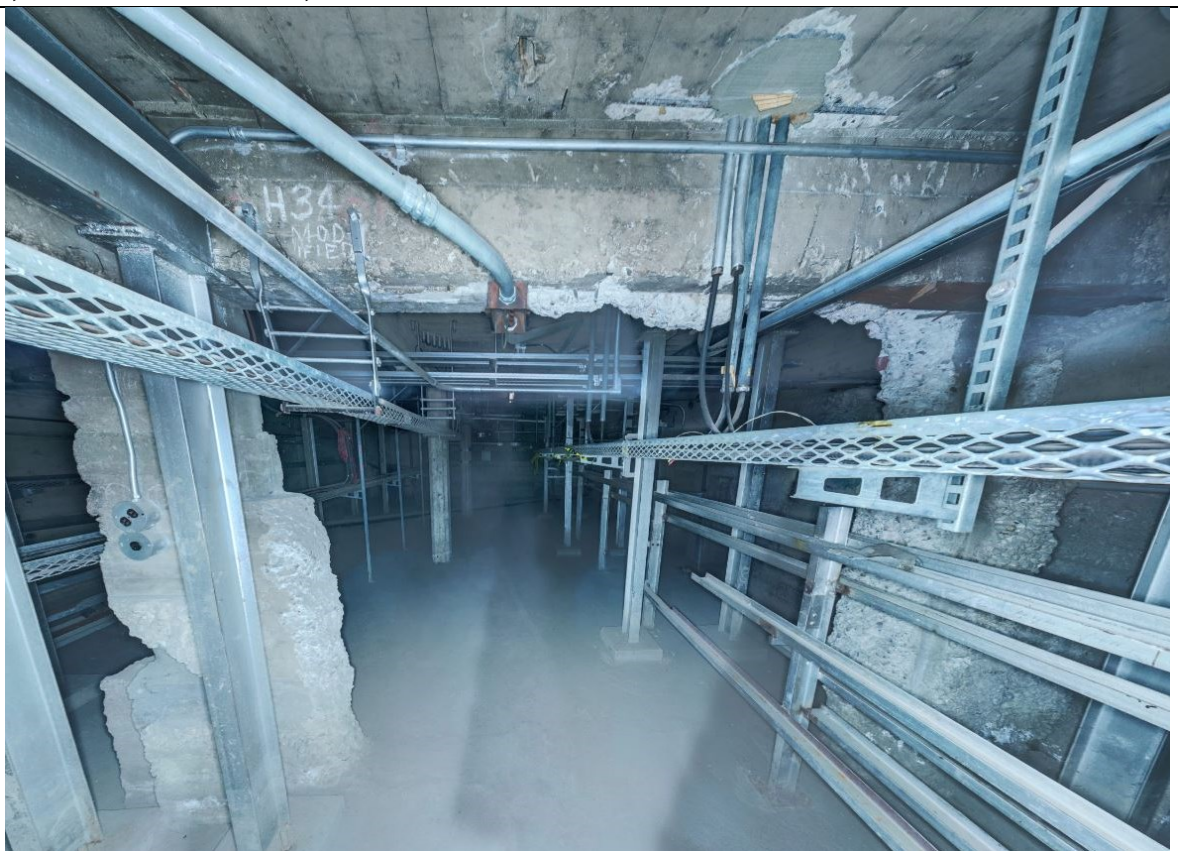
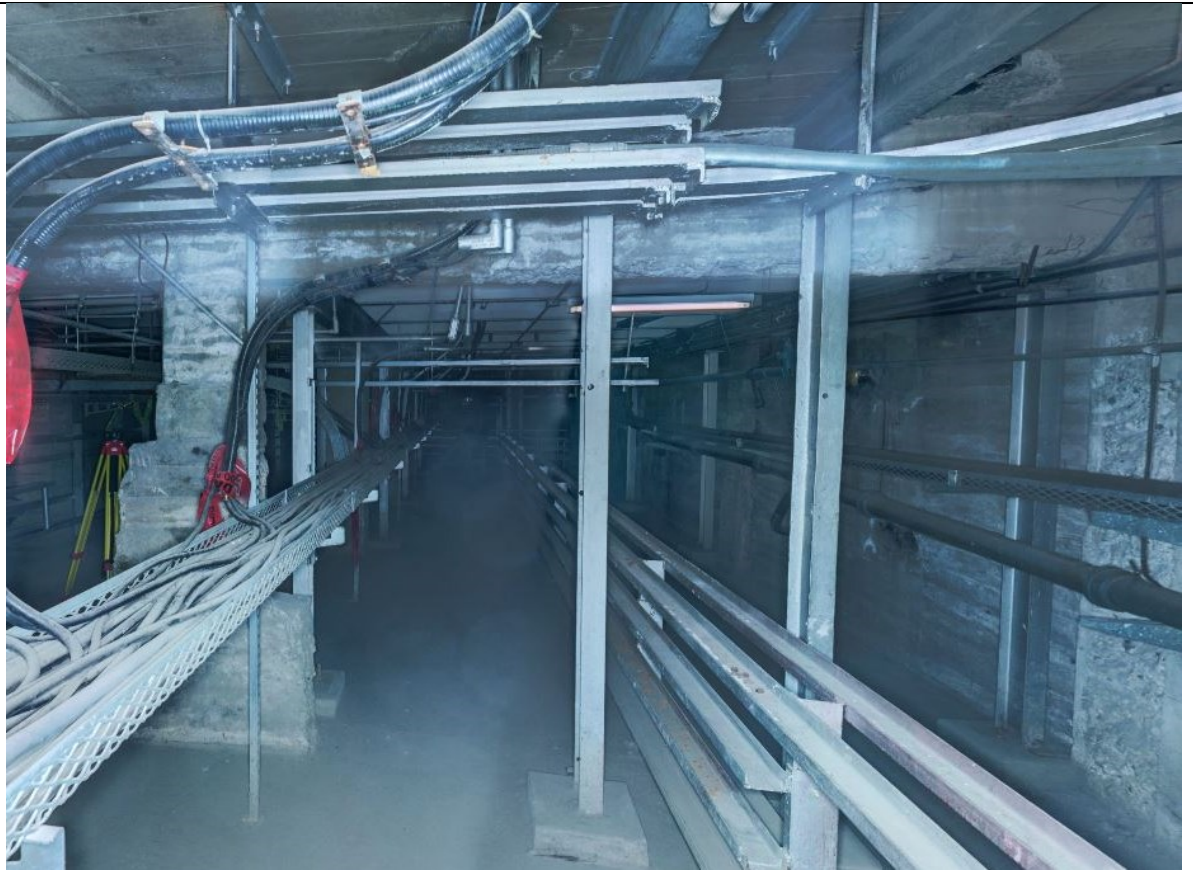
**2.3.4 BM-101 & BM-105, Switch House Basement, Conduit Rooms**

There are multiple losses to wall sections. Over time new openings were created for human access and new services. Some of these walls were likely the perimeter foundation for the earliest Switch House, as it was constructed over two phases, in 1941 and 1947.

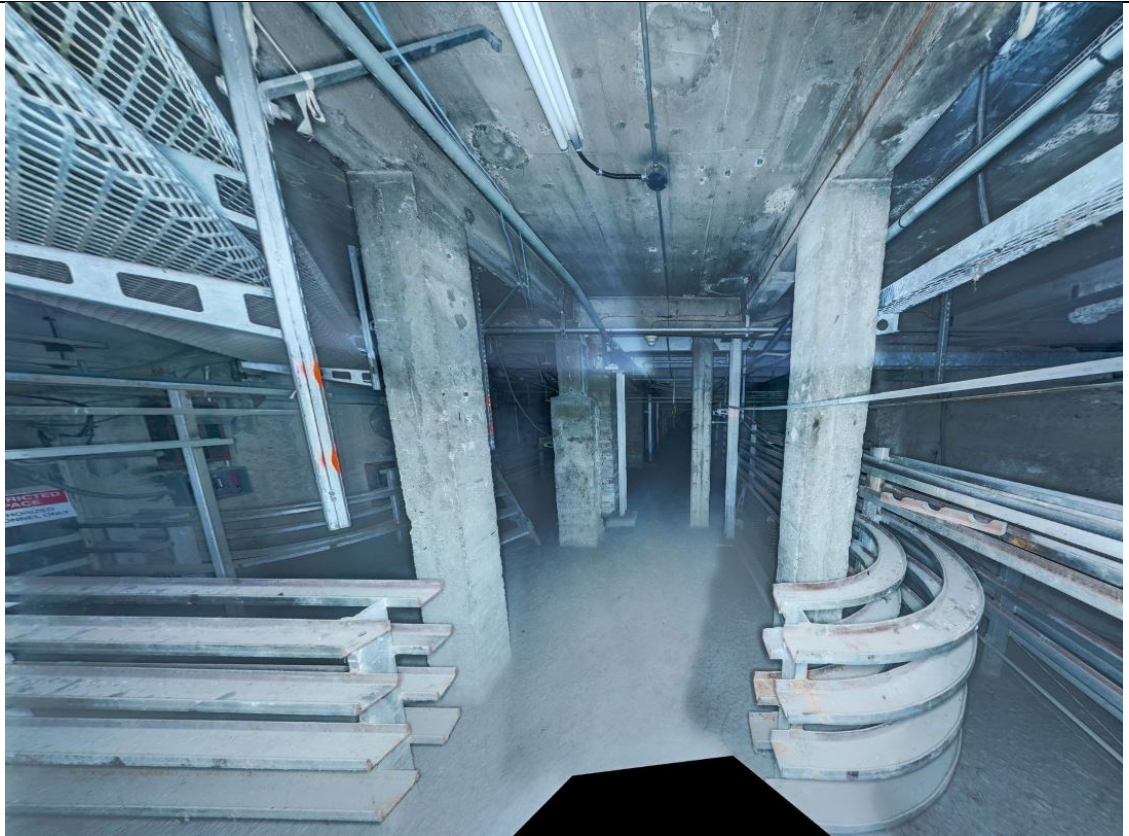
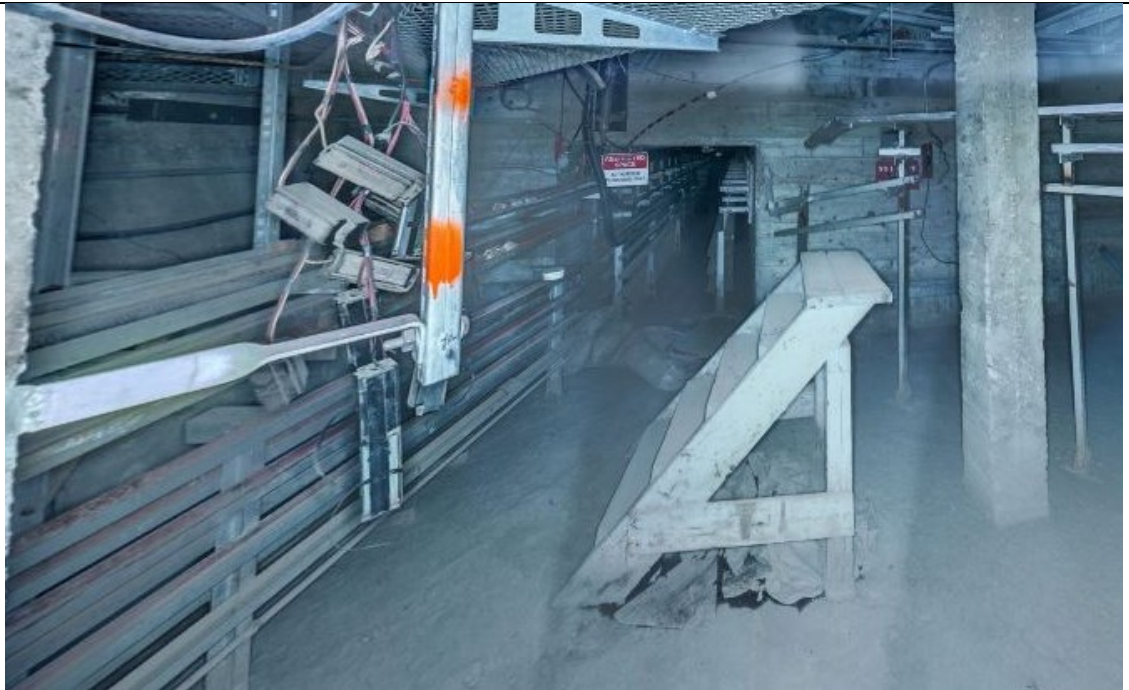
**BM-101, Relict Cable Trays:**

The basement obsolete cable trays are extensive. They have been cut for access, likely during plant decommissioning demolition and abatement work. Pairs of wood ladders remain that once served as access bridges for maintenance and servicing access.

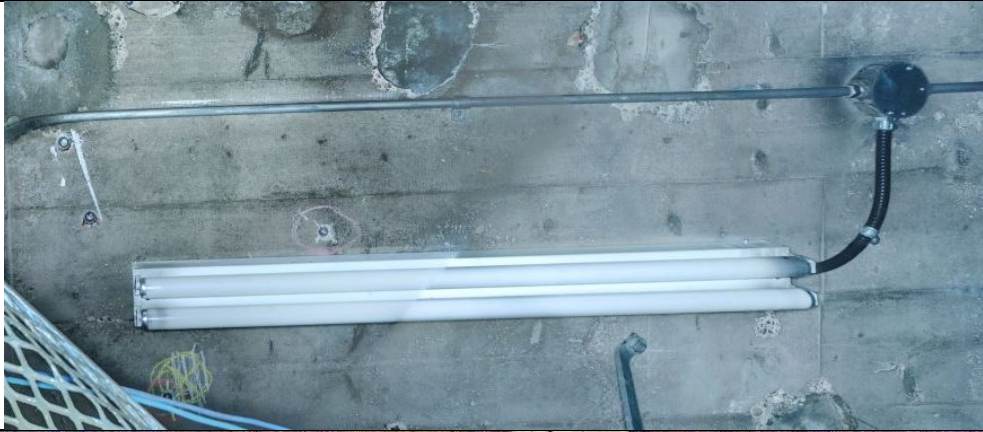
**BM-101 & BM-105, Lighting:**  
All fluorescent light tubes require replacement, fixtures remain operable.

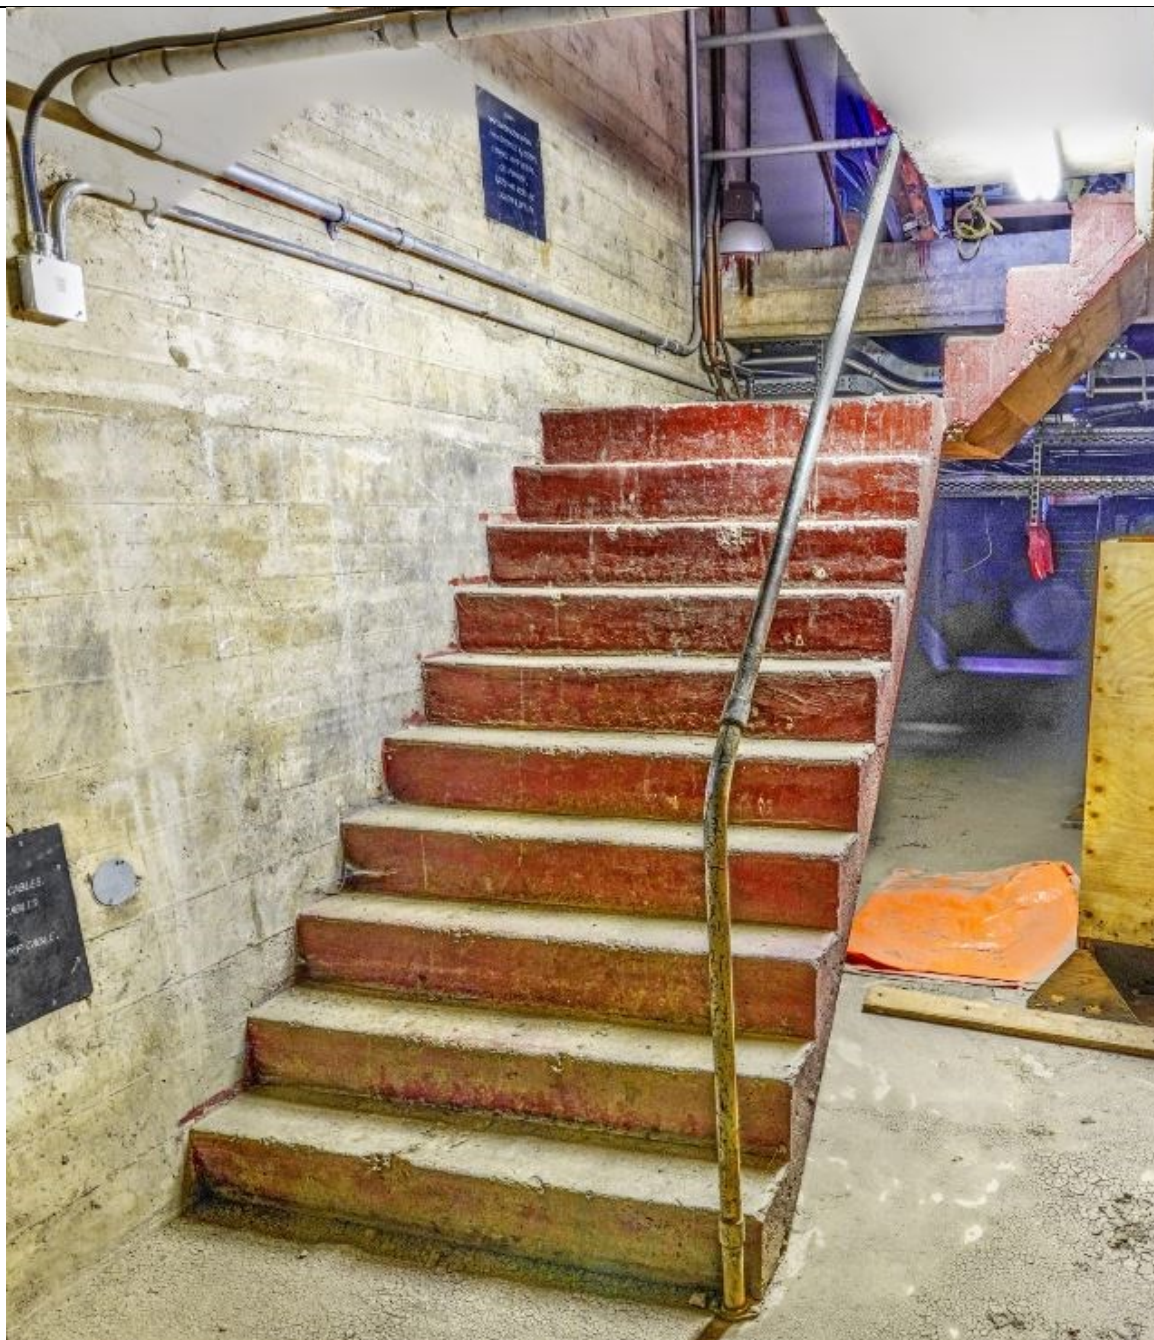
**BM-105 to MN-101, Stairs:**

Please also note that there is a fine layer of soil deposition throughout the basement floor. This is due to flooding which originates from the electrical shaft/tunnel to the east of the switch.

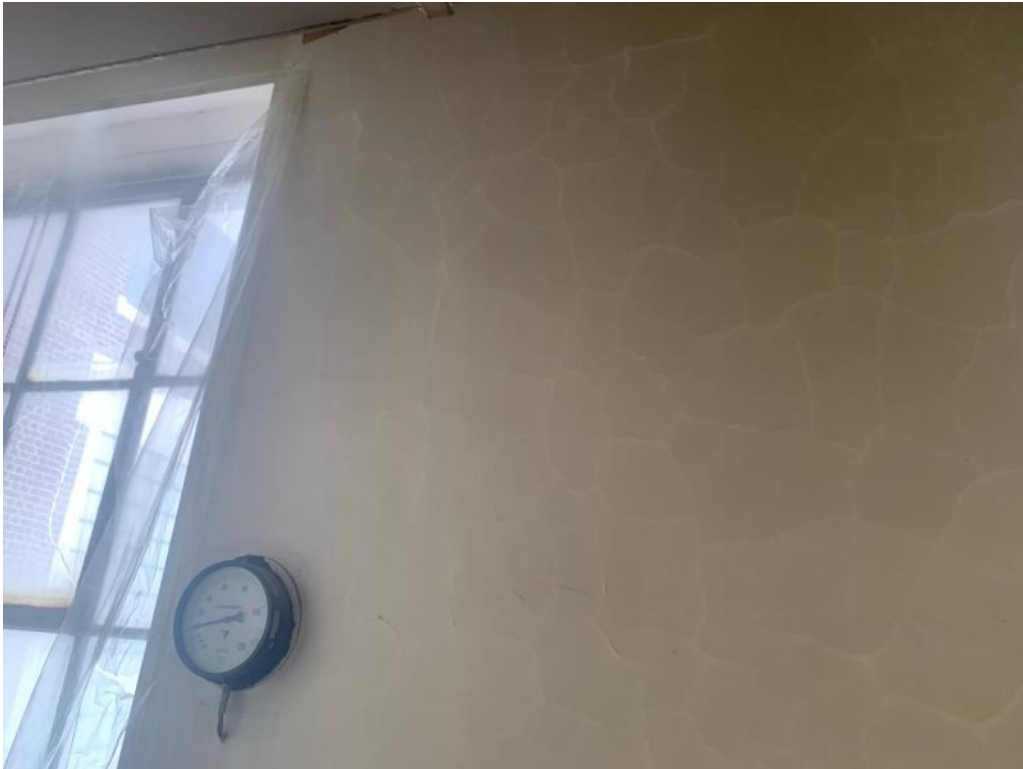
Above: Switch House – Drywall damage on 2<sup>nd</sup> floor
