October 4, 2019

Subject: Preliminary Geotechnical Assessment Report

North Shore Promenade

River Bank between Walterdale Bridge and Groat Road Bridge, Edmonton, Alberta

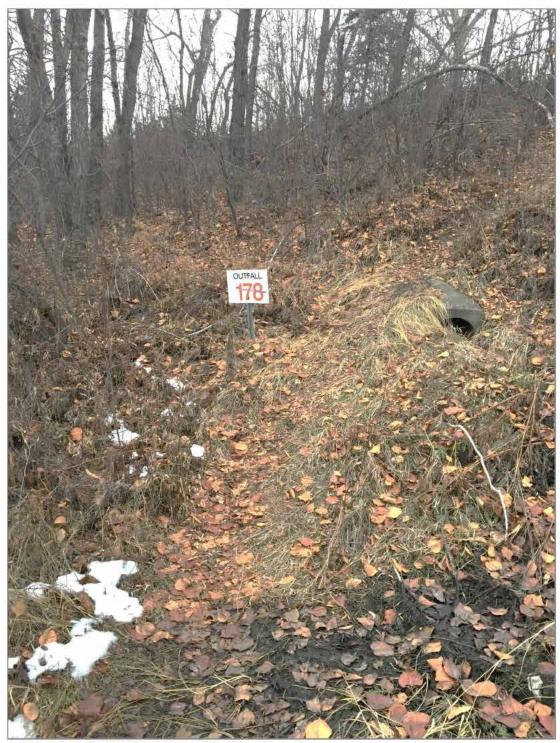
Photo 1: Outfall 178 at Mid-height of River Bank Slope

- Where existing outfall structures discharge on the middle or upper portion of the river bank, these outlets may
 need to be extended down to river level. For outfalls that exit close to river level, it would be advisable to raise
 the elevation of the promenade to be founded above the outfalls. Additional erosion protection and stabilization
 measures may be required where development is planned near the outfall locations.

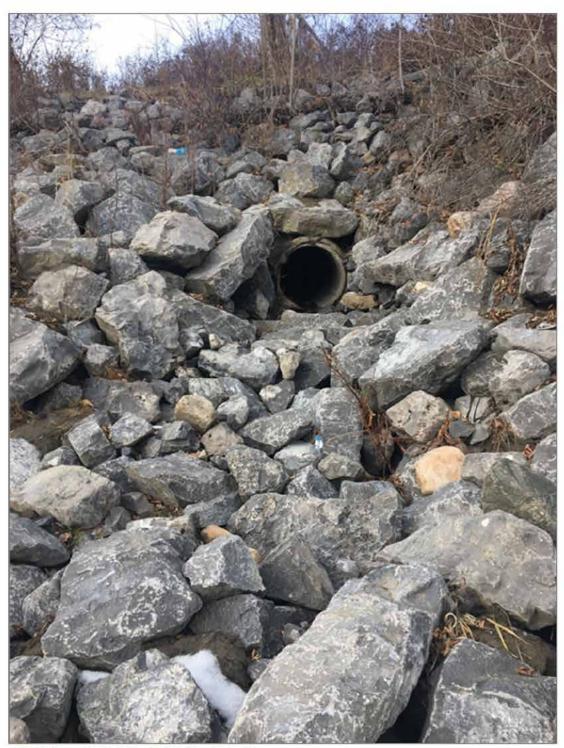
Photo 2: Outfall 33 with Rip Rap Protection

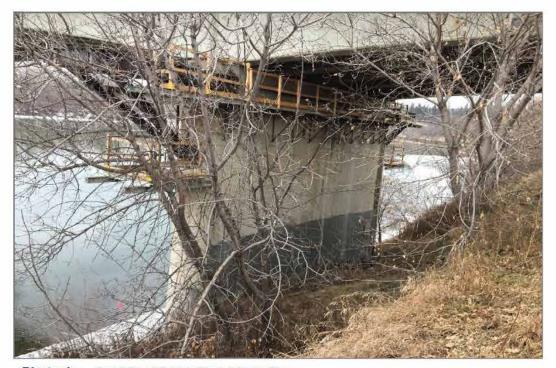
Photo 4: Groat Road Bridge Pier at Slope Toe

- At the west end of the project area, any new development must take into account or be integrated with the
 existing pier of the Groat Road Bridge. The proposed foundations of the promenade should not affect or be
 affected by the existing foundation, based on a geotechnical evaluation

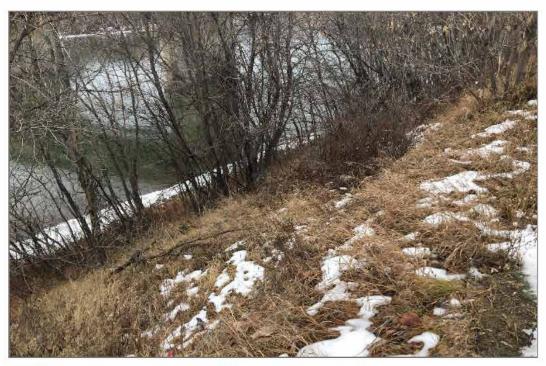
Photo 5: Existing Buried Gabion Wall at Top of River Bank Slope

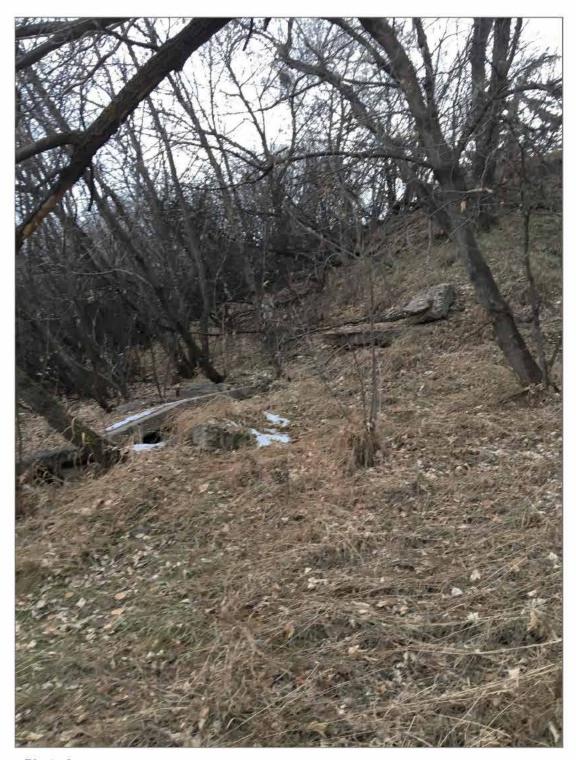
Photo 9: Large Concrete Blocks on River Bank Slope

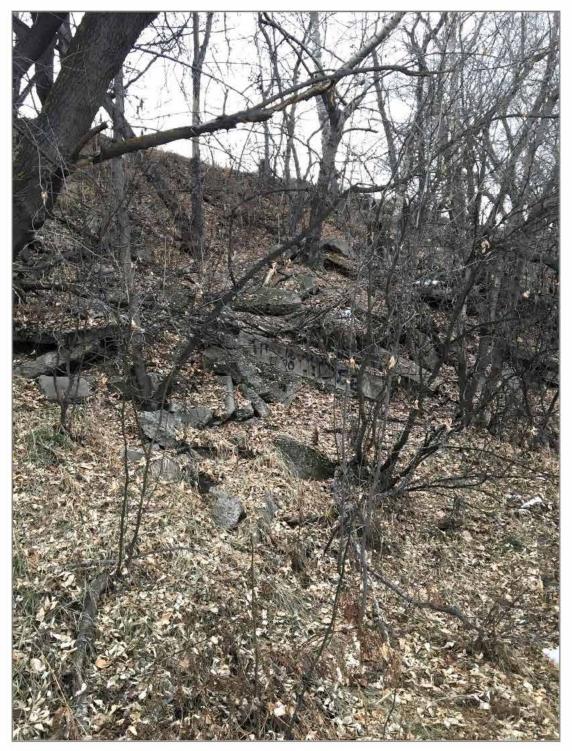
Photo 10: Large Concrete Blocks on River Bank Slope

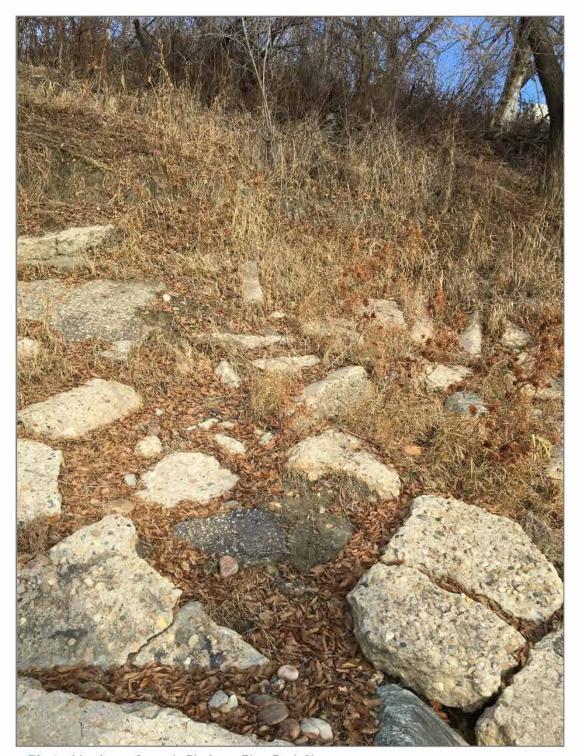
Photo 11: Large Concrete Blocks on River Bank Slope

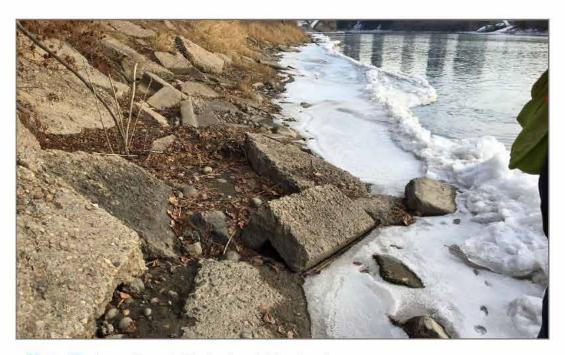
Photo 12: Large Concrete Blocks close to River Level

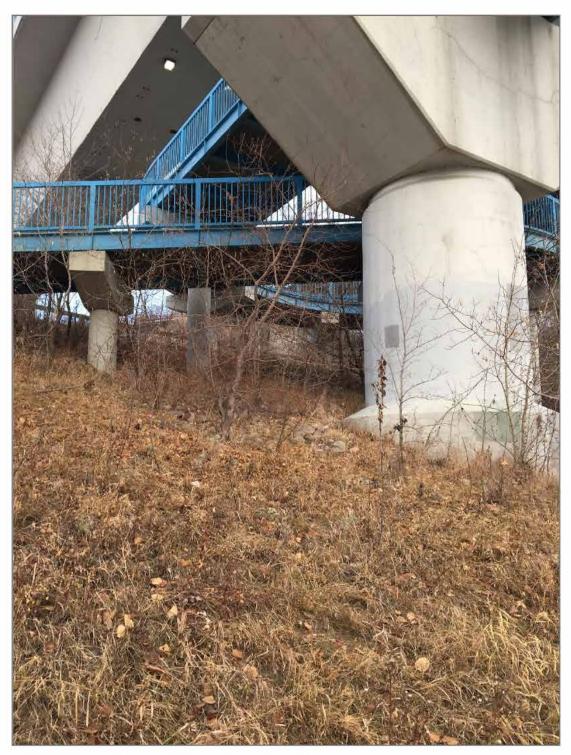
Photo 14: Piers of Existing Footbridge and LRT Bridge

- The proposed foundation of the promenade must not affect or be affected by the existing piers and associated headslope area of the LRT Bridge, ramp structure of the existing pedestrian footbridge, and the High Level Bridge, based on a geotechnical evaluation.

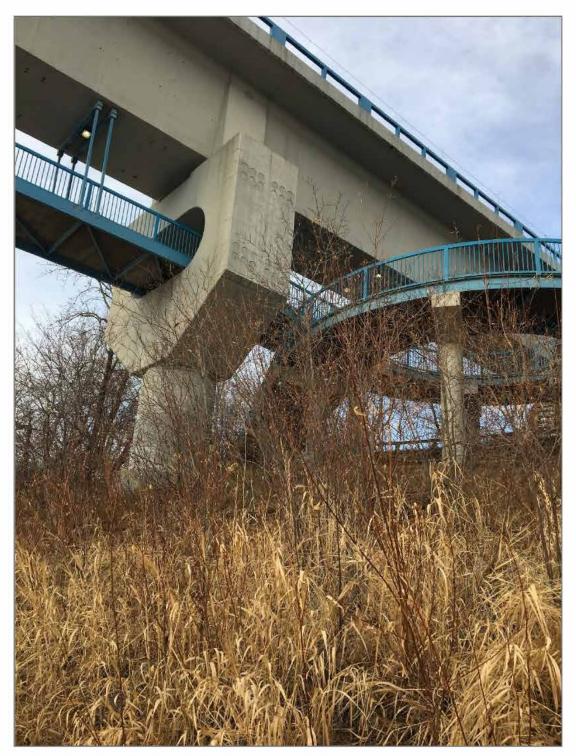
Photo 15: Piers of Existing Footbridge and LRT Bridge

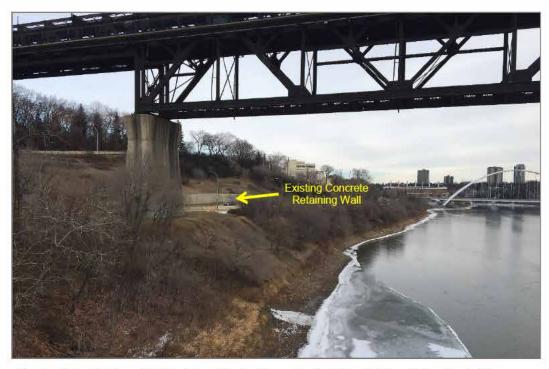
Photo 16: High Level Bridge Pier, Existing Concrete Retaining Wall and River Bank Slope

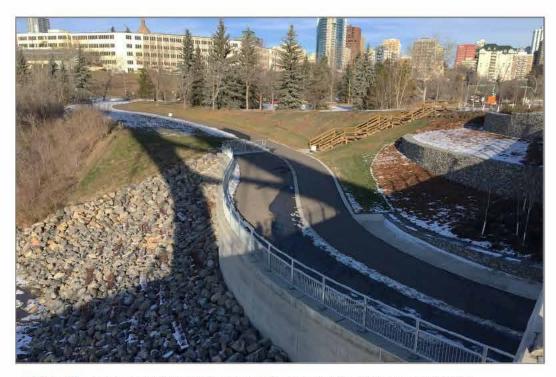
Photo 17: Existing Retaining Wall and Trail near Walterdale Bridge (Looking West)

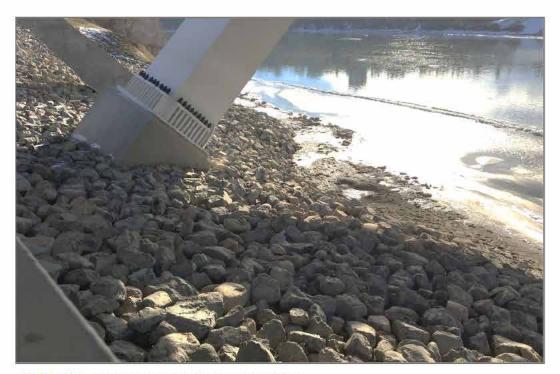
Photo 18: Rip Rap at Walterdale Bridge Abutment

- The new NSP development design must not adversely affect the stability of the newly constructed headslope, retaining wall and abutment foundations of the Walterdale Bridge, based on a geotechnical evaluation.

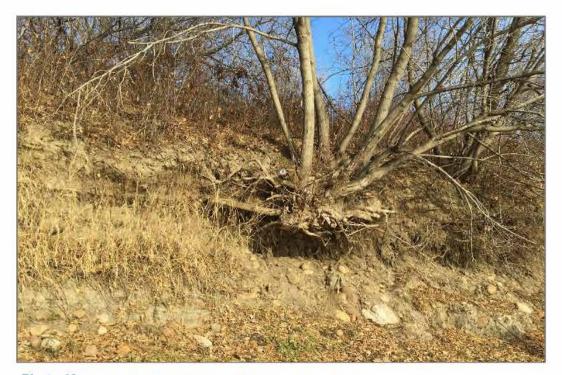
- Evidence of a major slope failure was not observed during the site visit. Minor cracks were observed on the
 paved trails occasionally that may be associated with creep slope movement. Active erosion was observed
 along the river bank slopes at several locations with exposed tree roots as shown in Photo 19.

Photo 19: Eroded River Bank Slope and Exposed Tree Roots
