**City of Edmonton**  
**Valley Line Stage 1 – Light Rail Transit (LRT) Project**  
**Environmental Impact Screening Assessment Update**

**Final Report**

Project Number EP - 576

February 2015

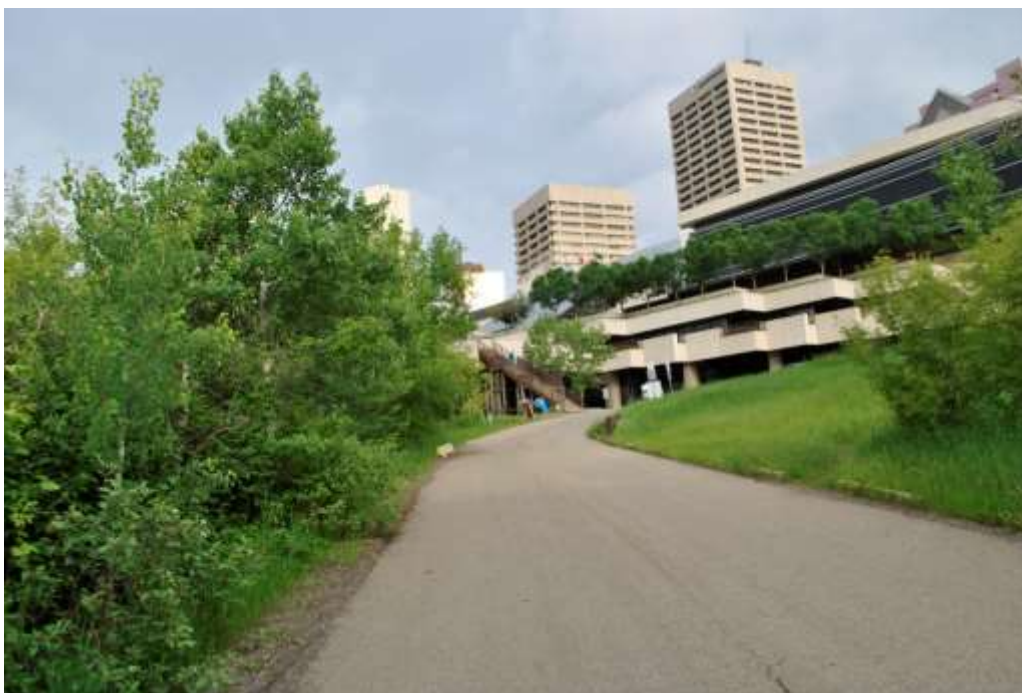
**Plate 2.1. Segment of proposed Louise McKinney Riverfront Park Construction Access Road using existing maintenance road, looking northeast.**

The proposed primary north valley construction access route enters LMRP from Grierson Hill Road near the Shaw Conference Centre, at the park main vehicle access point (Plate 2.1). From there, the access road travels southeast along the existing paved maintenance vehicle access, to the Riverfront Plaza, and then ties into an existing paved SUP (Figure 2.1b; Plate 2.2). The entire route follows existing asphalt, of variable width. Project Co will be required to design and construct the access road to the standard needed to carry out the work safely and without adversely affecting slope stability in the park. Based on the anticipated types of required construction equipment and the anticipated volume of traffic, Project Co is expected to upgrade the existing route. At a minimum, this is expected to involve some re-grading along the SUP to create a road base, and some preparatory work to assure a stable base. The road will have to accommodate two-way construction traffic and must fit within the corridor shown on Figure 2.1b. Temporary fencing may be installed to ensure safe separation of the route from public areas. The tight curves and narrow width of the existing access road from Grierson Hill to the Riverfront Plaza may be unable to accommodate large construction equipment. Thus, at this stage the City has not ruled out the need for Project Co to widen that route, which may require some clearing into adjacent natural vegetation.

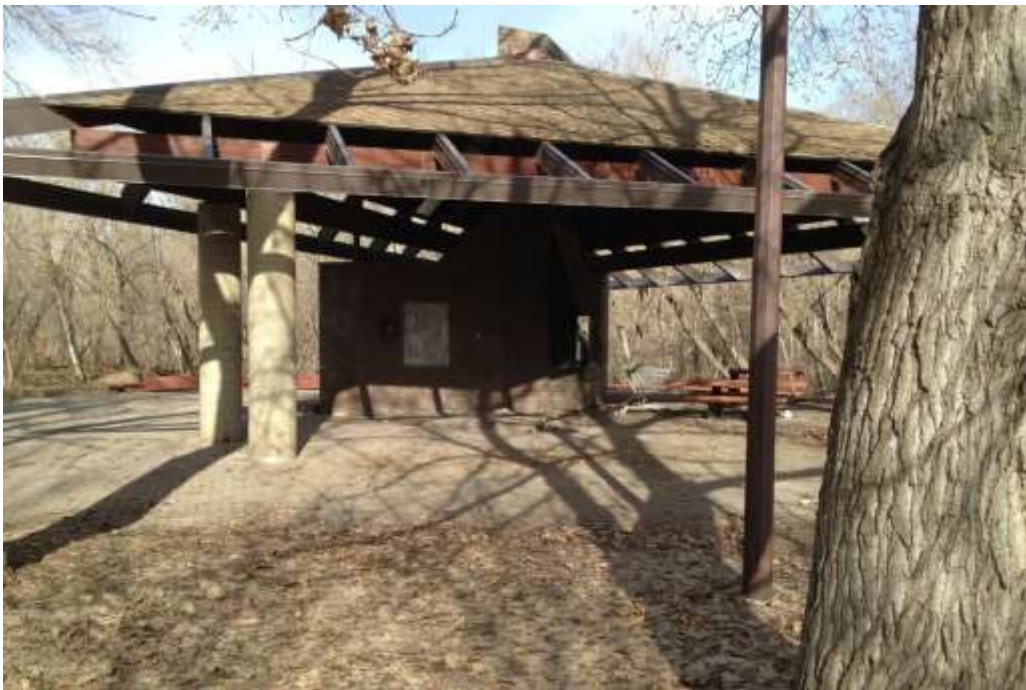
**Plate 2.4. Derelict picnic shelter and grounds in HMEP (April 2013).**

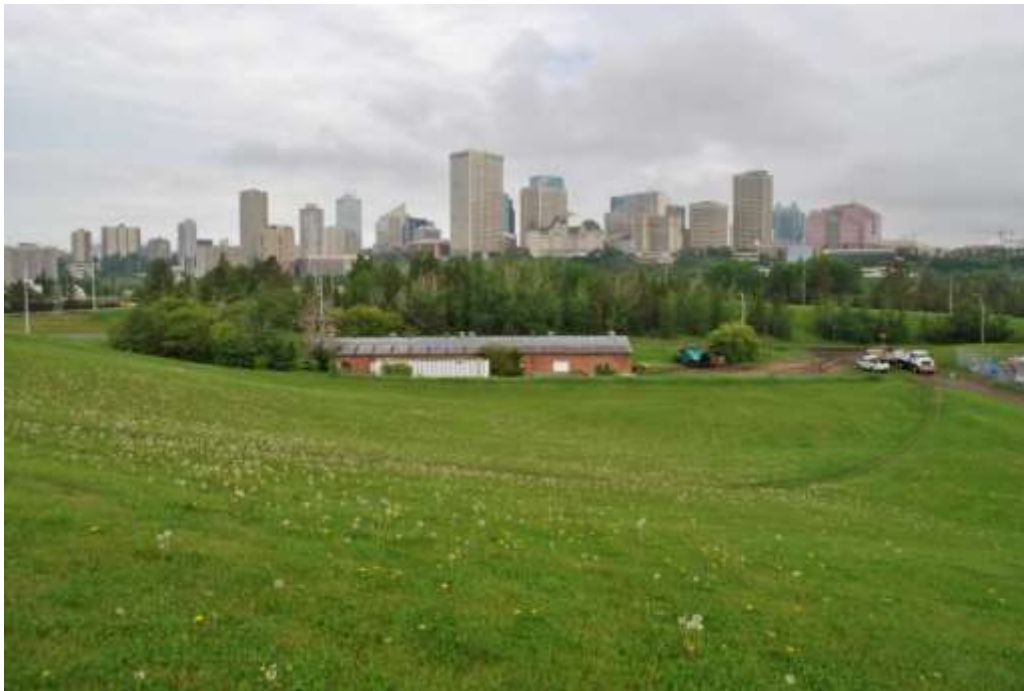
**Plate 2.7. Manicured lawn of proposed MCSB replacement and parking area (hill to be re-graded in foreground, existing building will be situated mid-ground), view to northeast (Sept. 2014)**

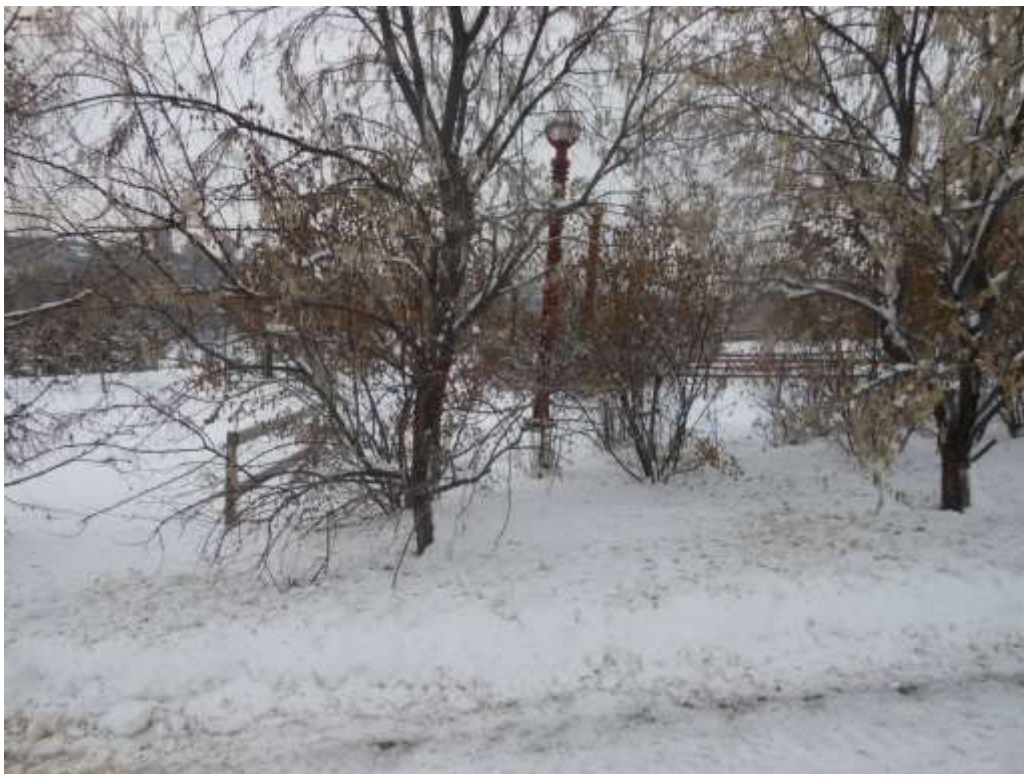
**Plate 2.8. Approximate area of proposed LMRP temporary trail connector, looking south (Jan. 2015).**

The trail will cut through an existing planting bed and, thus, will require some site preparation, including relocation of several shrubs from the planting bed; stripping approximately 30 m<sup>2</sup> of shrub bed mulch and topsoil, and, stockpiling for re-use in nearby sites. Post-construction, all disturbed lands will be returned to their pre-disturbance condition.

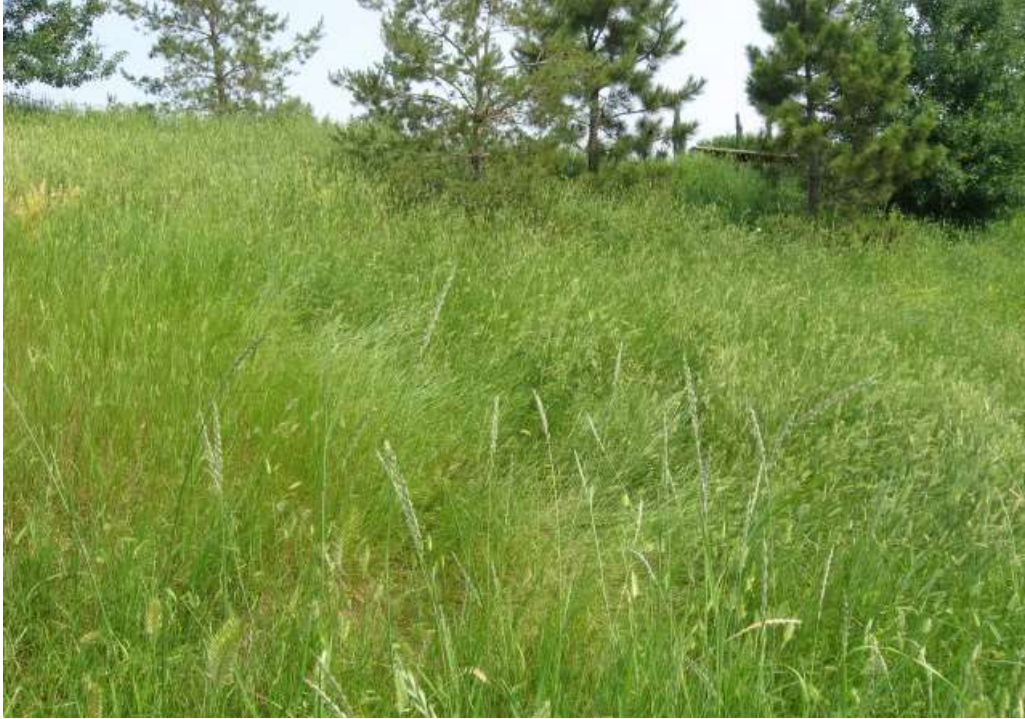
**Plate 4.2. Naturalized (unmanicured) grassland communities on the slopes of Louise McKinney Riverfront Park (July 2014)**

Small naturalized grasslands (G) communities were located throughout the park including parallel to the SUP that will form the proposed construction access road and were commonly dominated by exotic grass species, including smooth brome, quack grass, and crested wheatgrass (Plate 4.2). Reed canary grass (*Phalaris arundinacea*) and slender wheatgrass (*Elymus trachycaulus*), both native grasses, were also dominant or abundant in some areas; Kentucky bluegrass (*Poa pratensis*) and western wheatgrass (*Agropyron smithii*) were frequently observed. Other common species included wild vetch (*Vicia americana*), alsike clover (*Trifolium hybridum*), common goat's-beard (*Tragopogon dubius*), prickly rose (*Rosa acicularis*), and buckbrush (*Symphoricarpos occidentalis*). A total of 52 species was detected in grassland communities, 20 (38%) of which were native. The remaining 32 species (62%) were exotic, with five of those species listed as noxious under the Alberta *Weed Control Act*.

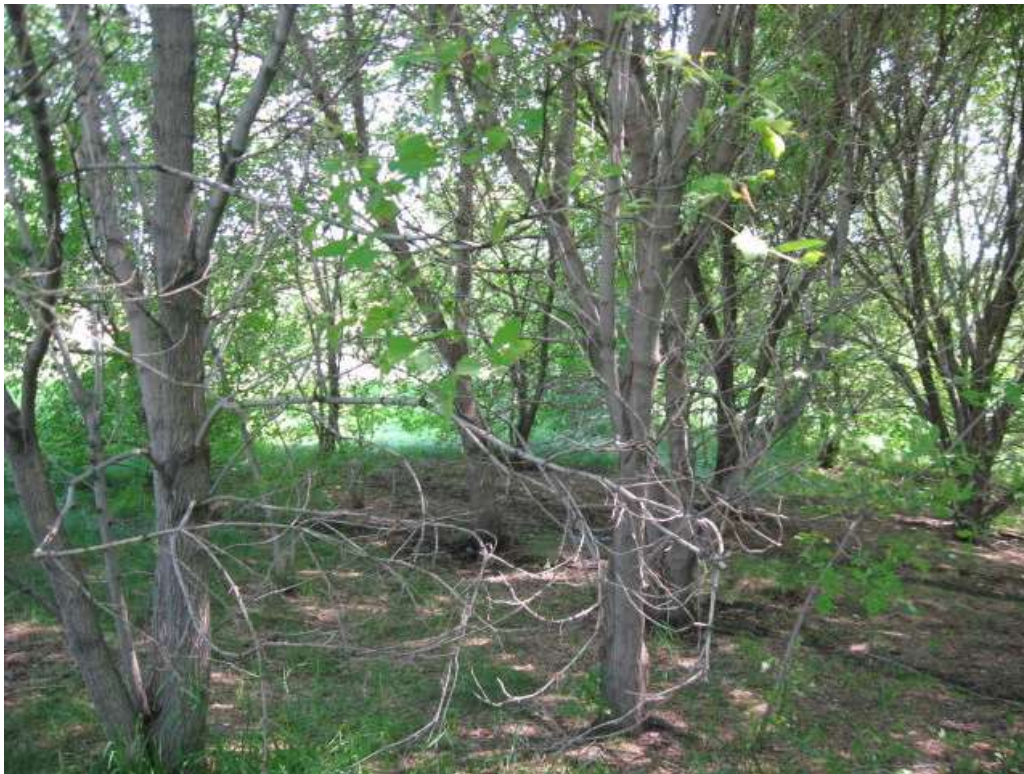
**Plate 4.3. Open understory in a Manitoba maple community in Louise McKinney Park (July 2014)**

One naturalized Manitoba maple (MM) community was located in the west end of the park bordering the maintenance vehicle access road (Figure 4.3). That community was dominated by Manitoba maple, with occasional balsam poplar (*Populus balsamifera*) and red-osier dogwood (*Cornus stolonifera*). The understory was typically open, comprising reed canary grass, smooth brome (*Bromus inermis*), and quack grass (*Elytrigia repens*) (Plate 4.3). A total of 11 species was detected in this community, 7 (64%) of which were native. The remaining four species (36%) were exotic, with one noxious weed species observed. Manitoba maple is not native to this region of Alberta but has naturalized and commonly occurs in the NSRV and is often found as a sub-dominant tall shrub or tree species.

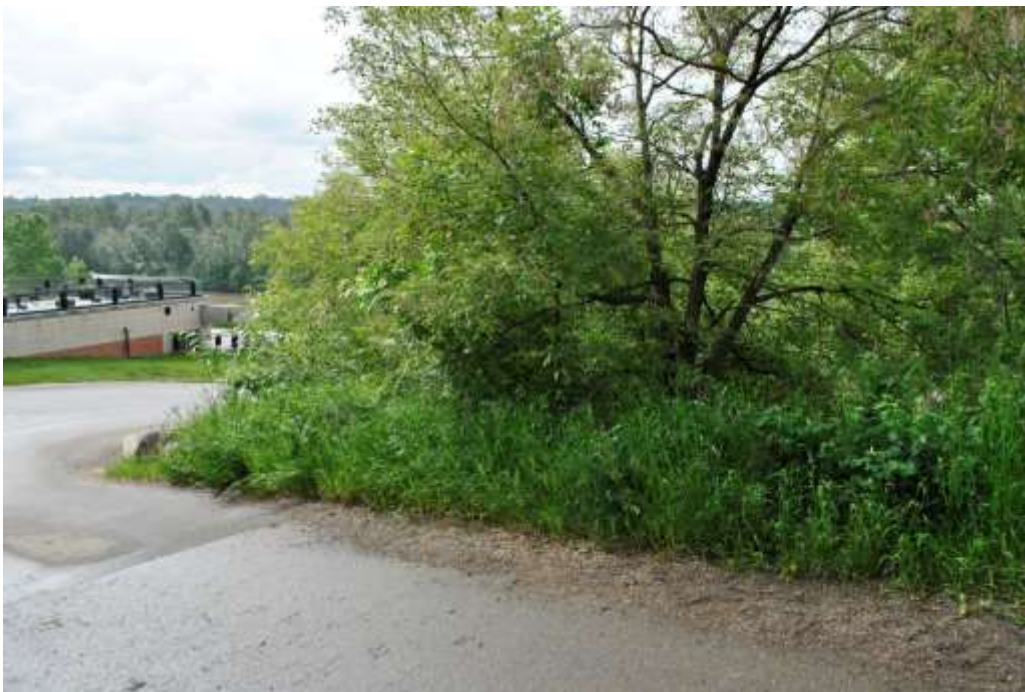
**Plate 4.4. The margins of the PMM community, adjacent to along the existing access road typified Edmonton river valley forest edge communities, view looking south (July 2014)**

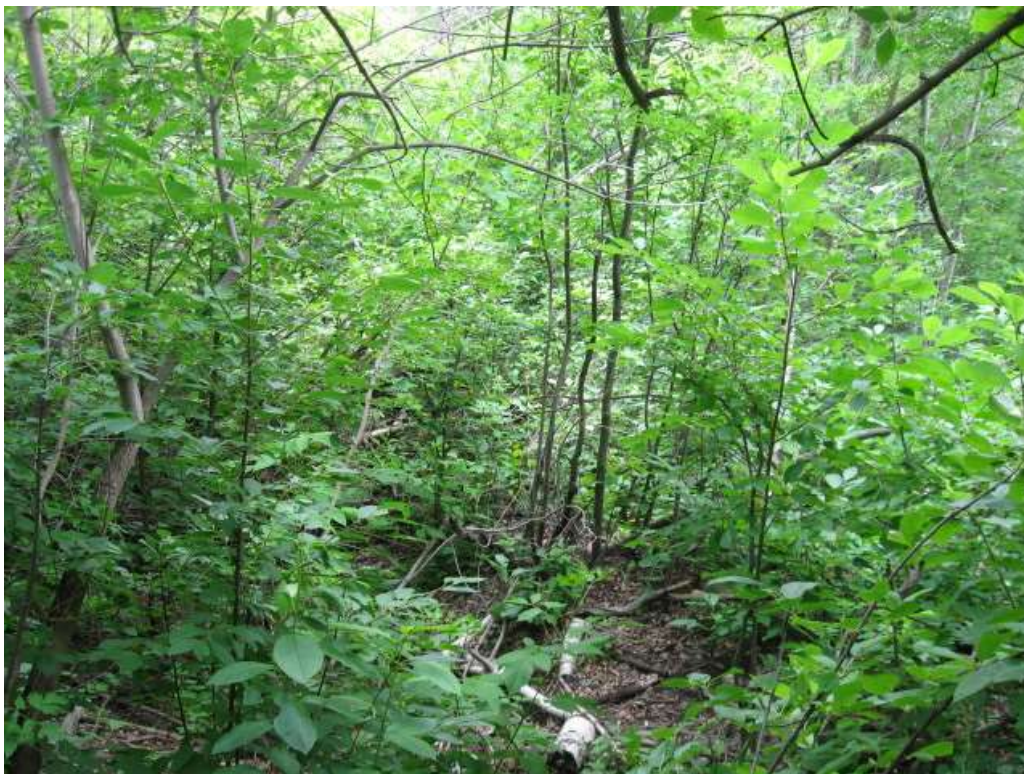
**Plate 4.5. Dense understory in the interior of the PMM community along the west edge of LMRP (July 2014)**

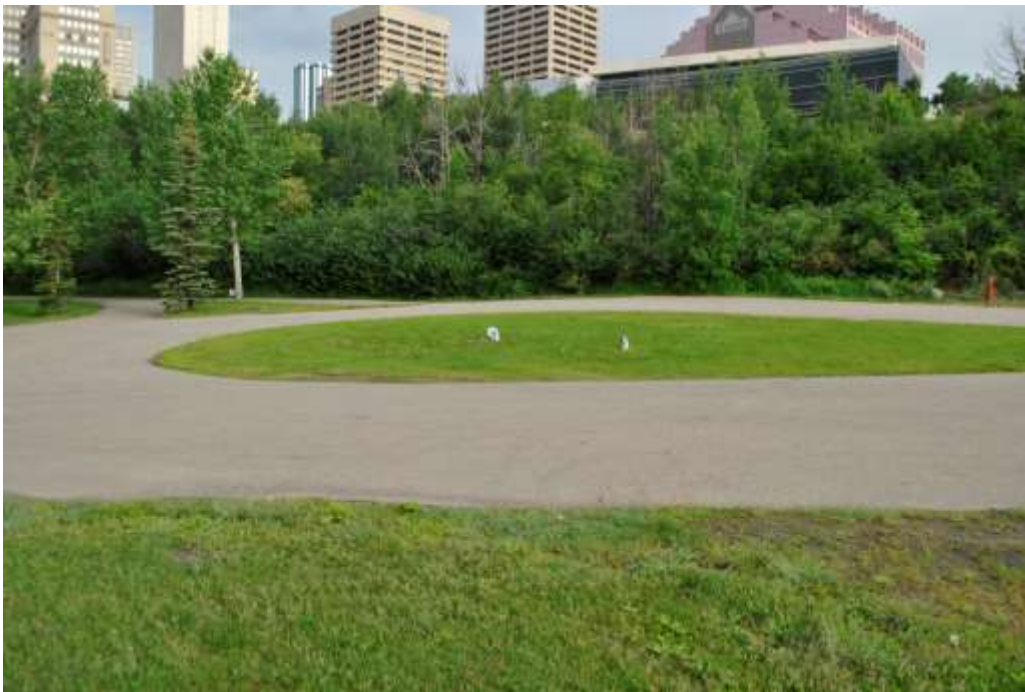
**Plate 4.9. Maintenance/service vehicle road turn-around, looking north (July 2014). This road does not provide vehicular park access or parking for the general public.**

- A paved maintenance/service vehicle road and turn-around that connects to the gravel east-west park maintenance road and recreational businesses and public washrooms. It also facilitates regular holding tank service. This road does not provide vehicular park access or parking for the general public (Plate 4.9)

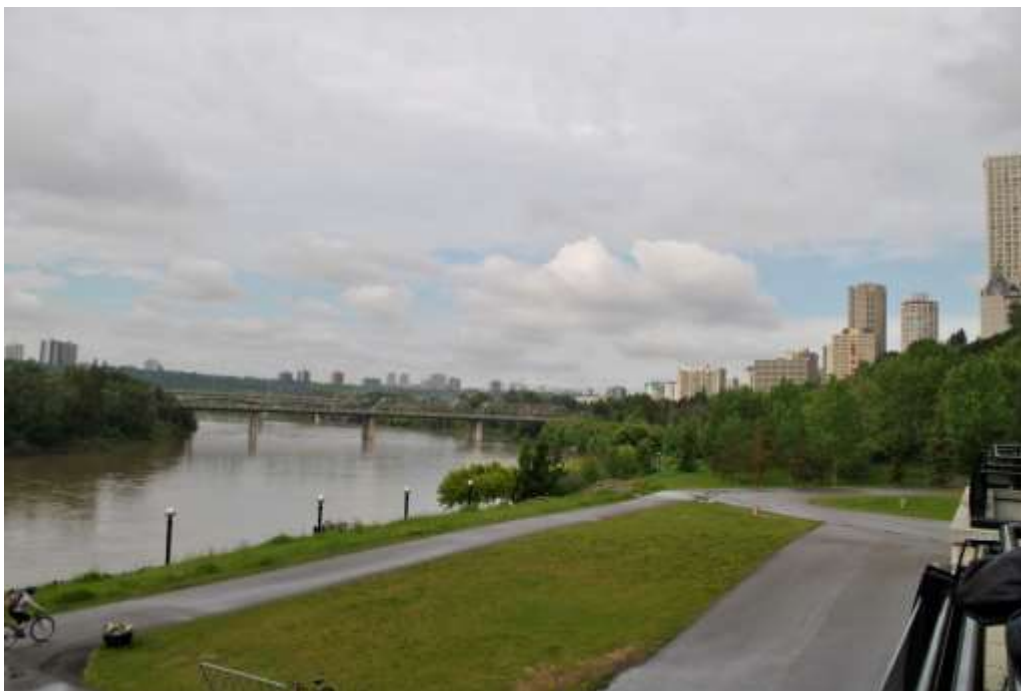
**Plate 4.18. Three pathways (from west, south and east) connect to vehicle maintenance access road (July 2014).**

- There is potential for construction traffic to pose a safety hazard to members of the public using available shared use routes and where pathways intersect with the vehicle access route (Plates 4.17 and 4.18).

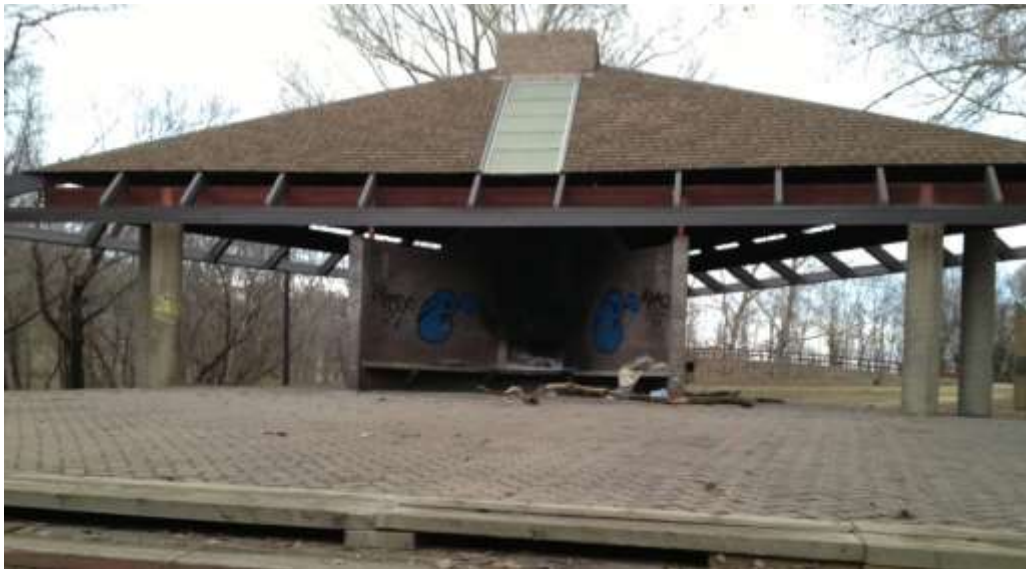
**Plate 5.8. The picnic shelter and hard surface appear to be in disrepair and public fireplaces installed as part of the picnic shelter structure have been boarded over (April 2013).**

Lands involved in the west project boundary modifications at HMEP include a formerly-important picnic area whose amenities include a large picnic shelter, several benches, picnic tables, garbage cans and one drinking fountain (Plates 5.6, 5.7). A commemorative sign is installed at the entrance to the picnic shelter area. The picnic shelter and hard surfaces (paving stones) appear to be in disrepair and public fireplaces installed as part of the picnic shelter structure have been boarded over (Plate 5.8). According to Community Services, the area is not a bookable space and has no heritage value (S. Buchanan, *pers. comm.*). All of these facilities are situated in the Project Area to be expanded. There are no recreational facilities in the two areas proposed to be excluded from the Project Area.

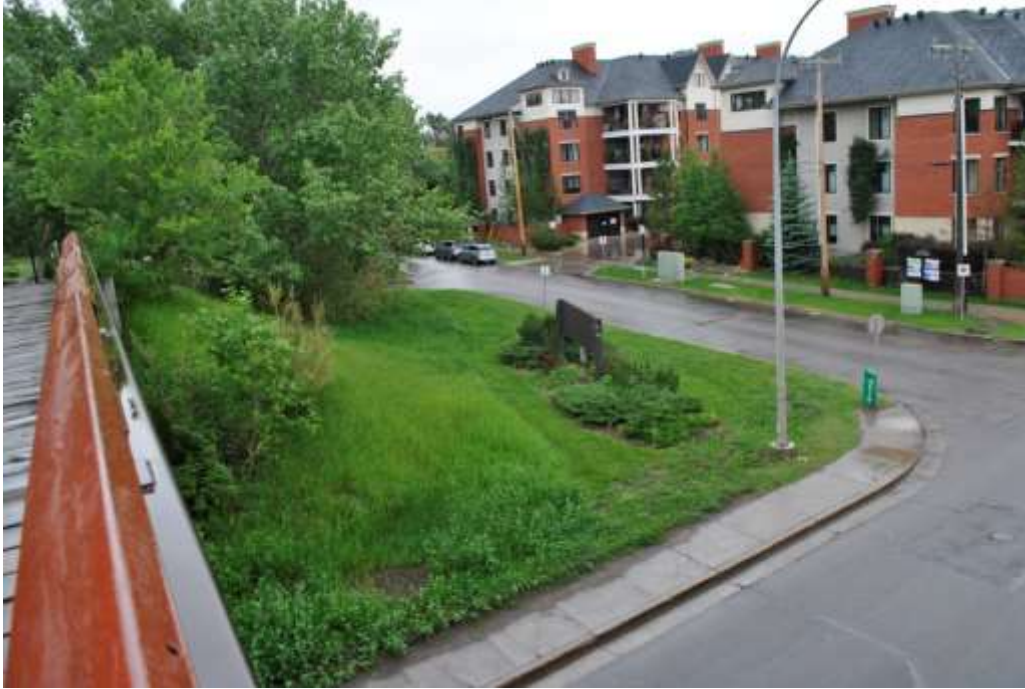
**Plate 6.1: Bridge abutment fill in the parcel to be added to the Project Area, looking northeast (June 2014).**

Soils in this parcel have likely been subject to past disturbance associated with the construction of the existing 98 Avenue Pedestrian Bridge and associated landscaping. The soils present appear to be fill material. A constructed embankment associated with the bridge abutment occupies much of the area (Plate 6.1). The Phase 1 ESA undertaken for the Valley Line LRT did not identify issues pertaining to soil contamination or slope stability for these lands (ConnectEd Transit Partnership 2013a). Geotechnical studies have not been undertaken as there is no intended infrastructure in this area.

The proposed parcel is the landscaped entrance to HMEP and is signed as such (Plate 6.1); however no active recreational use occurs on the parcel. There is no trail access through the parcel to the 98 Ave Pedestrian Bridge; access to the bridge is from the parking lot and trails further north. The pedestrian bridge is an important recreational facility but it is excluded from this parcel and will remain open to the public during construction activities associated with the Valley Line LRT.

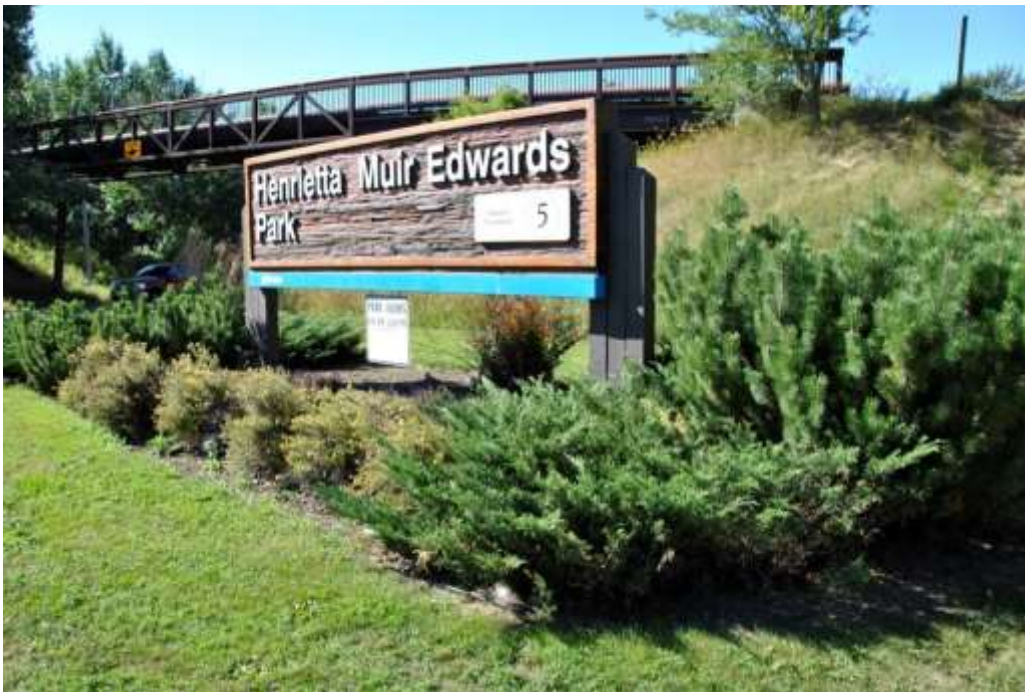
**Plate 6.2. HMEP near the north end of the 98 Avenue Pedestrian Bridge looking northeast; planted bed with park entrance sign, looking southwest (Sept 2014).**

Vegetation within the proposed parcel includes manicured and non-manicured areas (Figure 5.2). Two planted beds are present: the first, in the southeast corner of the area, is manicured and includes junipers and pine shrubs (Plate 6.2), the second, in the north ends of the area, has naturalized and includes mature poplars with Manitoba maple shrubs interspersed throughout (Plate 6.3). Lands immediately around the planted beds consist of manicured lawns. Immediately west of the manicured planted bed is the constructed embankment associated with the 98 Avenue Pedestrian Bridge. No mowing appears to be conducted in this area likely due to the steep slope; vegetation consists of a mix of grass and weedy species with some small shrub saplings (Plate 6.4).

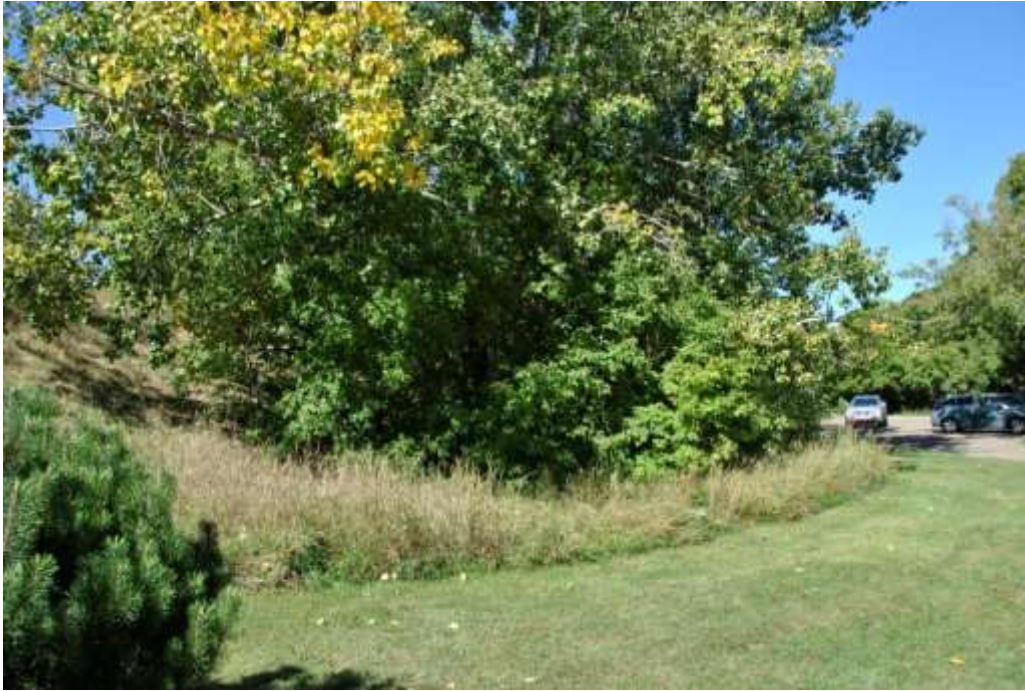
**Plate 6.3. HMEP entrance looking northeast; mature poplar and Manitoba maple stand, (Sept. 2104).**

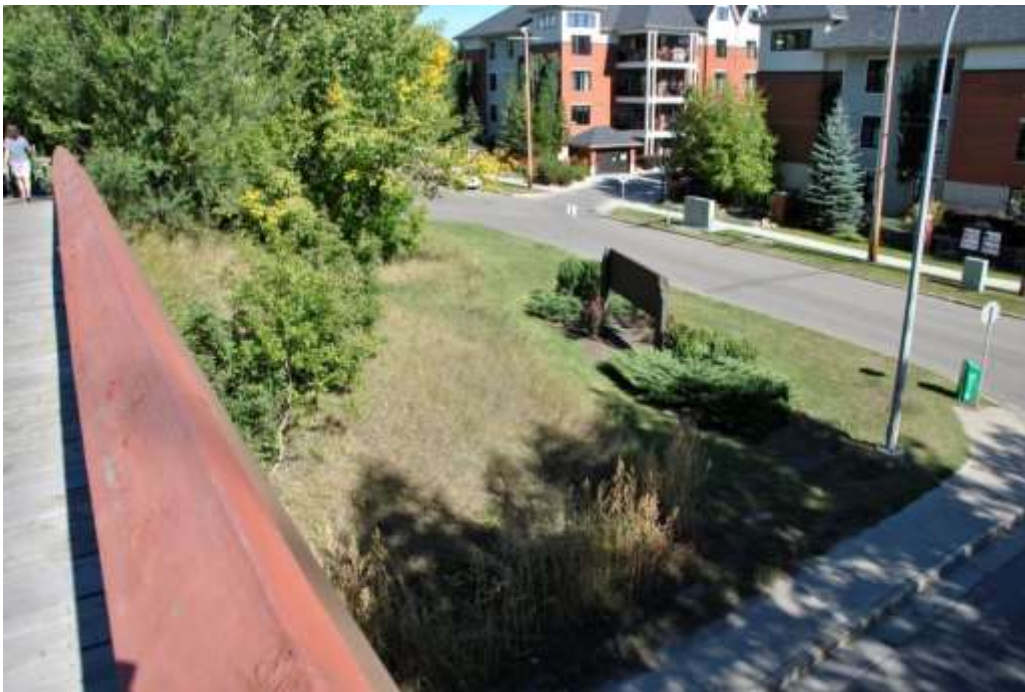
**Plate 6.4. HMEP entrance looking northeast; unmowed grasses on the pedestrian bridge embankment (Sept. 2014).**

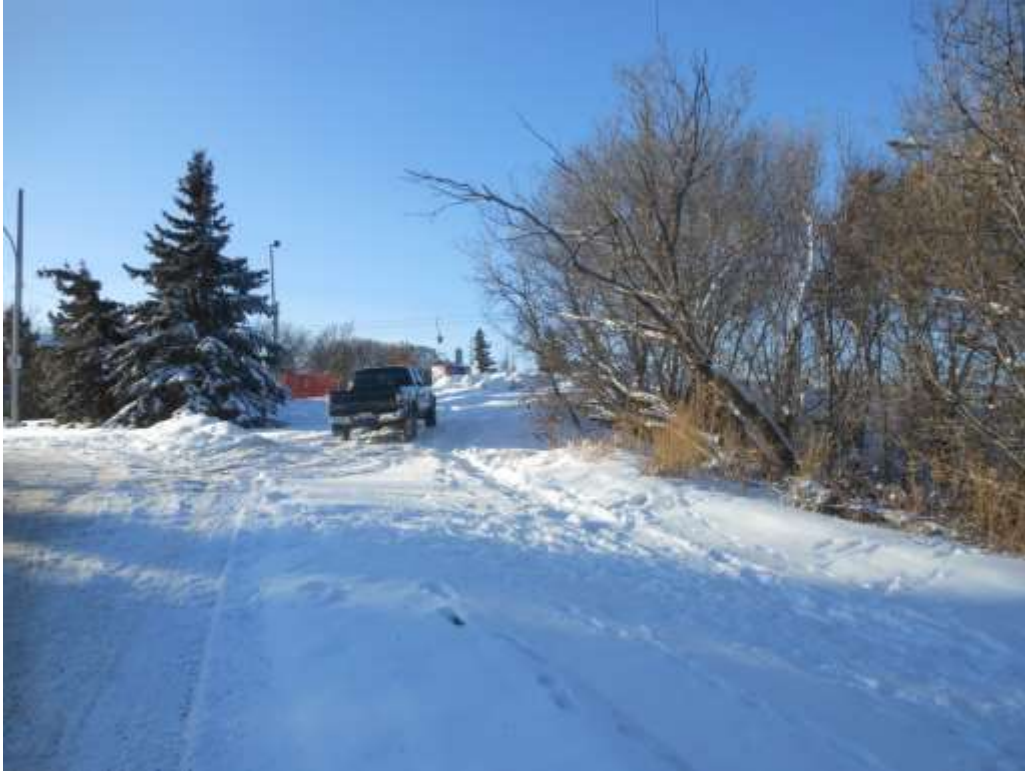
**Plate 8.2. Southeastern portion of lands required for ski club infrastructure relocation, looking west from Cloverdale Hill Road. Mature planted spruce on right are within the original Project Area. Deciduous stand of native vegetation shown on right is situated outside of the Project Area and will be undisturbed (Jan. 2015).**

Lands required to accommodate the ski run re-grading and infrastructure relocation are situated along sloping terrain immediately west of Cloverdale Hill Road, slightly north of Connors Road (Plate 8.2). Thurber Engineering's (2012) appraisal of geotechnical conditions along Connors Road determined that it is possible that existing fills associated with the grading of the ski hill slopes were placed in a somewhat uncontrolled manner. Slope instability associated with the loading of these fills and any underlying disturbed colluvium is a concern. This was also noted in the 2013 EISA.

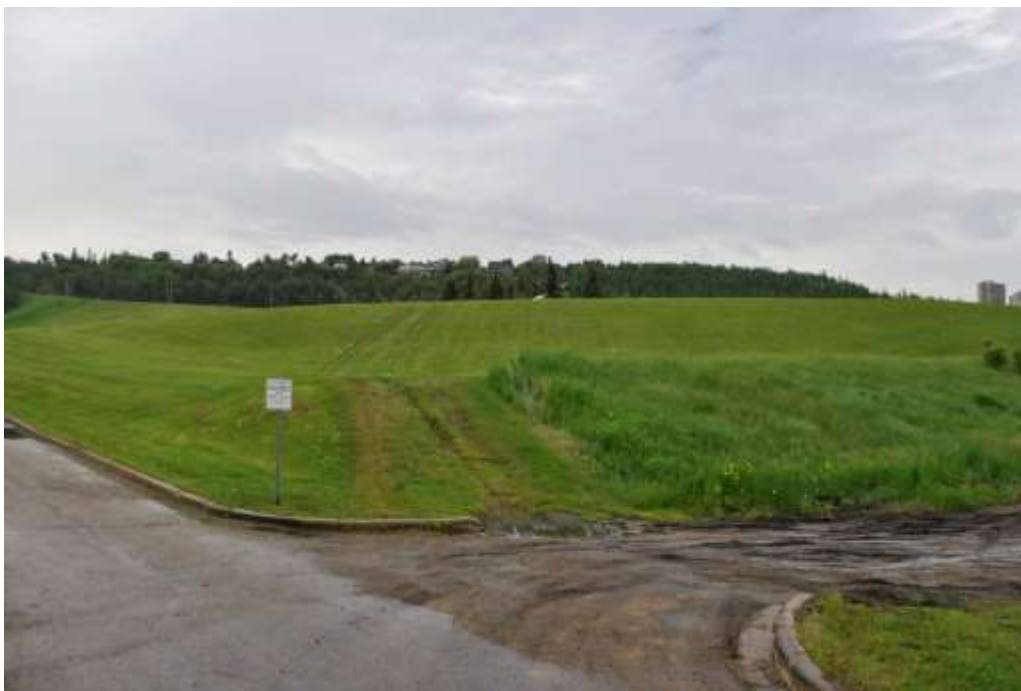
**Plate 10.1. MCSB replacement lands are situated on an existing bench and extend south into a shallow hill situated in Gallagher Park, looking southeast (July 2014).**

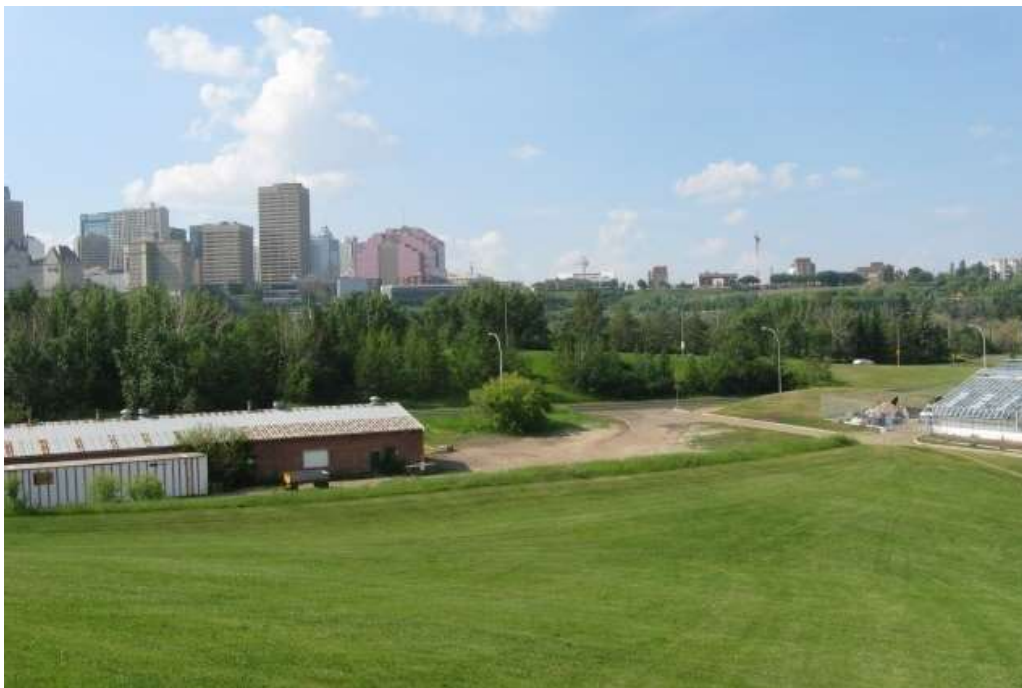
**Plate 10.2. Vegetation in the MCSB replacement site consists entirely of manicured lawn, looking north (09 July 2014).**

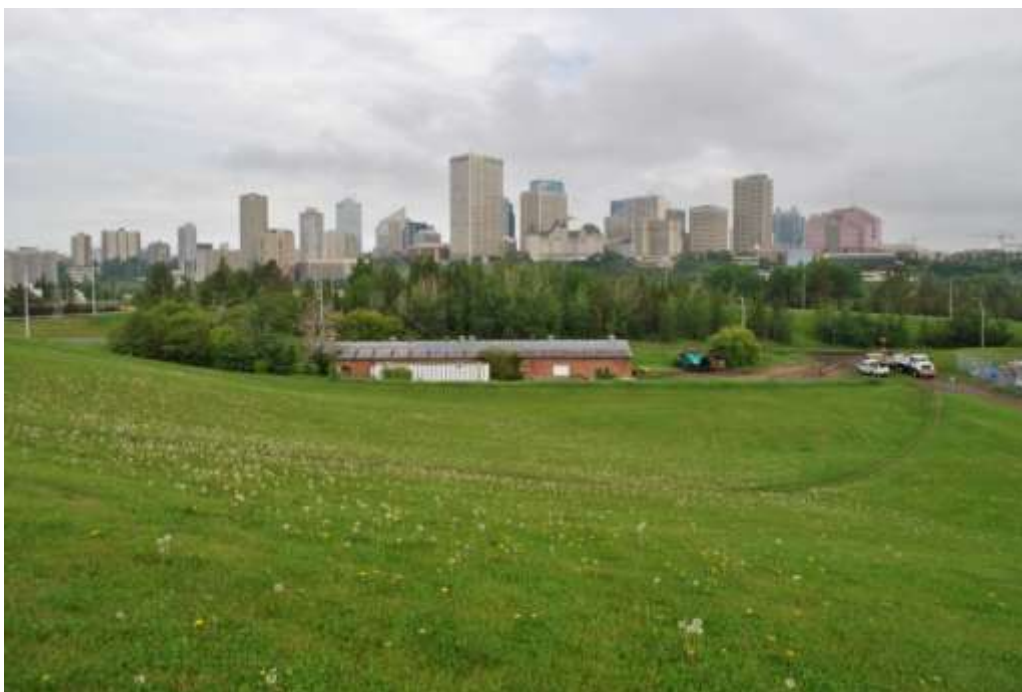
**Plate 10.3. View of MCSB Replacement site (in foreground) looking northwest; the existing slope provides passive recreation and one informal trail. Views from the site currently include the existing building (July 2014).**

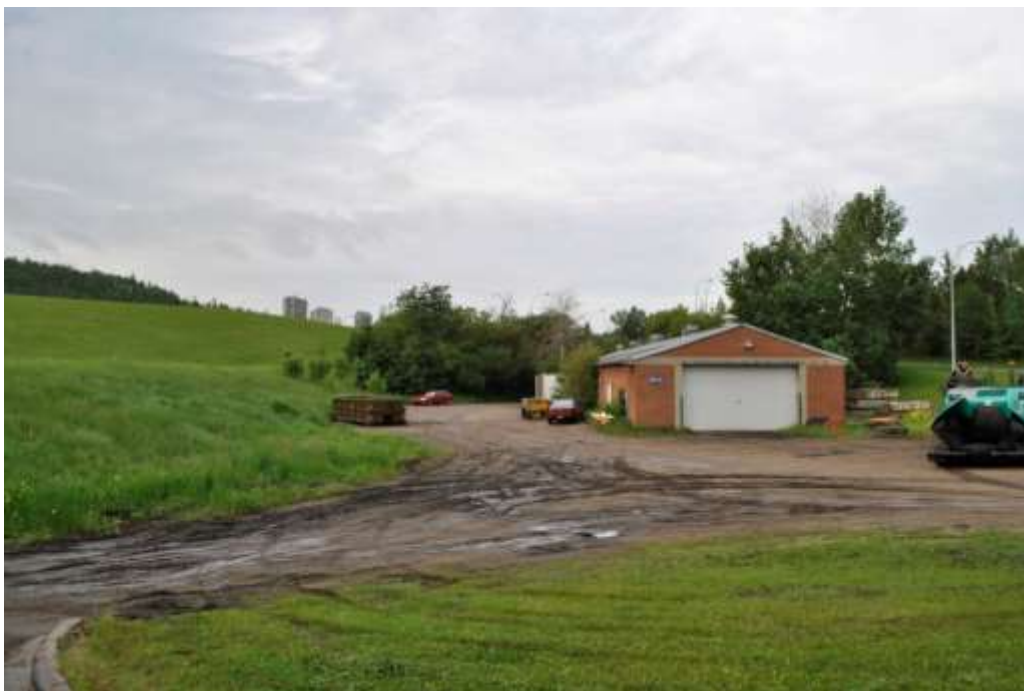
**Plate 10.4. Alternative view of existing storage building and surrounding grounds (July 2014).**

The project component is situated in a manicured lawn area, with rolling terrain that provides a vantage point within Gallagher Park, with a view of the Muttart Conservatory and downtown Edmonton. The site is visible to nearby recreationists at the Edmonton Ski Club, those using the upslope SUP path, and motorists on the Muttart Access Road. Current views from the hill include the existing storage building, which is slightly dilapidated, and grounds around the building, which are unpaved and only thinly graveled. Neither are considered aesthetically appealing (Plates 10.3 and 10.4).
