SUMMARY REPORT FOR 2020 CORROSION RESEARCH STUDY

City of Edmonton

**Prepared By:
Corrpro Canada, Inc.
Edmonton, AB**

CORRPRO DOCUMENT No.: 0120-4632-CED-CRR-002-0

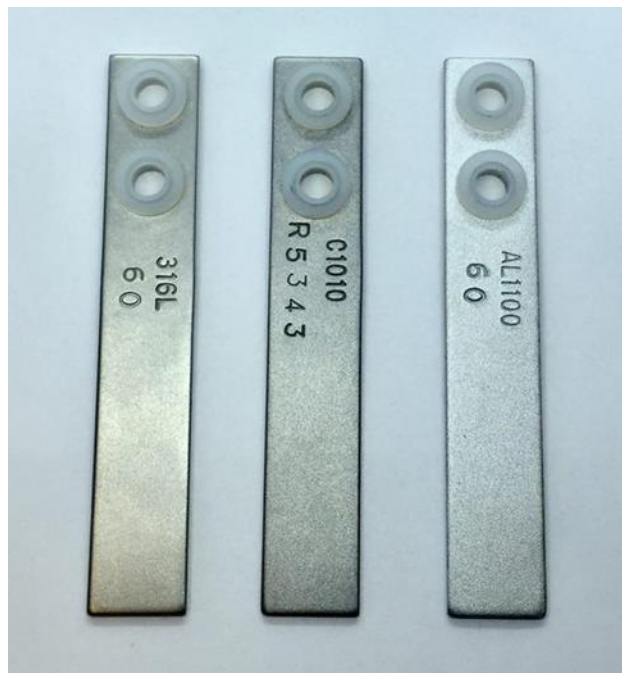
Figure 1 - As Received Field Coupons (Left to Right: Stainless Steel, Carbon Steel and Aluminum)

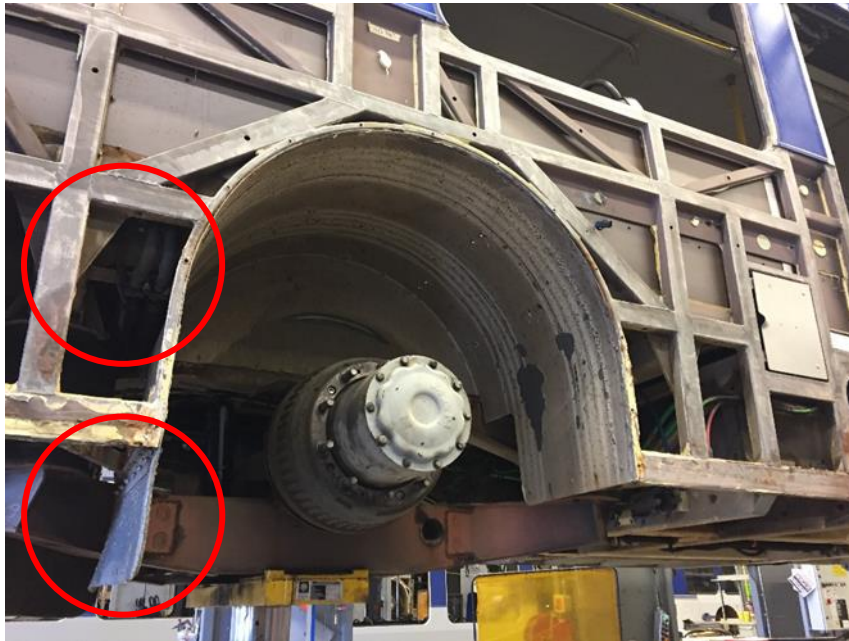
All of coupons were installed on the City of Edmonton and Spruce Grove buses by March 6, 2020. There were two sets of each metal coupon on each bus for the field program. All coupons were installed on the curbside of the bus near the rear wheel well, as this area typically is the most severely corroded. One set of coupons were installed

Figure 3 - Mounting Locations of Field Coupons on Buses

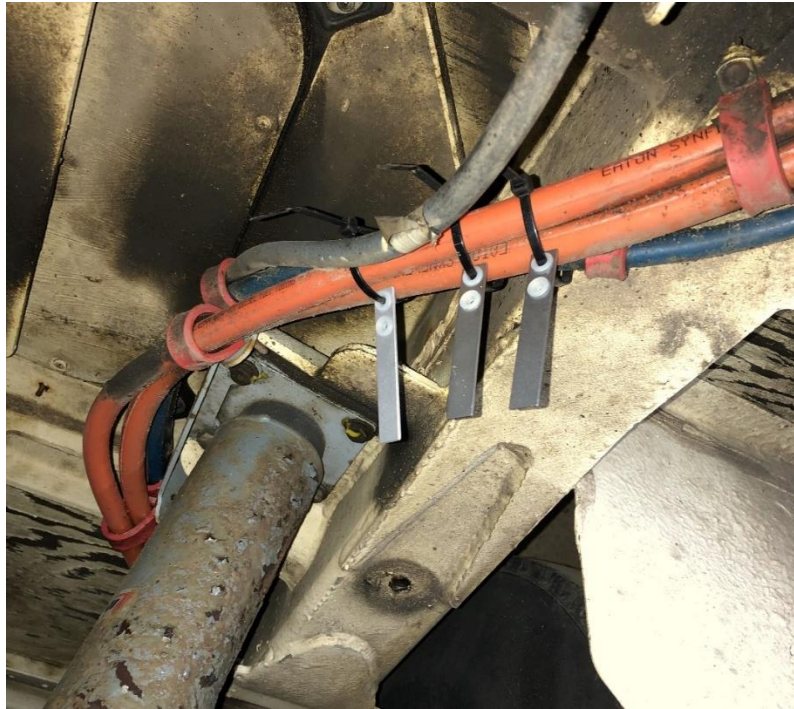
'Figure 4' shows the coupons behind the wheel wells were hung from wiring on the bottom of the bus. Heavy duty plastic cable ties were used to hang the coupons with the goal of securing the coupons while eliminating any metal-to-metal contact.

Figure 4 - Field Coupons Installed on Wiring Behind Wheel Well

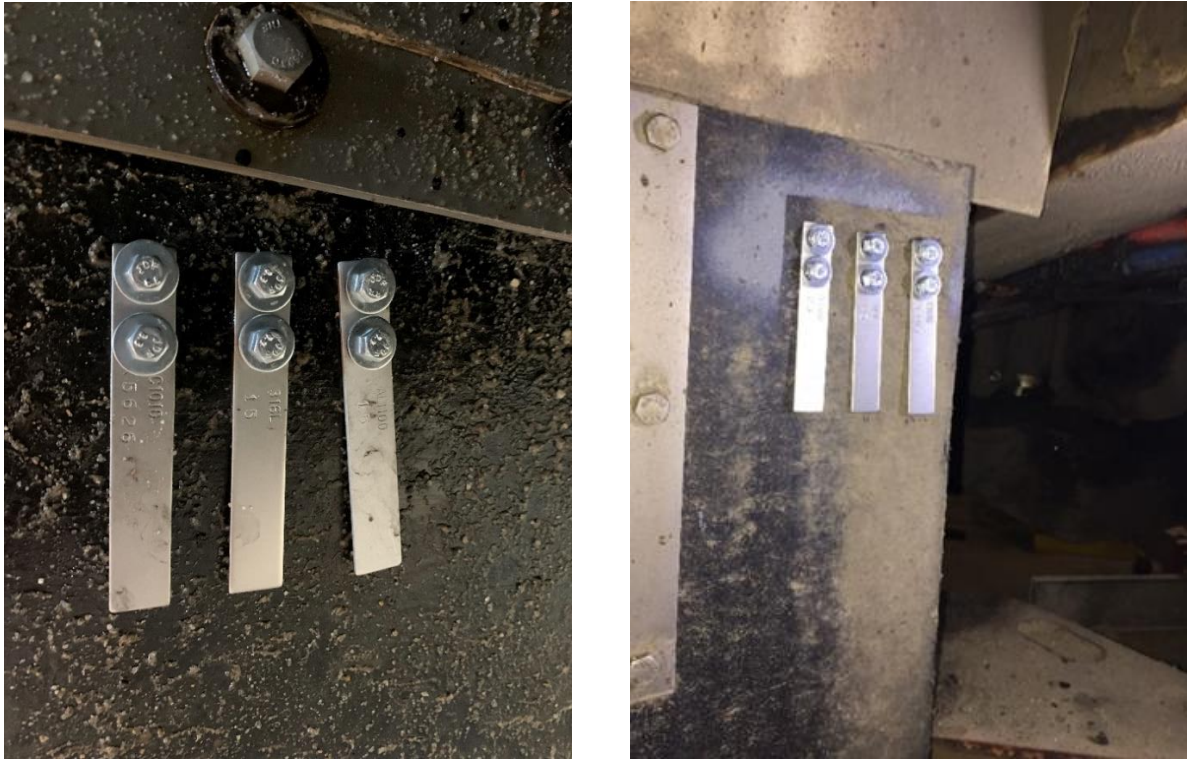
Another set of coupons was installed on the mud flaps, as shown in 'Figure 5'. The coupons exposed to the spray on the mud flap are in the highest exposure area; therefore, these coupons should see the most significant corrosion. The coupons are secured directly on to the mud flap with bolts and lock nuts. However, there is a nylon insulator between the bolts and the coupons to eliminate metal-to-metal contact.

Figure 5 - Field Coupons Installed on Mud Flaps

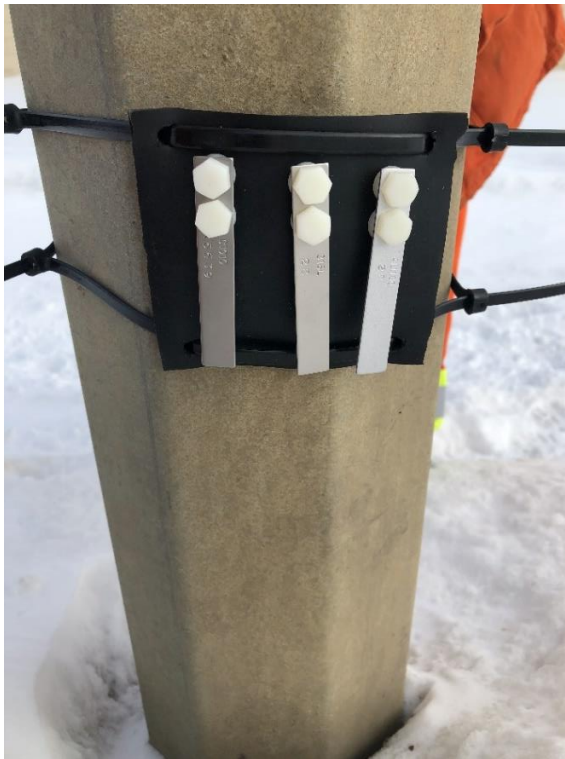
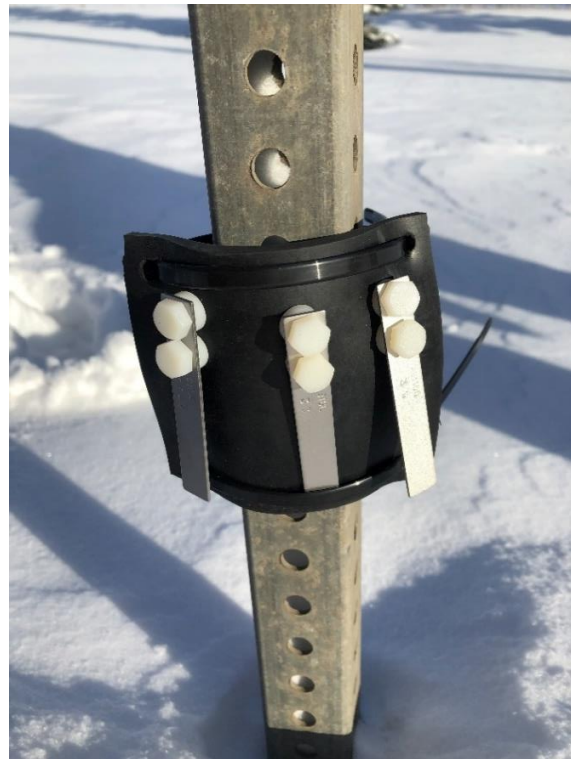
The coupons were mounted to a neoprene sheet with nylon bolts, washers and nuts. Holes were drilled into the neoprene to allow for heavy duty cable ties to secure the apparatus to metal infrastructure. 'Figure 6' shows the field coupon mounting apparatus and examples of how the coupon apparatuses were mounted to various metal infrastructure on the specified routes.

Figure 6 - Field Coupons Installed on Metal Infrastructure Near Roadways

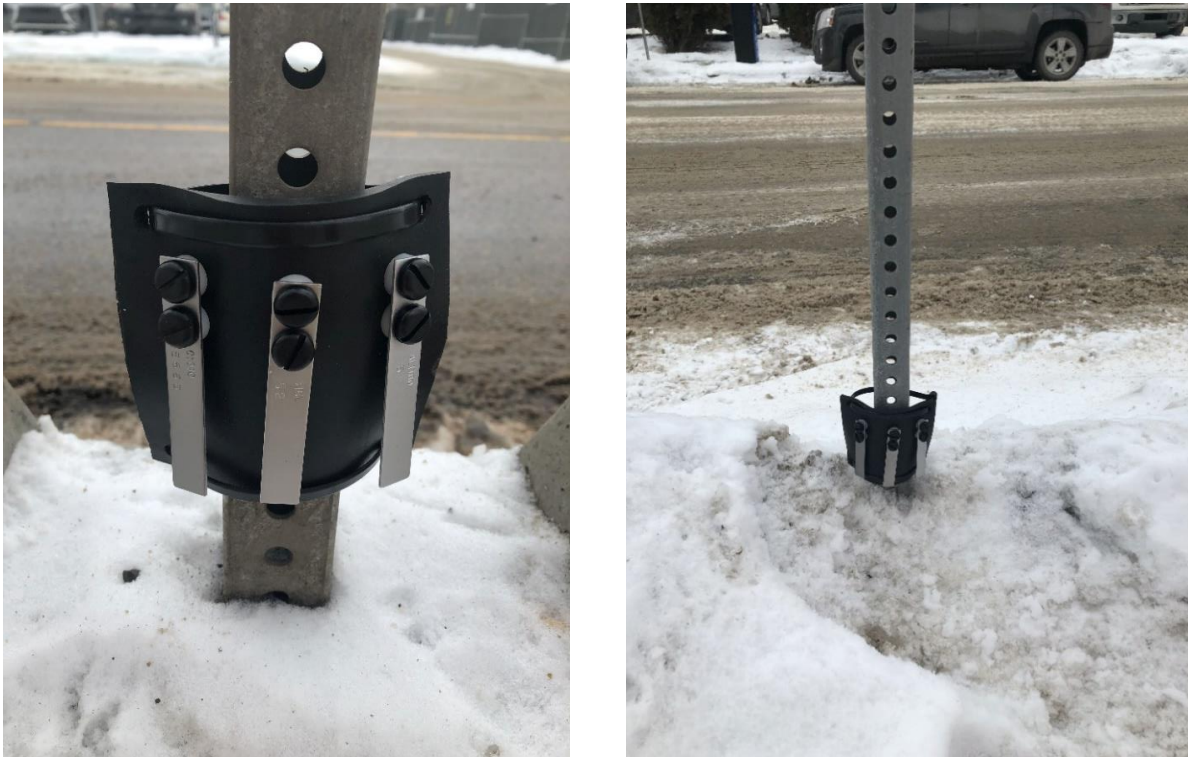
barriers, etc. that are near the designated bike lanes in the city. The coupons were installed on bicycle lanes in downtown Edmonton, as shown in 'Figure 7'.

Figure 7 - Field Coupons Installed on Bicycle-Related Structures
