# Rossdale Power Plant Advanced Assessment and Priority Rehabilitation

## Turbine Hall Condition Assessment

Submitted to: City of Edmonton

Date Submitted: 2021-03-15

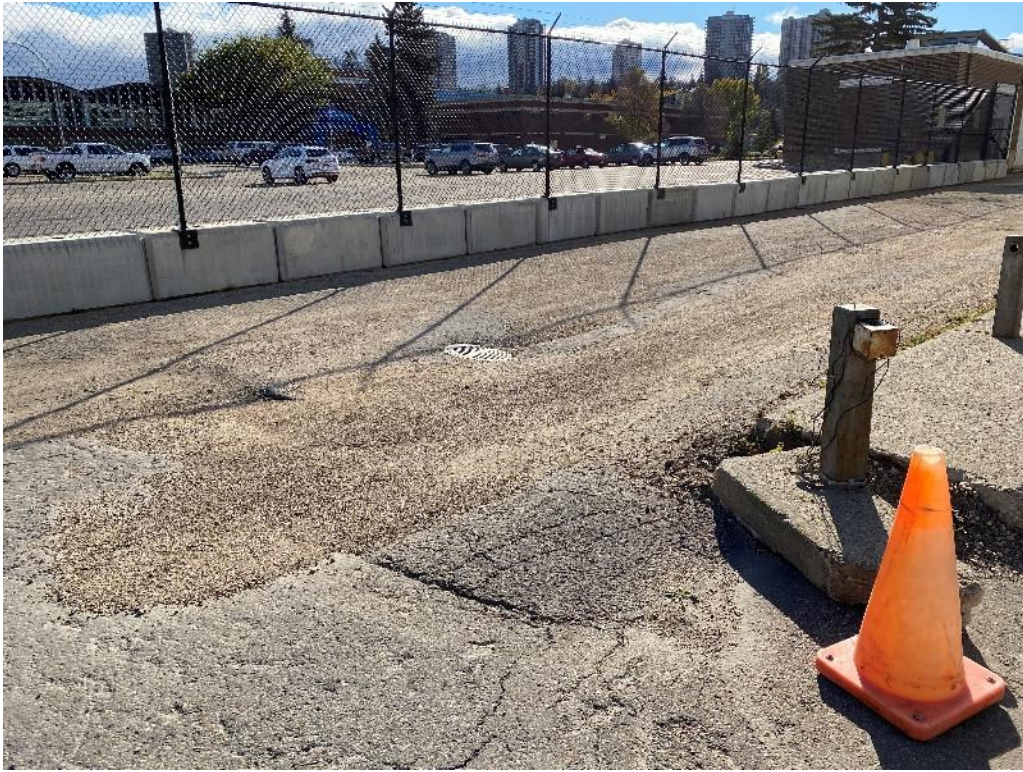
**Above: Storm catch basin east of the Switch House**

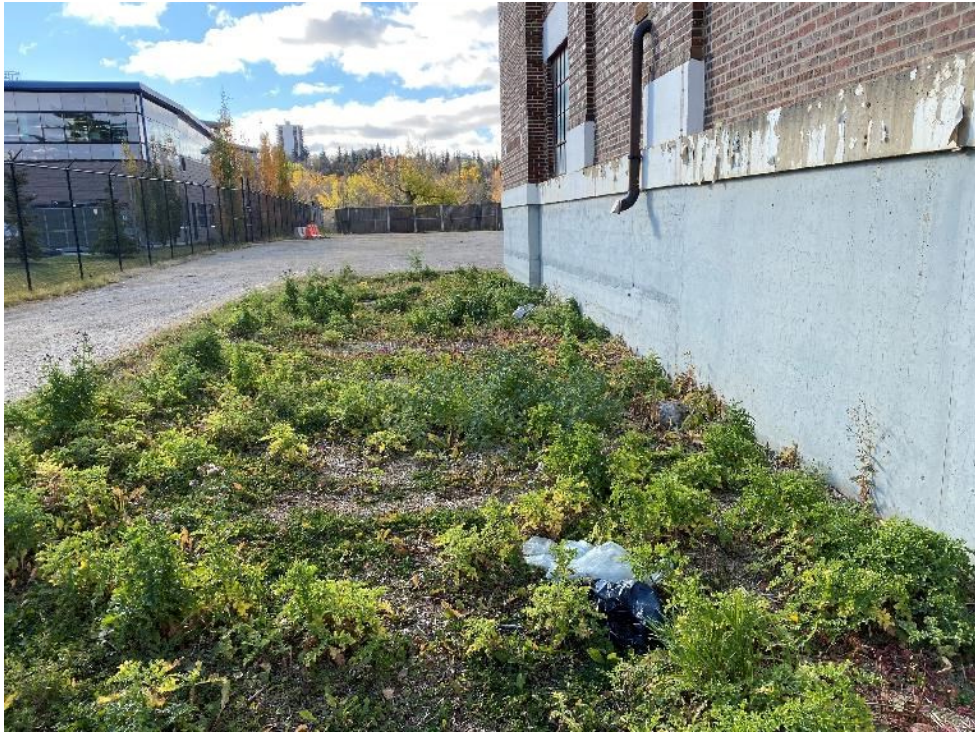
**Above: Landscaped area east of the Switch House**

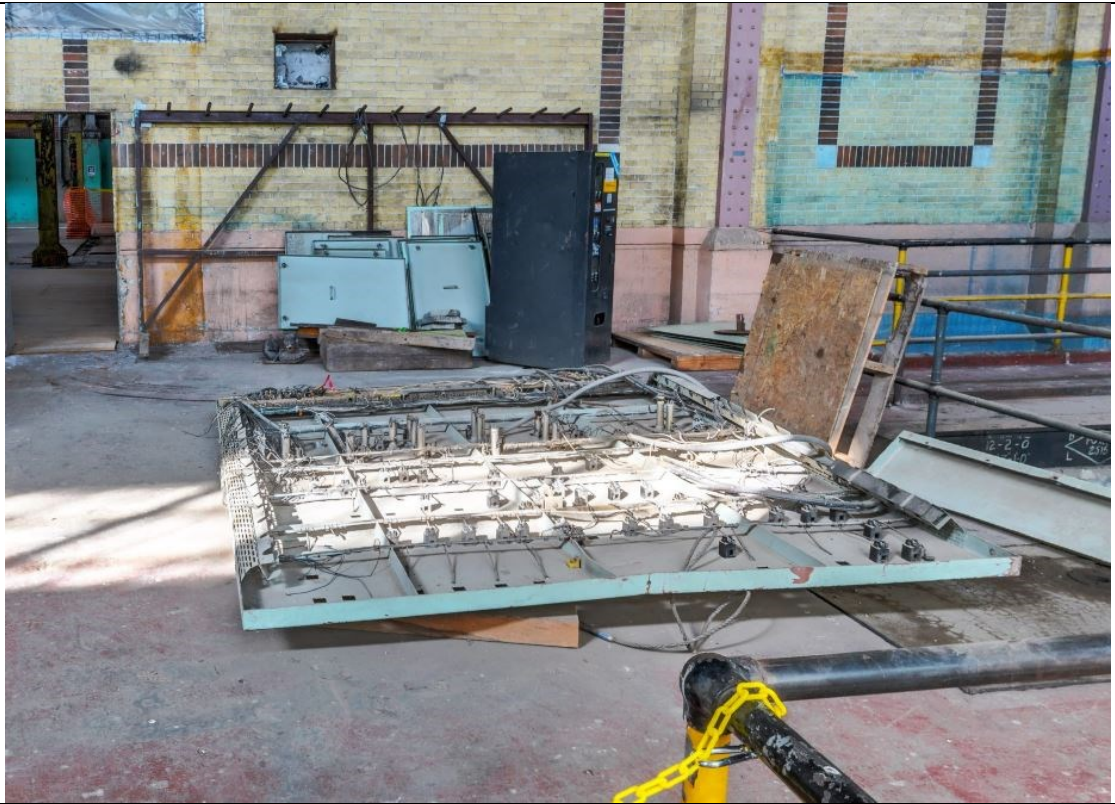
**Plant Decommissioning Artefacts:**

Various relict artefacts from the High Pressure Plant, such as control room panels and past structural elements have been abandoned in the Turbine Hall.

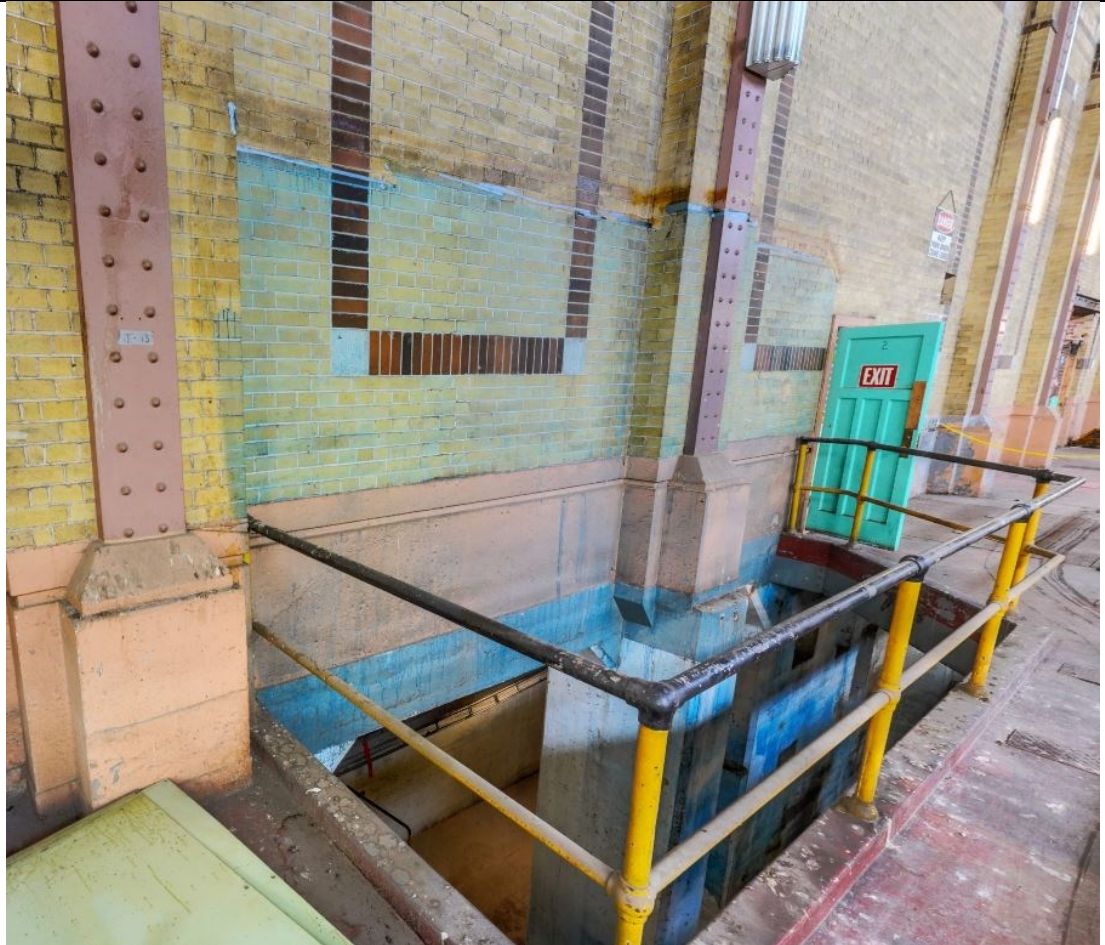
**Blue Abatement Stain:**

Blue staining is indicative of post-abatement marking of areas where hazardous materials have been removed. These stains are evident in isolated areas in main floor Turbine Hall only.

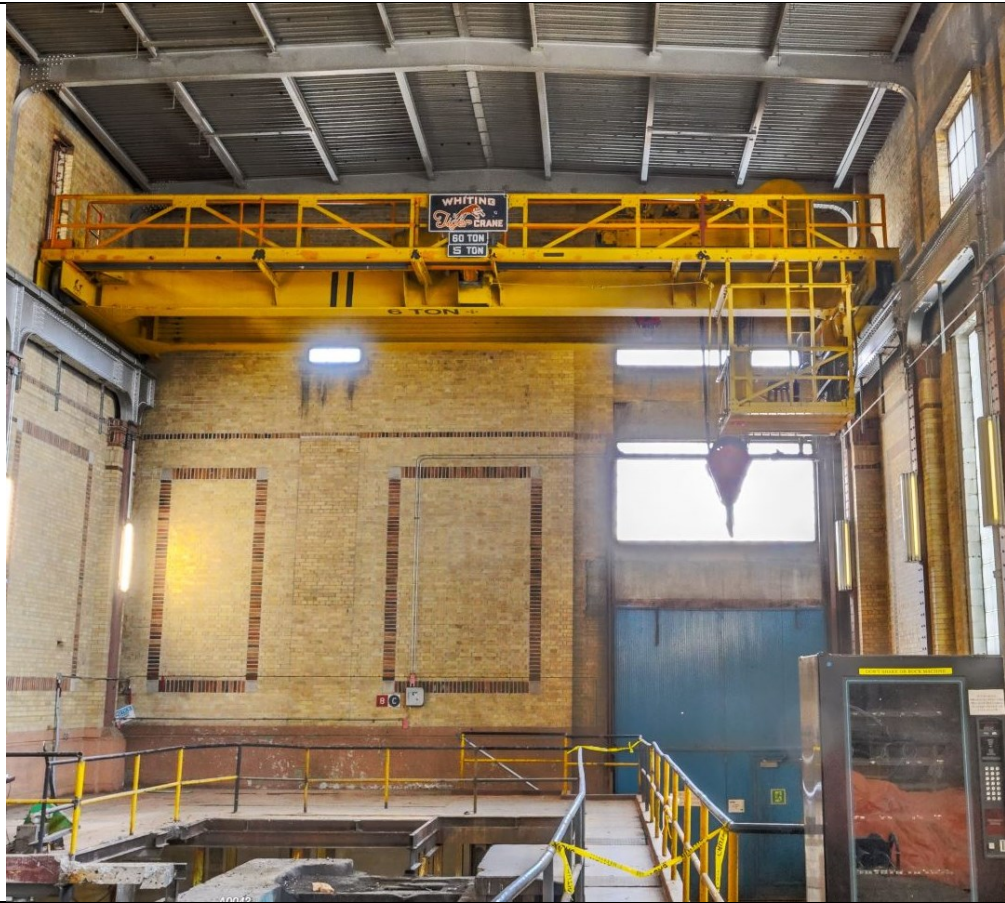
**Crane:**  
Gantry crane appears to be in good working condition, paint is in excellent condition. Mechanical operations are not confirmed.

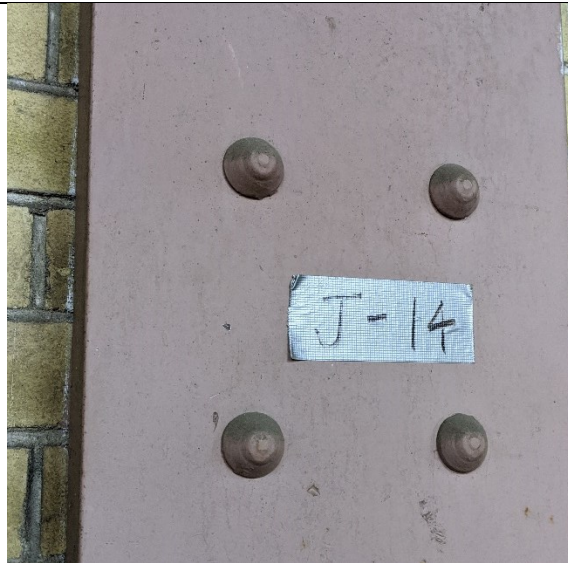
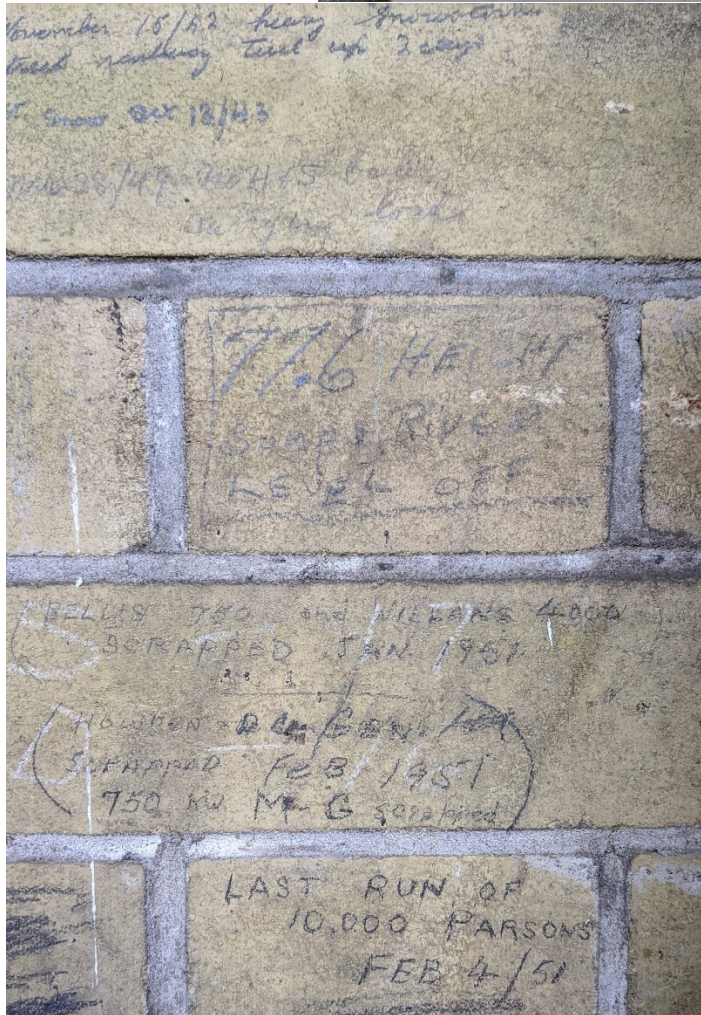
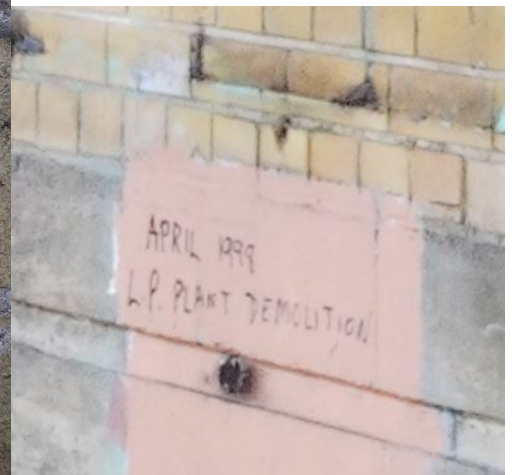
**Historic Graffiti:**

There are historic industrial subject mementos written from as early as the 40s and 50s, near column "J-14" as identified by duct-tape markings. Historic Graffiti is evident even into the late 90s as the lower most photograph take between column J-16 & J-17.

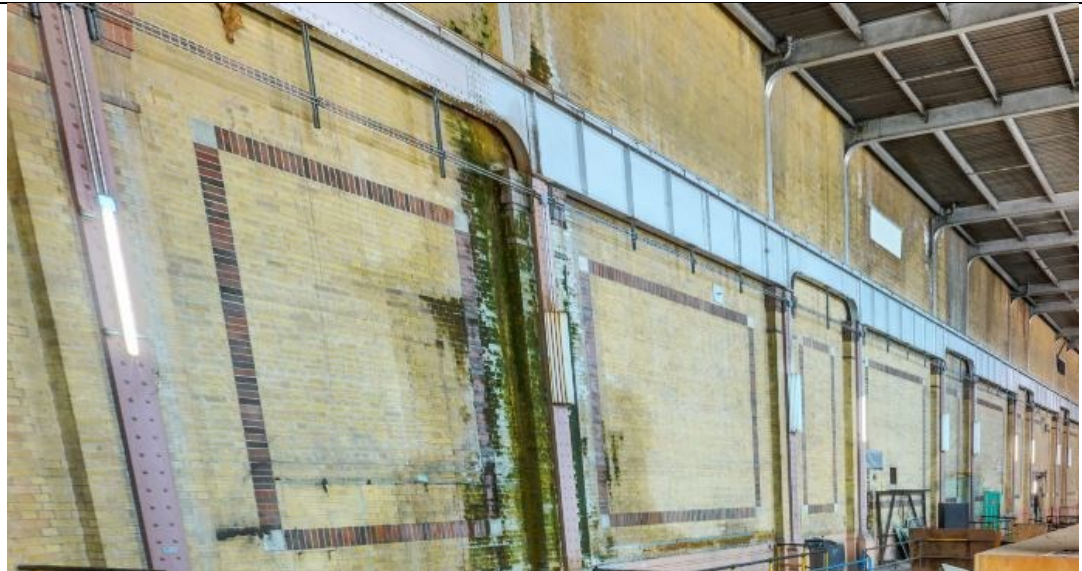
**Lighting:**  
 The lighting system composed of vertical tube lights installed in the 1970s, is in generally good condition. Some tubes may require replacement, and fixtures to be investigated further to confirm they are operative.

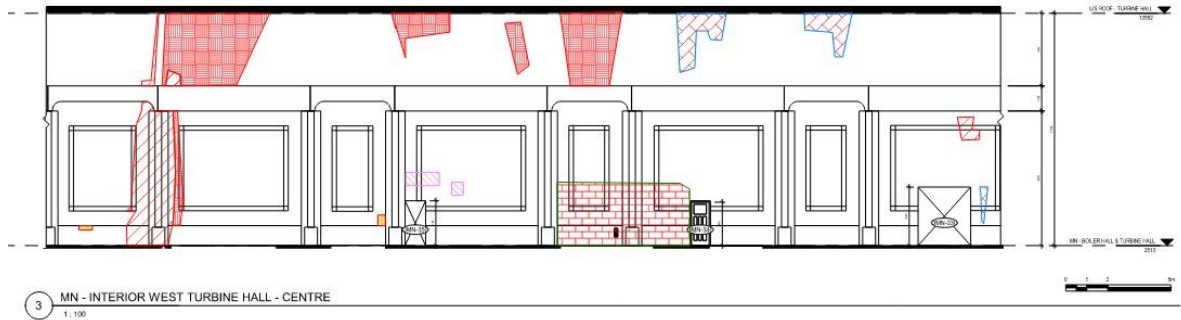
**Interior West Elevation Stains:**  
 Patterns of ferrous staining, Biogrowth, and efflorescence, predominate in the oldest section of the Turbine Hall, 1938, which likely also correlates to roof leaks in this same area from the Boiler Hall above. Please also see deterioration discussion of East exterior Elevation of Boiler Hall. Conditions Markup used to illustrate the numerous surface stains in this section of wall.

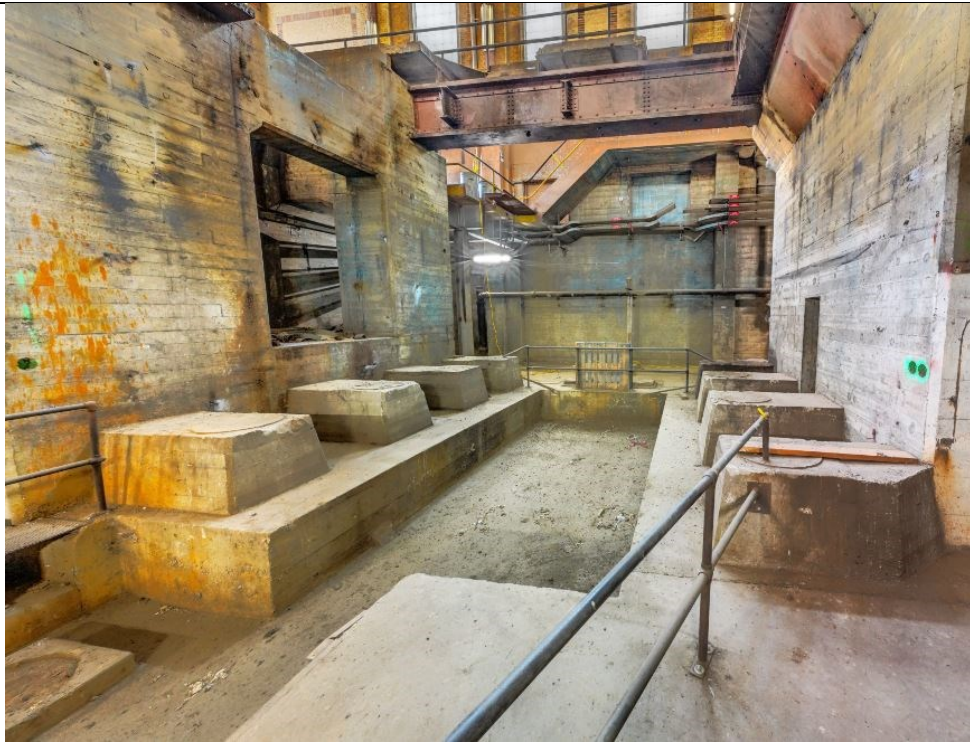
**Condenser Podium & Mechanical Basin:**

Condenser podiums soiled as all other surfaces in the LPP, as are the drainage/mechanical basins below. All are in good condition. Minor cracks, spalls, rust stains, and chips exist on each podium.

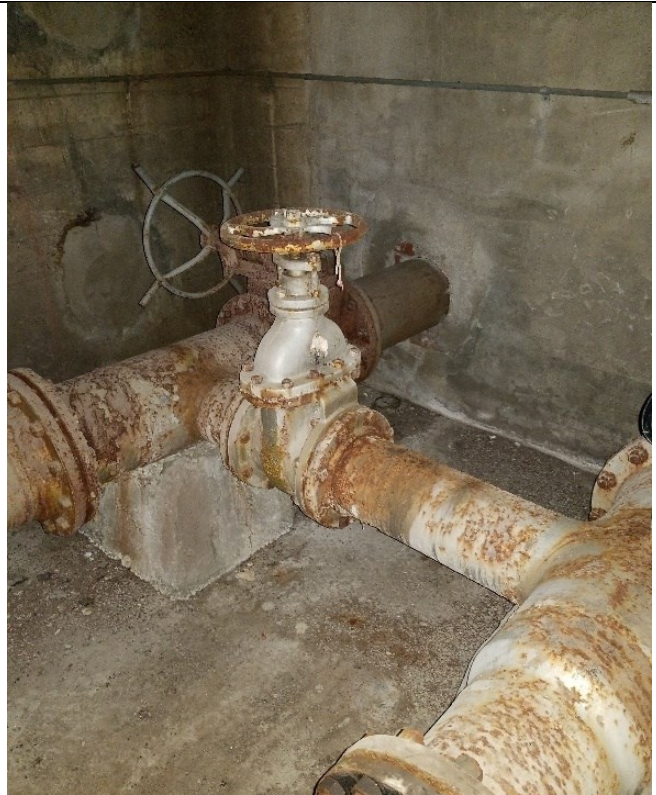
**Natural Gas:** There is no active gas service to the Low Pressure plant. Due to its former vocation as a gas fired electricity generating plant there is significant infrastructure which formerly supplied gas to the large turbines housed within. Although the connections are now abandoned and sealed at both ends, two 300mm diameter steel gas lines still enter the Low Pressure plant in the basement level of the Boiler Hall and terminate in a vault like room near the center of the boiler hall basement. These mains run North to an abandoned gas service trunk on the property. Although likely not suitable for returning to service these two mains could potentially be used a sleeves to insert smaller diameter gas piping to serve future heating systems within the low pressure plant building. Re-using this piping would retain some of the purely industrial character of the space while providing a sure route with minimal excavation through the many buried services on the site North of the building.

Above: 300mm steel gas piping

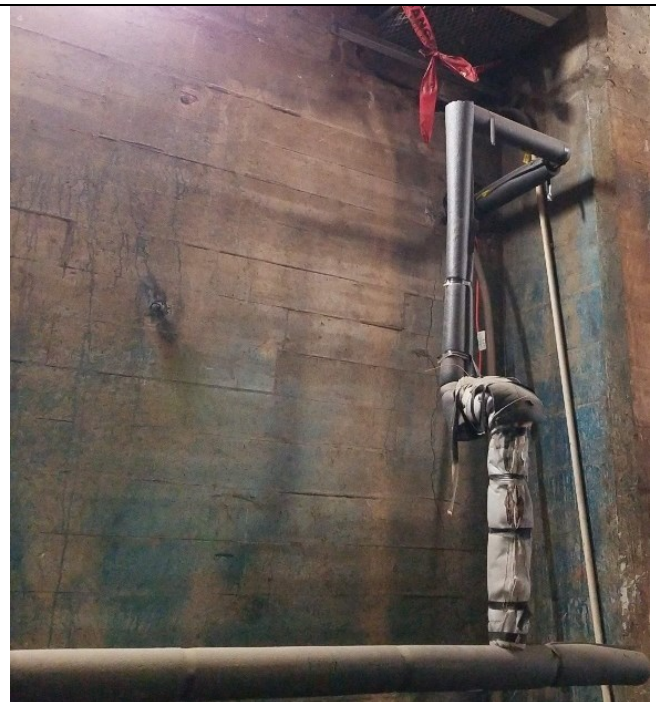
**Domestic Water Systems:** An existing 150mm domestic water service enters the turbine hall basement on the East side of the building just South of the Switch house. The piping is insulated, and heat traced over its entire length and serves the remaining washroom in the building. The condition of this piping is unclear; however, it is reportedly connected directly to the EPCOR water treatment plant, a condition which will likely no longer be tolerated once ownership is transferred to the City. Rather a service entrance to the domestic water main North below Rossdale Road will be preferred. This existing service connection also has no meter, isolation valve nor backflow preventer.

Above: 150mm domestic water connection from EPCOR Treatment plant

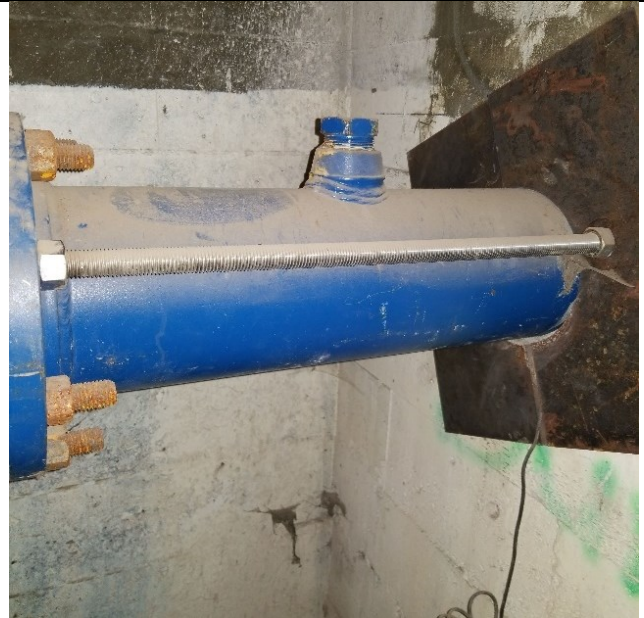
A new 100mm domestic water connection is already installed between the Northeast corner of the Low pressure plant, again on the basement level of the turbine hall, and the buried main beneath Rossdale Road. Reportedly, "Both [domestic water and sanitary] services were capped within the building without being put into service. Details for the installation of these two services are depicted on EPCOR drawing PMM-122 and PMM-124." <sup>1</sup> No isolation valve, meter nor backflow preventer are installed inside the building.

Above: 100mm domestic water connection North

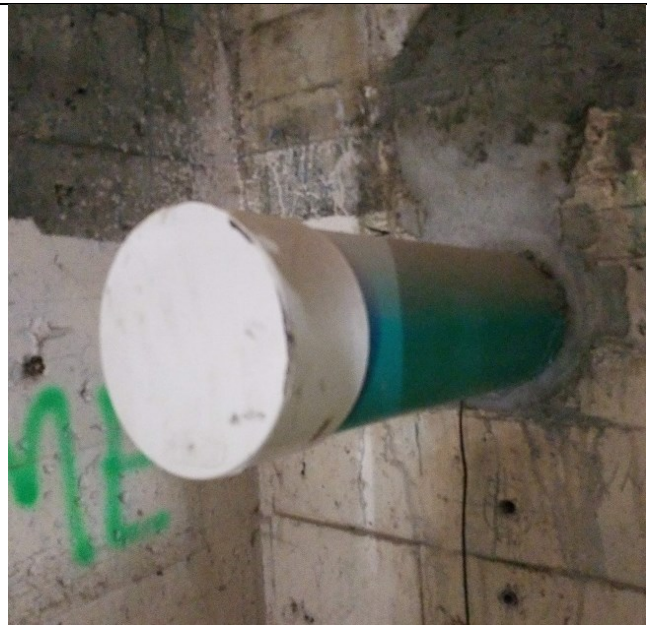
A new 150mm sanitary drain is installed between the Northeast corner of the Low Pressure Plant, again on the basement level of the turbine hall, and the buried main beneath Rossdale Road. The connection has been capped both within the building and below the road.

Above: 150mm Sanitary Connection North

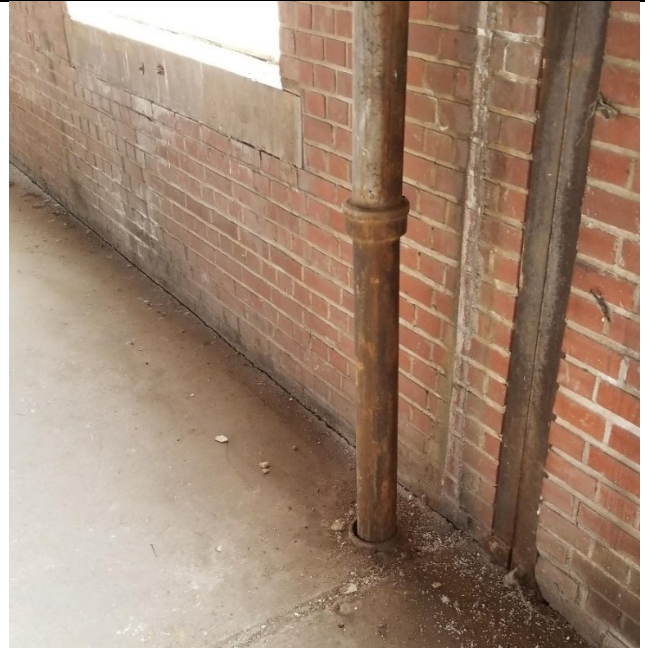
Rainwater leaders are almost exclusively cast iron with bell and spigot connections, exceptions are recently replaced rainwater leaders which are solvent welded PVC. Leaks from cast iron rainwater leaders at high level is resulting in staining of the interior brick, mold growth, and corrosion of archway lintels. Cleanouts at the base of the leaders have begun to fail resulting in water damage and standing water in the boiler hall during heavy rainfall.

Above: Cast iron rainwater leader, Boiler Hall

Failing rainwater leaders and cleanouts should be replaced immediately. Many roof drains in the older turbine hall roof pass into the boiler hall and contribute to water infiltration in the boiler hall and turbine hall wall. Roof drains in the turbine hall should be replaced as soon as possible, but in conjunction with repair or replacement of the turbine hall roof. Roof drain discharge should be separated from foundation drains which outfall directly to the river and directed toward storm water retention and drainage infrastructure.

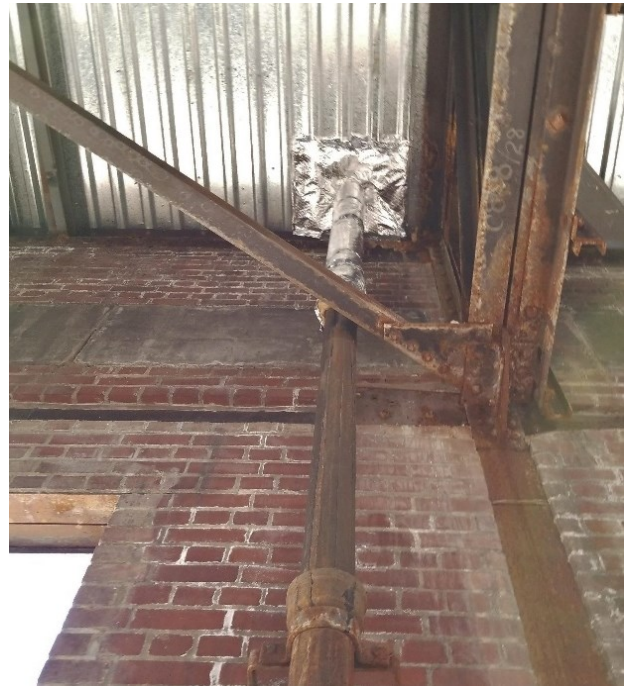
Above: New roof drain and connection to RWL (boiler hall)
