# Rossdale Power Plant Advanced Assessment and Priority Rehabilitation

## Switch House Condition Assessment

**Submitted to: City of Edmonton**

**Date Submitted: 2021-03-15**

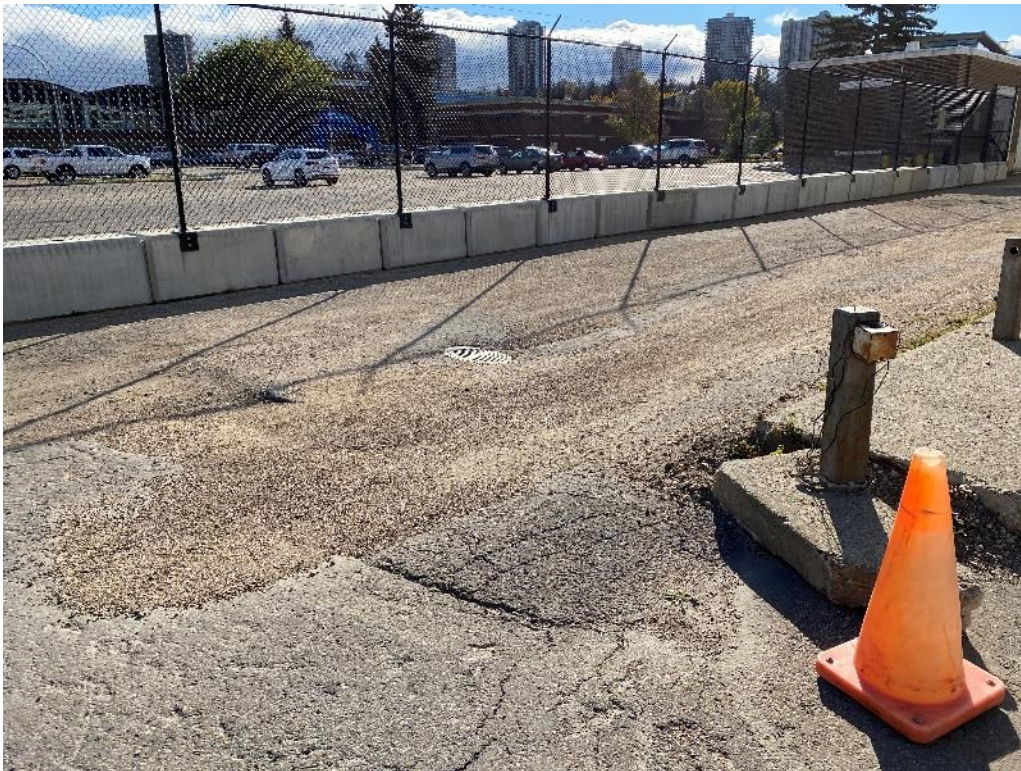
Above: Storm catch basin east of the Switch House

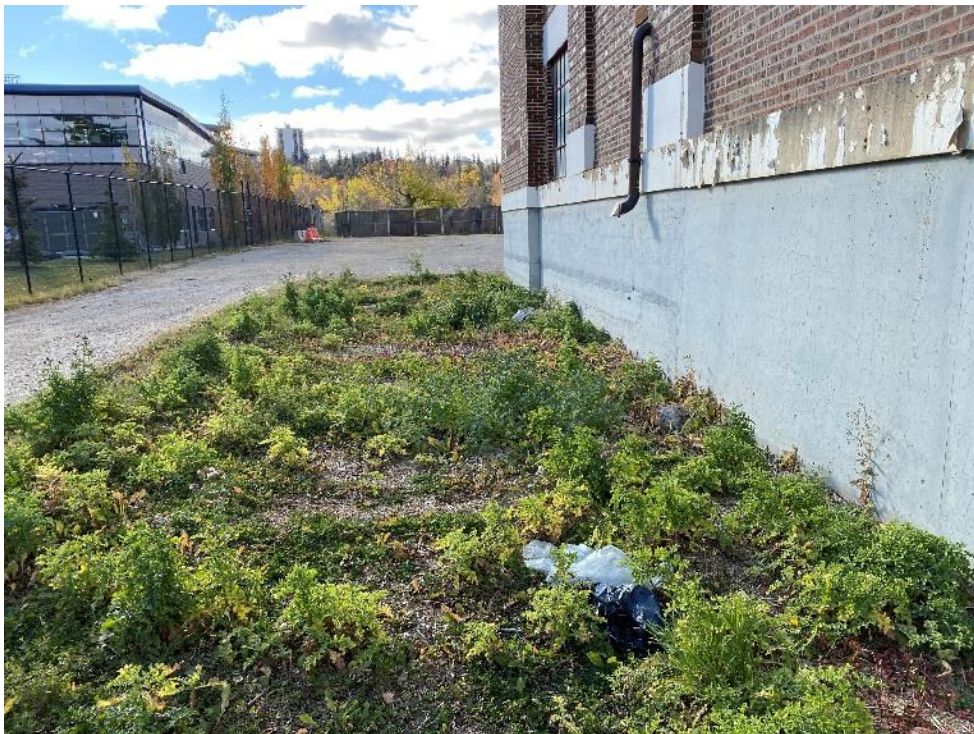
**Above: Landscaped area east of the Switch House**

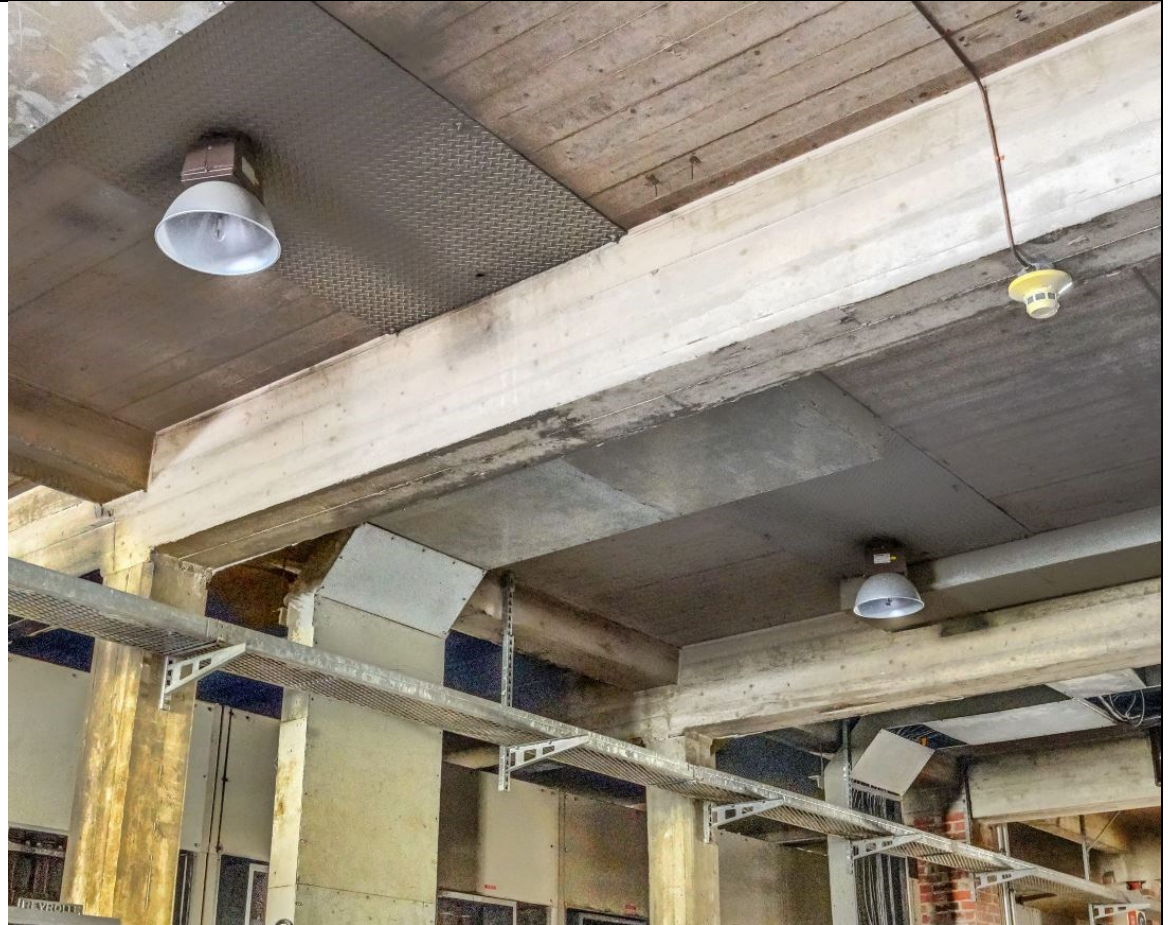
**MN-101, Cable Trays and Relict Hangars:**

All cable trays and the myriad of relict hangers and various fixtures are all in good shape, presenting no observed hazards.

Ad-hoc electrical chases have been made through walls and floor slabs, but have not overly affected heritage or architectural fabric in an adverse way (minor crack/spalling as seen in lower photo).

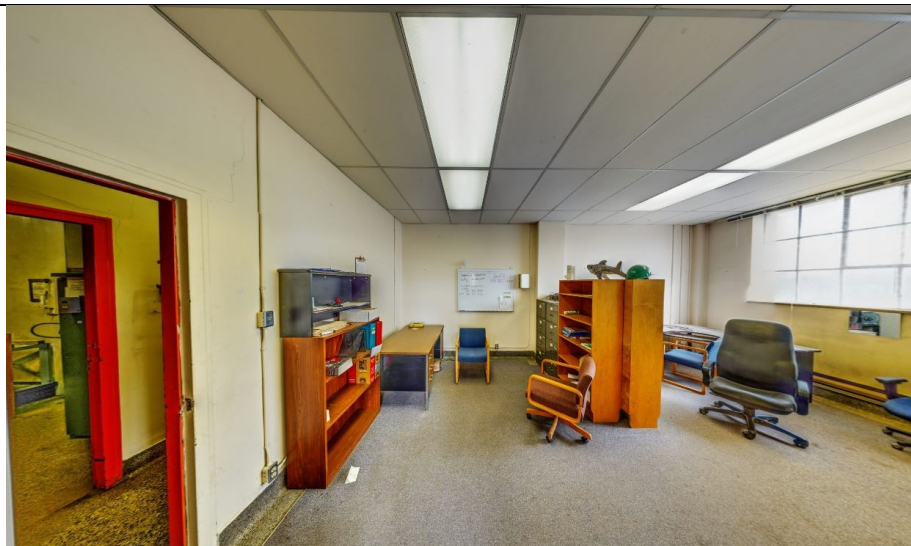
**02-108, Common Office:**

All surfaces are dirty and require cleaning. All painted surfaces are soiled. Generally, asides from finishes as throughout the LPP, the architectural fabric of this space is in good condition.

The window is a modern single insulated glazing unit, non-original. Concrete floor is in good condition despite paint erosion and minor cracks.

Original door, door surrounds, and obscura glass is in good condition.

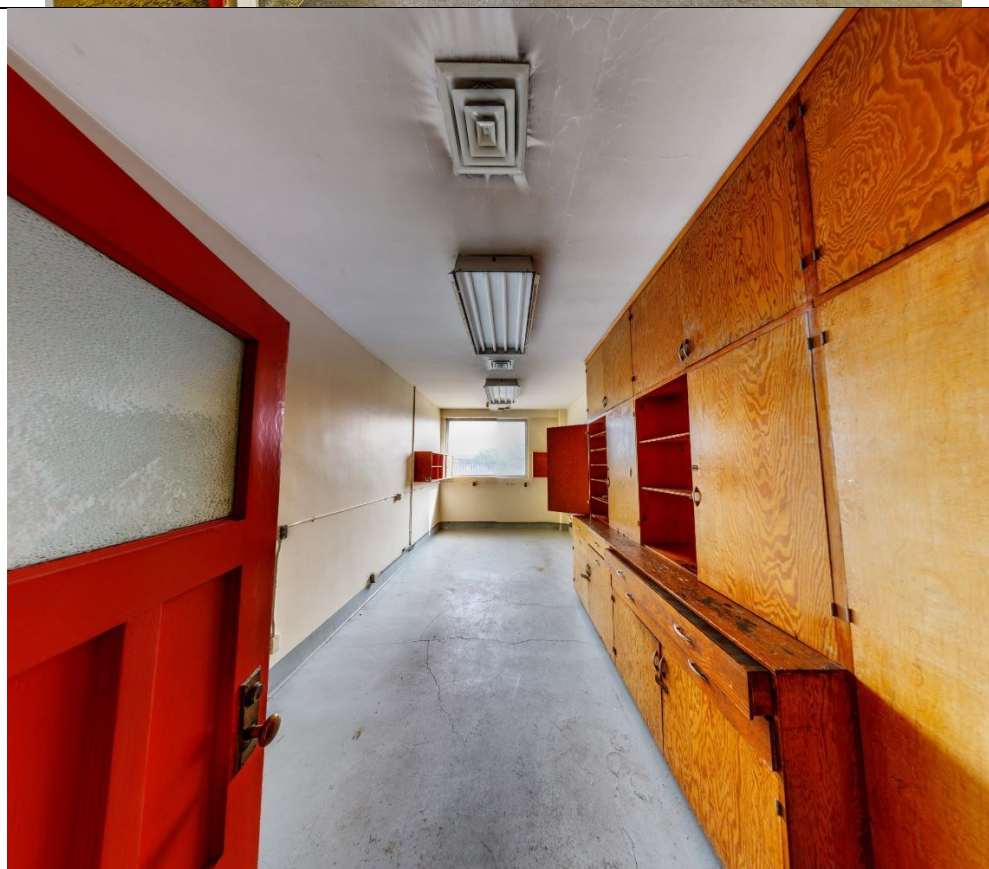
**02-108, Common Office, Finishes and Vents:**

Wall and ceiling finishes are in good condition, except for above the doorway. It appears that the vent unit has suffered from water ingress, much like the battery room. This is likely associated with water ingress at the location of an older ventilation unit, now gone, in the central corridor (02-114) which has strong evidence of water ingress as seen in the paint failure.

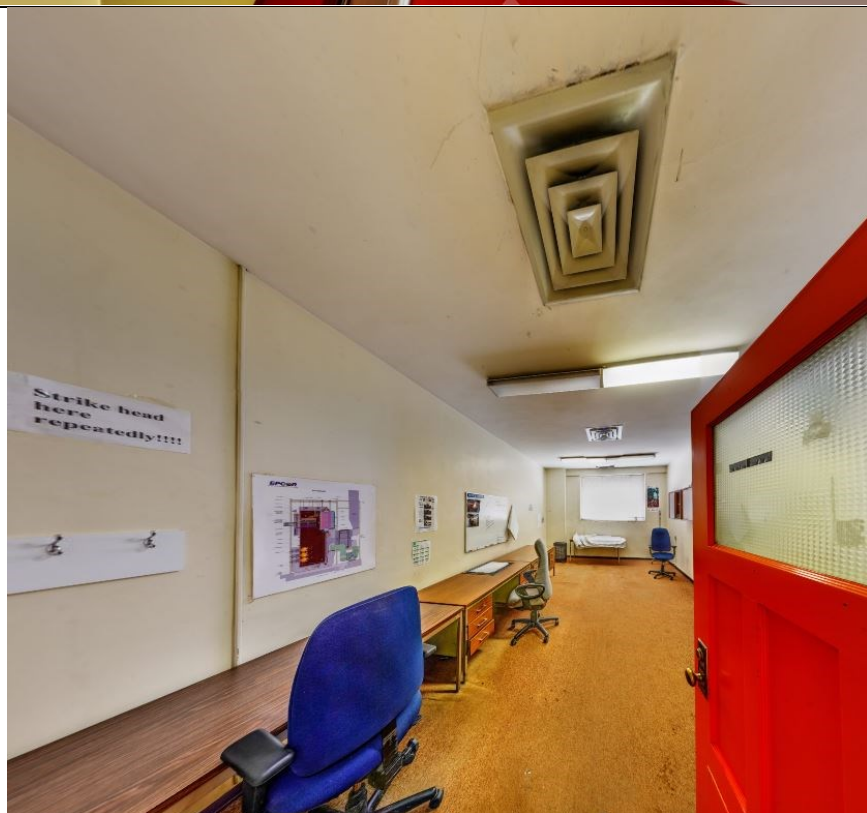
**02-112, Common Office:**

All surfaces are dirty and require cleaning. All painted surfaces are soiled. Generally, aside from finishes as throughout the LPP, the architectural fabric of this space is in good condition. Material underneath non-original carpet is unknown.

The window is a modern single insulated glazing unit, non-original.

Original door, door surrounds, and obscura glass are in good condition.

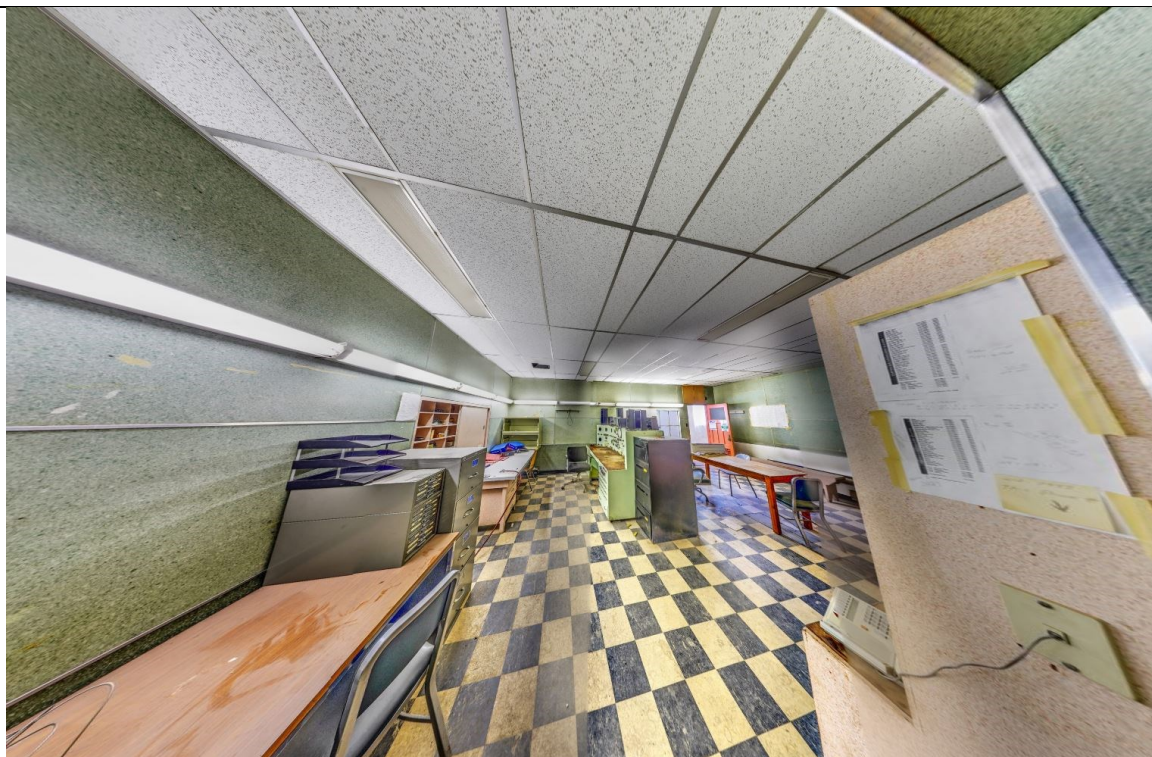
**02-110, Switch Room:**

The Transite wall panels are asbestos containing, but of heritage value dating to the same time around the construction of the HPP and the movement of the control room there. The ceiling in original drawings is recorded to be sprayed Limpet insulation (famous for being asbestos), however, EPCOR employees have commented that it tested negative during plant decommissioning.

The flooring is missing various checker board units, and some are damaged. All equipment is in excellent condition.

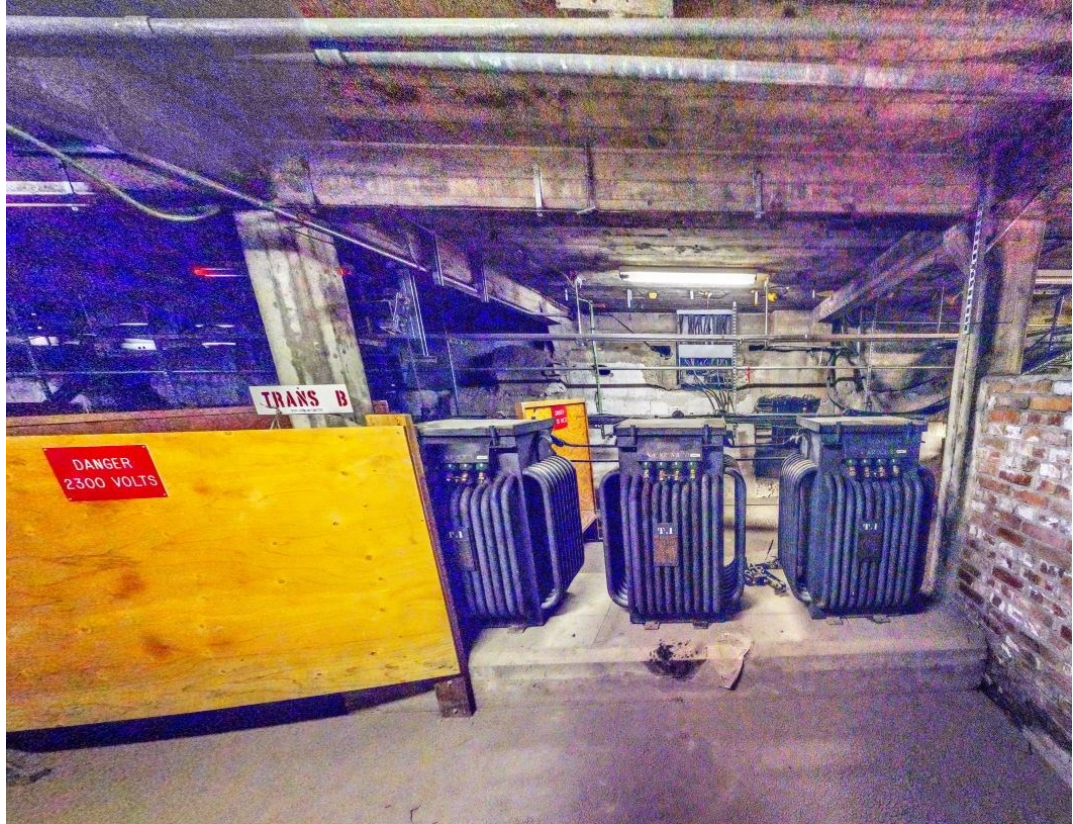
**BM-195 & BM-195, Basement Service Tunnels:** Radiating from BM-101, service tunnels with manhole access to the north and transformer house connection to the east, were not thoroughly assessed as confined spaces planning and safety plans and equipment would have had to been provided for. It is presumed that these are in good condition.

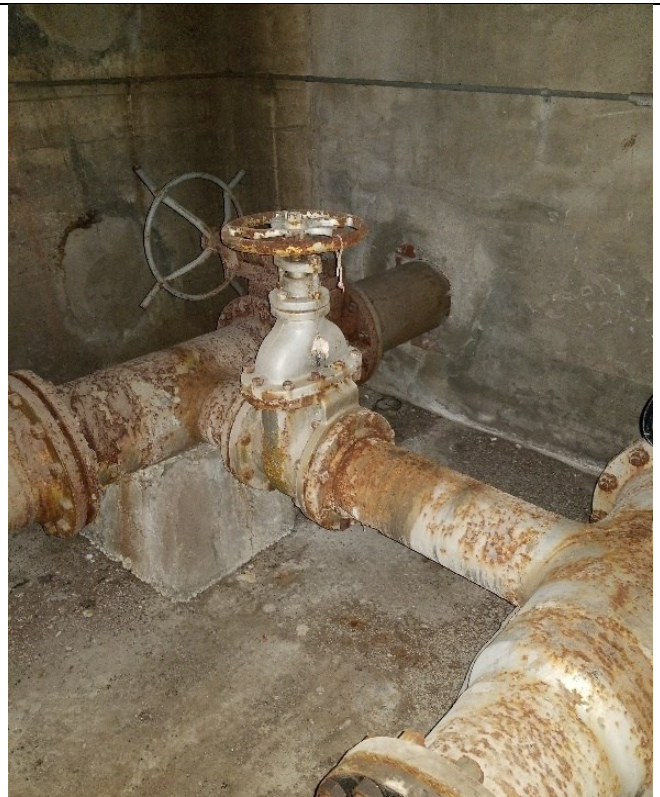
**Natural Gas:** There is no active gas service to the Low Pressure plant. Due to its former vocation as a gas fired electricity generating plant there is significant infrastructure which formerly supplied gas to the large turbines housed within. Although the connections are now abandoned and sealed at both ends, two 300mm diameter steel gas lines still enter the Low Pressure plant in the basement level of the Boiler Hall and terminate in a vault like room near the center of the boiler hall basement. These mains run North to an abandoned gas service trunk on the property. Although likely not suitable for returning to service these two mains could potentially be used a sleeves to insert smaller diameter gas piping to serve future heating systems within the low pressure plant building. Re-using this piping would retain some of the purely industrial character of the space while providing a sure route with minimal excavation through the many buried services on the site North of the building.

Above: 300mm steel gas piping

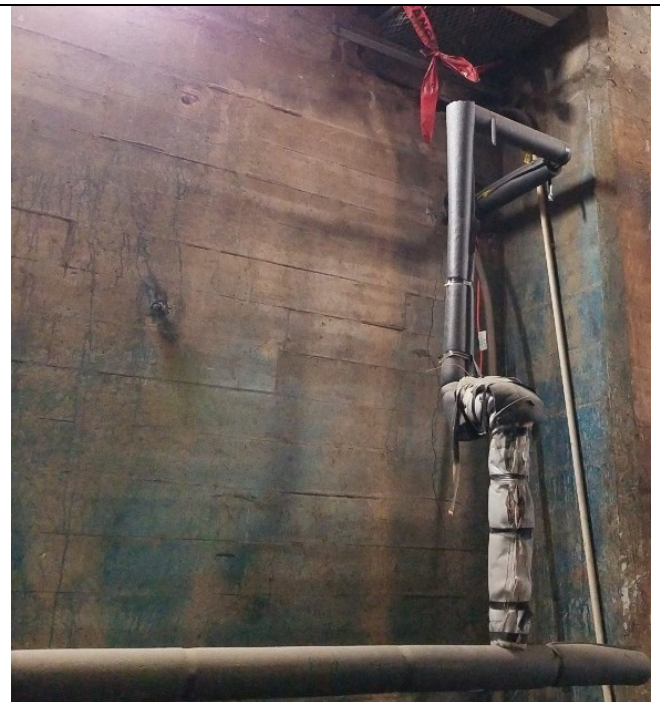
**Domestic Water Systems:** An existing 150mm domestic water service enters the turbine hall basement on the East side of the building just South of the Switch house. The piping is insulated, and heat traced over its entire length and serves the remaining washroom in the building. The condition of this piping is unclear; however, it is reportedly connected directly to the EPCOR water treatment plant, a condition which will likely no longer be tolerated once ownership is transferred to the City. Rather a service entrance to the domestic water main North below Rossdale Road will be preferred. This existing service connection also has no meter, isolation valve nor backflow preventer.

Above: 150mm domestic water connection from EPCOR Treatment plant

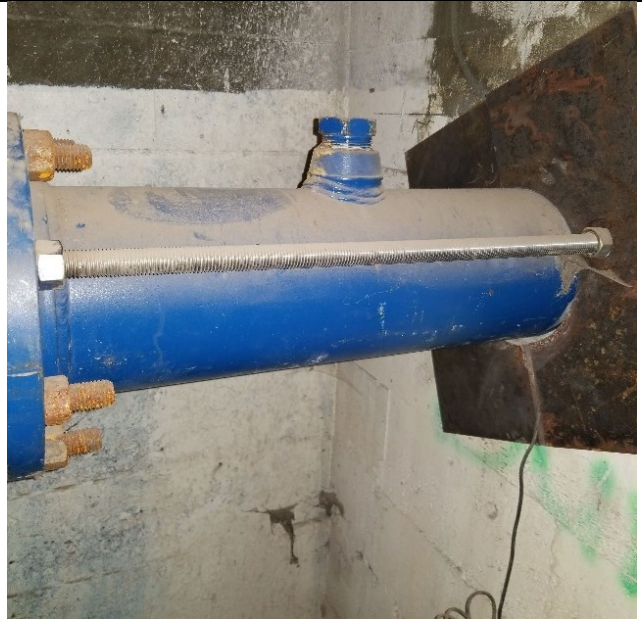
A new 100mm domestic water connection is already installed between the Northeast corner of the Low pressure plant, again on the basement level of the turbine hall, and the buried main beneath Rossdale Road. Reportedly, "Both [domestic water and sanitary] services were capped within the building without being put into service. Details for the installation of these two services are depicted on EPCOR drawing PMM-122 and PMM-124." <sup>1</sup> No isolation valve, meter nor backflow preventer are installed inside the building.

Above: 100mm domestic water connection North

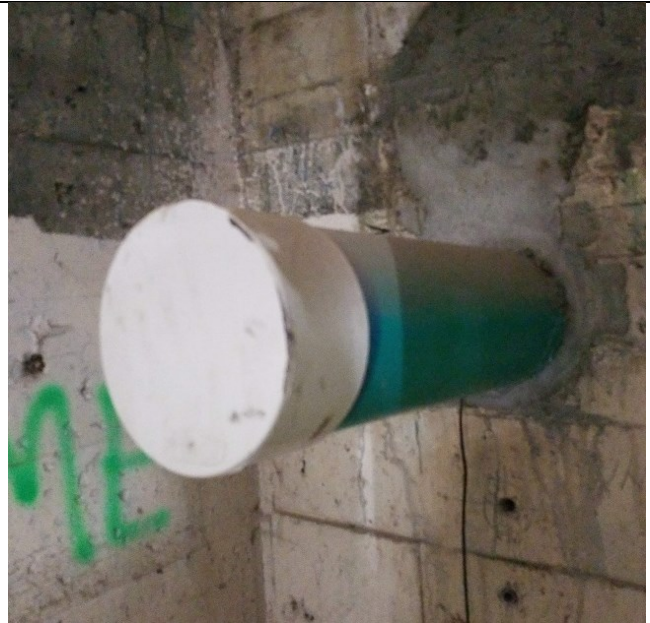
A new 150mm sanitary drain is installed between the Northeast corner of the Low Pressure Plant, again on the basement level of the turbine hall, and the buried main beneath Rosedale Road. The connection has been capped both within the building and below the road.

Above: 150mm Sanitary Connection North

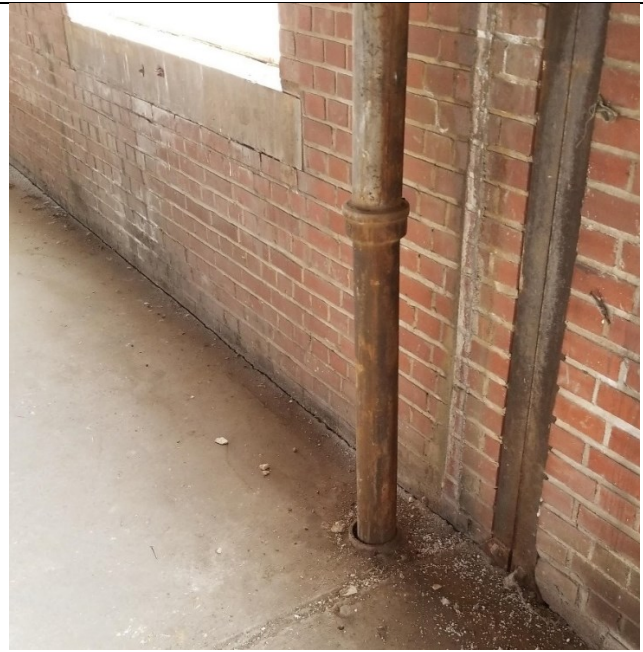
Rainwater leaders are almost exclusively cast iron with bell and spigot connections, exceptions are recently replaced rainwater leaders which are solvent welded PVC. Leaks from cast iron rainwater leaders at high level is resulting in staining of the interior brick, mold growth, and corrosion of archway lintels. Cleanouts at the base of the leaders have begun to fail resulting in water damage and standing water in the boiler hall during heavy rainfall.

Above: Cast iron rainwater leader, Boiler Hall

Failing rainwater leaders and cleanouts should be replaced immediately. Many roof drains in the older turbine hall roof pass into the boiler hall and contribute to water infiltration in the boiler hall and turbine hall wall. Roof drains in the turbine hall should be replaced as soon as possible, but in conjunction with repair or replacement of the turbine hall roof. Roof drain discharge should be separated from foundation drains which outfall directly to the river and directed toward storm water retention and drainage infrastructure.

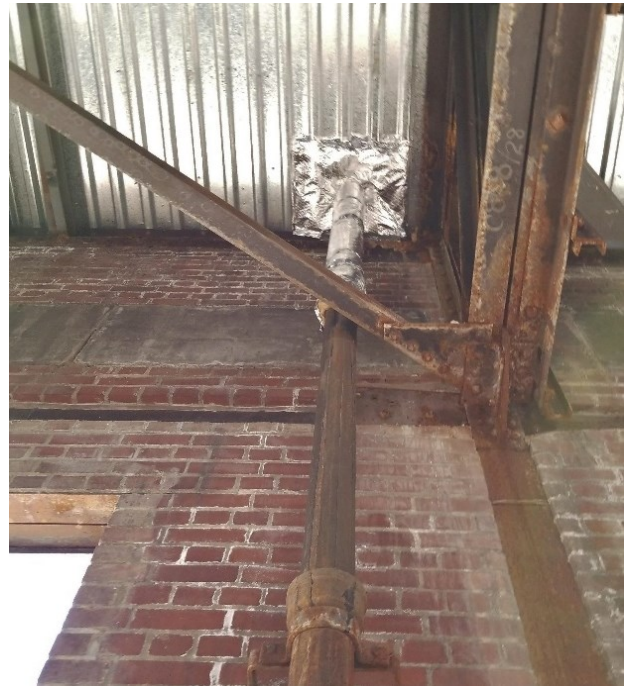
Above: New roof drain and connection to RWL (boiler hall)
