**Re: Geotechnical Investigation – Second Submission
Proposed Goodridge Corners Phase 3
Part of SE 12 – 54 – 25 – W4M
185 Avenue & 132 Street NW
Edmonton, Alberta**

REPORT NO: 6234-49

**GEOTECHNICAL INVESTIGATION – SECOND SUBMISSION
PROPOSED GOODRIDGE CORNERS PHASE 3
PART OF SE 12 – 54 – 25 – W4M
185 AVENUE & 132 STREET NW
EDMONTON, ALBERTA**

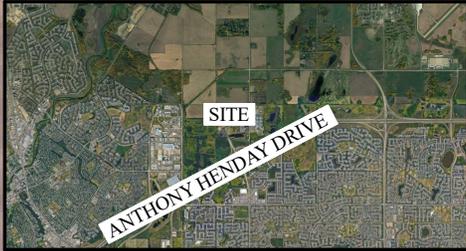
Site Boundary

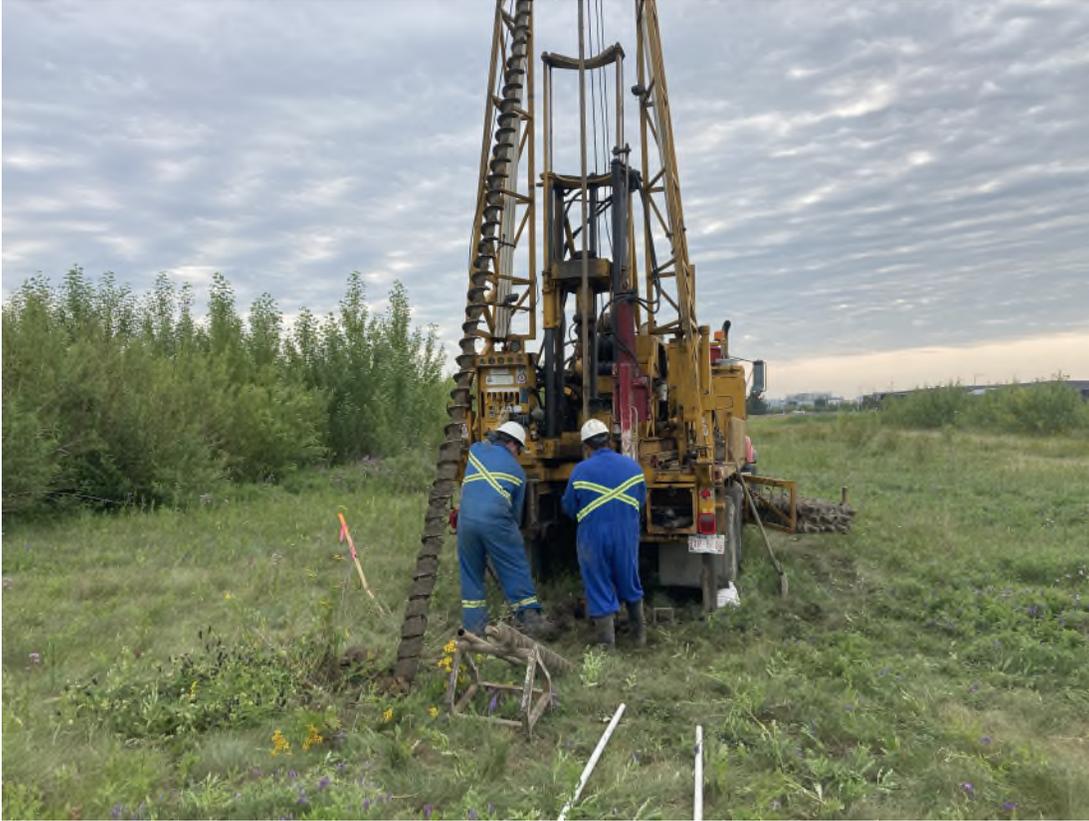
Photo 1: Drilling Testhole 2023-01 – Photo Looking East (August 2, 2023)
