# NORTHWEST LRT - 132 AVENUE STATION

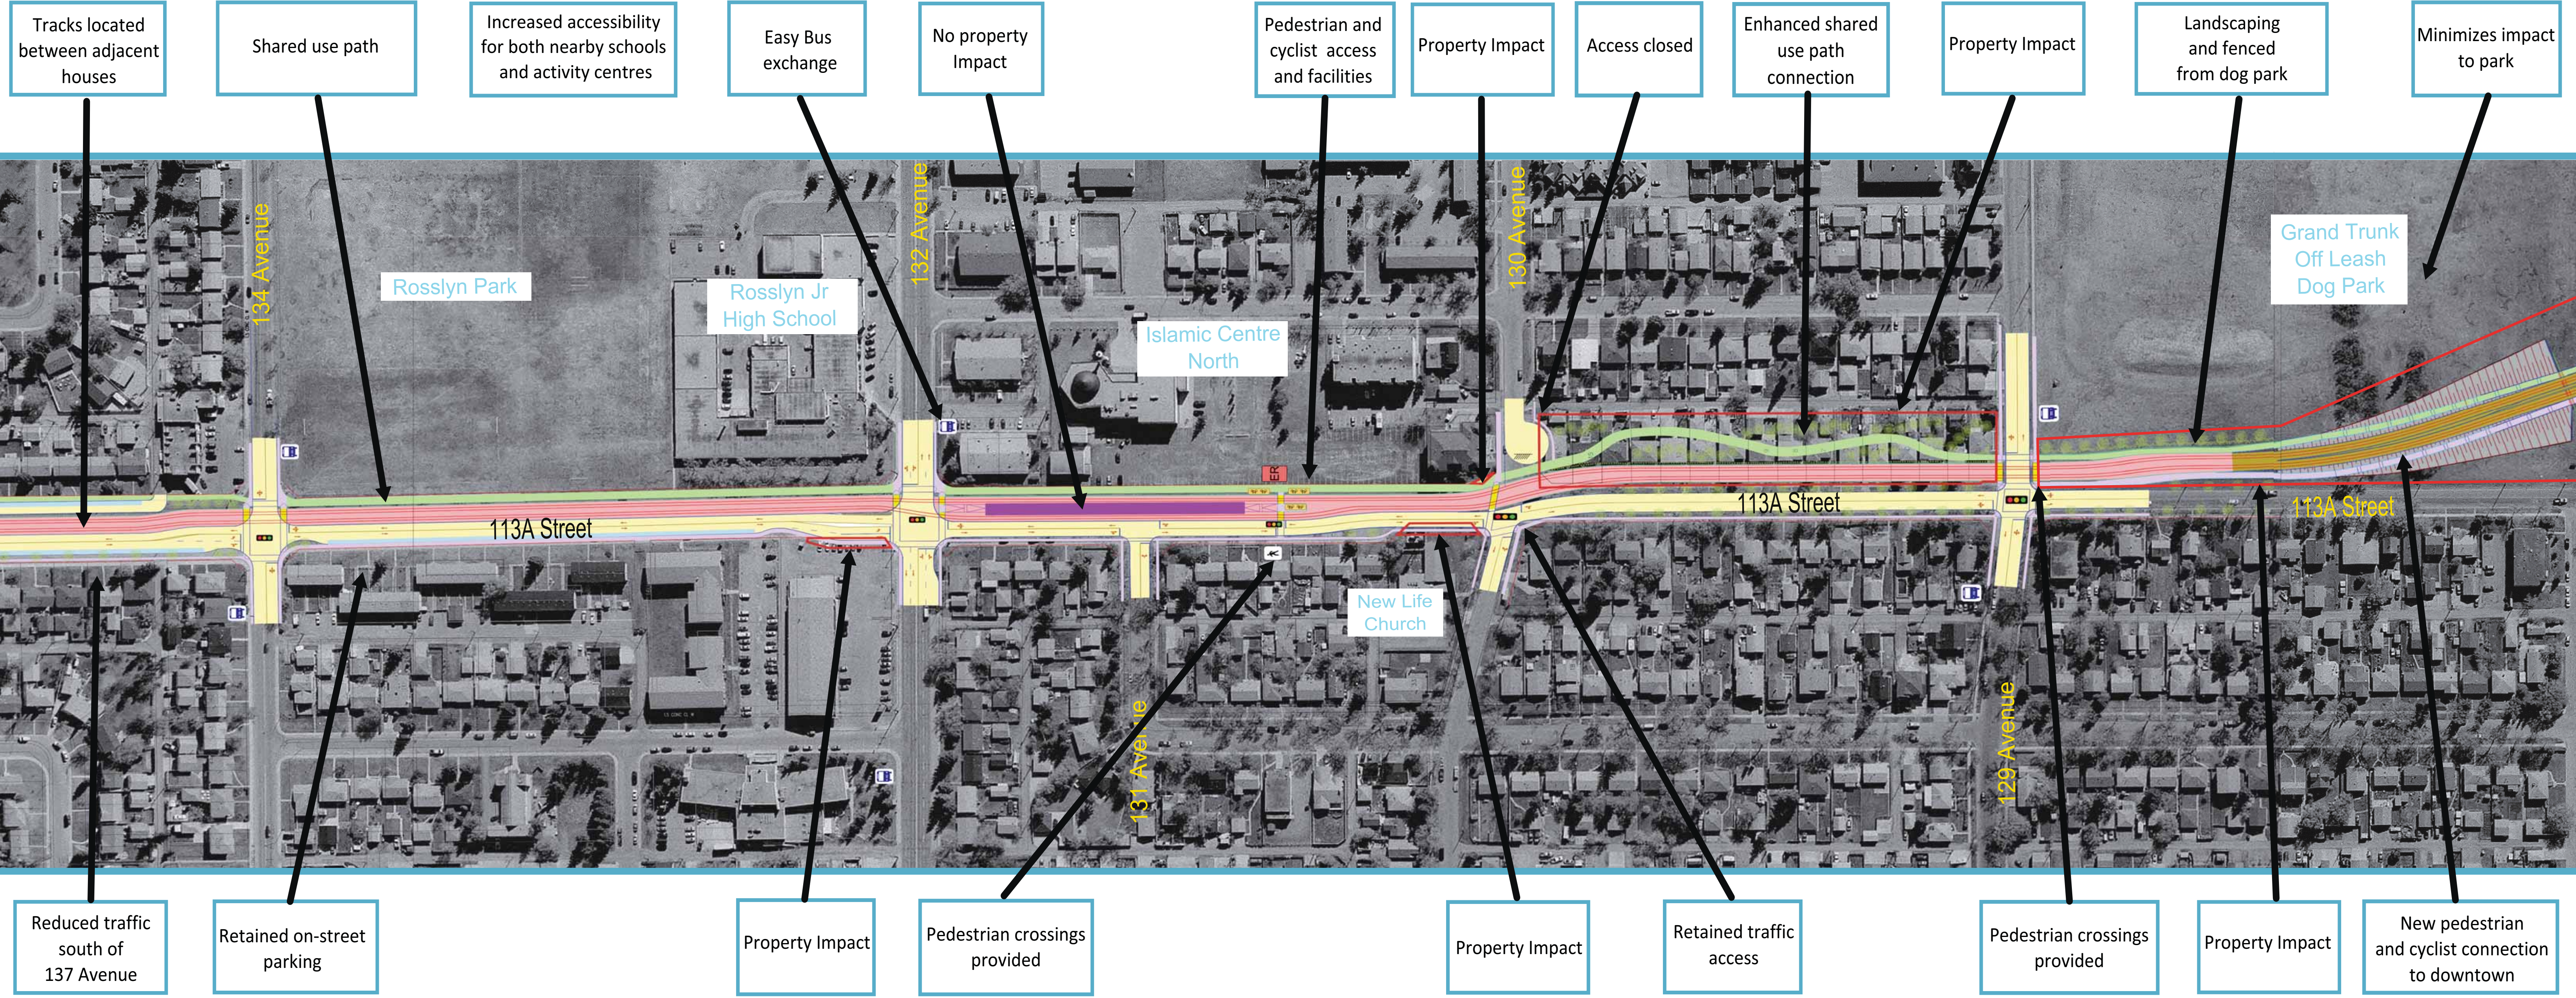
Tracks located between adjacent houses

Shared use path

Increased accessibility for both nearby schools and activity centres

Easy Bus exchange

No property Impact

Pedestrian and cyclist access and facilities

Property Impact

Access closed

Enhanced shared use path connection

Landscaping and fenced from dog park

Minimizes impact to park

Reduced traffic south of 137 Avenue

Retained on-street parking

Pedestrian crossings provided

Retained traffic access

New pedestrian and cyclist connection to downtown
