October 4, 2019

Subject: Preliminary Geotechnical Assessment Report

North Shore Promenade

River Bank between Walterdale Bridge and Groat Road Bridge, Edmonton, Alberta

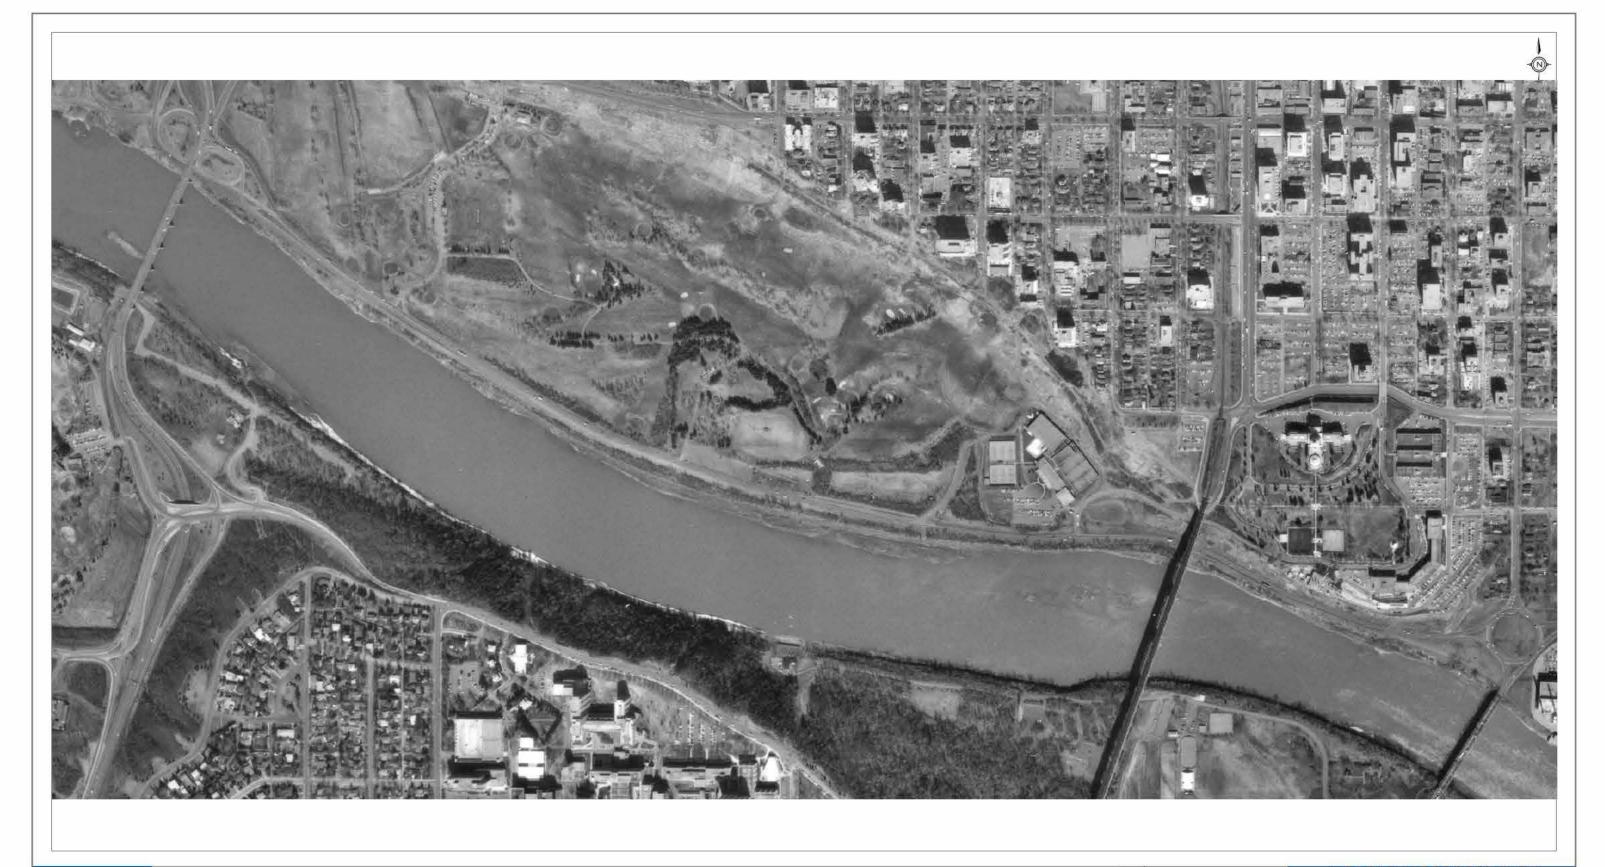
AERIAL PHOTOGRAPH 1978

- The outfall locations as presented on Figure 2 are not readily visible from the aerial photographs except for what appears to be evidence of significant discharge near Outfall #175 and #176 in 1978;

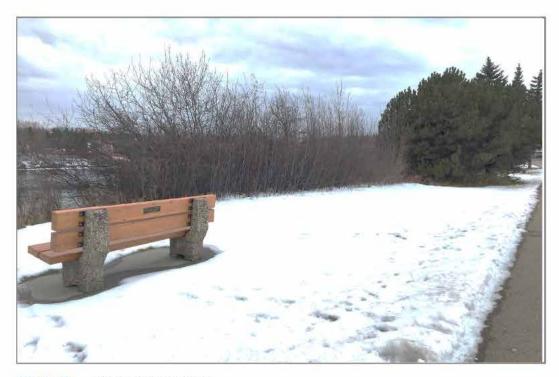
1.5 m high and 100 m in length;
- There were four existing viewing areas along the multi-use trail at the top of the river bank slope at approximately 190 m, 240 m, 280 m and 320 m east of the Groat Road Bridge. These viewing areas were generally level graded surfaces at the approximate elevation of the multi-use trail (Photos 6 and 7). The river bank slope supporting or immediately next to the viewing areas was relatively steep locally and was estimated to be around 1 Horizontal to 1 Vertical (i.e. 1H:1V) as shown on Photo 8.

Photo 6: Existing Viewing Areas

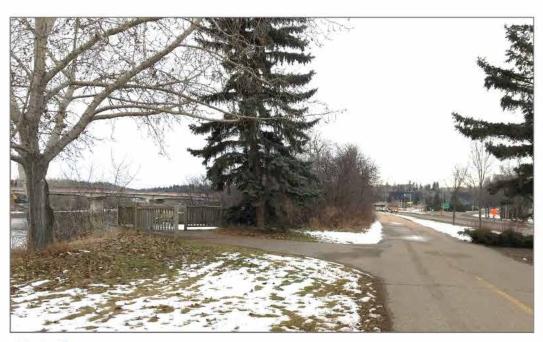
Photo 7: Existing Viewing Areas

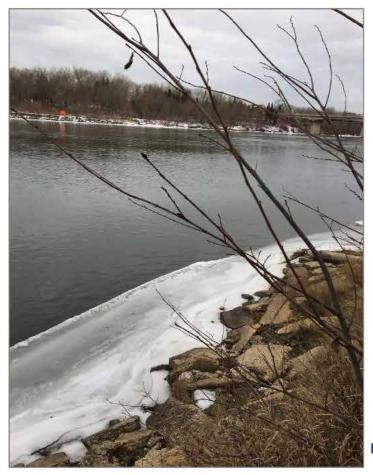
Photo 13: Large Concrete Blocks close to River Level
