Rossdale Low Pressure Plant

Structural Evaluation

10155 - 96 Avenue NW, Edmonton, AB

RJC Engineers

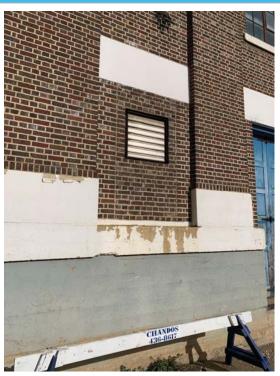
Photo 1: Switch House exterior

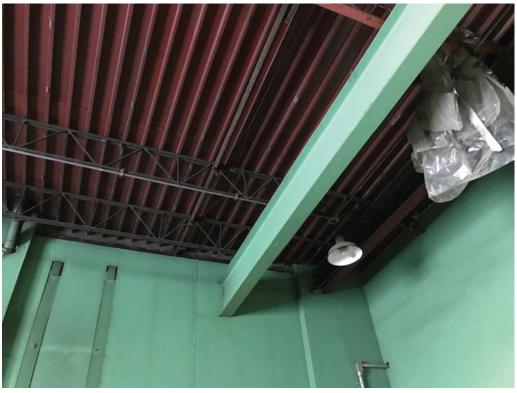
Photo 2: Roof – Typical framing

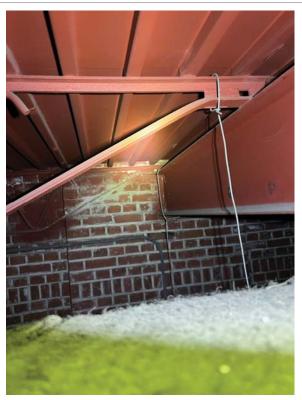
Photo 3: Roof – Framing

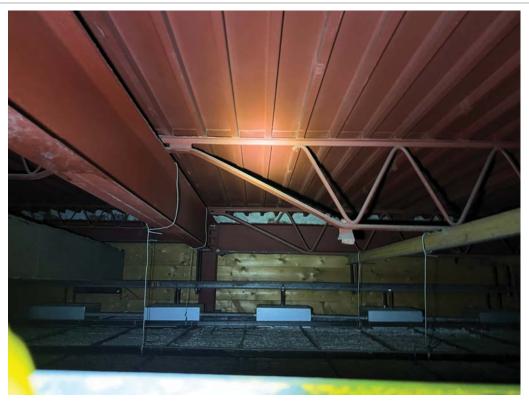
Photo 4: Roof – Joists

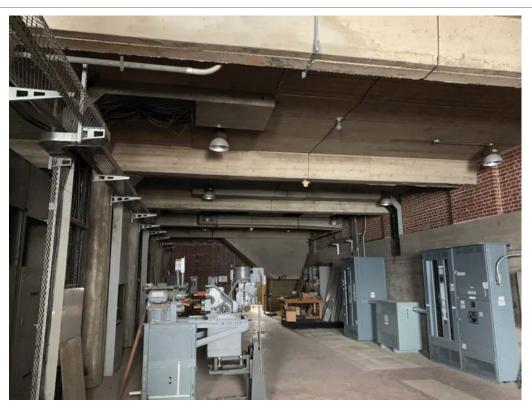
Photo 5: 2nd Floor – Typical

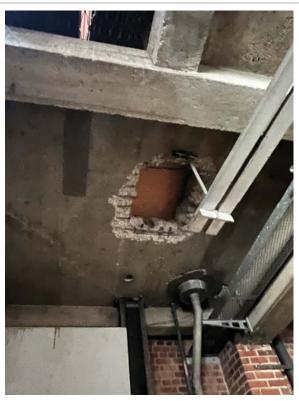
Photo 6: 2nd Floor – Opening to infill

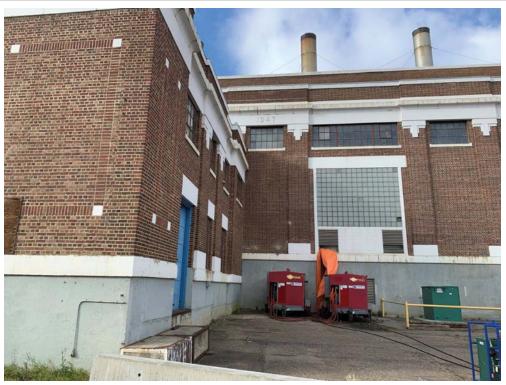
Photo 10: Exterior

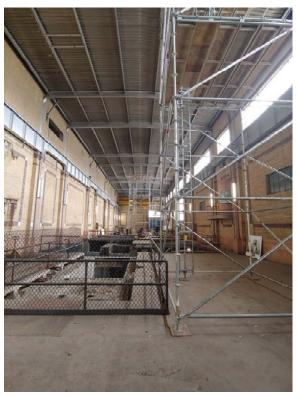
Photo 11: Roof - Overall

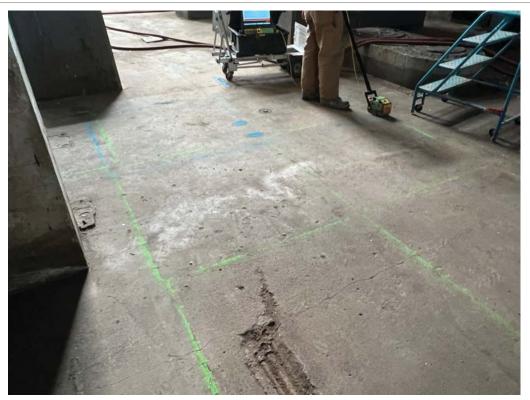
Photo 23: Basement - Floor scanning

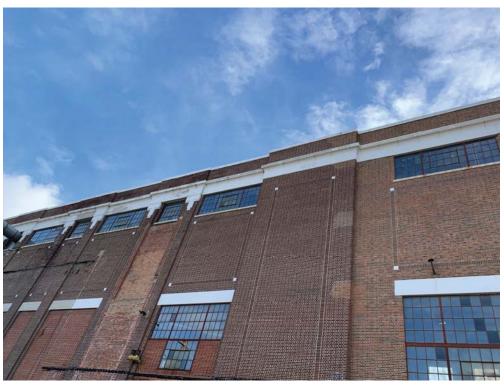
Photo 26: Boiler Hall Exterior

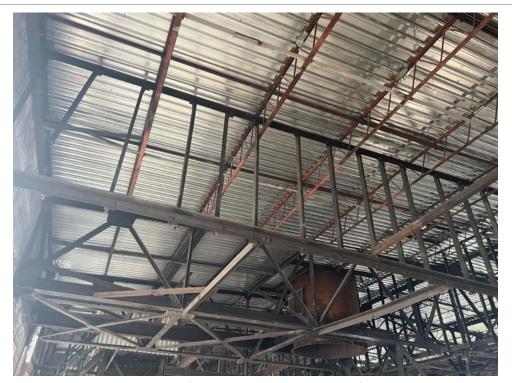
Photo 29: Roof – Joists and miscellaneous framing.

Miscellaneous steel is the vertical "wall" steel in foreground of photo

The trusses were found with a larger delta between capacity and required loads. Consideration for reinforcement of these members is considered even more critical than the joists. One other approach would be to reduce the dead load by removing the miscellaneous non-structural steel. This would decrease the demand on the structure and could reduce the amount of reinforcing necessary for the trusses. See photo 29/30 for examples of the non-structural steel that could be removed.

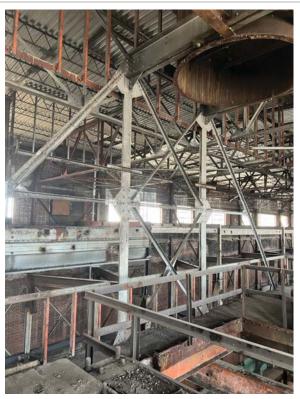
Photo 30: Roof – Stack and miscellaneous framing (orange most steel in top left).

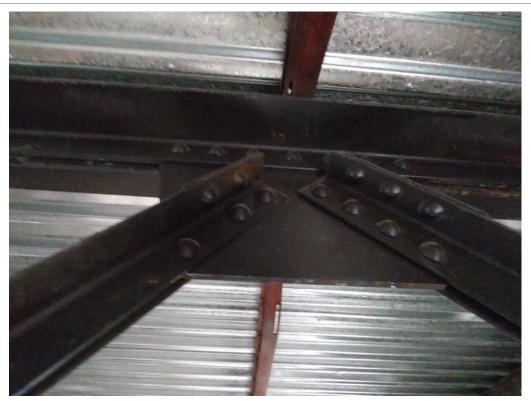
Photo 31: Roof - Truss bolting

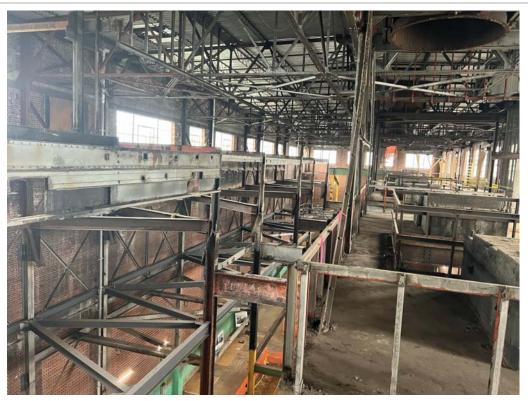
Photo 32: Mezzanine – Overall

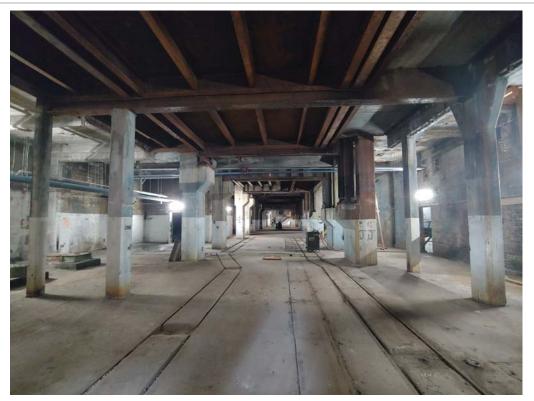
Photo 40: Main Floor – Overall from underneath

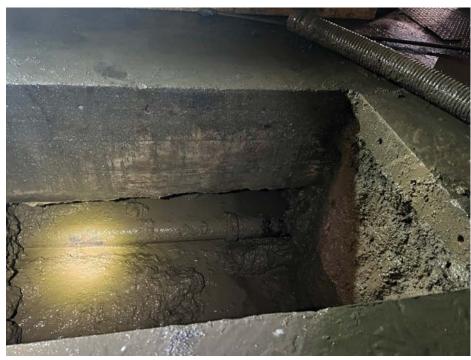
Figure 1: Hole #1 Looking towards footing

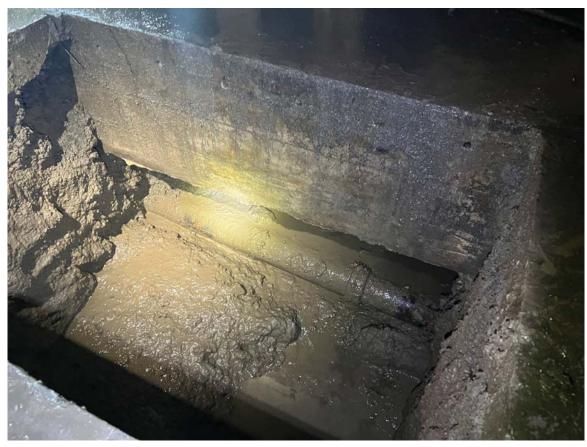
Figure 2: Hole 1: Looking toward footing

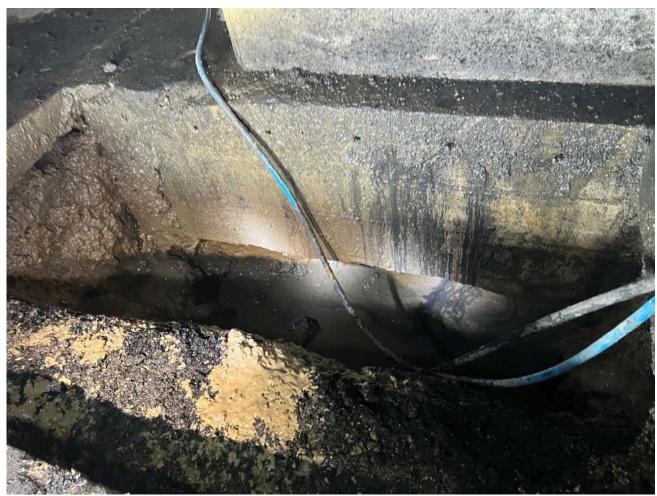
Figure 4: Hole #2 Looking towards footing

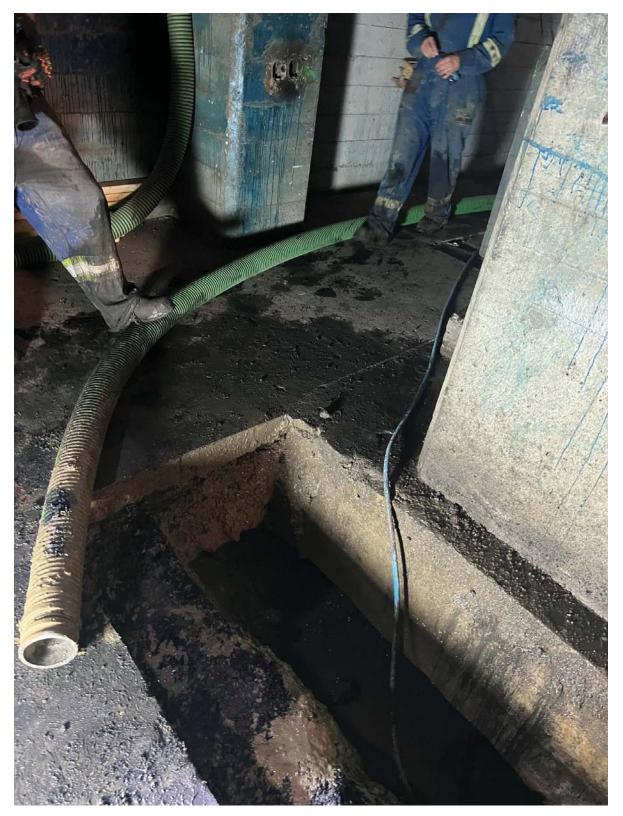
Figure 5: Hole 2: Showing footing/slab

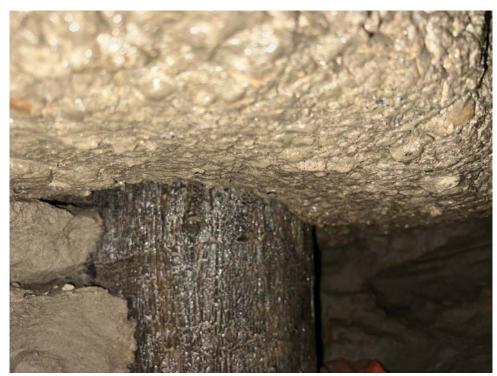
Figure 8: Wood Pile Surface

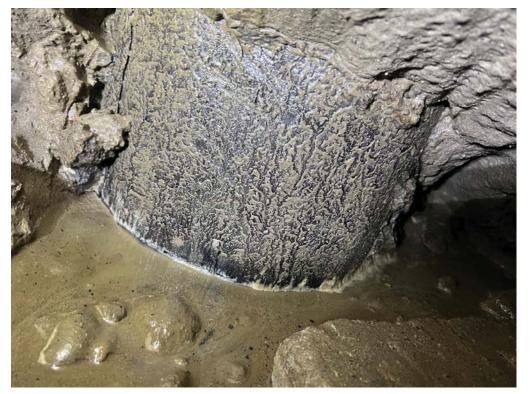
Figure 9: Wood Pile

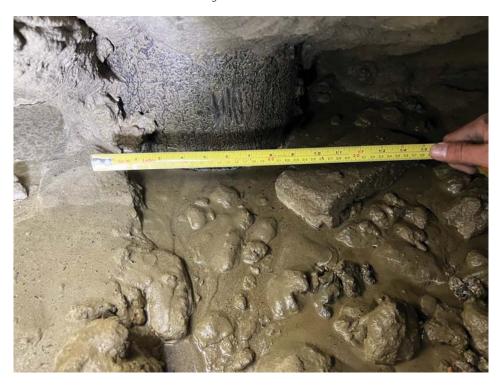
Figure 10: Wood Pile Size

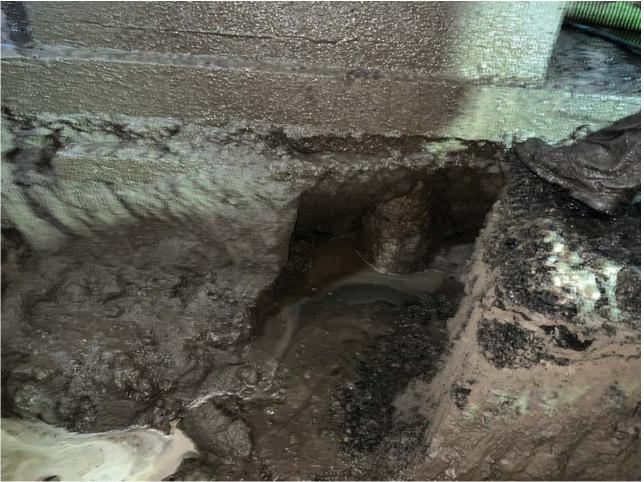
Figure 11: Concrete Pile

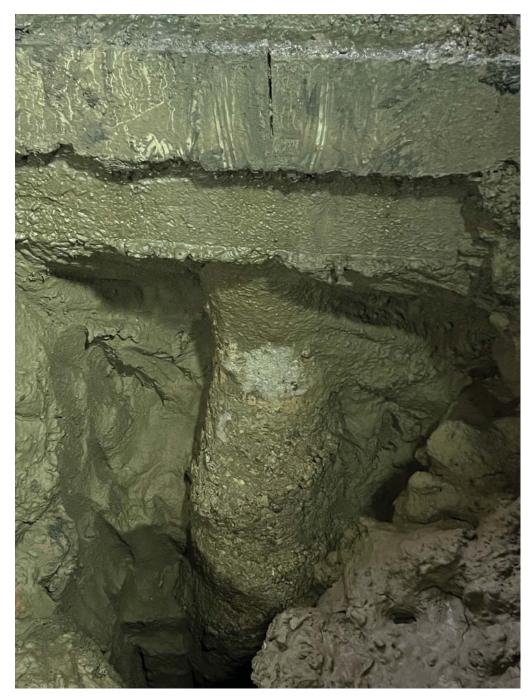
Figure 12: Concrete Pile
