The City of Edmonton

the marc boutin architectural collaborative inc.

#### 2.0 Conditions Assessment

RJC has completed a Civil condition assessment on the Rossdale Power Plant site located in downtown Edmonton, Alberta. The following report includes a summary of the documentation available for review, the site conditions observed and what can be expected for the site going forward.

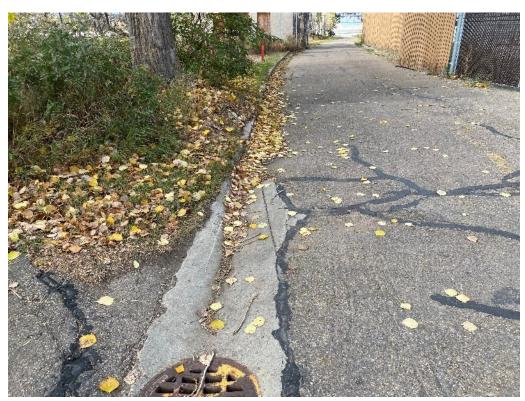
Above: Public trail between Pump House 1 and the Low Pressure Plant

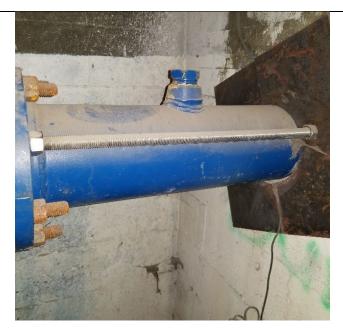
A new 100mm domestic water connection is already installed between the Northeast corner of the Low pressure plant, again on the basement level of the turbine hall, and the buried main beneath Rossdale Road. Reportedly, "Both [domestic water and sanitary] services were capped within the building without being put into service. Details for the installation of these two services are depicted on EPCOR drawing PMM-122 and PMM-124." <sup>1</sup> No isolation valve, meter nor backflow preventer are installed inside the building.

Above: 100mm domestic water connection North

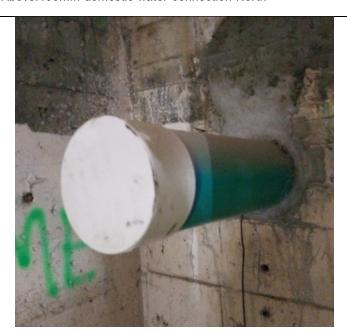
A new 150mm sanitary drain is installed between the Northeast corner of the Low Pressure Plant, again on the basement level of the turbine hall, and the buried main beneath Rossdale Road. The connection has been capped both within the building and below the road.

Above: 150mm Sanitary Connection North

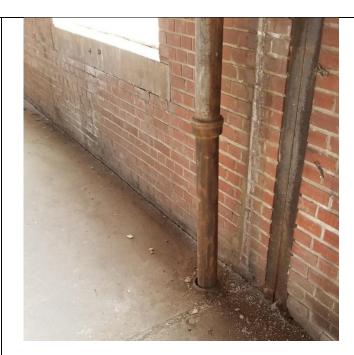
Rainwater leaders are almost exclusively cast iron with bell and spigot connections, exceptions are recently replaced rainwater leaders which are solvent welded PVC. Leaks from cast iron rainwater leaders at high level is resulting in staining of the interior brick, mold growth, and corrosion of archway lintels. Cleanouts at the base of the leaders have begun to fail resulting in water damage and standing water in the boiler hall during heavy rainfall.

Above: Cast iron rainwater leader, Boiler Hall

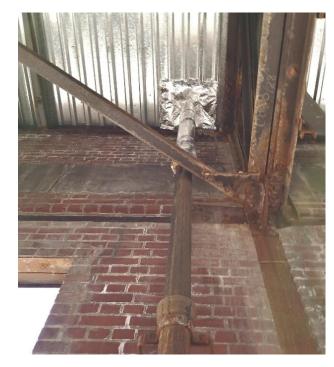
Above: New roof drain and connection to RWL (boiler hall)

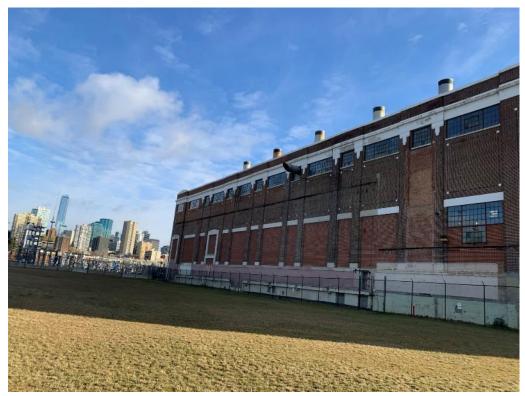
Above: West Wall of Boiler Hall

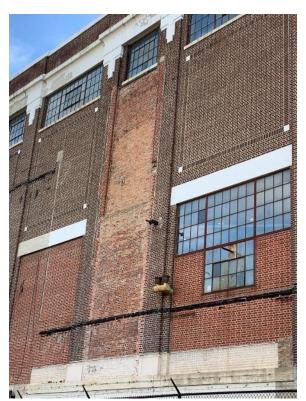
Above: West Wall of Boiler Hall

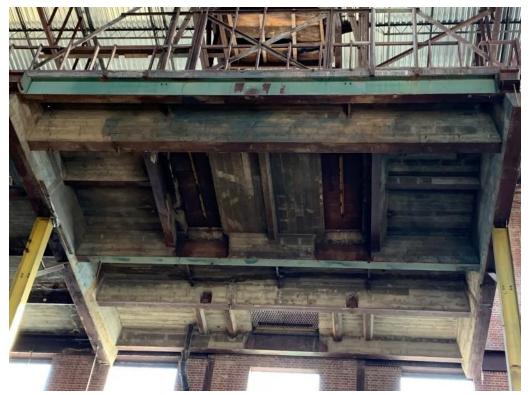
Above: Boiler Hall - Mezzanine Structure

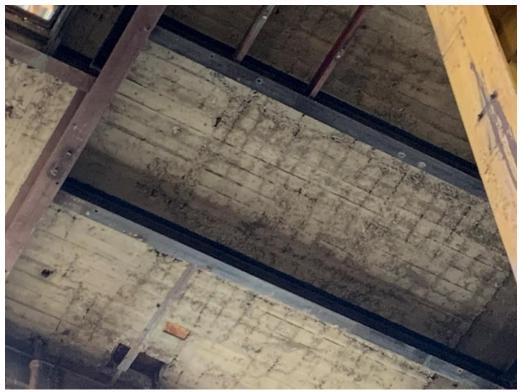
Above: Boiler Hall - Concrete on Mezzanine Structure

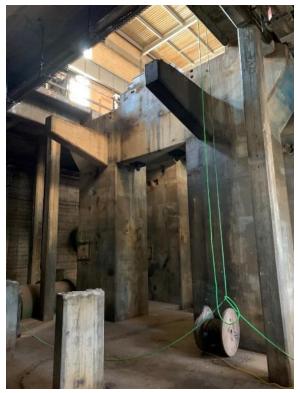
Above: Boiler Hall - Basement Pedestals

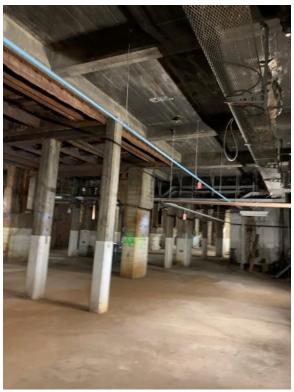
Above: Boiler Hall- Basement Structure

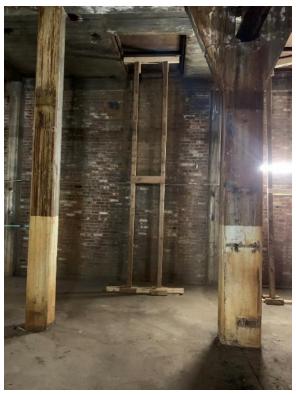
Above: Boiler Hall - Support Structure Typical for Openings

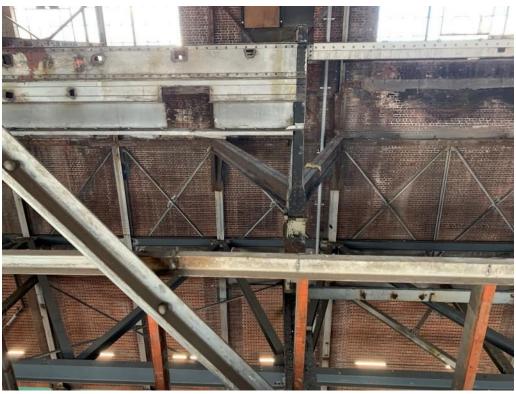
Above: Boiler Hall - Photo from Mezzanine at Boiler Structure

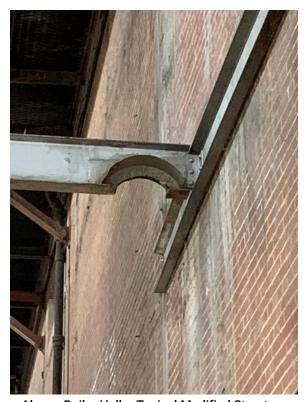
Above: Boiler Hall - Typical Modified Structure

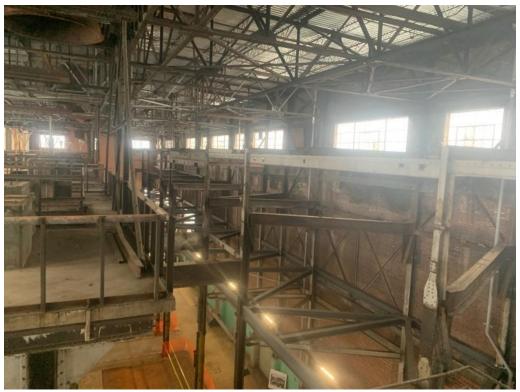
Above: Boiler Hall - Roof Structure

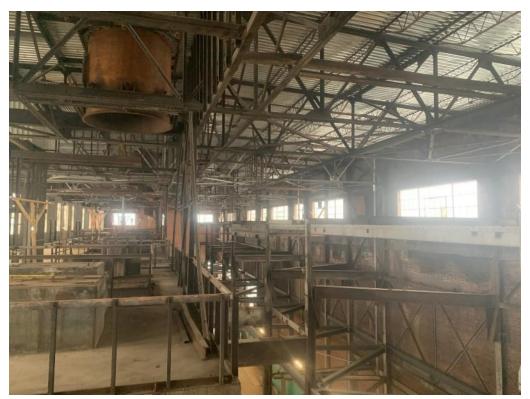
Above: Boiler Hall - Roof and Mezzanine Structure

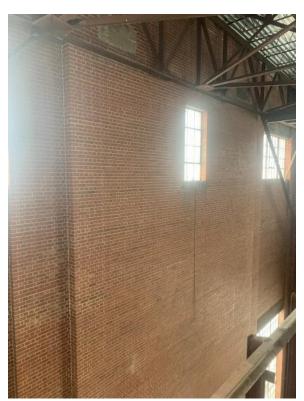
Above: Boiler Hall – Exterior Brick Wall

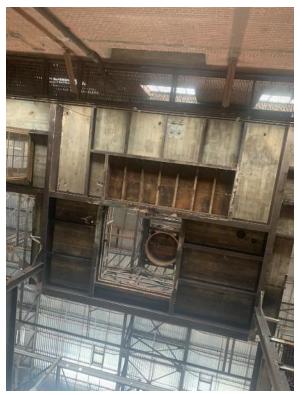
Above: Boiler Hall - Smokestack structure

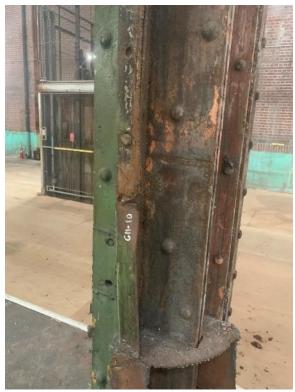
Above: Boiler Hall- Modified Structure

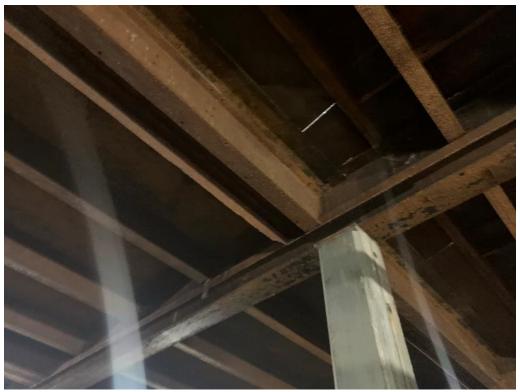
Above: Boiler Hall – Basement Structure
